ARCHAEOLOGICAL WATCHING BRIEF at the FOSSE, RICHMOND

A report to Richmondshire District Council

10th June 2004

Planning application no 1/92W/1600/FULL

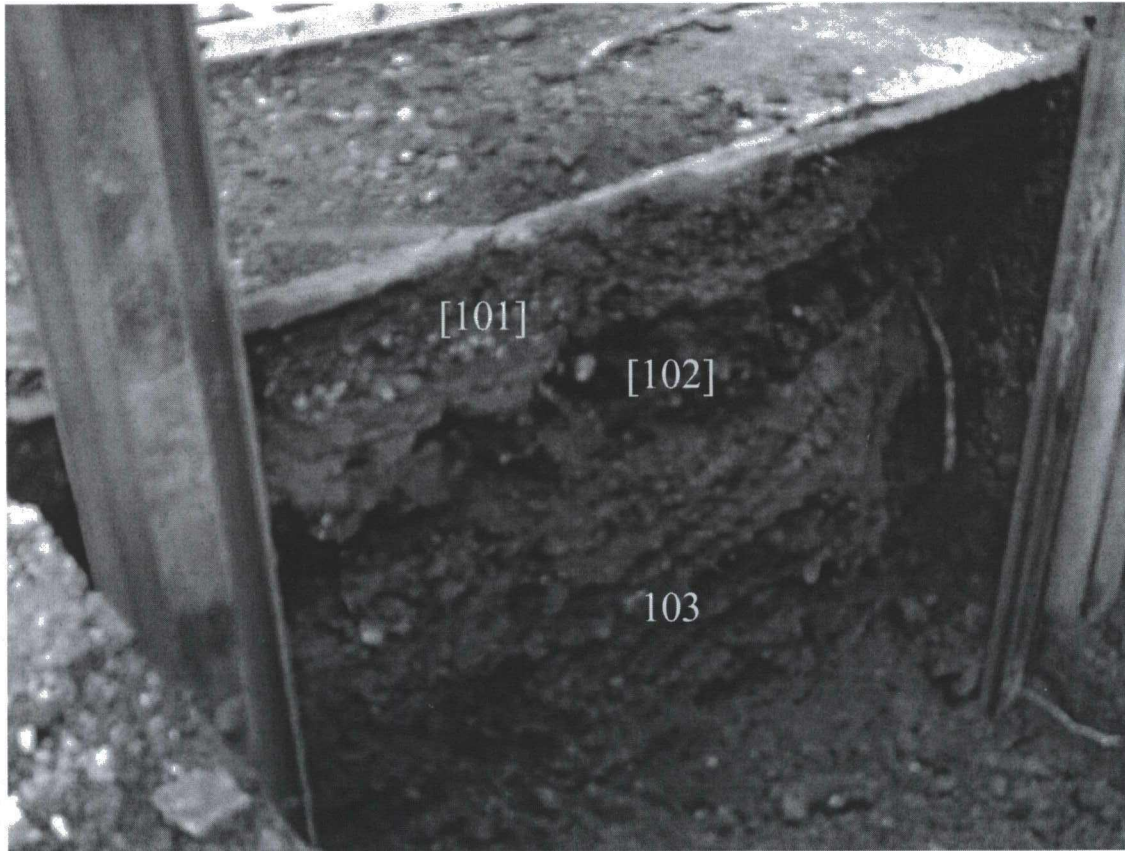
Fig. 3

[101] 0-40 cms Modern asphalt and make-up

[102] 40cms- 1m. Old asphalt and make-up, apparently heavily contaminated with tar

[103] 2m.-3m. Loose backfill of rubble in clay matrix: contained modern material (brick, undecomposed wood, *etc.*), heavily contaminated by tar and other chemical materials

Upper deposits

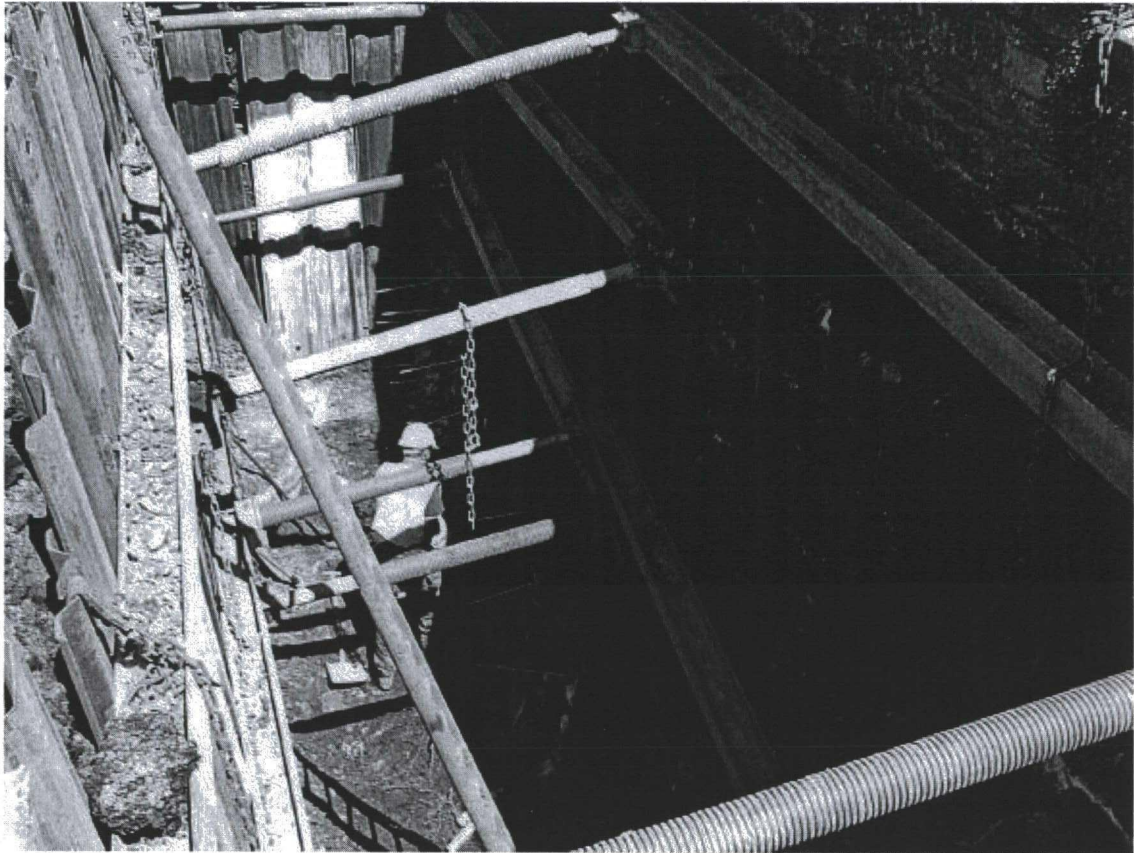
Fig. 4

[104] 3m.-4.8m. Clay backfill with abundant cobbles and boulders, some obvious chemical contamination and small quantities of brick. This deposit, a relatively modern backfill, was nevertheless quite distinct from [103] and clearly represented a separate episode of backfilling.

[105] Below [103] there appeared to be a cut along the south side of the trench, parallel to the river wall and *circa* 1 metre from it: it was filled with material which appeared to be indistinguishable from [103]. Because of the similarity of the deposits, and the constant collapse of the unshored sides, it was not possible to record this in detail, but it appeared to represent a construction cut for the insertion (or more probably the maintenance) of the river wall at a date after the deposition of [103] and approximately contemporary with [104].

Below this level lay the natural rockhead, of flat water-worn slabs identical to those on the river side of the wall.

Full depth of excavation

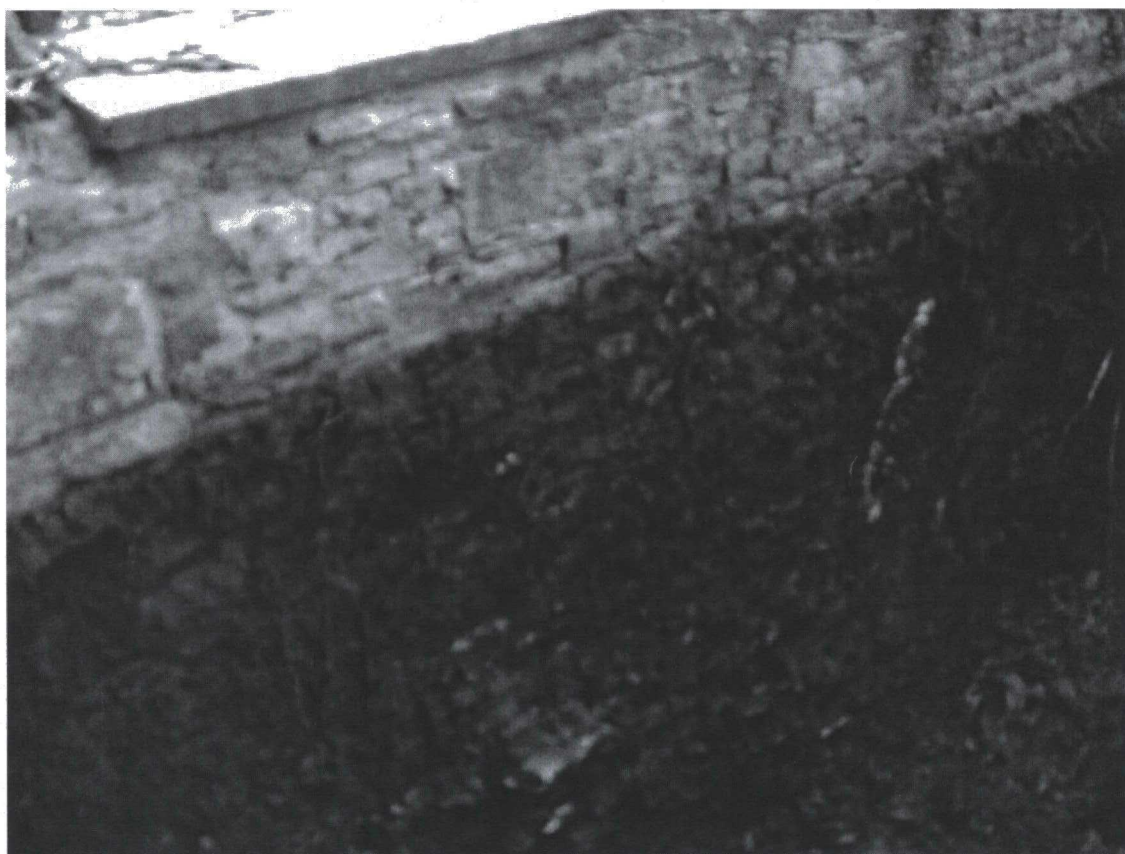
Fig. 5

9. The north face of the river wall itself was exposed during the excavation of the trench: it was not, however, possible to enter the unshored trench to record it in detail. It was a coursed rubble wall, fairly regular in construction, and became decidedly rougher and more irregular in construction below the base of [103]. No trace was seen of any sluice or other feature which might have been associated with the downstream parts of the paper mill.

10. No structural trace was found of the former gasworks or of the paper-mill recorded by the Ordnance Survey (though the latter was situated rather to the south-east of the site under investigation). It seems probable that [102] was associated with the laying-out of the site as a public amenity area in 1972, and [103] seems likely to derive from the decommissioning of the gasworks in 1955 (this would certainly account for the very evident hydrocarbon contamination). The nature of the river wall seems to have been purely as a retaining wall, and the original construction of the gasworks (presumably contemporary with [104]) seems to have been the most

appropriate occasion for its having been built: a subsequent rebuilding or repair would account for [105].

River retaining wall
