**Burton Old Hall Farm
Mam Street
Burton Salmon
SE 4930 2745**

**Building Photographic Survey
and Archaeological Watching Brief**

June 2005

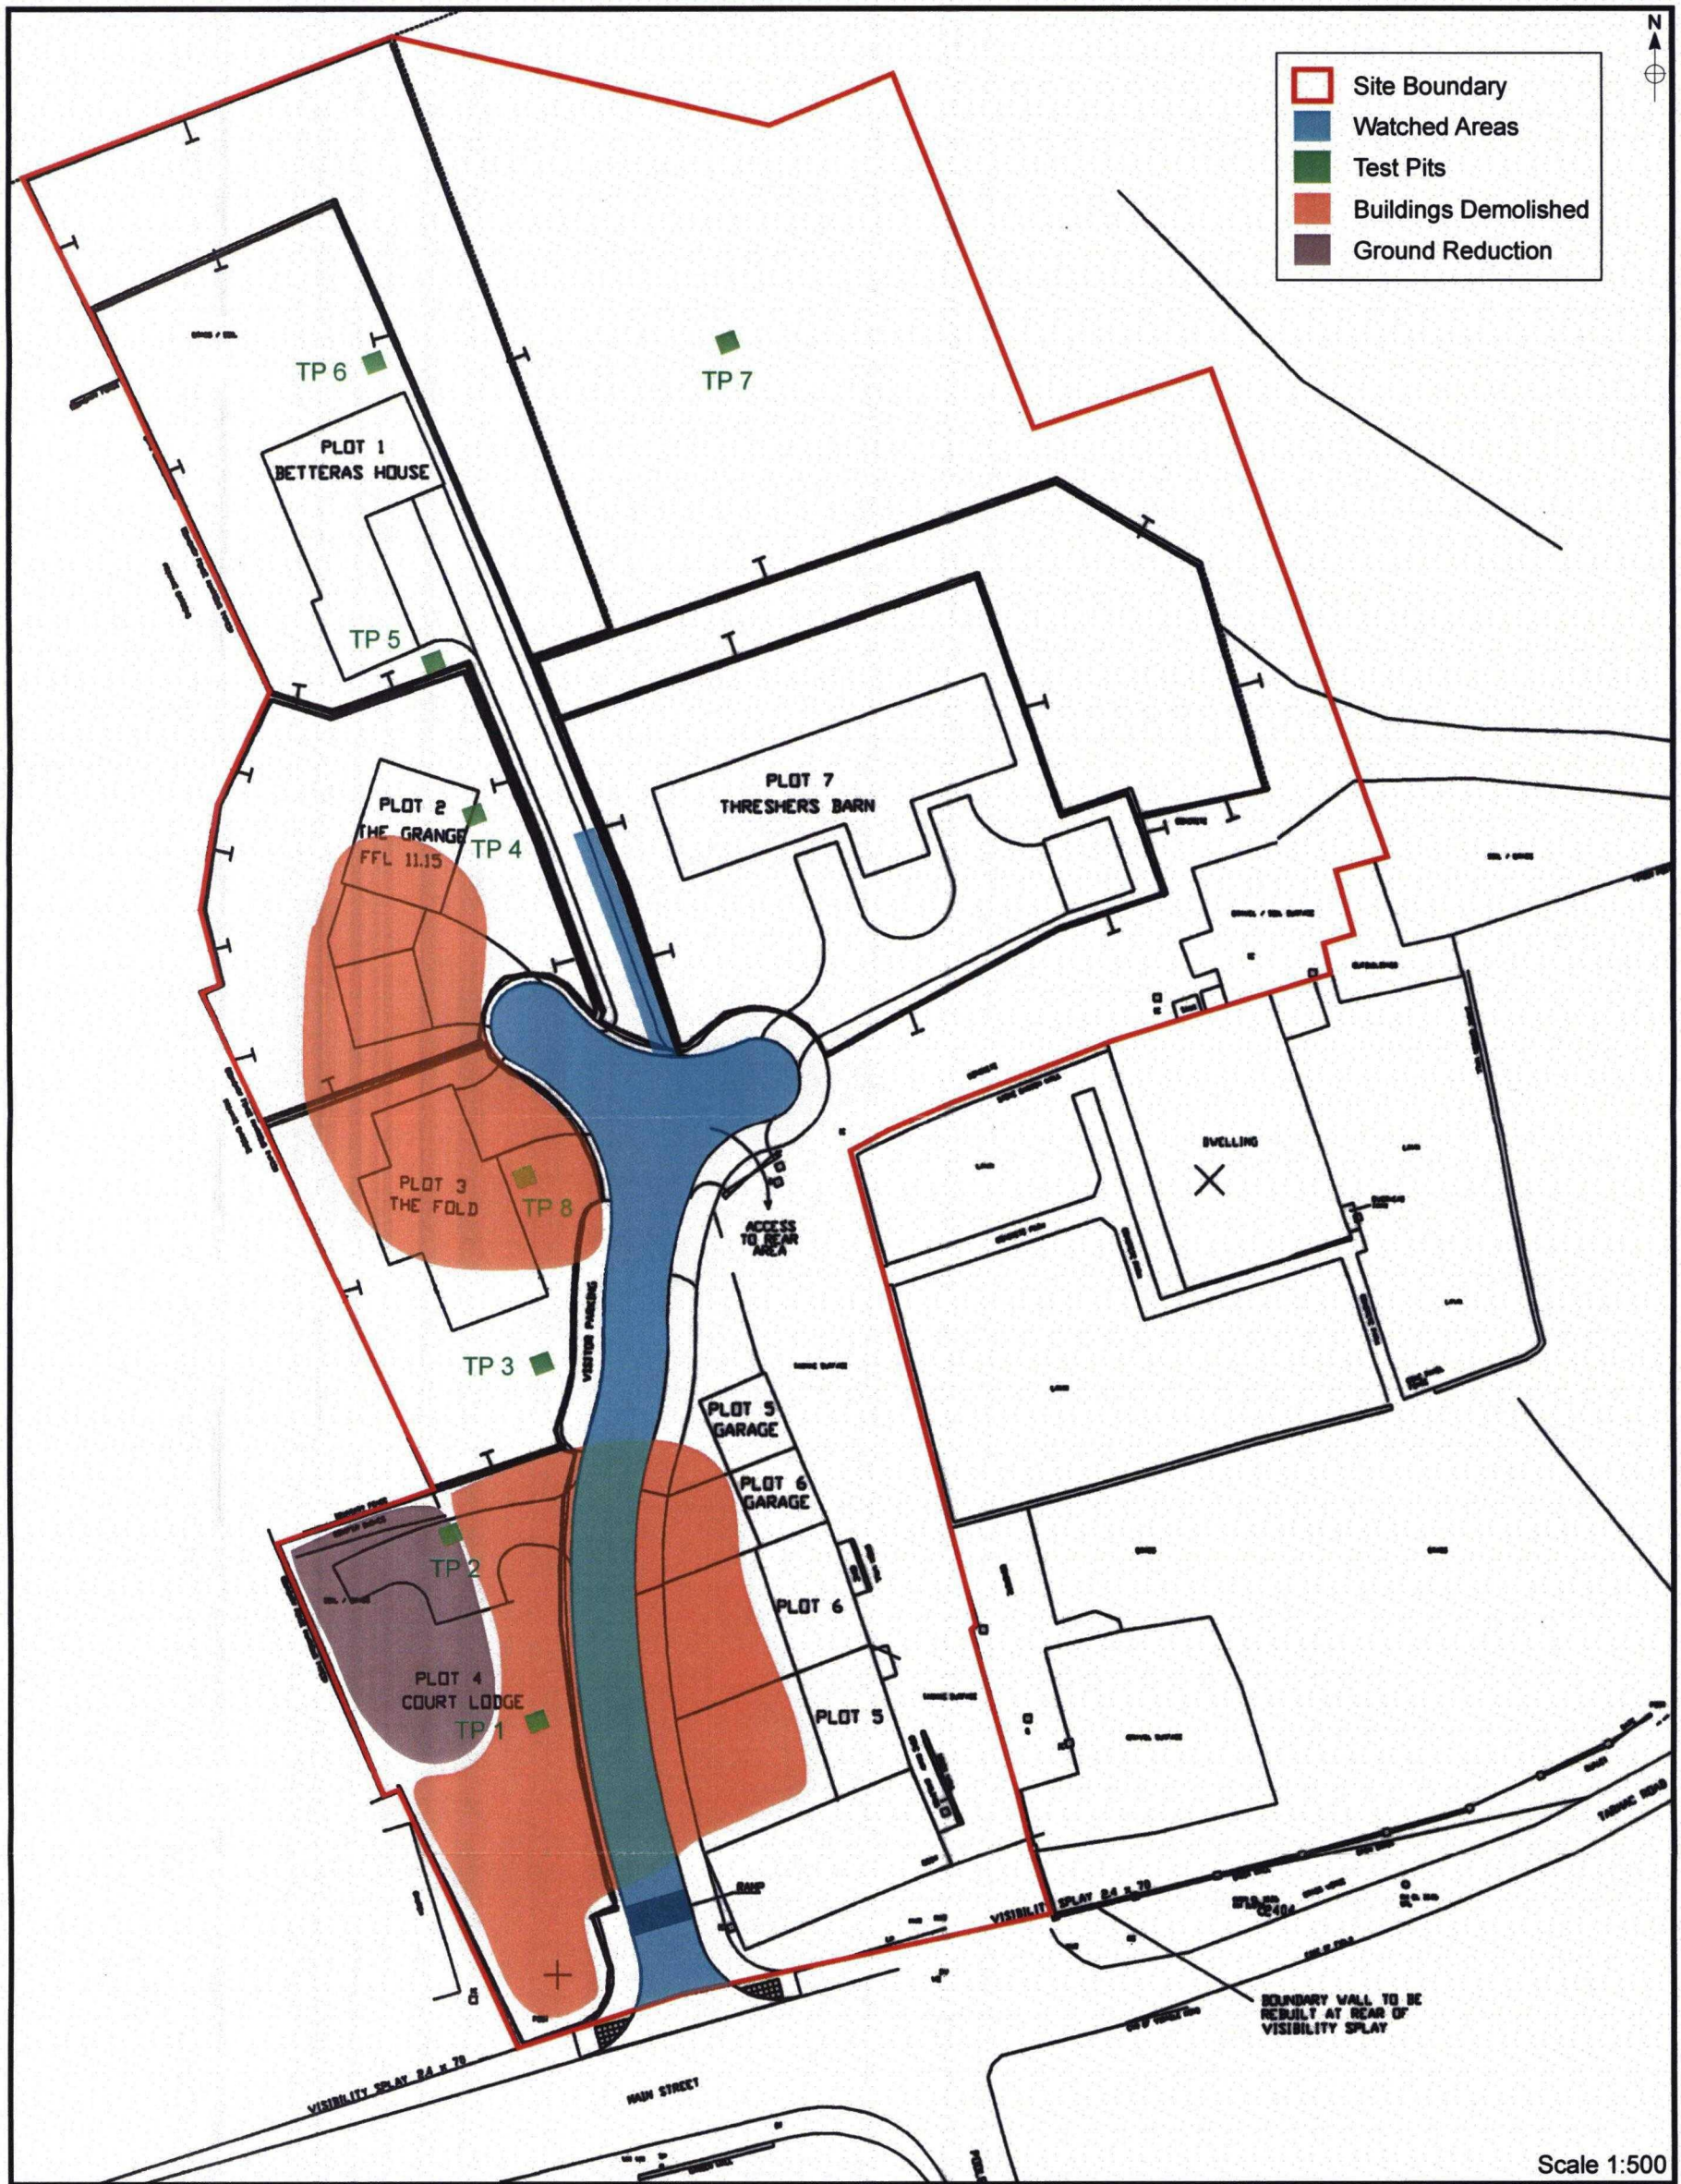
Figure 5. Plan of the Areas Observed During the Watching Brief

Areas observed under the watching brief between April 2004 and June 2004 include demolition and grubbing out of foundations, site topsoil and subsoil stripping in areas for the road ground reduction and excavation of drains (Appendix 2 Fig 5 Pls 17 18 25, 28-32 45—55 57-60)

Engineering Testpits 1 to 7 were excavated under archaeological supervision, and uncovered topsoil subsoil and natural bedrock (Appendix 2 Fig 5, Pls 33 44)

No archaeological features or finds were observed during the watching brief

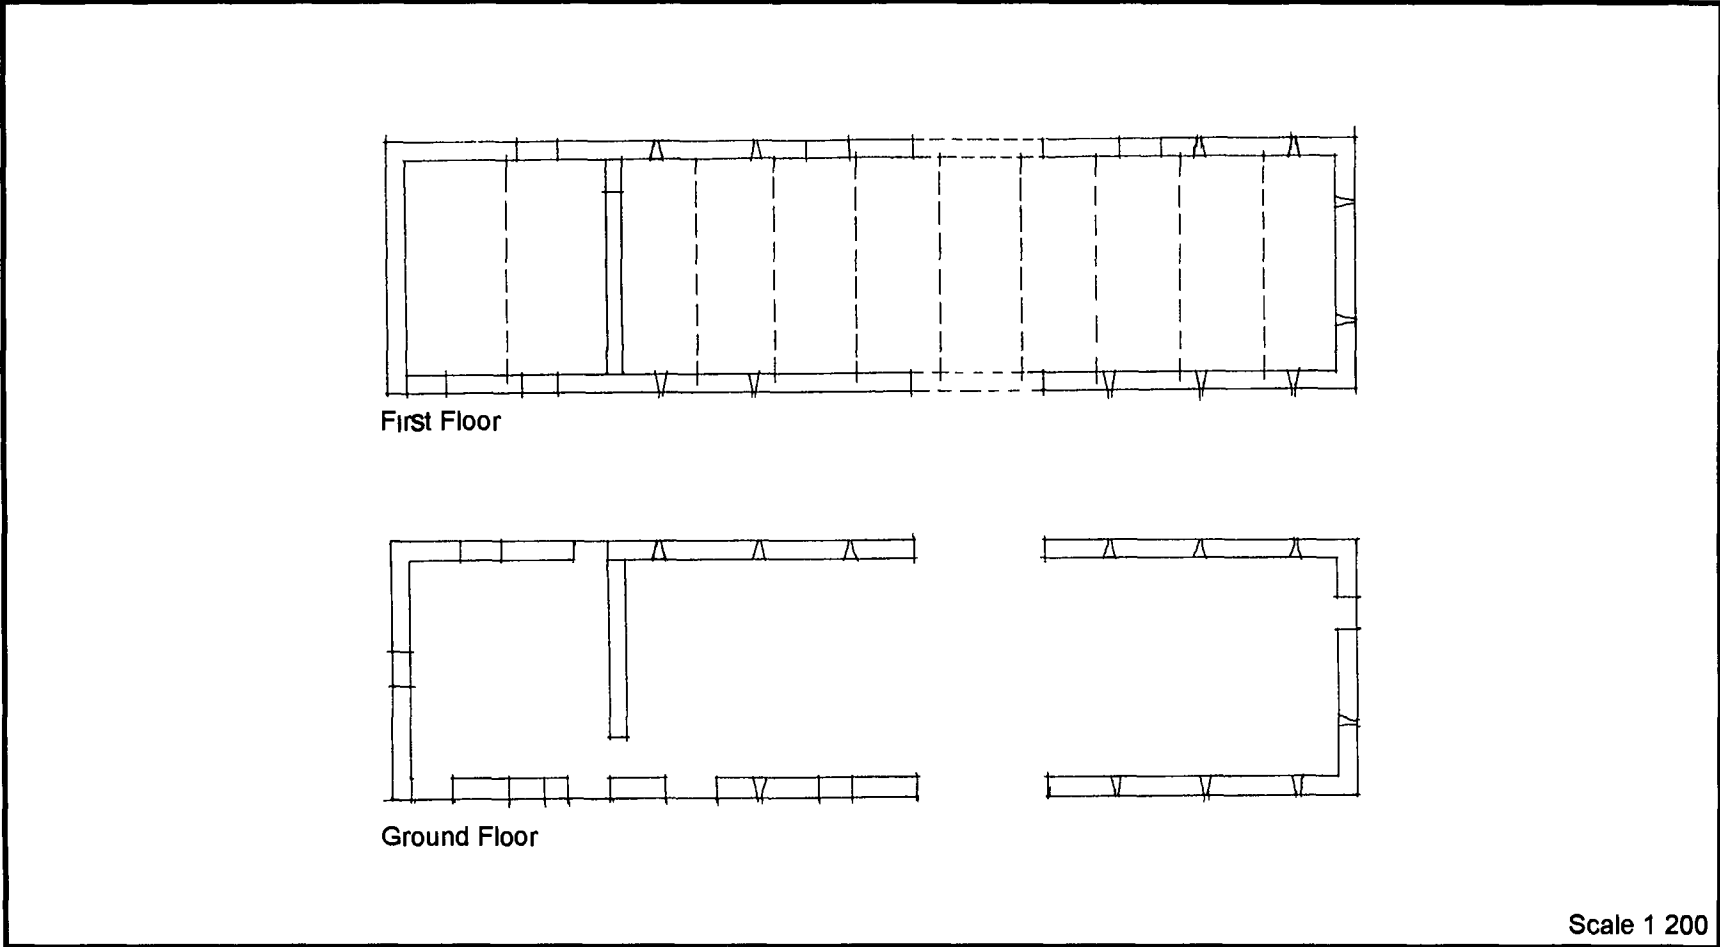
Figure 7 Ground Floor and First Floor Plan of the Barn (Mike Swinglehurst)

The building was a two storey, detached single pile, post-medieval stone built barn with gabled tiled roof. The ground floor had two large cart entrances in the north and south elevations and five other doorways and was lit by three windows and eleven ventilation slits. The first floor was had one door way and five windows and twelve ventilation slits.

Interior Description (Fig 7 & Pls 21 22 82 83 84 85)

The hayloft had previously been removed but the joist holes remain in the walls.

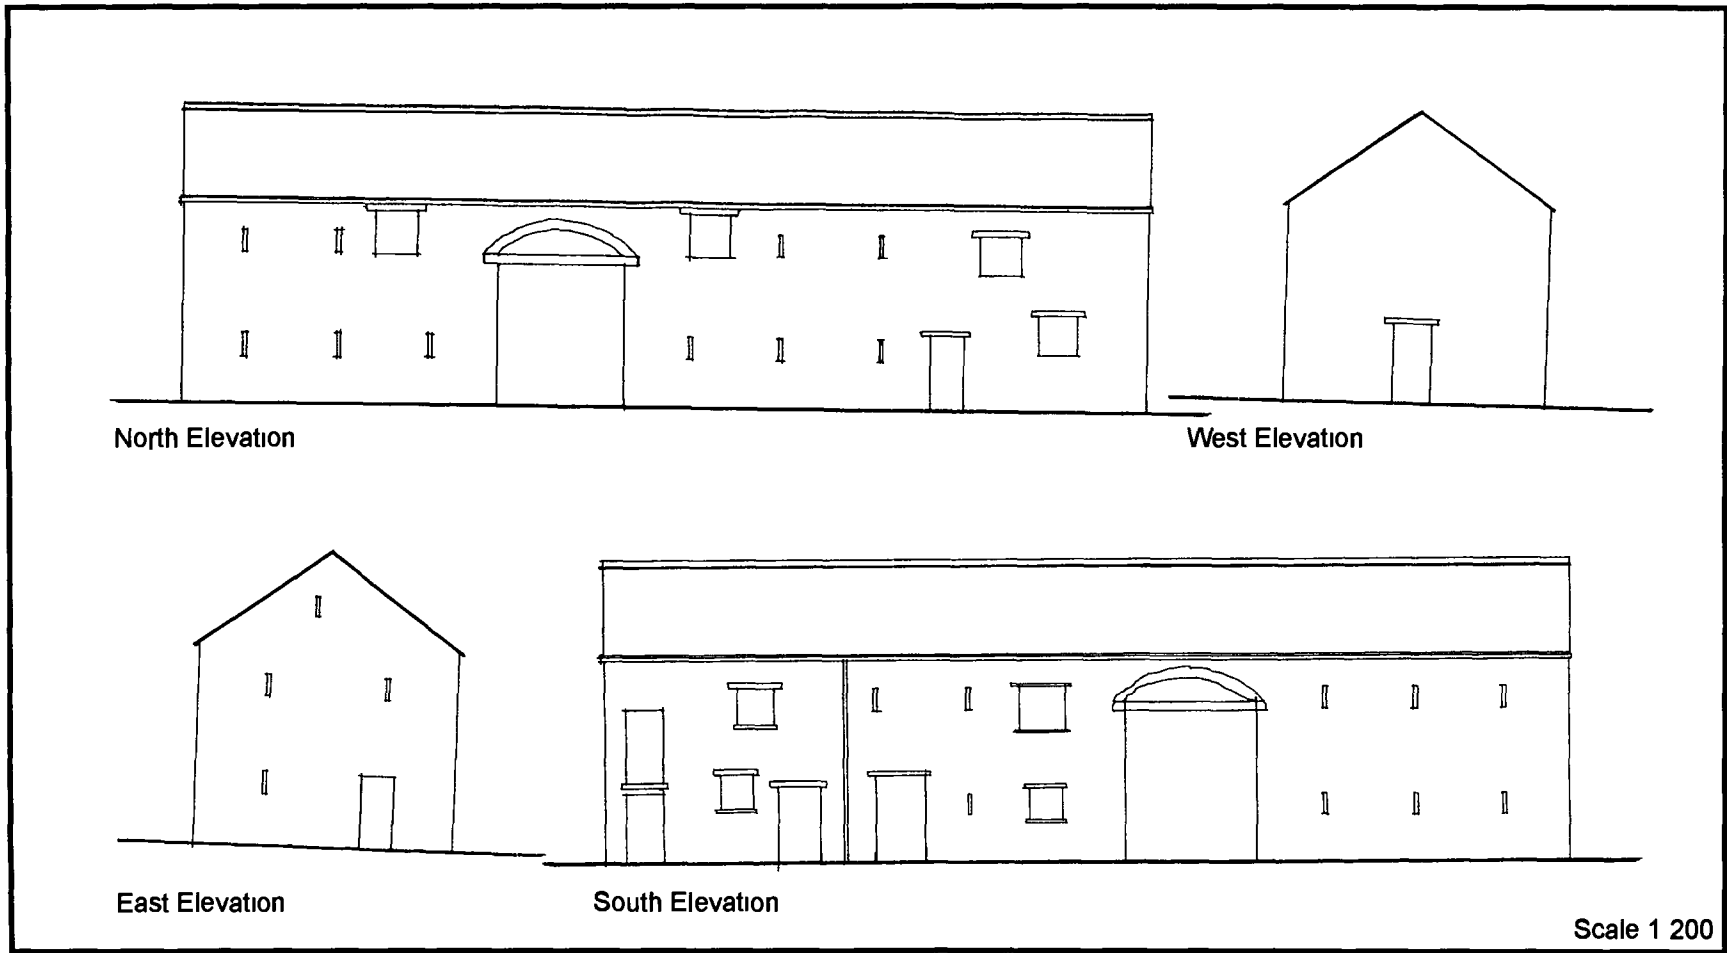
Figure 8 Plan of North West East and South Elevations of the Barn (Mike Swinglehurst)

Exterior Description (Figs 7- 8 & Pls 5-9 13 15 20 23 24 56 61 62 63-81 86-98)
