**Report on watching brief for fence construction on top of Silbury Hill,
Wiltshire,
December 2000**

**By Thomas Cromwell,
English Heritage Centre for Archaeology**

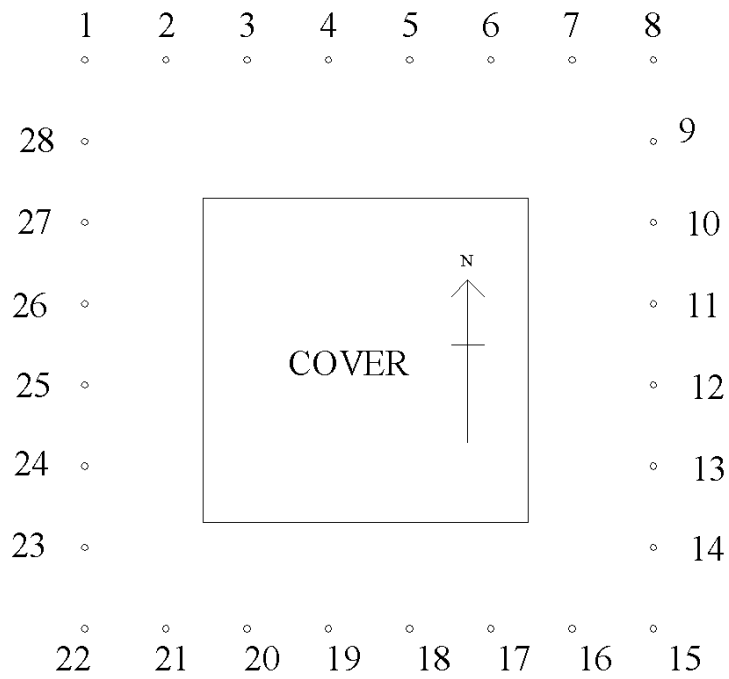
The holes formed a square around the collapsed centre of the hill, and were numbered starting in the Northwest corner and proceeding clockwise. Posts #8, 15, and 22 formed the Northeast, Southeast, and Southwest corners respectively. The enclosure is aligned roughly to the road (the A4), and thus square with respect to the Ordnance Survey mapping grid, although this was not checked by survey.

Sketch plan with numbering of holes. Note that North Arrow is only approximate.
