My ref: 224L06R(b)

**REPORT ON**

**GEOTECHNICAL ASPECTS OF THE STABILISATION**

**OF SILBURY HILL**

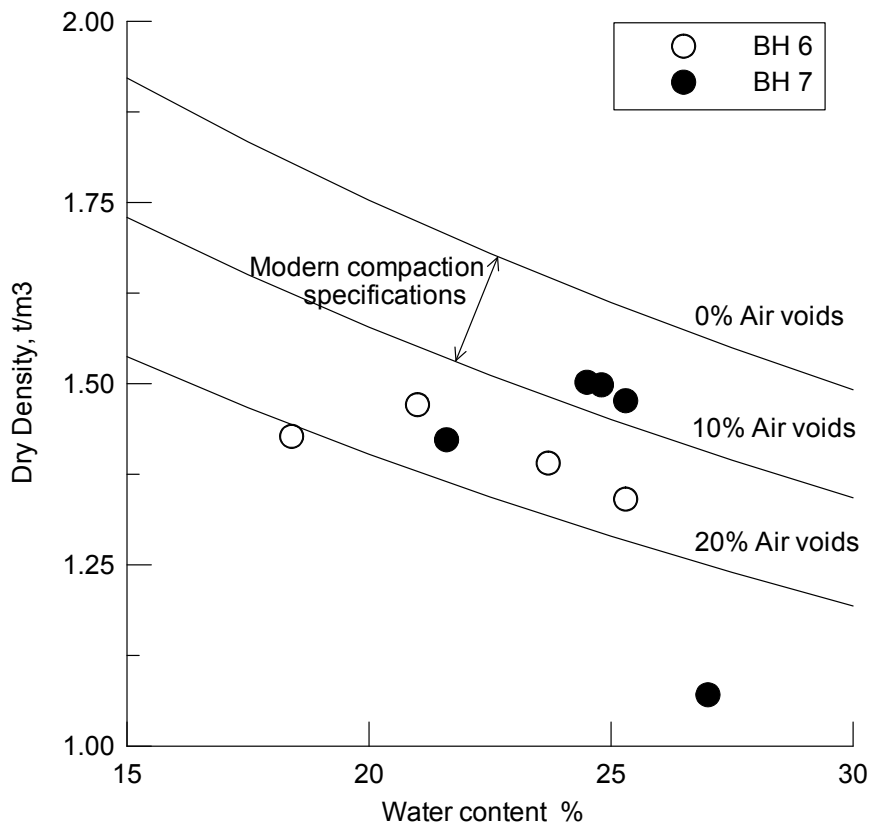
**3.1. Density of the chalk fill in Silbury Hill.** The results of density determinations on samples recovered from boreholes 6 and 7 are shown in Figure 1. Comparison with modern specifications for compacted chalk fill show that most samples are significantly less dense (*e.g.* Lord *et al.*, 2002) than would now be the case. The density measurements are doubtless biased towards more dense material since less dense samples would be unlikely to be sufficiently competent for the measurement technique used, namely determining volume and mass. The sampling process itself may also have resulted in some densification. Thus it is probable that the average density of the chalk fill of which much of the Hill is composed is less than these test results indicate.

**Figure 1. Relationship between dry density and water (moisture) content for the chalk fill recovered from boreholes 6 and 7.**
