Cross Butts, Whitby
Historic Building
Recording

Client: THE INN COLLECTION GROUP

AB Heritage Project No: 62021

Level 2 – 3 Historic Building Recording

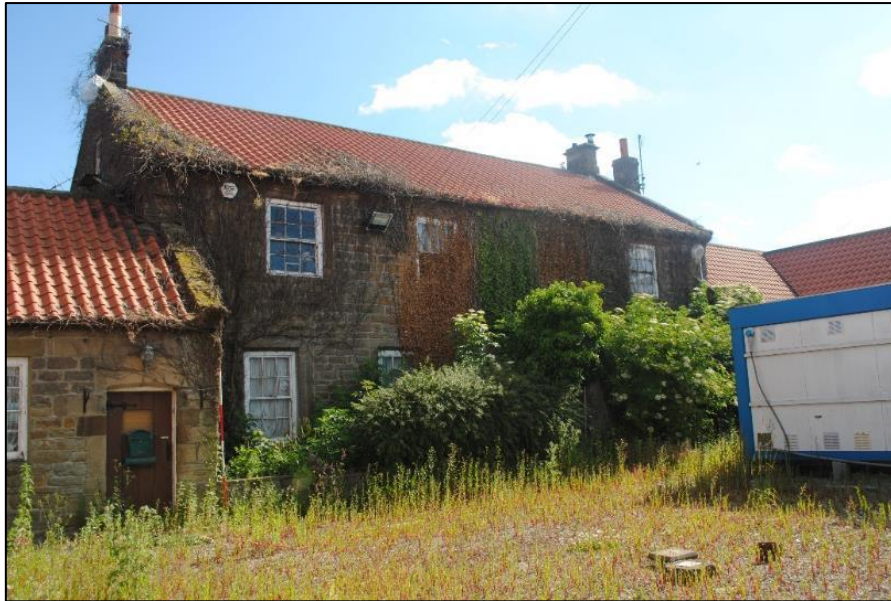
- 4.3.2 As shown on Photo 2 extensive vegetation on this elevation makes full observation of this façade, its features and condition, difficult.

Photo 2. North elevation of Cross Butts Farmhouse [AB 1]

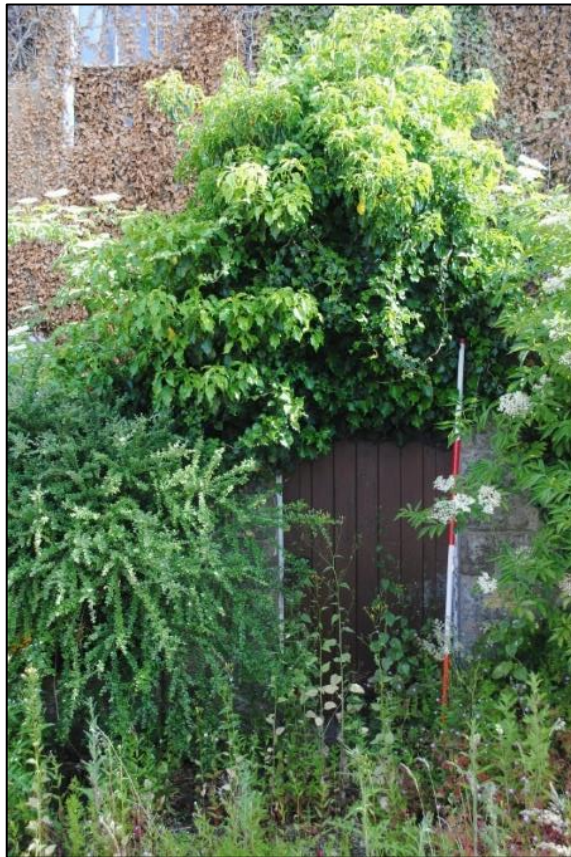
- 4.3.3 The symmetrical façade has a solid and well-constructed appearance typical of a gentleman farmers residence in the late 17th century. The view towards the two-storey farmhouse, with its two flanking single storey barns, when originally observed by passers-by on the Guisborough Road must have been an impressive one.
- 4.3.4 **Walls:** Structural masonry, coursed regular blockwork
- 4.3.5 **Roof:** Modern Pantiles
- 4.3.6 **Windows and Doors - North elevation:** This elevation features non-original, but nevertheless historic sash-windows and there is a redundant, centrally placed entrance porch (Photo 3).

Photo 3. Cross Butts [AB 1] north elevation porch and front door

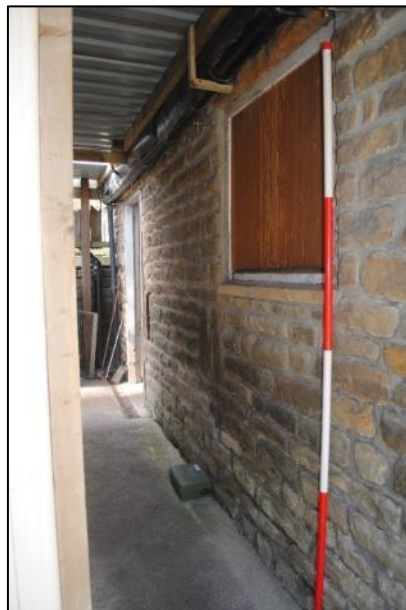
- 4.5.3 **Original built fabric:** On this Grade II Listed Building original built fabric is largely confined to the external built envelope of the structure. To the south the building is connected to the main farmhouse [AB 1] via the small cottage building [AB 3]. The external walls are constructed on course masonry (Photo 22).
- 4.5.4 **Roof:** The buildings have been re-roofed in modern red pantiles.
- 4.5.5 **West wall: Windows:** Windows on the west elevation (Photo 22) are mostly of wooden sash-construction and while not original to the 17th century, are nevertheless of historical date. One of the windows (Photo 23) is currently boarded up.

Photo 23. AB 2 west wall; view NE

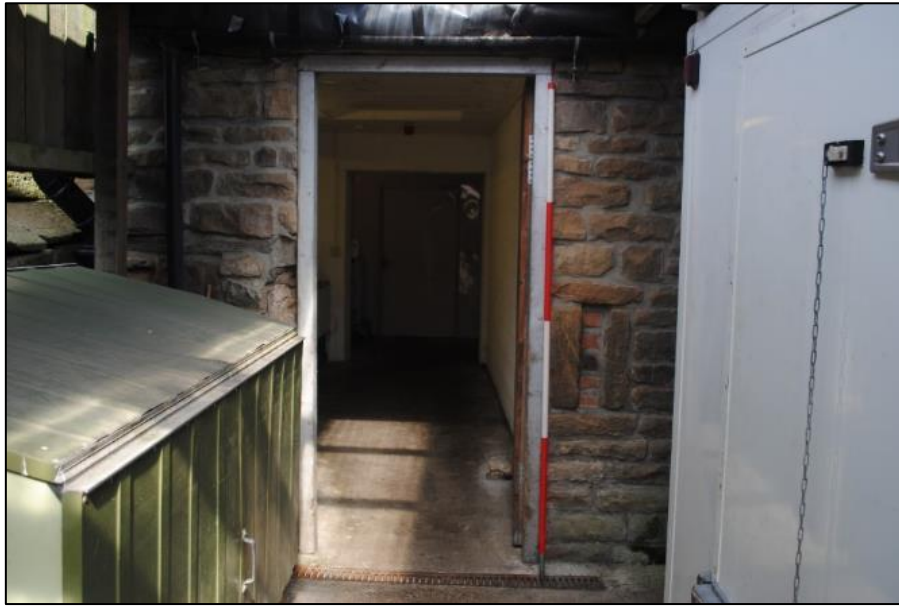
- 4.5.6 **West Wall: Doorways:** As described on the Listed building description and shown on Photos 22 and 24, there are two doorways into the farmyard on this elevation. The northern most doorway has however lost its original stone lintel, and has a timber replacement inserted (Photo 24).

Photo 24. AB 2 west wall, north doorway

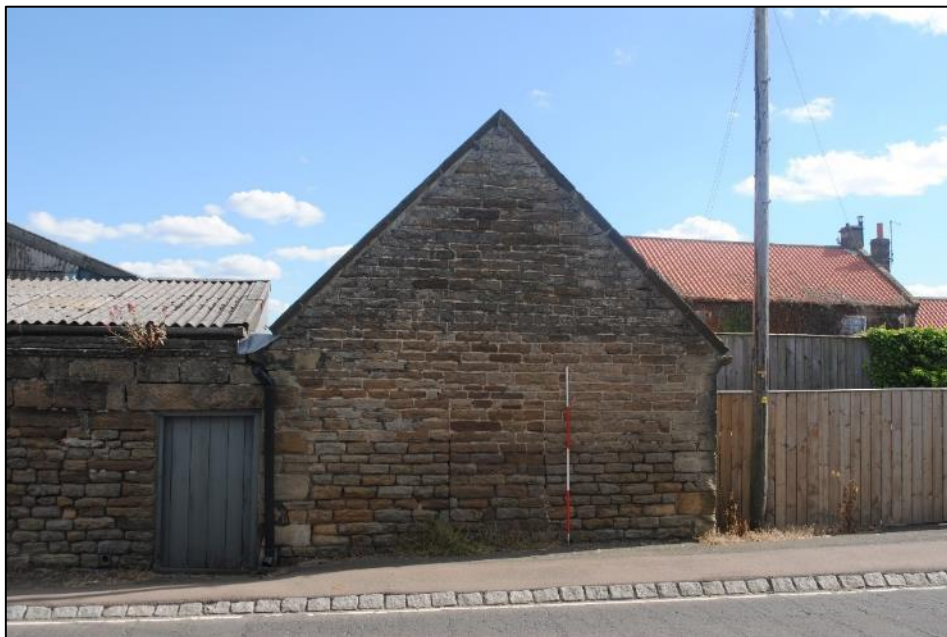
- 4.5.7 **North Wall:** The north gable of the building (Photo 25) is adjacent to the Guisborough Road and features prominent quoins. There is a centrally placed blocked doorway on this elevation (Photo 25).

Photo 25. North gable of AB 2; view south across Guisborough Road

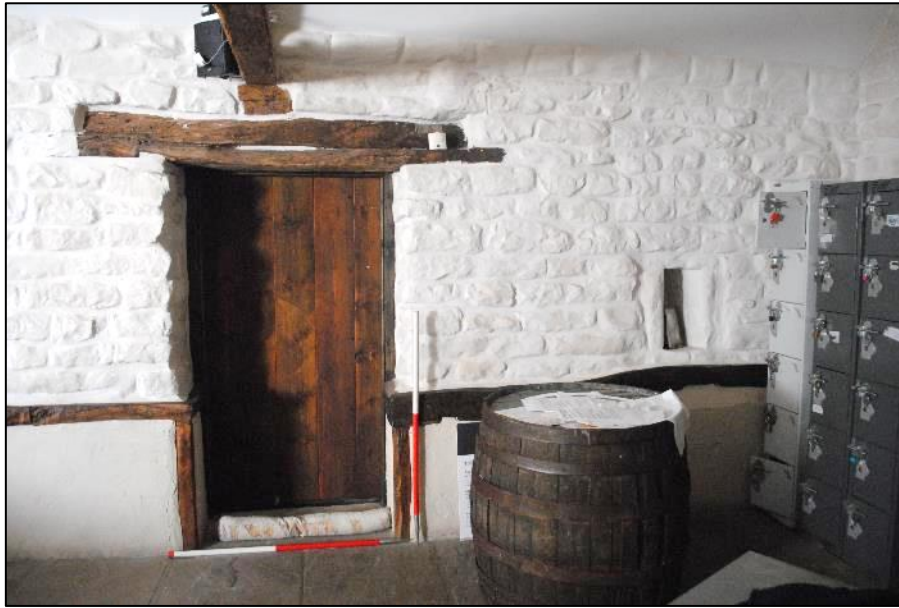
- 4.6.6 There are stone niches along this wall; one of these is shown on Photo 29. These have been interpreted as slots for creating timber partitions for the penning of livestock within the barn (Photo 29).

Photo 29. Room G4, east wall with a stone niche to the right

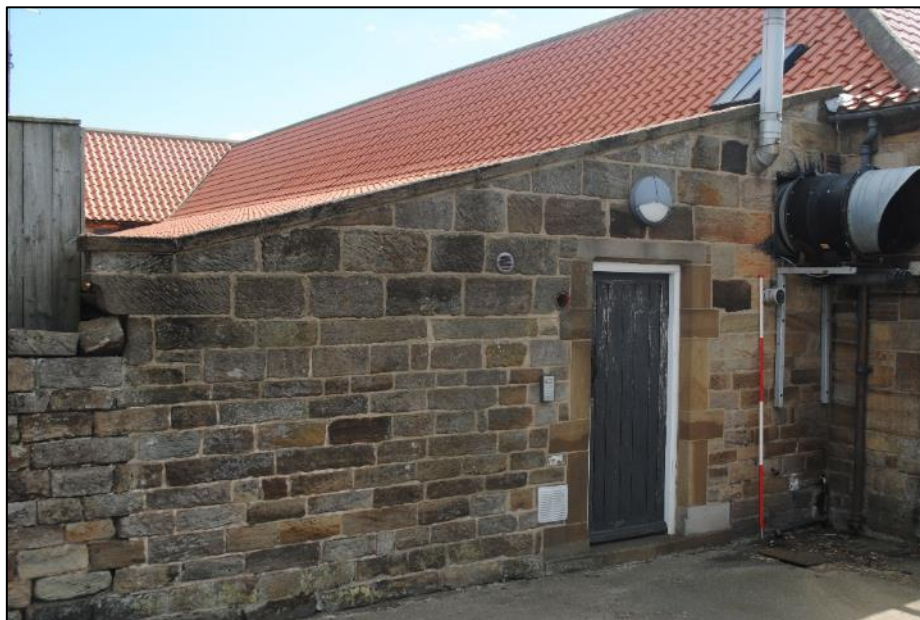
- 4.7.6 **Kitchen extension:** It is assessed that the mono-pitched kitchen extension (Photo 35) has been constructed in part using new stone matching the historic stonework used on Cross Butts farmhouse [AB 1], the east Barn [AB 2], the Cottage [AB 3] and the former Stables; elsewhere it appears that the stonework formerly forming the east wall of the west barn has been shifted eastwards by the width of the kitchen extension and this rebuilt to form the east wall of the Kitchen (K1) (Photos 35 to 37).

Photo 35. North wall of the Kitchen extension (K1); view SW

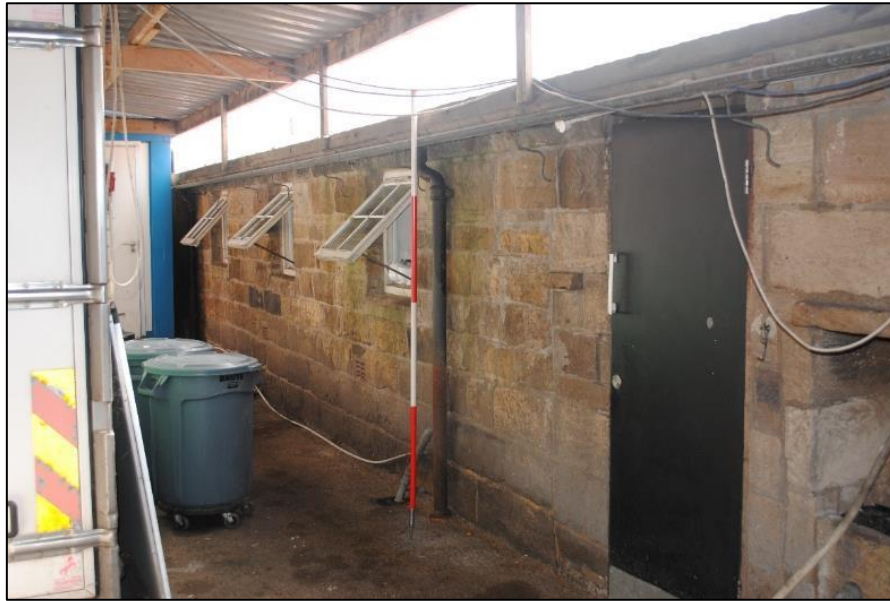
- 4.7.7 The quality of the stonework and the craftsmanship used to re-construct the structure in a manner that is visually almost indistinguishable from the more historic elements of the wider site, is a credit to the skills of the people who have undertaken this work.

Photo 36. Kitchen extension (K1) east wall; view SW; interpreted as re-use of older stonework

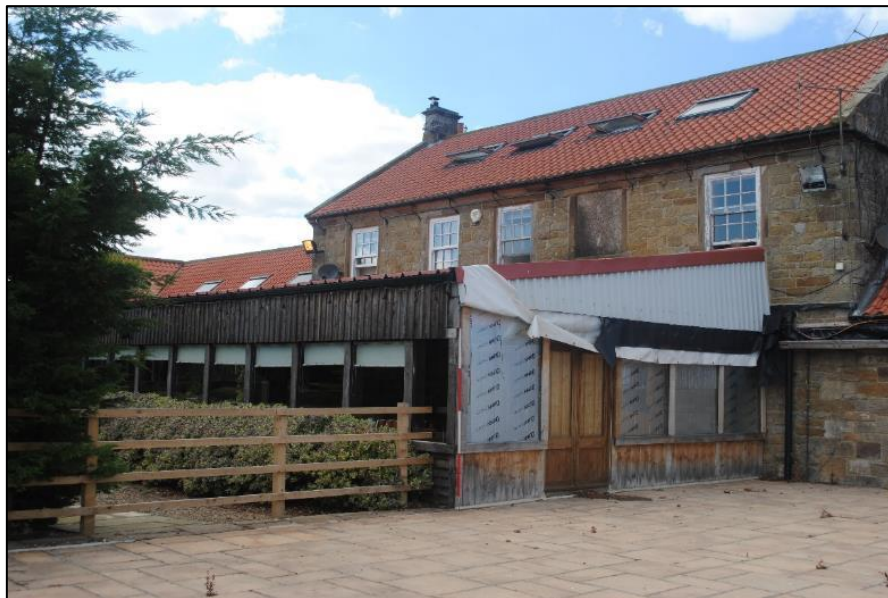
Photo 59. Sun Terrace (S1); poor quality finish to the east gable; view NW

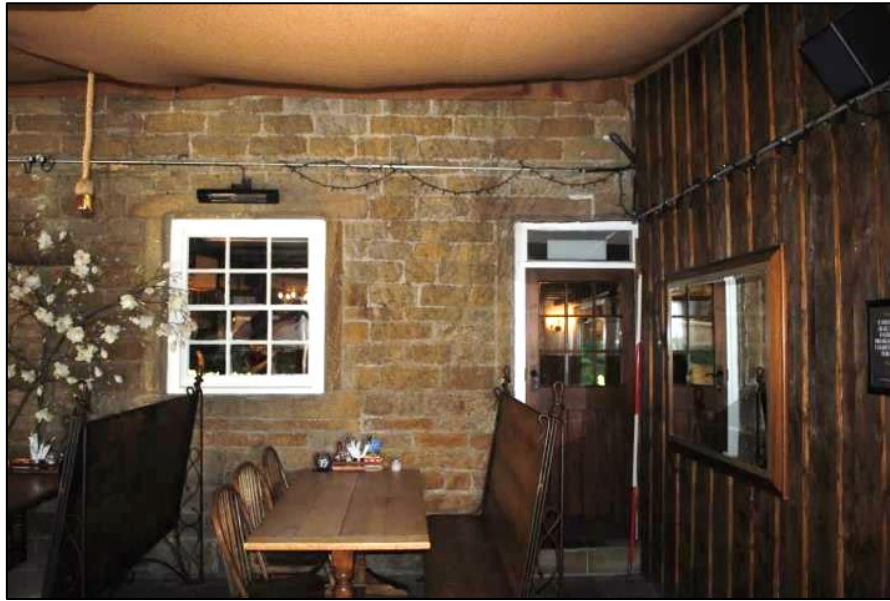
Photo 64. Later doorway (on the right) and an original window location (on the left); view N

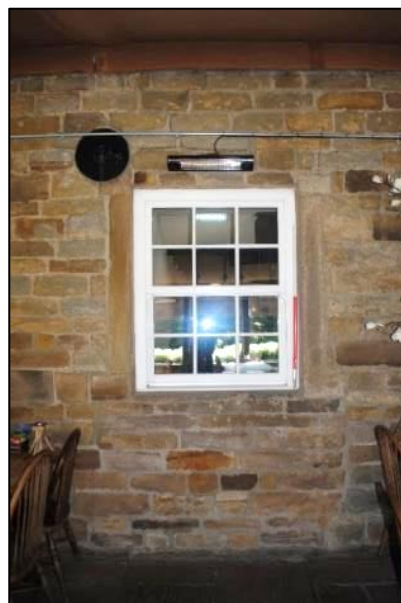
Photo 65. Window inserted into a former doorway; view N

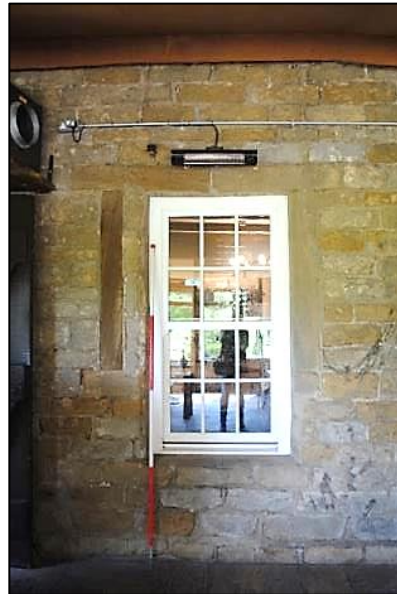
4.11.12 The western of the three windows on this wall is assessed to be a taller and later replacement. The current sash-window is taller and narrower than the original square window

Photo 66. Sash-window replacing an earlier square opening; view N
