# No. 65 High Street, West Malling, Kent Historic Building Recording

Client: DEBLANC STUDIOS AB Heritage Project No:10583 Date:10/07/2015

Client	Deblanc Studios
Project Number	10583
Prepared By	Kerry Kerr-Peterson
Illustrated By	Zoe Edwards
Approved By	Andy Buckley

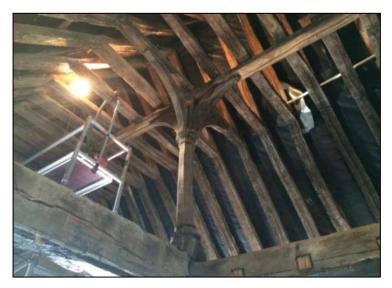
Photo 2: The crown post roof within No. 65 High Street, viewed from the first floor level, taken during the refurbishment works

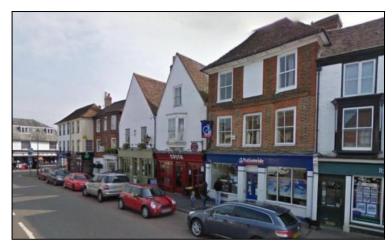
Photo 2: No. 65 High Street along the West Malling High Street. Viewed from the south-west prior to the refurbishment works

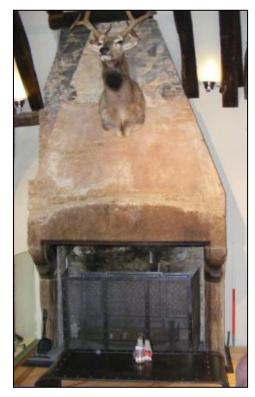
Photo 4: The original Medieval stone fireplace with later brick stack, taken during the site visit

- 3.6.14 A stone and brick chimneypiece is located on the north wall (Photo 4). This has a stone lintel and is supported by two carved stone corbels. The canopy is a later chamfered plastered English bonded brick replacement of 16<sup>th</sup> or 17<sup>th</sup> Century date. The stack has been reduced in width on the west side (Photo 13). The upper part of the stack is a 19<sup>th</sup> Century replacement. In the attic space the rafters have been reduced to make way for the insertion of the stack and reattached to a horizontal beam running across the upper part of the stack.

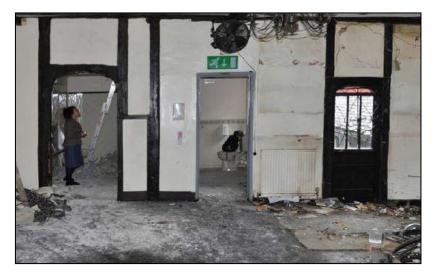
Photo 5: Medieval doorways located on the east wall of the first floor, taken during the conservation works

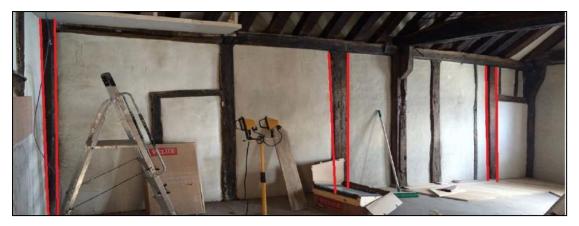
Photo 6: South wall of the 1<sup>st</sup> floor. The beams (digitally outlined in red) may mark the previous line of a structure that ran along the position of No. 67 & 69 (taken during conservation works)

- 3.6.12 Two later doorways have been inserted into the south wall (Photo 6). A later plastered ceiling had been inserted with painted narrow wooden joists. On the advice of Historic England, in a letter to Tonbridge and Malling Borough Council (dated 17<sup>th</sup> January 2014), this later ceiling was removed during the conservation works, in order to expose the crown post roof.
- 3.6.13 Pegs holes and slots were present on the north and south end of the central truss for a missing arch brace (Photo 13). The missing arch braces have been replaced during the conservation works and secured to the truss using wooden pegs and the original peg holes.

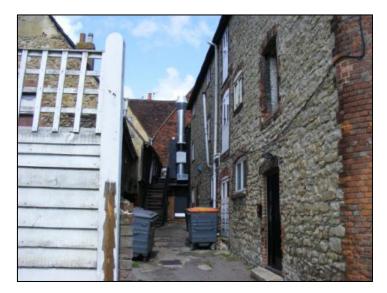
- 3.6.4 The upper part of the rear of the building is clad with 19<sup>th</sup> 20<sup>th</sup> Century industrially produced overlapping red ceramic tiles. The lower part consists of a small modern stretcher bonded brick extension on the east side of the building with a door leading to the rear yard. The encroachment of the link block on the north side of No. 67 High Street is evident at the rear of the properties (Photo 8).

Photo 8: The rear of the properties shows the encroachment of the link block into No. 65 High Street, taken during the site visit

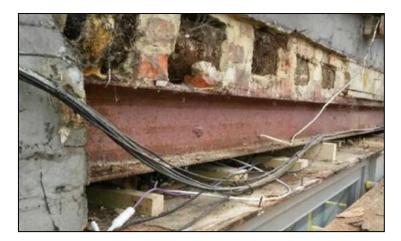
- 3.6.3 During the replacement of the wooden signage board on the front of the building, the ends of a number of the first floor timber joists were visible behind a layer of stucco that had been removed. The jetty plate had been replaced with a steel girder. The gaps between the timbers had been filled with modern industrial bricks with a buff yellow mortar (Photo 9). The ends of the timbers had been removed when the jettied front of the building was cut back, probably during the 19<sup>th</sup> Century. The ends of the timbers were recovered by the new signage board.

Photo 9: Timber first floor joists located behind the stucco on the front of the building, taken during the refurbishment works

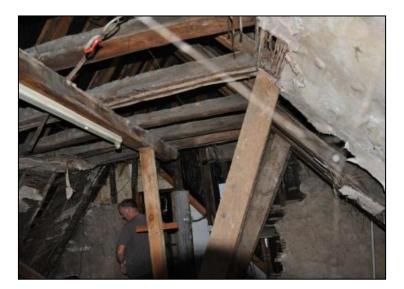
Photo 10: The plastered wooden lath stud walls and reed ceiling within the former attic space, taken during the early stages of the conservation works

- 3.6.7 Several modern timbers had been inserted beneath the crown plate and a number of the rafters, to provide additional support. (Photo 10). These modern timbers were removed during the refurbishment.
- 3.6.8 The attic space revealed the interior of the 19<sup>th</sup> Century stretcher bonded brick chimney stack on the south wall (Photo 11).

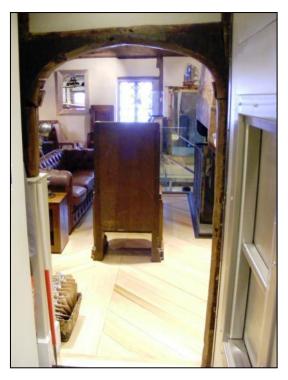
3.6.11 The first floor east wall contains a doorway with a four-centred doorhead that dates to c. 1450-1475. The exterior head and jambs of this doorway have chamfered edges (Photo 12). An additional medieval former doorway is located further to the south (Photo 5). During the refurbishment this was converted into a window. Both of these doorways would have originally led to a former extension on the eastern side of the building.

Photo 13: Medieval chamfered doorway on the east wall of the first floor, taken during the site visit

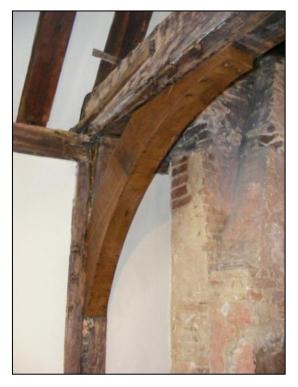
Photo 14: Replacement arch brace on the first floor, taken during the site visit

- 4.1.7 Historic England commented in a letter to Tonbirdge and Malling Borough Council dated 17<sup>th</sup> January 2014, that they were conscious that replacement timbers were sympathetically adjoined to the historic fabric and that as many of these were retained as possible. The replacement of a number of the failed original timbers was necessary during the conservation works to ensure the structural integrity of the building was maintained. These timbers had deteriorated due to the results of water ingress and wood boring insects over a lengthy period of time. The replacement timbers are sympathetic in nature and design and have been connected to the original timbers using traditional wooden pegs and the original peg holes (Photo 13).

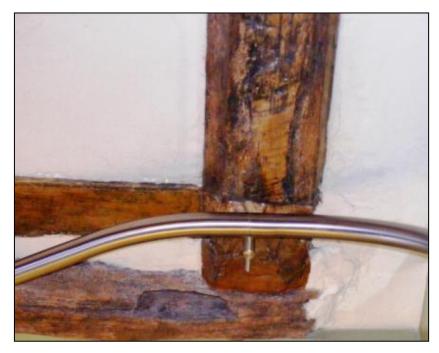
Photo 15: Tooling marks on timber in the stairs area of the building, taken during the site visit

- 4.1.5 Some original tooling marks were identified on a stud wall timber in the stairs area of the building (Photo 14).
- 4.1.6 As discussed above, several features of the building were exposed during the refurbishment, including timber lath stud walling (Photo 10), a later blocked window (Photo 16) and the first floor timber joists behind the stucco on the front of the building (Photo 9). All of these historic features have been covered over with new stud walling, which may improve survival of original features beneath the modern refurbishments.

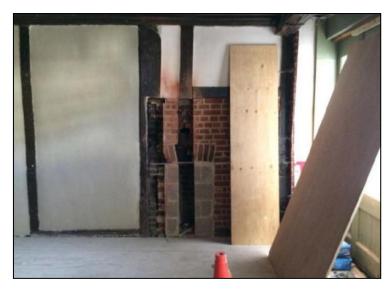
- 3.6.17 A 19<sup>th</sup> Century chimney stack was exposed at the western end of the south wall. This had a narrow hearth and a curved brick overarch and had been blocked with modern breeze blocks (Photo 15).

Photo 15: 19<sup>th</sup> Century heath and chimney stack located in the south wall of the ground floor, taken during the refurbishment works

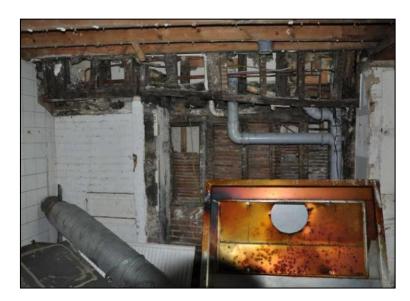
- 3.6.19 In the south-east corner of the ground floor, beneath the stud walling, part of a probable c.
  16<sup>th</sup> 17<sup>th</sup> Century projecting timber window frame was visible. The window frame had rectangular panes and flat, square stanchions. The width of the window had been extended and incorporated into a later brick bay constructed from narrow stretcher bonded bricks. There is a layer of bricks beneath the window that have been laid obliquely for decoration (Photo 16).

- 3.6.20 The window had been blocked from the adjacent property with plastered wooden laths and the patina and nail holes on the window frame suggest that it had formerly also been blocked

with wooden laths (Photo 16). The stud wall and window were concealed behind new stud walling during the redevelopment.

Photo 16: Timber wall studs and blocked window in the south-east corner of the ground floor, taken during the refurbishment works

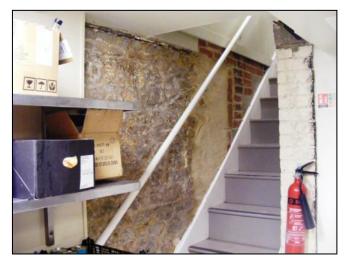
Photo 17: Ragstone wall and sill beam visible in the cellar, taken during the site visit

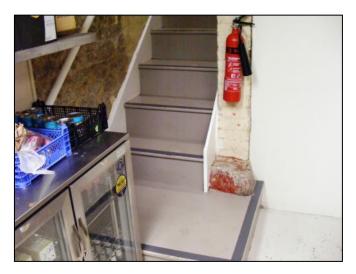
- 3.6.22 The cellar was accessed via a short modern staircase from the ground floor kitchen. The western part of the northern wall was constructed from 13 rough courses of sub rectangular shaped blocks of Kent ragstone, averaging c. 0.30m long x 0.30m wide. These were bonded with a moderately coarse buff yellow mortar. The bottom of a sill beam is visible above the stonework. Both of these have evidence of a former covering of lime plaster (Photo 17).
- 3.6.23 The eastern part of the northern wall and the exposed part of the southern wall of the stairway were constructed from modern stretcher bonded bricks (Photo 17).
- 3.6.24 The corner of the one of the original lower stone steps was visible on the southern side of the base of the modern wooden staircase (Photo 18).

Photo 18: Evidence of the original stone steps at the base of the modern cellar staircase, taken during the site visit
