Level 2 Historic Building Survey
Project Code: A0098.1
Report no. 0105

The Ash Barn, Woodhouse Lane, Audlem, Cheshire, CW3 0DT

Level 2 Historic Bulding Survey Aeon Archaeology 25, Mold Road **Broughton** Chester CH4 0PQ

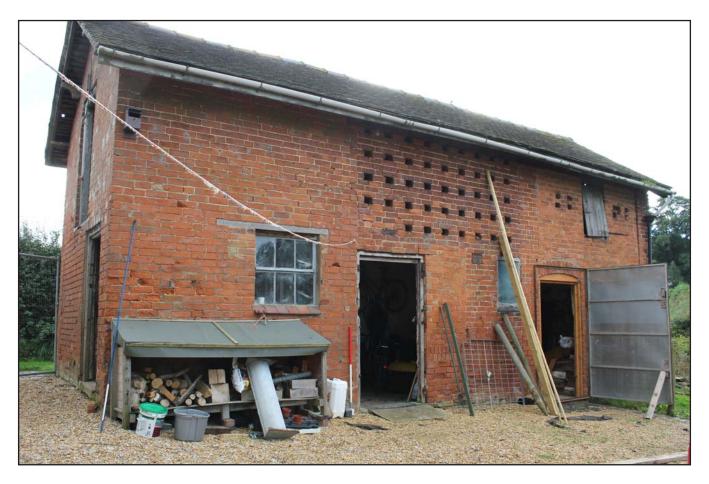
The barn's roof is comprised of ceramic 'nibbed' roof tiles with red ridge tiles running across its spine. Directly below the eaves of the roof, pine purlins support the roof's wooden structure and also visible are some of the battens that the tiles hook onto. At the extreme southern end of the building there is a modern plastic downpipe finished by a traditional cast iron hopper head. The roof of the structure sits upon a reasonably substantial pine purlin along three quarters building's length from the south, and on a smaller purlin towards the northern end.

From the left end of the elevation the original brickwork demonstrates an 'English Cross' pattern. There is a window located approximately 1.70 m from the left corner and 1.30 m up from ground level. The window is approximately 0.90 m square, single glazed with lead window cames. The exterior window sill is formed from dark red tile.

Immediately to the right of this window there is a wooden framed door with original door jambs; on the left half of the frame is a barrel bolt lock receiver and simple pin lock with a chain. On the right half of the frame the original hinges are visible where a door would have initially been fitted onto the outside of the frame. The door's construction is of heavily reinforced plank and battered design which opens inwards on hinges from the interior of the frame at the left hand end.

Above the door frame the brickwork changes to allow for ventilation slots demonstrating bricks on-end design; these slots are arranged in four banks of nine north to south separated by a single brick separator (the lowest bank is of seven ventilation slots), each of these banks are separated by three courses of bricks. The bricks appeared to be more weathered at this location. Also visible on this section of the western elevation are two metal grates, presumably also for ventilation. To the right of door mentioned earlier the brick type changes to a darker variety. Also 0.70 m up from ground level at this point two distinct courses of bricks are visible demonstrating a header design, or perhaps they were coping on end bricks reflecting an earlier wall level. Approximately 1.50 m to the south from the door and 1.60 m up from ground level is a small single-glazed window with a wooden frame 0.84 m tall by 0.64 m wide.

The southern portion of the western elevation is slightly different in terms of brickwork from the northern portion; it is composed of a darker fabric of brick in the central part to southern area of the elevation before becoming a lighter orange in the upper right corner; these probably represent a later phases in reconstruction. There is a distinct 'gap' running parallel with the window frame demonstrating the presence of an earlier brick pillar (0.48m width) another potential pillar is also visible at the southern end of the building, this is also made visible by a distinct 'gap' in the brickwork. Therefore the remaining brickwork on the western elevation appears to be an attempt at "bricking-up" in between the pillars clearly making it a later phase than the pillars. Into this phase of building a modern doorframe has been inserted

into the wall with a brick arch possibly installed above the door to act as a lintel supporting the brickwork above. The modern door jambs are supported by square cut stones with an end-on course of darker bricks forming the step-up into the barn at this point. Furthermore an exterior metal frame has been fixed to the brick wall here in order to support a modern metal security door. This metal door covers the door frame and brick arch when closed and measures 2.40 m in height and 1.50 m in width.

Immediately to the south of this modern door is another metal venting grate and just prior to the gable end is another small wooden framed window, dual-paned with a dark quarter brick window sill measuring 0.90 m in height by 0.60 m in width. Above the metal security door and also within this 'bricked-up" phase two banks of two ventilation slots are visible. These banks of ventilation slots are separated by a dilapidated wooden latched door with decorative cast iron hinges.

Plate 01: Western elevation showing windows and doors - from Northwest - Scale 1m

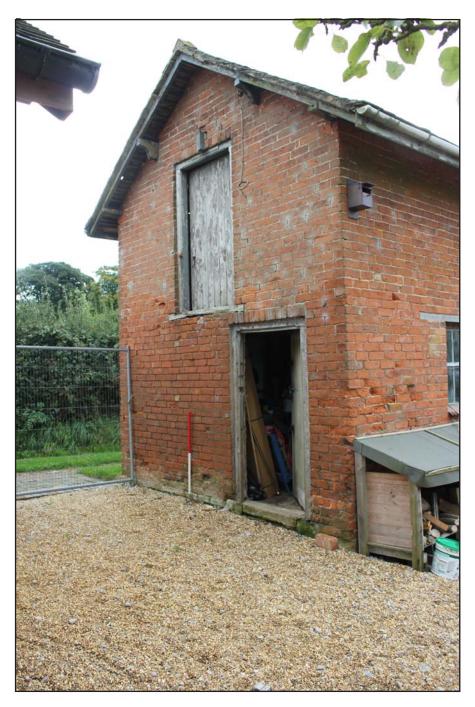
Emanating from through the gable end brick-work are the ends of the roof purlins which are finished rather decoratively with a crescent cut. All the brickwork on the open northern gable end is of a uniform 'English cross' pattern. The upper portion of the gable is dominated by a large wooden door with wooden door jams surmounted by a single course of bricks (bricks on-end coping) and single cut-off rafter, the saddle of the door demarked by a wooden threshold. Slightly offset to the west below the central door is a lower entrance door also of wooden construction but with a sandstone threshold.

Plate 02: Northern gable showing upper door and workshop entrance - from Northwest - Scale 1m

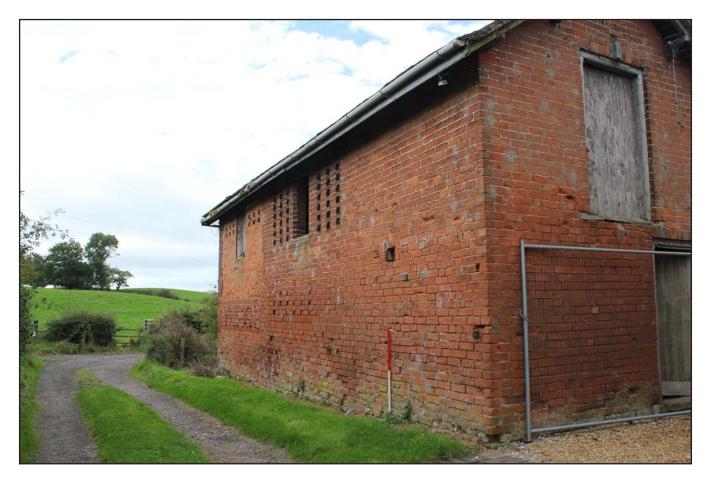
From the southern end a door hatch is visible that matches the one directly opposite on the western elevation, it is quite dilapidated with a cast iron latch on the door and the same decorative set of cast iron hinges found on the western example. In the center of the elevation is an opening with no door, which is of the same dimensions as the other door. This is surrounded by ventilation slots mirroring the opposing elevation but the layout is different due to the presence of the opening; there are seven banks of three slots located on either side of the opening. Furthermore there appears to be a distinct area of repair or rebuilding in the central area containing the opening with ventilation slots; approximately a 3.40m long section of wall near the top of the building appears to have been rebuilt at some point.

From the north the brickwork once more conforms to the pattern seen on the northern gable and appears to be uniform and bonded by mortar. At approximately 3.20 m from the north the brickwork changes on the lower section of the building; with a two course 'bricks on end coping' once more visible 1.10m from ground level, this is reminiscent of the same pattern found on the western elevation. At the southern end the brick pillars are once again discernible with a phase of 'bricking up' once again evidenced by large gaps in the brickwork. In the upper portion of brickwork in this area there appears to be a distinctly different brick and mortar combination used; bricks appear lighter and more orange with rounded pebble inclusions prevalent both within the mortar and the bricks themselves.

Plate 03: Eastern elevation showing hatches and ventilation slots - from Northeast - Scale 1m

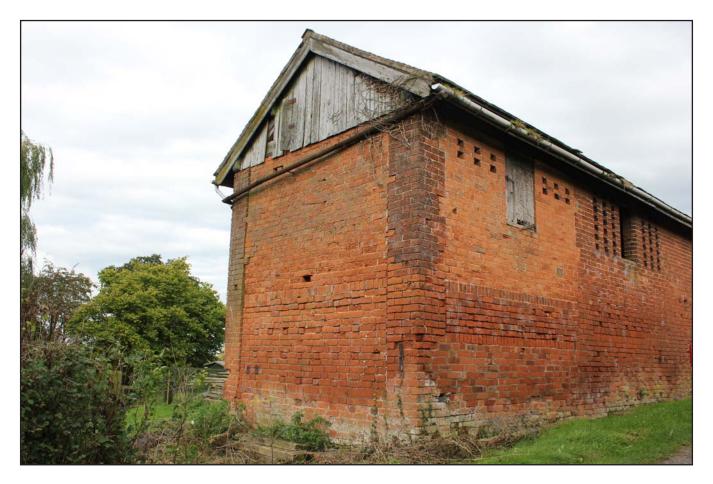
Decorative purlin ends are visible emanating from above the brick piers that are prominent on this gable; once more they are cut into a crescent shape and some of the pine roof truss behind some cladding (discussed later in section) is made visible due to a poor state of repair. Two brick pillars measuring 0.48 m in width dominate this elevation. It is possible that these pillars are the same phase as the first nine courses of bricks from ground level due to a similar brick and mortar combination. Upon these brick courses sits a single course of header 'bricks onend coping' reflecting the potential for a low wall on three elevations of the barn at the

southern end. There is distinctly different method of brickwork in existence between the pillars above this coping or line of header bricks; fourteen courses of bricks arranged in a familiar pattern before another single course of bricks on-end coping, perhaps an extension to the southern wall. Above which sits the same lighter orange bricks with rounded pebble inclusions found on the eastern elevation, suggesting perhaps the brickwork on the southern gable end and eastern elevation took place at the same time. Pine cladding covers the upper portion of the gable wall, these planks run vertically from the eaves of the roof to the beginning of the brickwork. One of these boards has some hinges attached to it suggesting it has been reused as cladding from elsewhere.

Plate 04: Southern gable showing piers and weather boards - from Southeast - Scale 1m

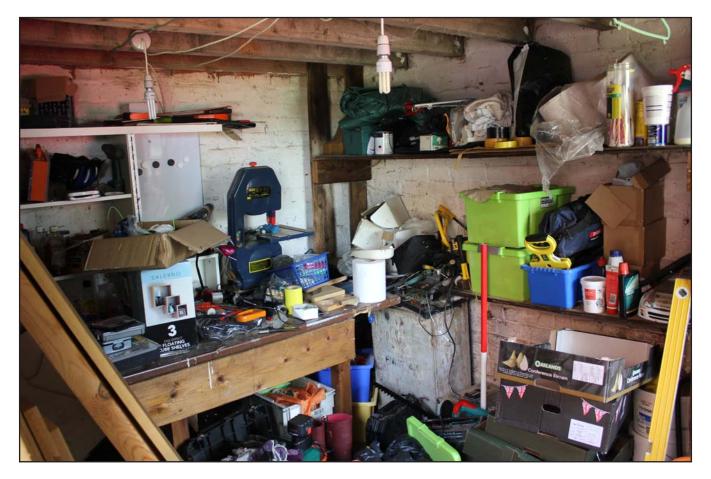
The ceiling joists are visible in this room supporting the planked floor above; the joists are unpainted and are made of pine. Along the northern elevation towards its western extent there is a plank and battened door with a wooden lintel supporting the brickwork above. The southern elevation is of painted white brick. The eastern elevation and southern elevation are also painted white brick. The western elevation has a single glazed window with lead cames towards its southern extent which stands approximately 1.0 m from the floor. The floor appears to have been cast from concrete and is currently used as a storage space or workshop. The room measures 3.80 m north to south and 3.60 m east to west.

Plate 05: Northern room, ground level - from Northwest - Scale 1m

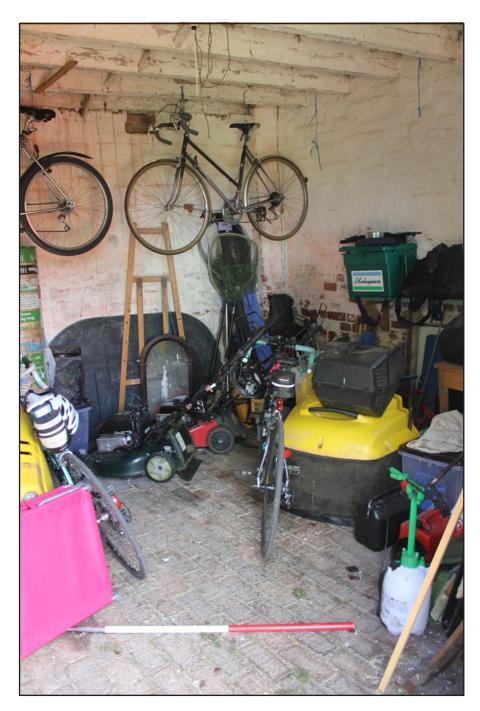
The ceiling joists are visible and support a white-painted plank floor above the northern elevation is a brick wall painted white as is the eastern elevation. Two slots of missing bricks in the eastern elevation close to the ceiling reveal a double skin brick wall beneath. The southern elevation is also of white-painted brick and at each end brick pillars project into the room space. The western elevation contains a window at the southern end with an ornate grate just to the north of this window. The northernmost part of the room is dominated by the doorframe. The floor is undulating and made of a darker brick laid in a herringbone style. The room measures 3.75 m north to south and 3.80 m east to west.

Plate 06: Central room, ground level - from Northwest - Scale 1m

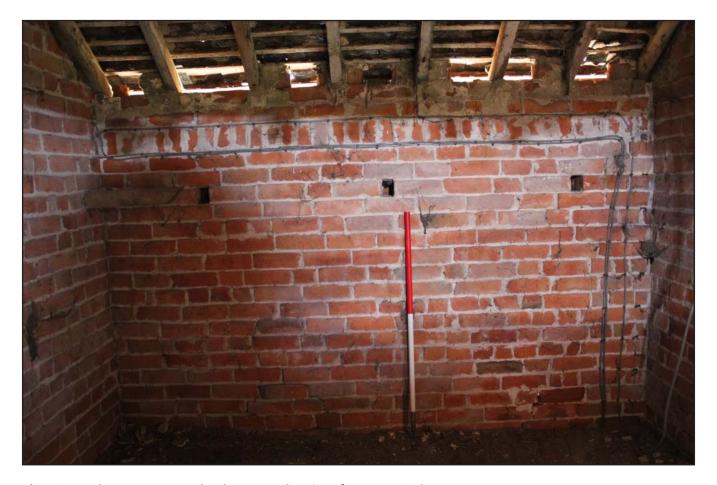
The ceiling is dual pitched with a central rafter and two purlins that run from north to south along the length of the building. The central rafter runs through a brick partition wall upon which ventilation slots are visible. Three ventilation slots are visible on the eastern and western elevations respectively; located one third of the way down from the top of the walls. Slots are also visible on the southern partition wall and are positioned roughly along the middle of the wall but are more likely to have been used for ceiling joists rather than ventilation. Two wooden supports set into the brickwork are visible at the base of the purlins as they pass through the partition wall. The floor comprises of wooden planks running east to west. The room measures 3.80 m north to south and 3.60 m east to west.

Plate 08: Northern Room, upper level, western elevation - from East - Scale 1m

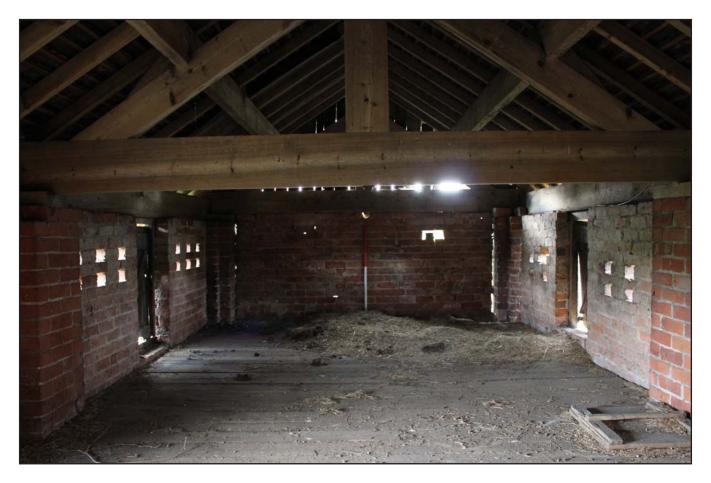
Two roof purlins are visible either side of the room supporting rafters and roof battens; the western and eastern elevations support a dual pitched roof via a substantial pine purlin. When looking into the roof space the 'nibbed' roof tiles are evident hanging from the battens. There are two king-post roof trusses visible in the hayloft; one situated within the southern gable and another roughly halfway along the room sitting on top of the northernmost pillars. The northern elevation is the partition wall that separates the smaller northern room from the longer hayloft. The eastern and western elevations mirror each other in terms of where the ventilation slots are located and also where the two hatches at the southern end are situated. One difference however is on the eastern elevation (at the northern end) where there is an additional access hatch situated in between the two banks of ventilation slots; it measures 1.10 m in height by 0.60 m in width. Pillars are once again visible on the southern elevation as is the daylight on the western side. A wooden floor made of planks runs east to west all the way across the room. A wooden access hatch is situated along the western elevation near to the northernmost pillars. Furthermore the pillars project into the room by one course of bricks and the roof trusses sit on top of these. The room measures 3.80 m north to south and 7.65 m east to west.

Plate 09: Hayloft showing southern gable and roof trusses - from North - Scale 1m

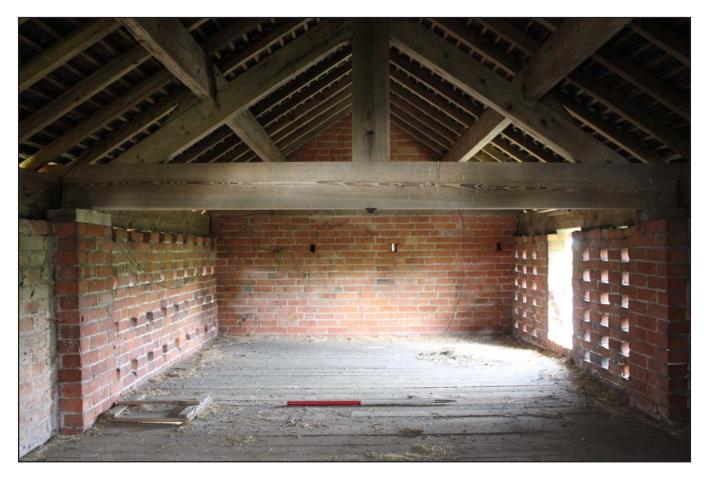
Plate 10: Hayloft showing northern partition wall and roof trusses - from South - Scale 1m

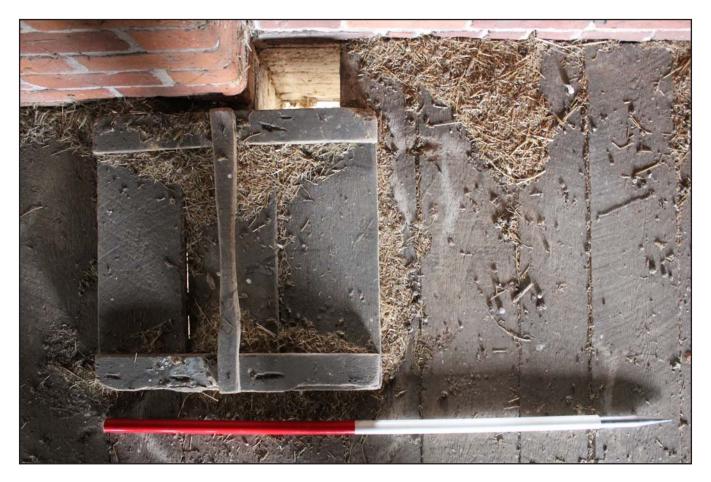
Plate 11: Wooden hatch leading to central room on ground floor - from East - Scale 1m

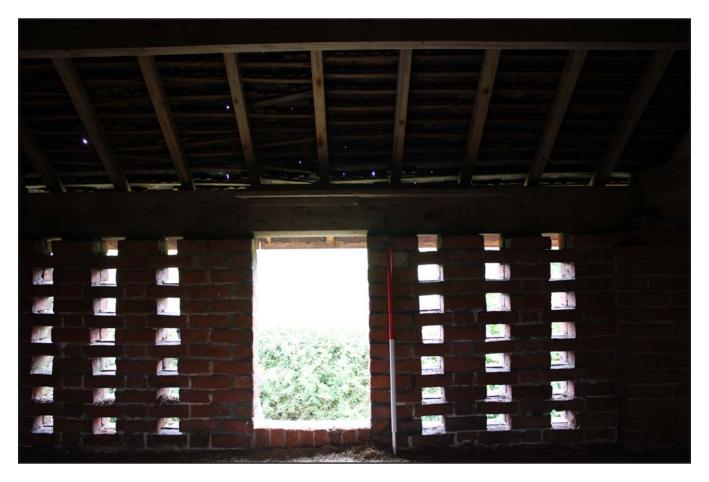
Plate 12: Eastern elevation of hayloft showing ventilation slots, access hatch and roof batons - From West - Scale 1m
