High Farm, Normanby, Middlesbrough Heritage Report And Building Recording

Report Title: **High Farm, Normanby, Middlesbrough – Archaeological Desk
Based Assessment and Building Recording**

Revision: **Final**
Issue Date: **May 2011**
Report Ref: **2982**

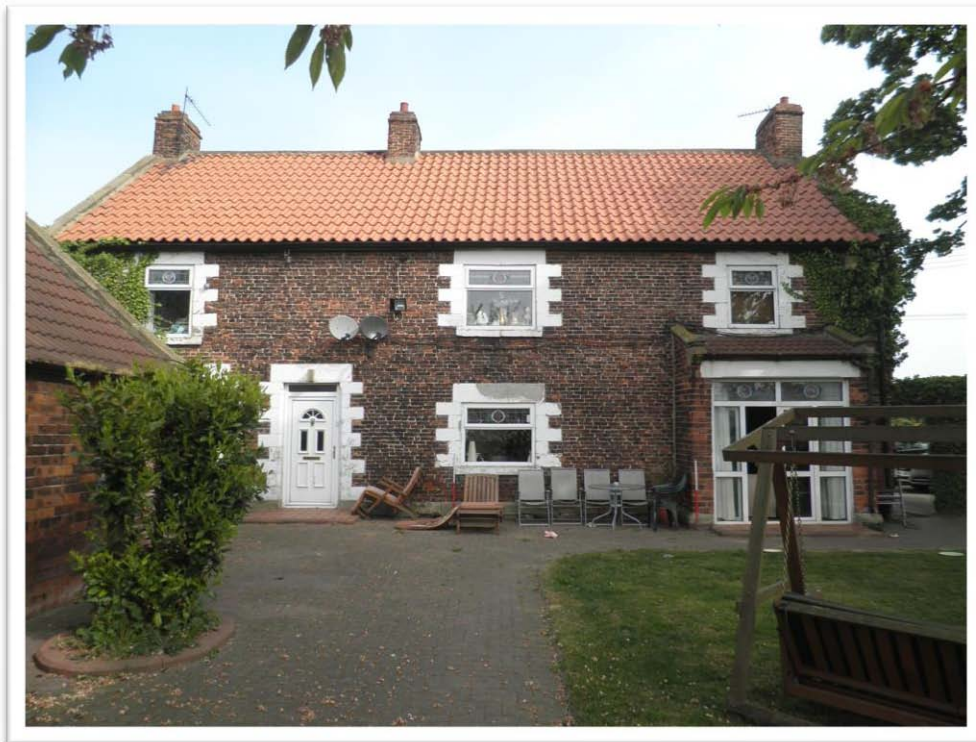
- 7.1.1 The Farmhouse is constructed of handmade 18th century brick dating between 1750 and 1799. The brick work is of English Bond with approximately six courses of stretcher bond between each course of headers. The south frontage (Plate 1) consists of five original windows, three 1st floor and two ground floor, all with stone framing. The remaining ground floor window has been altered to form a modern French window which serves as entrance into the living room and dining room. There is also an original doorway, also stone framed, although the current door is a modern PVC replacement of the original.

Plate 1: South front of the main Farmhouse

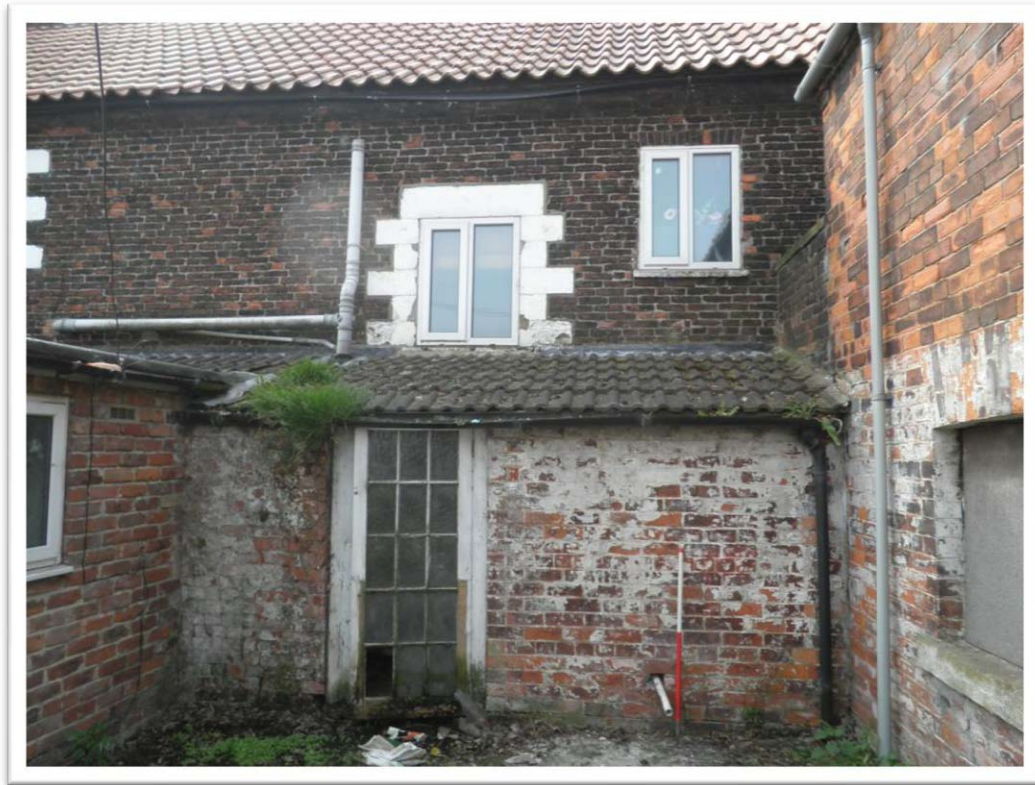
- 7.1.2 At the rear of the property there is a low lean to structure (Plate 2) which conceals the original ground floor elevation. This is currently inaccessible from the exterior and interior of the house. The upper floor has three windows, as the front, although one is clearly a later addition. The central window is also slightly lower in order to light the interior stairway of the building.

Plate 2: Lean to structure AN3 at rear of farmhouse

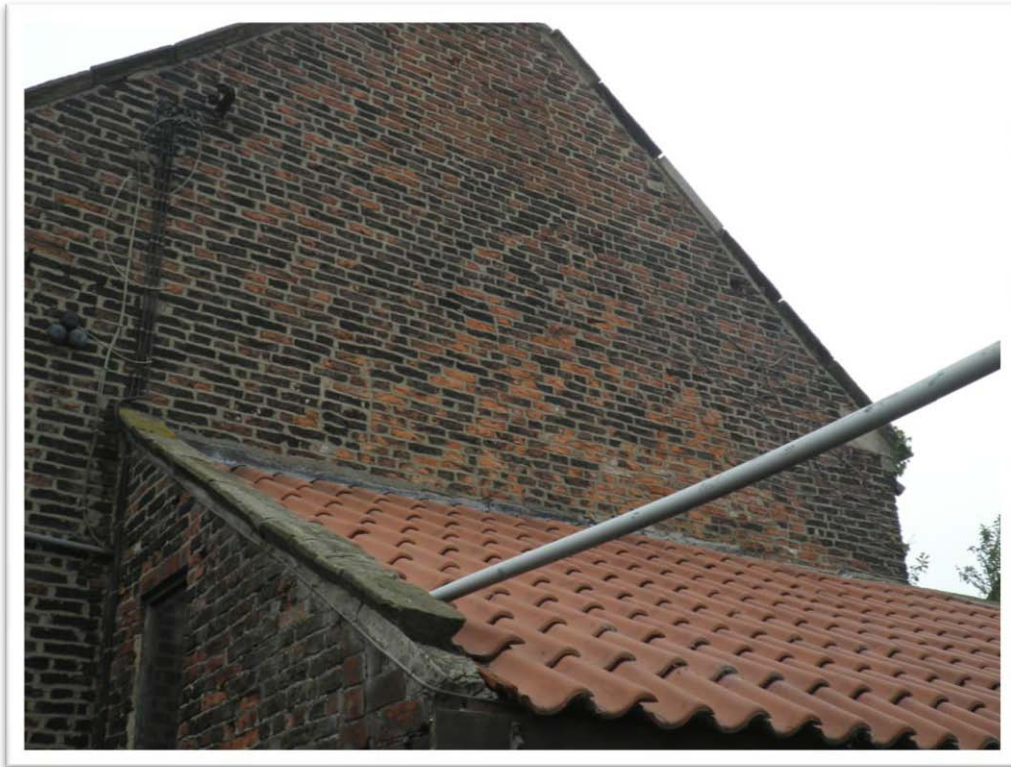
- 7.1.3 The western elevation shows the scar of a former building (Plate3), possibly the continuation of out-building OB5. However there is no map evidence to support this conclusion. There is now a small lean to structure (AN2) made of 18th century brick which houses the water tank for the main house in place of the original. However this has clearly been altered as the western wall of this structure is made of later 19th century. The wall lines up with that of the other 18th century building OB5, so this evidence supports the theory that OB5 originally joined with the main farmhouse and was shortened and the lean to structure AN2 built instead. There is evidence in the roof structure of AN2 for a re-used roof truss and beams. There is also evidence for a blocked up window in the western gable end of the Main farmhouse, possibly blocked during the construction of AN2. There is also another small annex which accesses AN3 and possibly OB1 however this is currently also in accessible.

Plate 3: Scar relating to former building linking the farmhouse with OB5

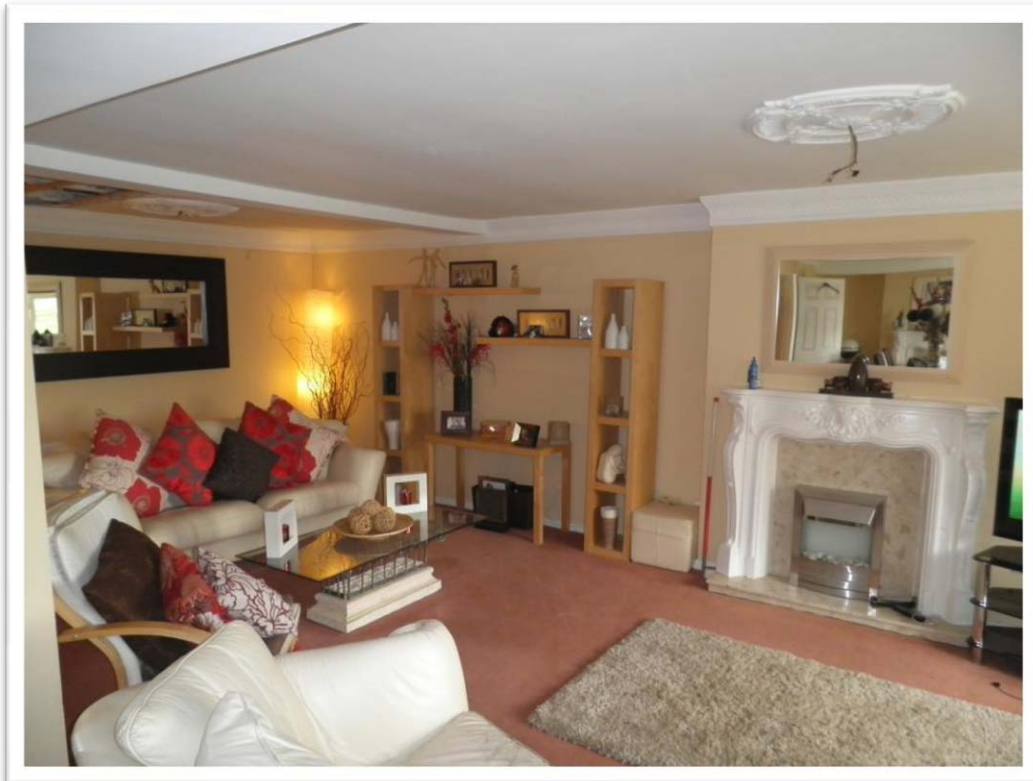
Plate 4: Interior of living area within farmhouse (FM7)

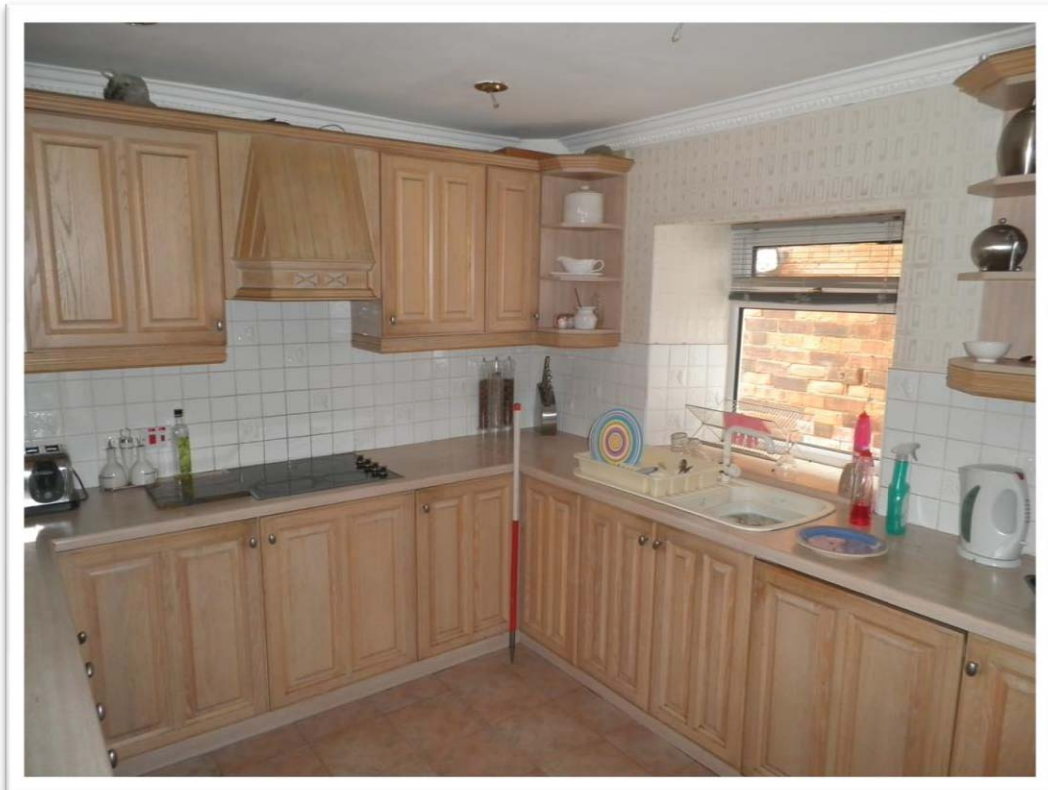
- 7.1.7 Moving through the house westward the last ground floor room is the kitchen FM1 (Plate 5). This has a north and south window, and has been completely remodelled. There is no evidence of the original range or fireplace and the windows to the north are later additions. Moving upstairs there is a central staircase (FM5) leading onto a landing (FM10). There are four bedrooms FM12, 13, 14, and 16. FM14 has a walk in wardrobe (FM15). Bedroom FM16 has a walk in wardrobe (FM17) and it is clear a certain amount of remodelling has taken place to accommodate this and the bathroom (FM9) as the south eastern window is split between both rooms.

Plate 5: Modern fitted kitchen on ground floor of Farmhouse

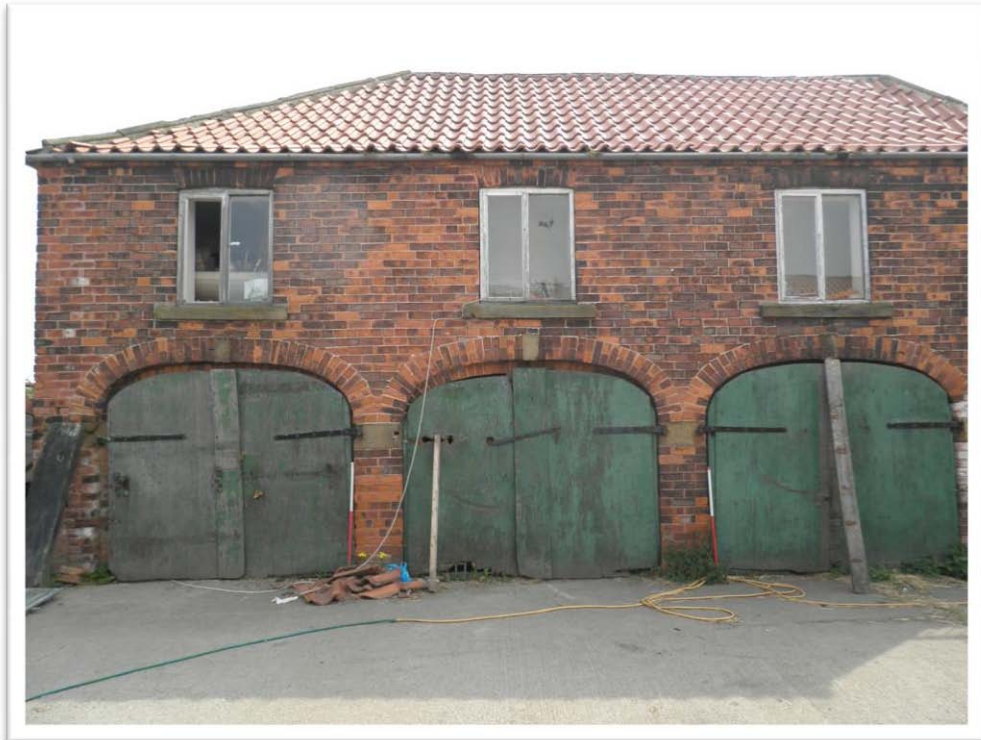
7.2.1 The stables comprise the bulk of the site and it would appear that the farm was designed to house horses and carts. OB1, OB2, OB3, OB7 OB10, and OB9 all date from the 19th century and are designed to stable horses. OB1, 9 and 10 all have 3 arched with gates (although OB10 is now bricked up) and would house small carts or farm machinery such as ploughs. The upper floors of OB1 (Plate 6) have been converted into offices at some point in the 20th century and are now used as storage. These buildings all have their original roof truss and beams in place and are still in use either as storage in the case of the ground floor of OB1 or for stabling as in the case of OB10 and OB1-3.

Plate 6: OB1 showing 3 in situ archways for storing carts and farm equipment

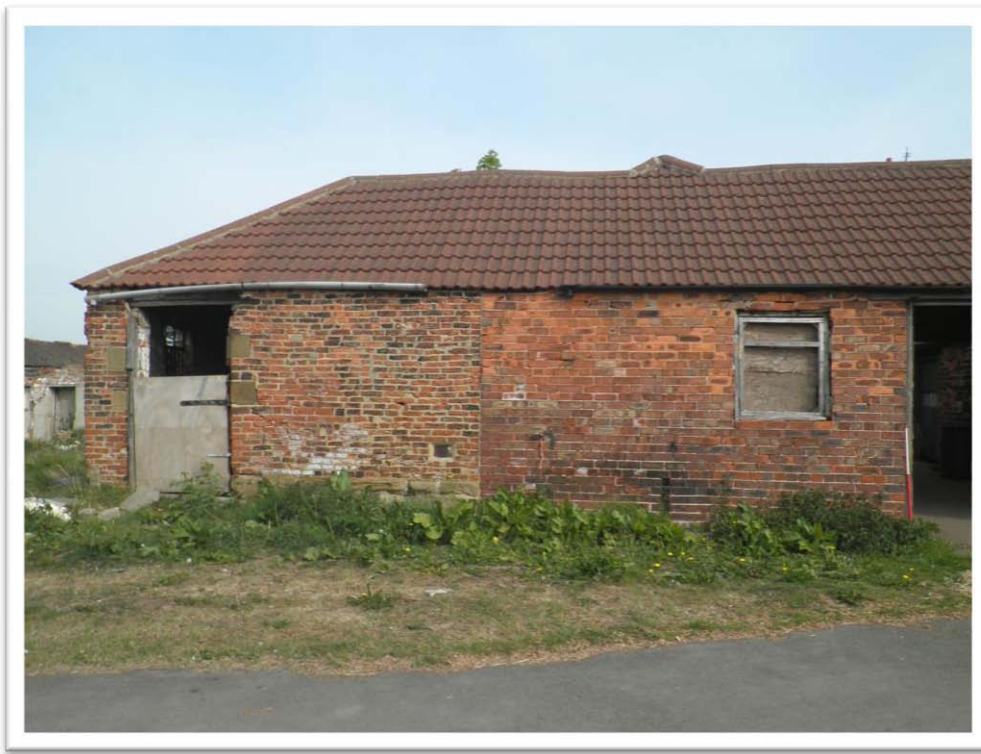
Plate 7: OB3 (right) and OB4 (left) showing the contrast between 18th and 19th century brickwork

7.2.3 OB4 (Plate 7) was also most likely a stable block and is now fire damaged and partially collapsed. This is an earlier block with window and door frames dating to the 18th century. The foundation course is also in sandstone, not in brick as with the later 19th century stables.

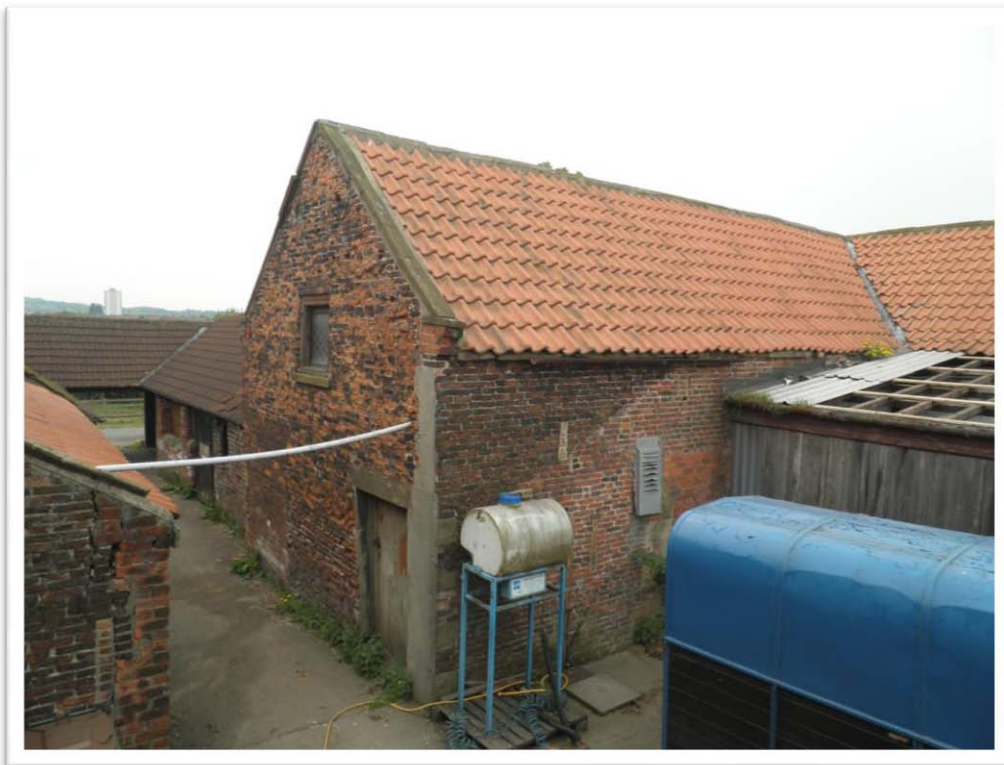
7.3.1 There are two probable barns within the farm complex, OB7 and OB5 (Plate 8). These are also either side of a possible threshing barn, no longer extant but visible on the early Ordnance survey mapping so are likely candidates. Internal arrangements such as first floor access and ventilation slits also suggest that these buildings began life as barns. However much of the original character has now been lost by the construction of the lean to structure OB6 and the extension of OB5 in the 19th century. It was not possible to examine the interior of OB5 in detail except through a first floor window via a ladder due to boarded up doors that had been nailed shut. The south eastern corner of the building contained a key stone with possible 18th or 19th century graffiti. OB7 is now used to store and maintain a vintage car and retained no additional features of interest.

Plate 8: OB5, a former 18th century barn (ventilation slots visible, now bricked up)

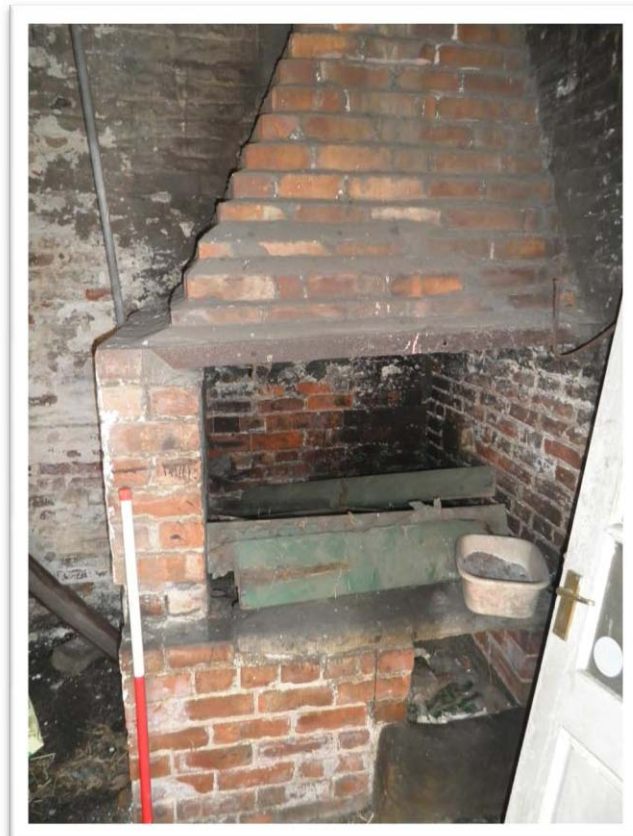
Plate 9: Small forge with hearth and chimney intact.

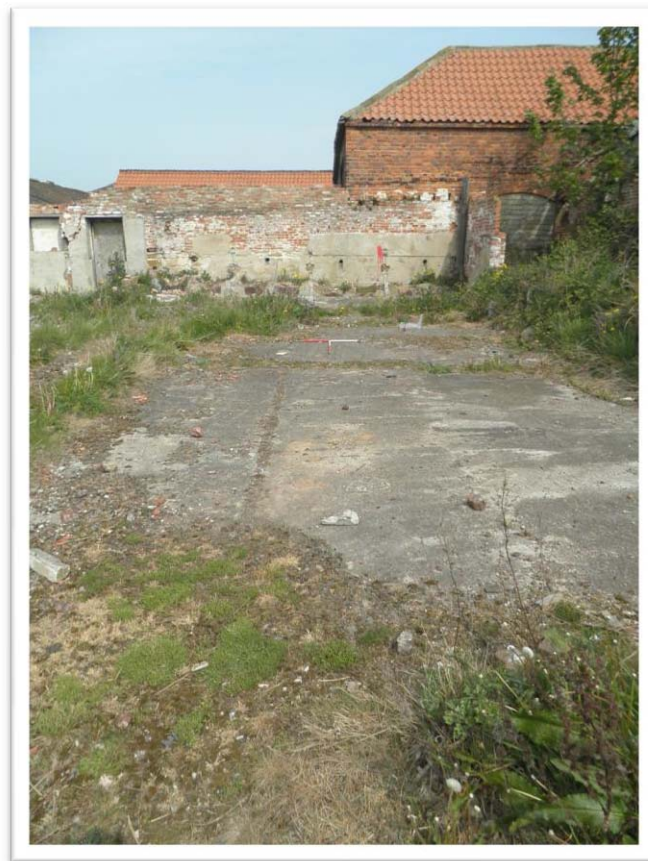
- 7.5.1 There is evidence of a demolished building (Plate 10), containing the remains of eight cattle feed troughs, demonstrating that there was formerly a winter cattle shed on site. This building is visible on all the Ordnance Survey mapping until the 1990s so was only recently demolished. The footprint of these buildings is clear from both the Ordnance survey maps and remains on the ground

Plate 10: Area of demolished buildings
