Ana Cross Round Barrow, North York Moors – Archaeological Watching Brief Report

North York Moors National Park Authority

February 2018

Report Ref: **Project No.: 10702**

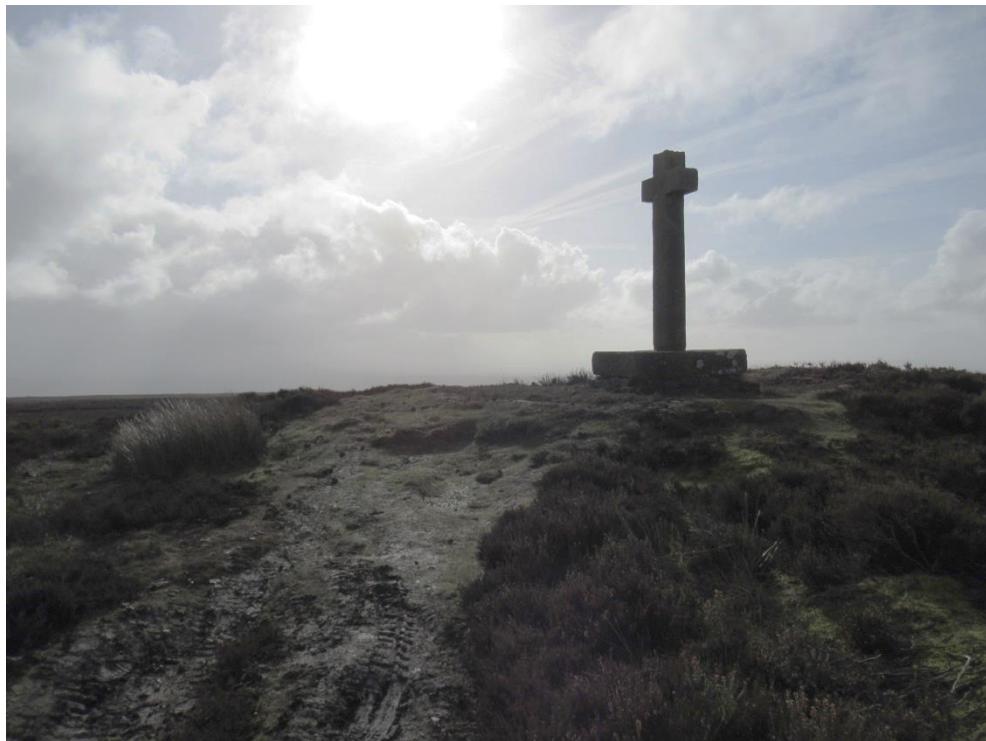
- 1.2.1 The site is located at the Scheduled Monument Ana Cross Round Barrow and Wayside Cross (NHLE: 1018976). The monument lies within the North York Moors National Park (**Figure 1**). It is defined by a 3m high cross situated on top of a prehistoric round barrow (**Plate 1**).
- 1.2.2 The site is situated approximately 290 m above Ordnance Datum. The underlying geology of the site comprises sandstone, mudstone and siltstone of the Ravenscar Group; sedimentary Bedrock formed approximately 165 to 176 million years ago in the Jurassic Period. There are no recorded superficial deposits (British Geological Survey 2018).

Plate 1: View of the Scheduled Monument looking south

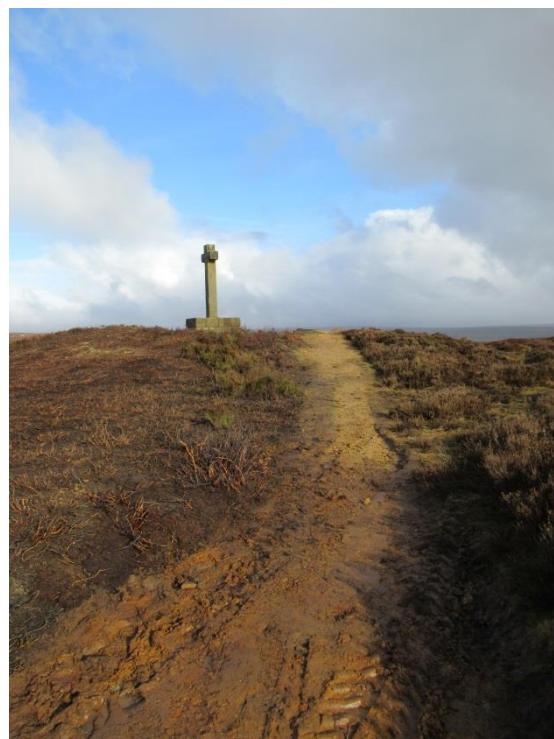
Plate 2: View of the southern side of the mound showing the placed heather turves and sandstone aggregate

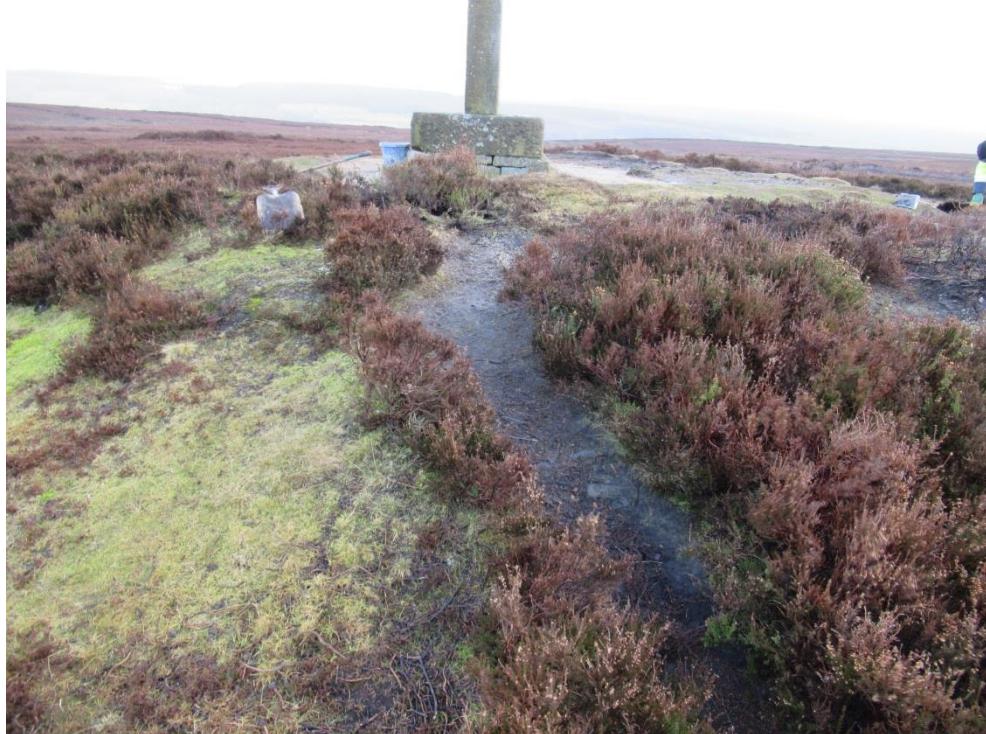
Plate 3: View of the western track prior to the placement of heather turves

- 2.2.6 E: The desire line on the western slope of the mound formed by footfall did have grass re-generating. However, in order to mask the line to dissuade visitors from using it as an alternative route to the main path, cut heather brash was placed along the route. It was subsequently topped with locally extracted mineral soil and SSSI approved grass seeds. Heather turves were positioned at the top of the route to blend it into the natural surroundings and deter visitors walking up to the monument in this direction (**Plate 3**).

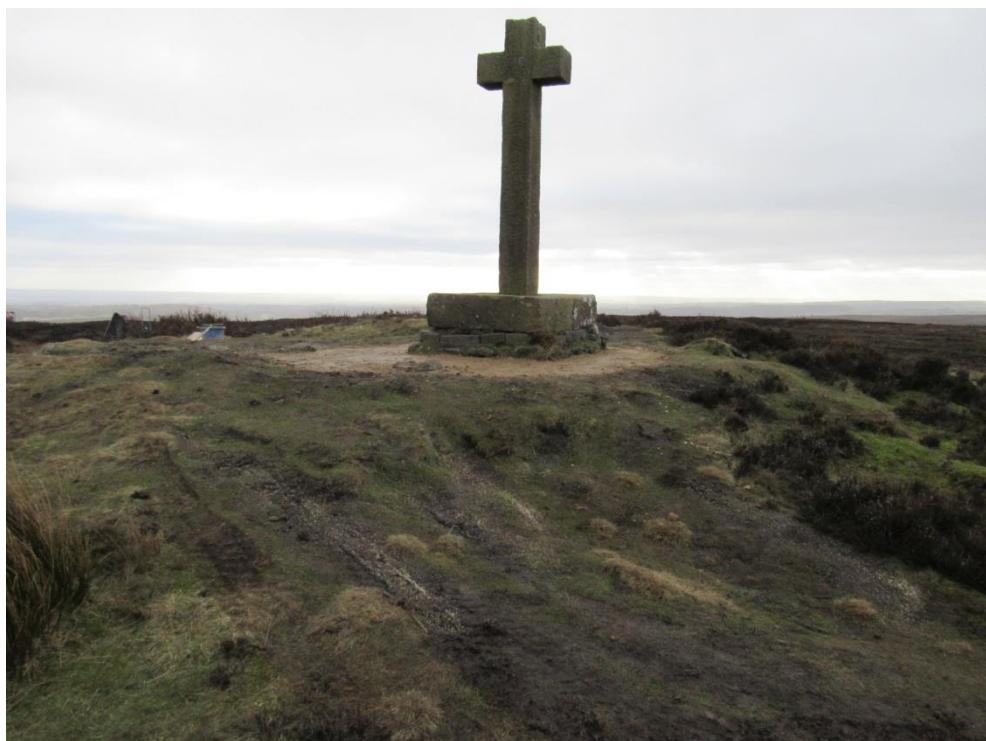
Plate 4: View of the crushed sandstone aggregate surrounding the cross base

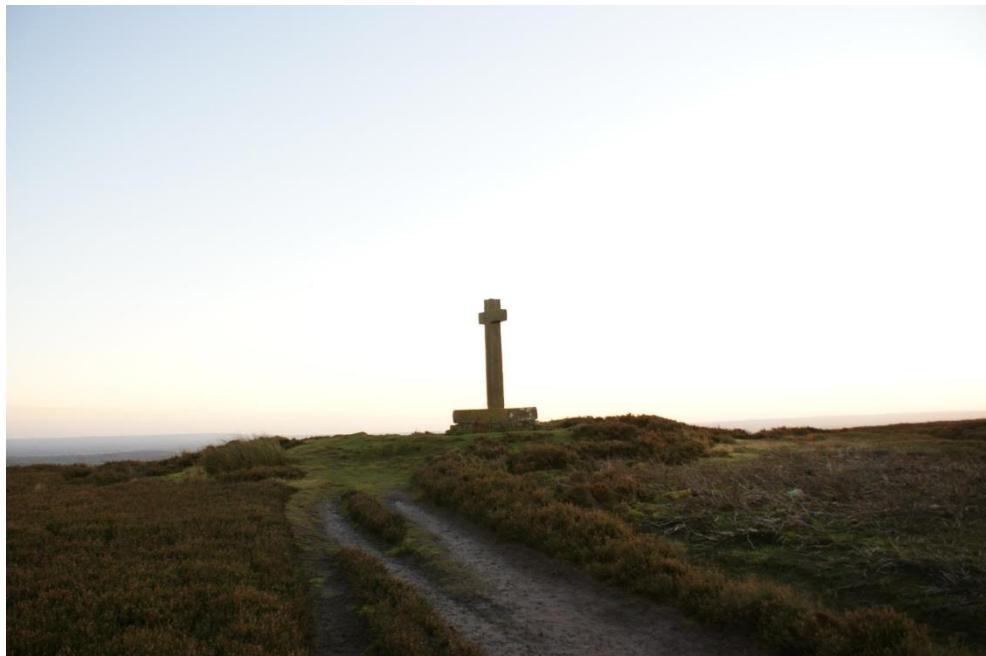
- 3.2.1 The northern slope to the mound had areas of exposed soil due to footfall from visitors and vehicular erosion most likely from mountain bikes and quad bikes. In addition shallow eroded areas had formed at the east edge at the top of the mound. As part of the remedial works this erosion has been repaired by covering the area with a thin layer of mineral soil mixed with grass seed which will aid re-vegetation (see **Plates 5 and 6**).

Plate 5: The northern side of the mound before remedial works (November 2017)

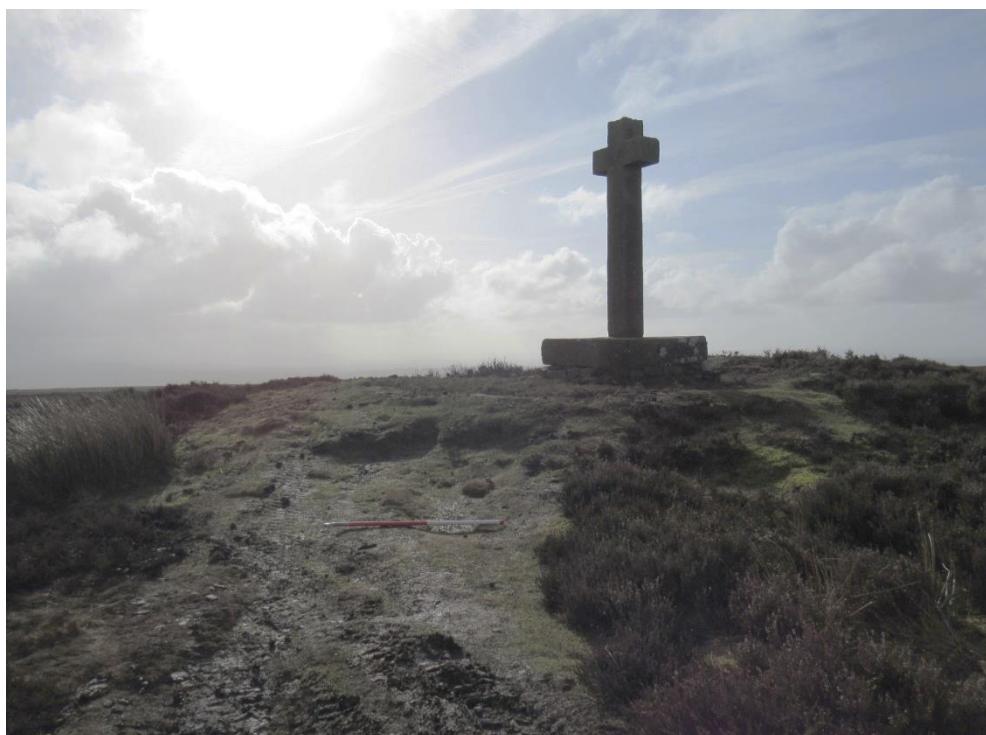
Plate 6: The northern slope to the mound with scattered grass seeds (February 2018)

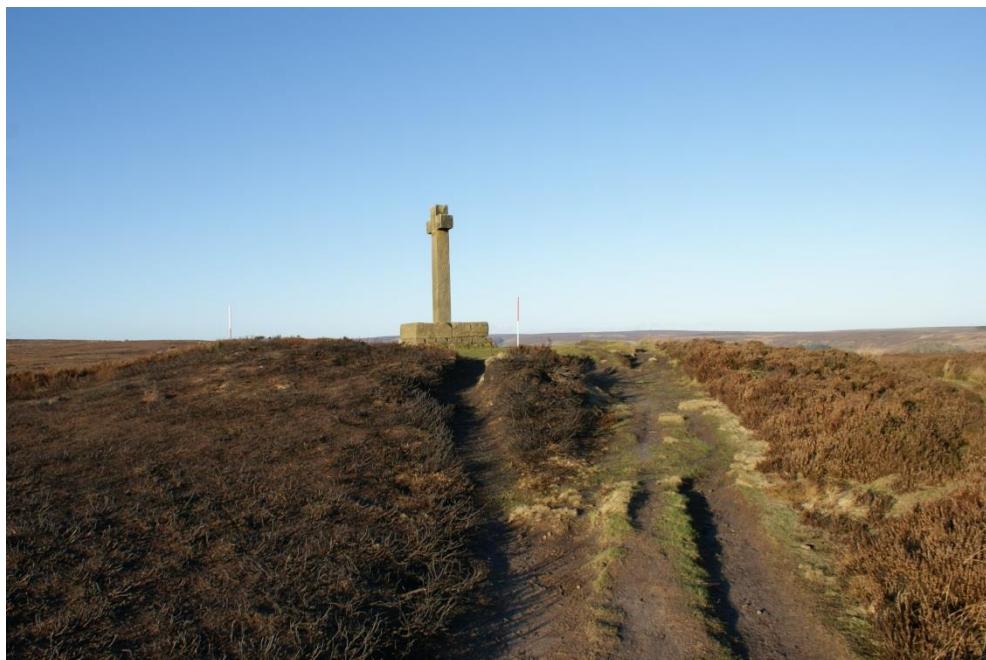
- 3.3.1 The main path on the southern side of the mound had deep erosions due to footfall, bicycles and quad bikes. The remedial works have resulted in a more level smoother path which is more defined as the main route around and to the monument. The mixed grass seed and mineral soil will aid the natural re-vegetation of the mound in the future (see **Plates 7 and 8**).

Plate 7: View of the path on the southern slope to the mound (November 2017)

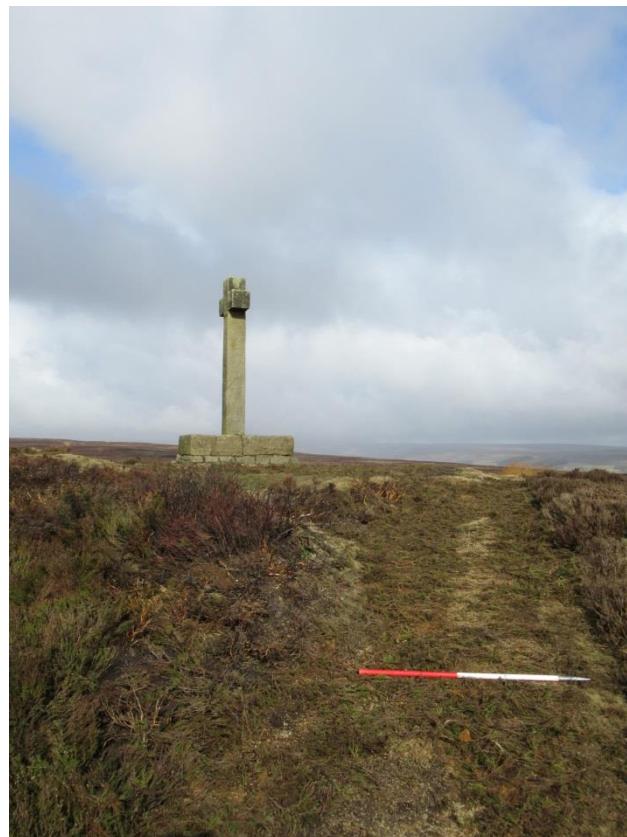
Plate 8: View of the southern slope after the remedial works (February 2018)

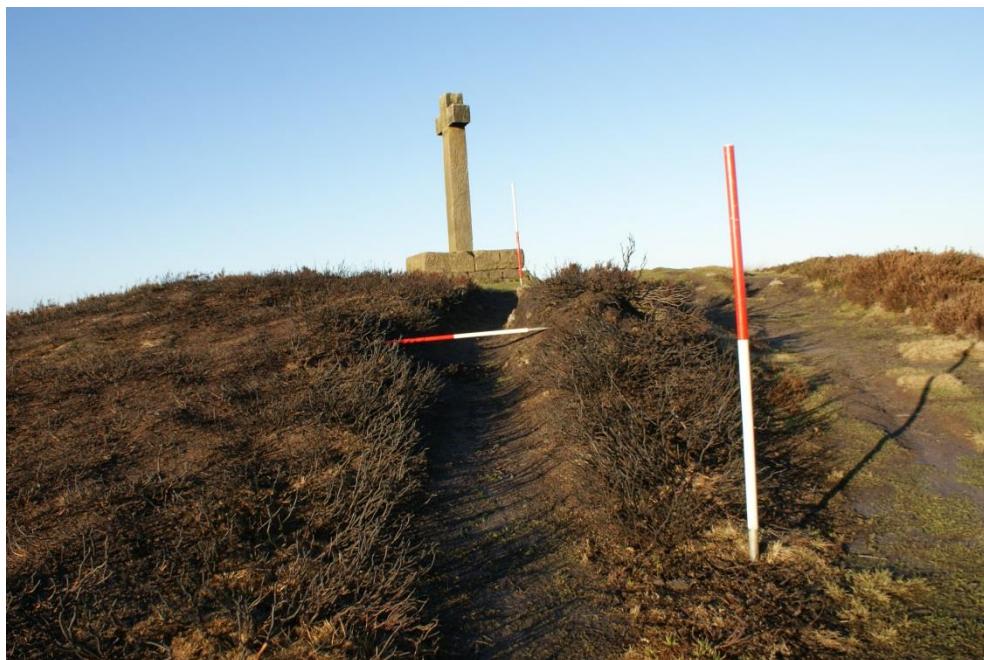
- 2.2.5 D: A secondary deep gully path had formed adjacent to the main path on the southern side of the mound. The deep gully was initially filled with a layer of locally sourced natural stone. This was in order to create a sturdier platform for the succeeding layers. A layer of locally extracted mineral soil was placed on top to provide a platform for heather turves to grip into when they were subsequently placed on top.

Plate 9: A view of the deep gully on the southern slope of the mound (November 2017)

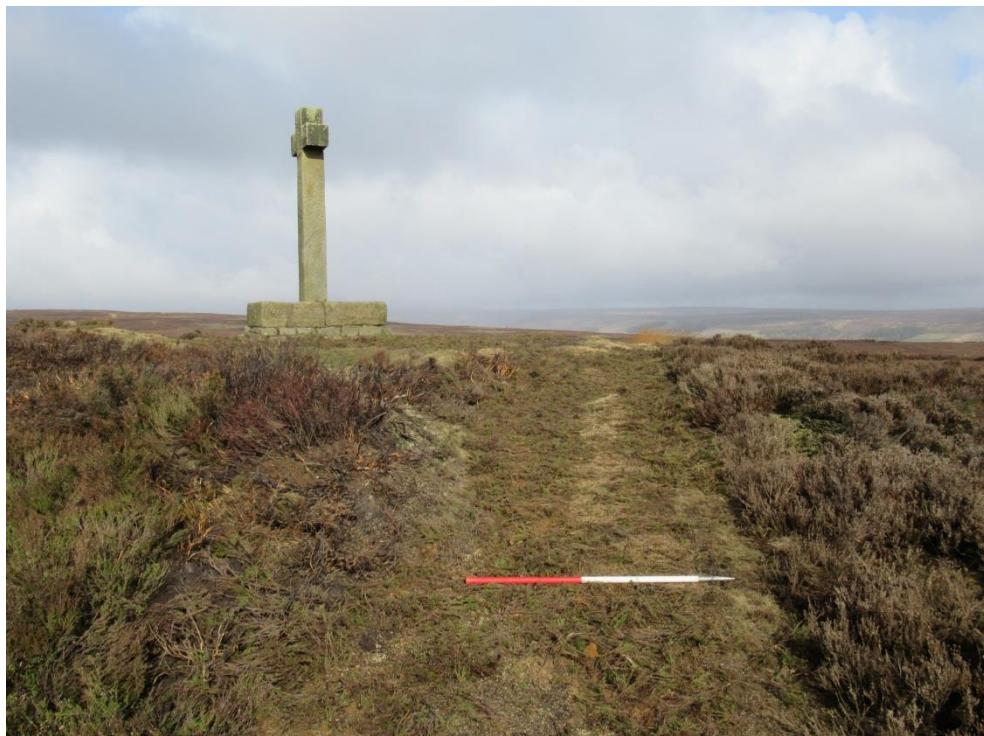
Plate 10: A view of the infilled deep gully on the southern slope of the mound after remedial work has been conducted

- 3.4.1 The remedial works have successfully in-filled the deep gully with sandstone, mineral soil and heather turves. The contractors used locally sourced heather turves to ensure the repair blends into the surrounding topography of the barrow. The turves were laid on slightly higher ground in order to define the adjacent path (Area C) more clearly for visitors (see **Plates 9 and 10**); this will discourage visitors from creating their own path to the monument and thereby create another erosion scar.

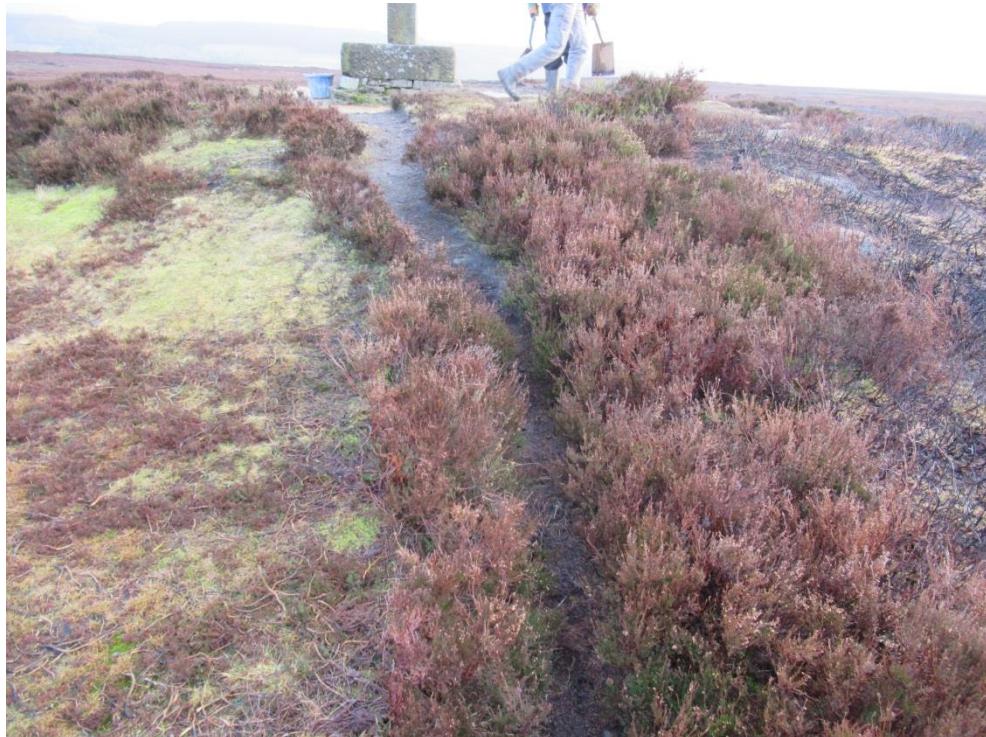
**Plate 11: A view of the track way on the western slope of the mound before remedial work
(February 2018)**

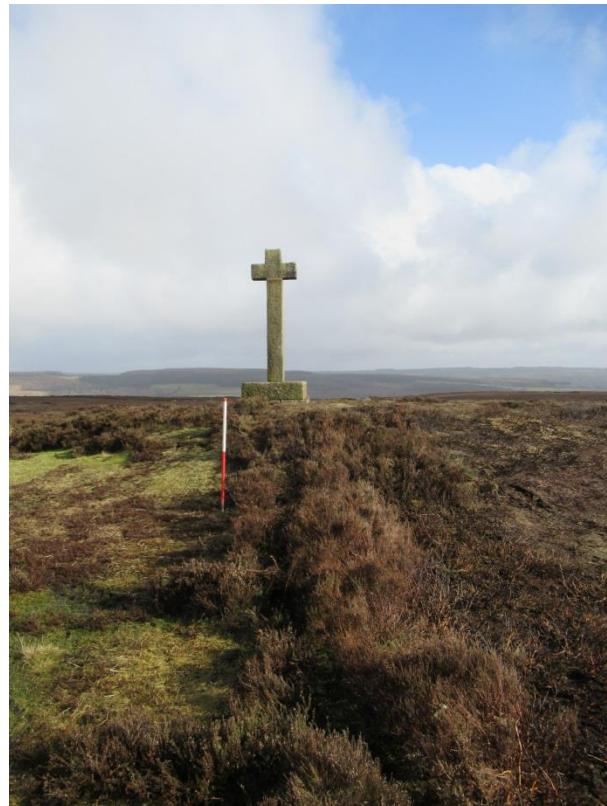
Plate 12: A view of the western track after remedial work (February 2018)

- 3.5.1 The placing of heather turves at the top of the eastern side of the mound has created a natural vegetation barrier to deter visitors from approaching the mound from this direction. In addition, cut heather brash placed on this side of the monument will discourage visitors from using this animal track that was forming as a new route way onto the monument. The mixed mineral soil and grass seed will aid in re-vegetation which will allow grass to cover and infill the eastern path (see **Plates 11 and 12**)

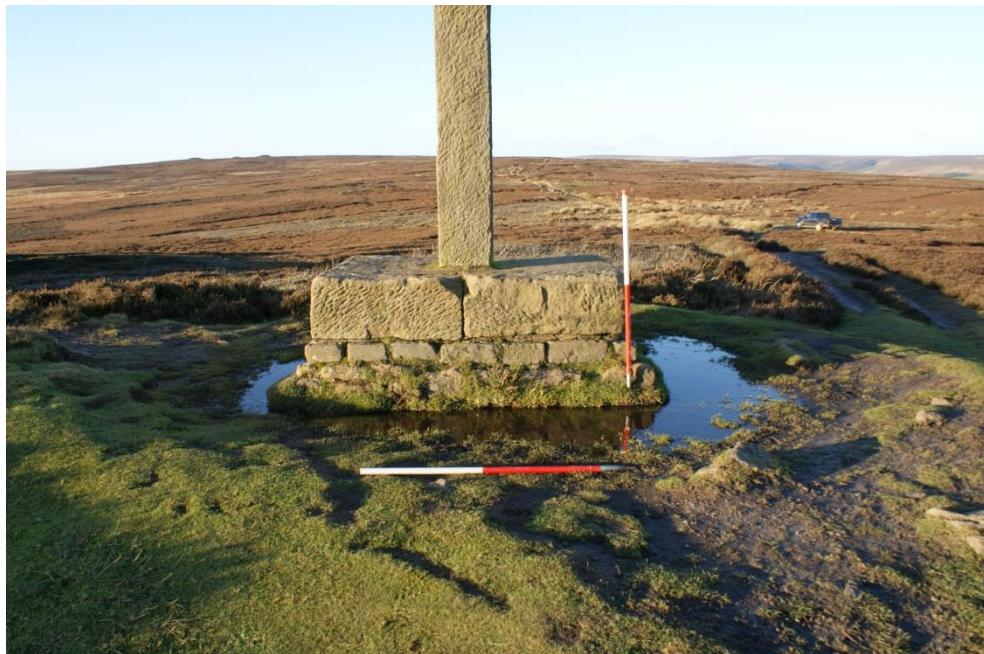
- 2.2.7 F: Due to visitor footfall, a deep hollow had formed around the base of the cross. This caused water to pool around the cross and local wildlife used it as a water source which caused further erosion to the mound. Imported sandstone aggregate mixed with SSSI approved grass seeds were placed to infill the deep hollow. This was compacted with an approved small vibrating plate to create a level area and to aid in re-vegetation (**Plate 4**). The area was checked by the contractors to ensure the ground was level in order to prevent future water pooling. The area was subsequently topped with cut heather brash, locally sourced mineral soil and further grass seeds. The west to north sides of the mound were topped with heather turves.

Plate 13: A view of the waterlogged hollow surrounding the monument before remedial work
(November 2017)

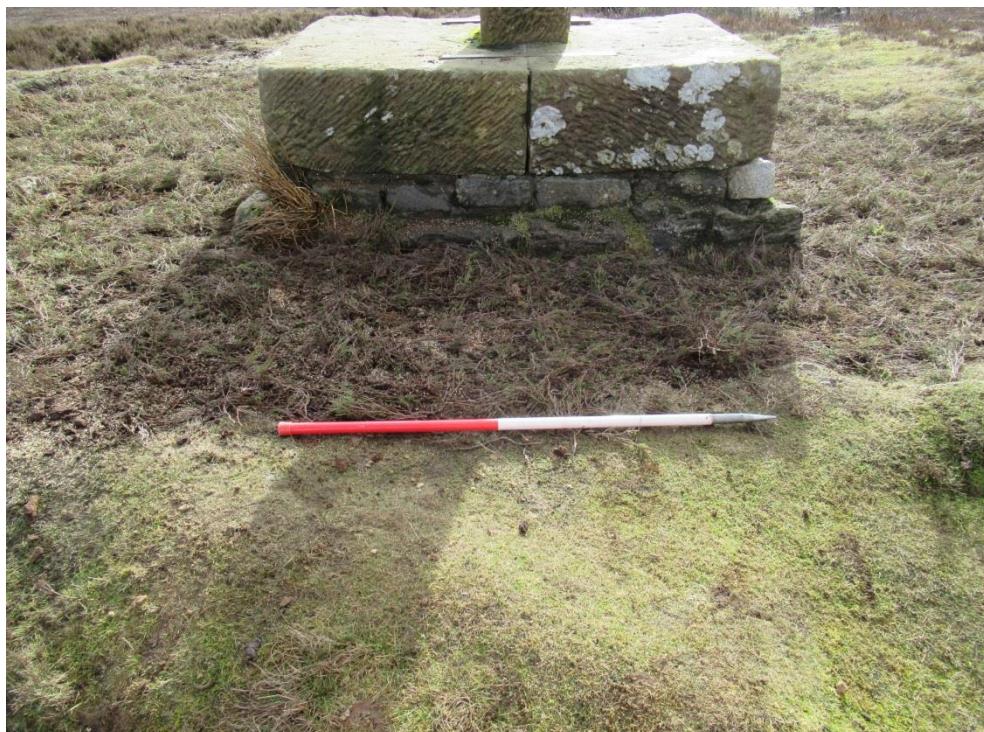
Plate 14 : A view of the repaired hollow surrounding the monument after remedial work
(February 2018)

- 3.6.1 The remedial works on the deep hollow around the base of the cross has resulted in a level surface that will prevent future pooling of water. The mixed mineral soil and grass seeds will aid re-vegetation on the top of the monument. In addition, the cut heather brash has added a layer of protection for the grass seeds as well as creating a more positive visual setting (see **Plates 13 and 14**).

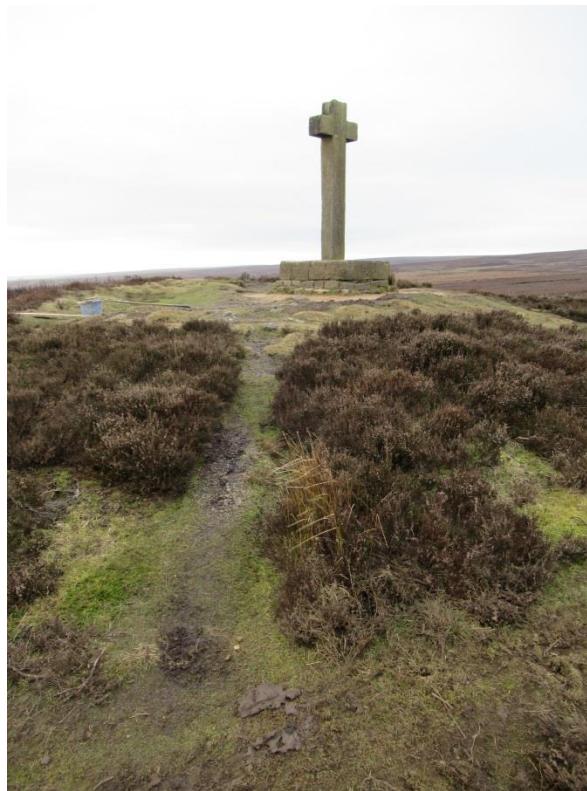
Plate 15: A view of the eastern sheep track before remedial work (February 2018)

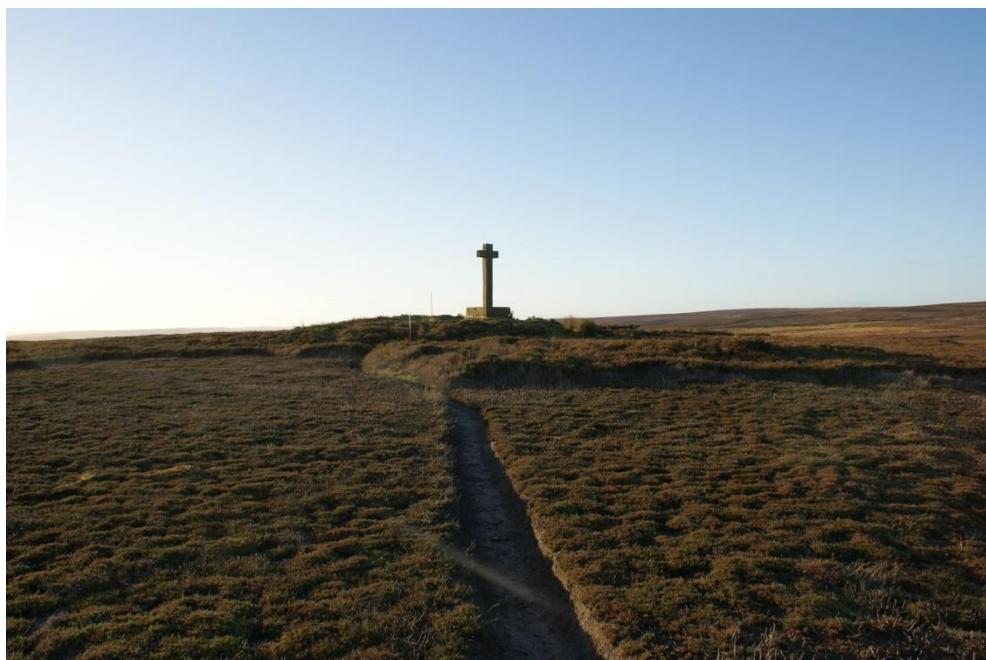
Plate 16: A view of the eastern sheep track before remedial work (November 2017)

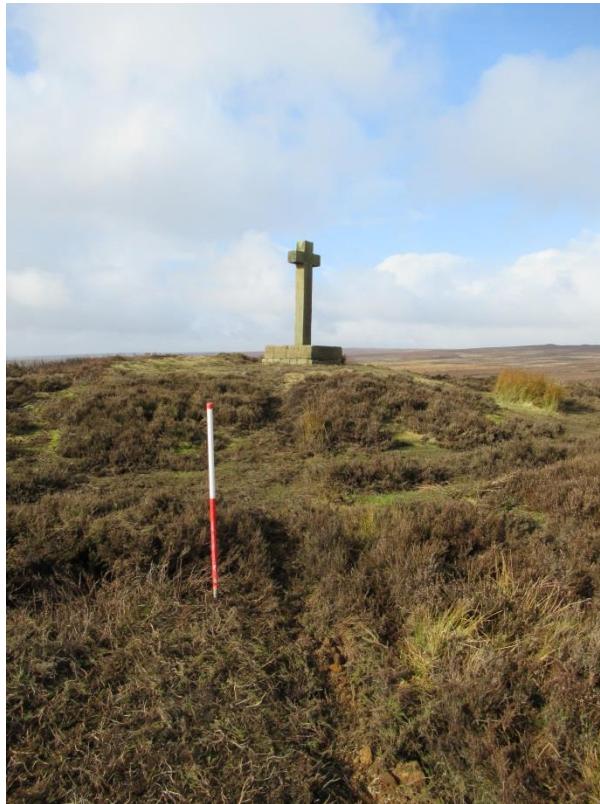
Plate 17: A view of the eastern sheep track after remedial work (February 2018)

- 3.7.1 Cut heather brash was placed along the track on the eastern side of the monument to create a natural looking mask to cover the track. This will discourage visitors from using this path until the route is filled with grass from the mixed mineral soil and grass seeds that were sown to aid re-vegetation (See **Plates 15, 16 and 17**).
