HISTORIC SCOTLAND PROPERTIES IN CARE
MINOR ARCHAEOLOGICAL WORKS 2011

Duff House: Watching Brief, August 2011.

SITE: Duff House, near Banff.

DESCRIPTION: Watching Brief during the excavation of trenches to locate and repair a water leak.

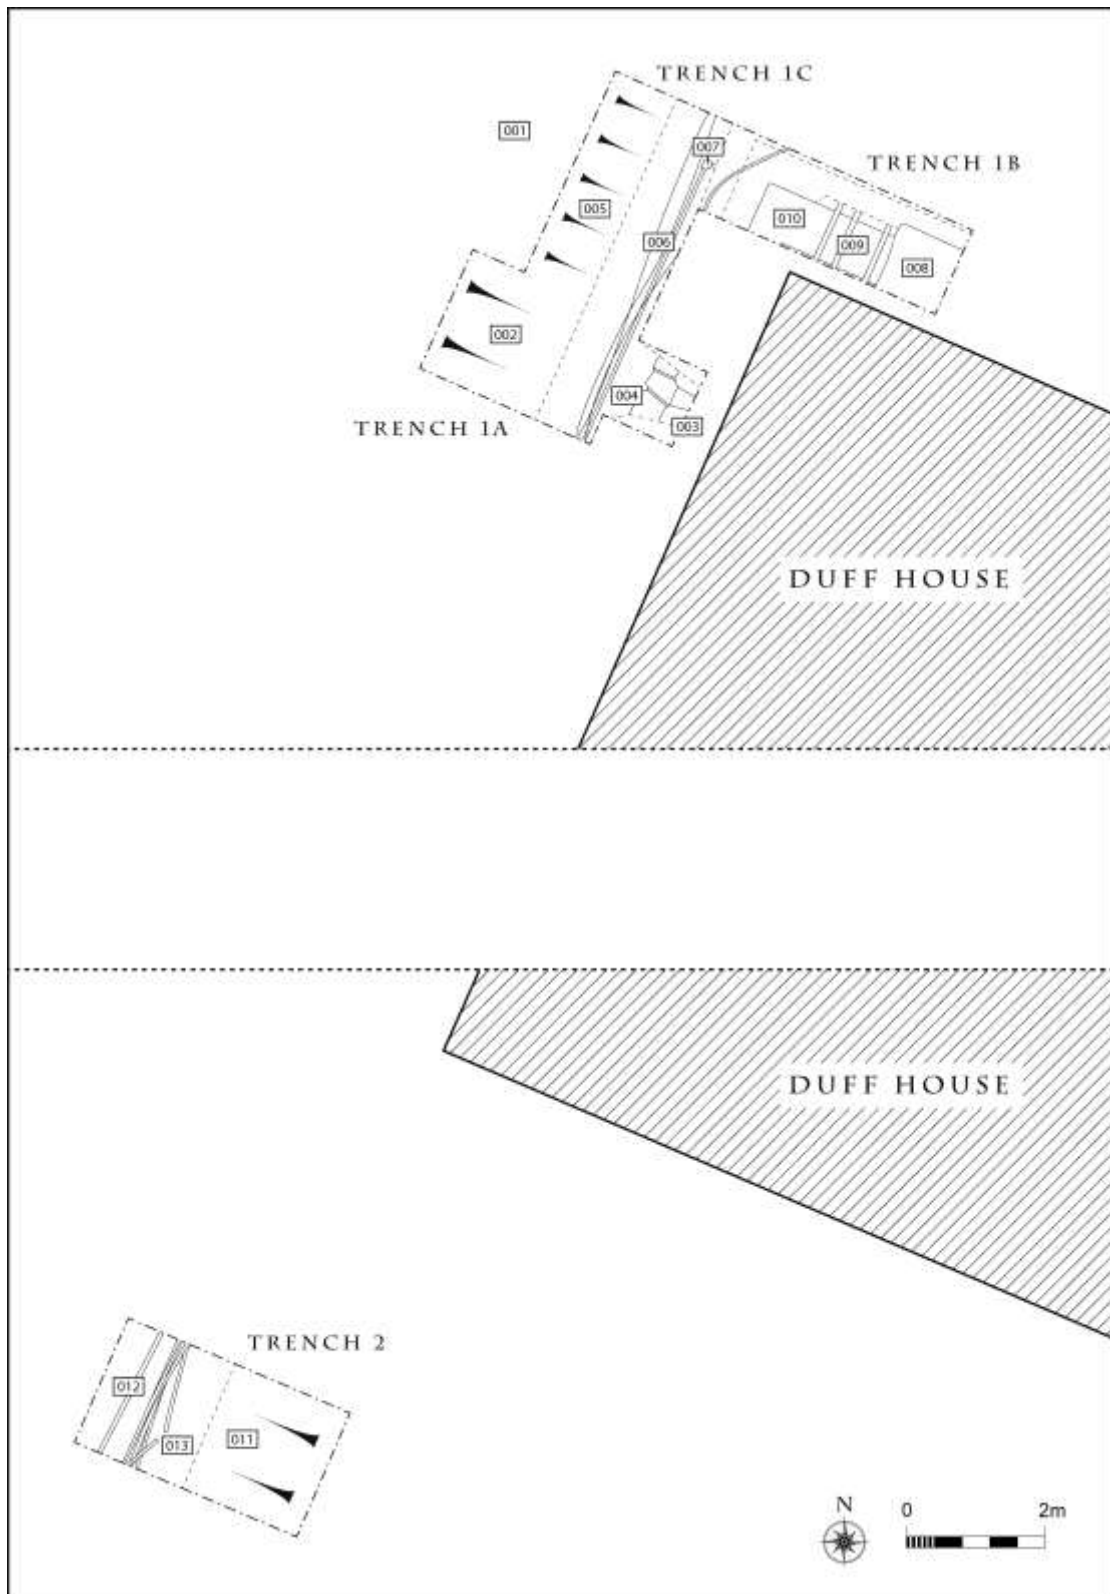
Figure 2: Post-excitation plan of Trenches 1A, 1B, 1C and Trench 2.

This trench measured 3.6m E/W x (up to) 1.8m N/S x 1m deep. A series of electrical and water pipes **006** had been located at a depth of 0.7m – 0.85m with a cast iron waste pipe at 1m depth; these were all running N/S. To the E of the pipes, a breach had been made in a slabbed drain **003/004** some 0.4m below the ground surface, an original part of the William Adam design from the 1730s. The breach, 30cm x 30cm, allowed limited visual access to the drain. The drain was formed of two side walls consisting of coursed pieces of split horizontal basaltic bedrock bonded in a lime mortar. The drain was approximately 1m deep (although it was unclear how much sedimentation covered the actual base). The side walls were approximately 0.3m thick with a flush face to the drain cavity and a rough exterior face; they also had a splayed upper course which carried the large flat cover-slabs of the same stone, the slabs being up to 0.1m thick. The drainage channel itself was 0.75m wide. Having located the water pipe, it was decided to open the next trench at the SW angle of the house.

Trench 2 was located 5.40m from the SW angle of the house. The trench measured 3.5m E/W x 2m N/S x (up to) 1.25m deep. The water pipe **013** was located 1m from the W edge of the trench at a depth of 70cm. There were also several electrical cables **012** within the same pipe cut. The water pipe was cut and capped. The water was then turned on and could be heard flowing into the slabbed drain in Trench 1A. It was therefore clear that the leak was somewhere close to the area of the original trench. It was decided to open another trench to the N of the NW angle of the house in order to investigate the slabbed drain further, and locate the source of the leak.

Trench 1B measured 3.5m E/W x 1.3m N/S x (up to) 0.35m deep onto the slabbed drain. The drain **010** had previously been covered over in green plastic sheeting **015**. To the E of the trench was the original stone-slabbed cap **008** while an area 1.25m wide had been re-capped with concrete slabs **014**. Once lifted, these were shown to be supported on 0.1m thick concrete beams **009**. This arrangement presumably dates back to the 1990s when the drain was obviously discovered and exploited as part of the new water management scheme which saw the W wall of the drain breached to receive an outflow pipe. To the W of the concrete slabs, an area of the original stone slabbing had collapsed; although it was not clear whether this was a result of the recent water leakage. This whole corner of the slabbed drain was now exposed. When the water was turned on, it could be seen leaking not from the pipe within the slabbed drain, but to the rear where it was coming up and over the drain's side wall. This meant that a further excavation was required to find the source the leak.

Trench 1C measured 1.9m - 2.25m E/W x 3.2m N/S x (up to) 1.4m deep. This connected the W side of Trench 1B with the N side of Trench 1A. To the N of the trench, at a depth of 0.7m, the source of the leak was found. A 90 degree collar **007**, jointing two lengths of pipe, had a large split up and through its threaded portion. The pressure in the pipe had been forcing water up and over the drain wall where it was then

escaping. This flow of water had washed a lot of sediment into the drain cavity which was removed by Historic Scotland staff. The slabbed drain would be re-capped (and utilised to solve an internal damp problem) under the direction of the Historic Scotland architect. The pipe was re-jointed in Trench 1C, while a bridging joint reconnected the cut pipe in Trench 2.
