**HISTORIC SCOTLAND PROPERTIES IN CARE
MINOR ARCHAEOLOGICAL WORKS 2011**

Fort Charlotte: West Bastion Wall Investigation, August 2011.

SITE: Fort Charlotte, Lerwick, Shetland Isles.

DESCRIPTION: Test trenching to establish the cause of structural cracks within the N and W walls of the W bastion.

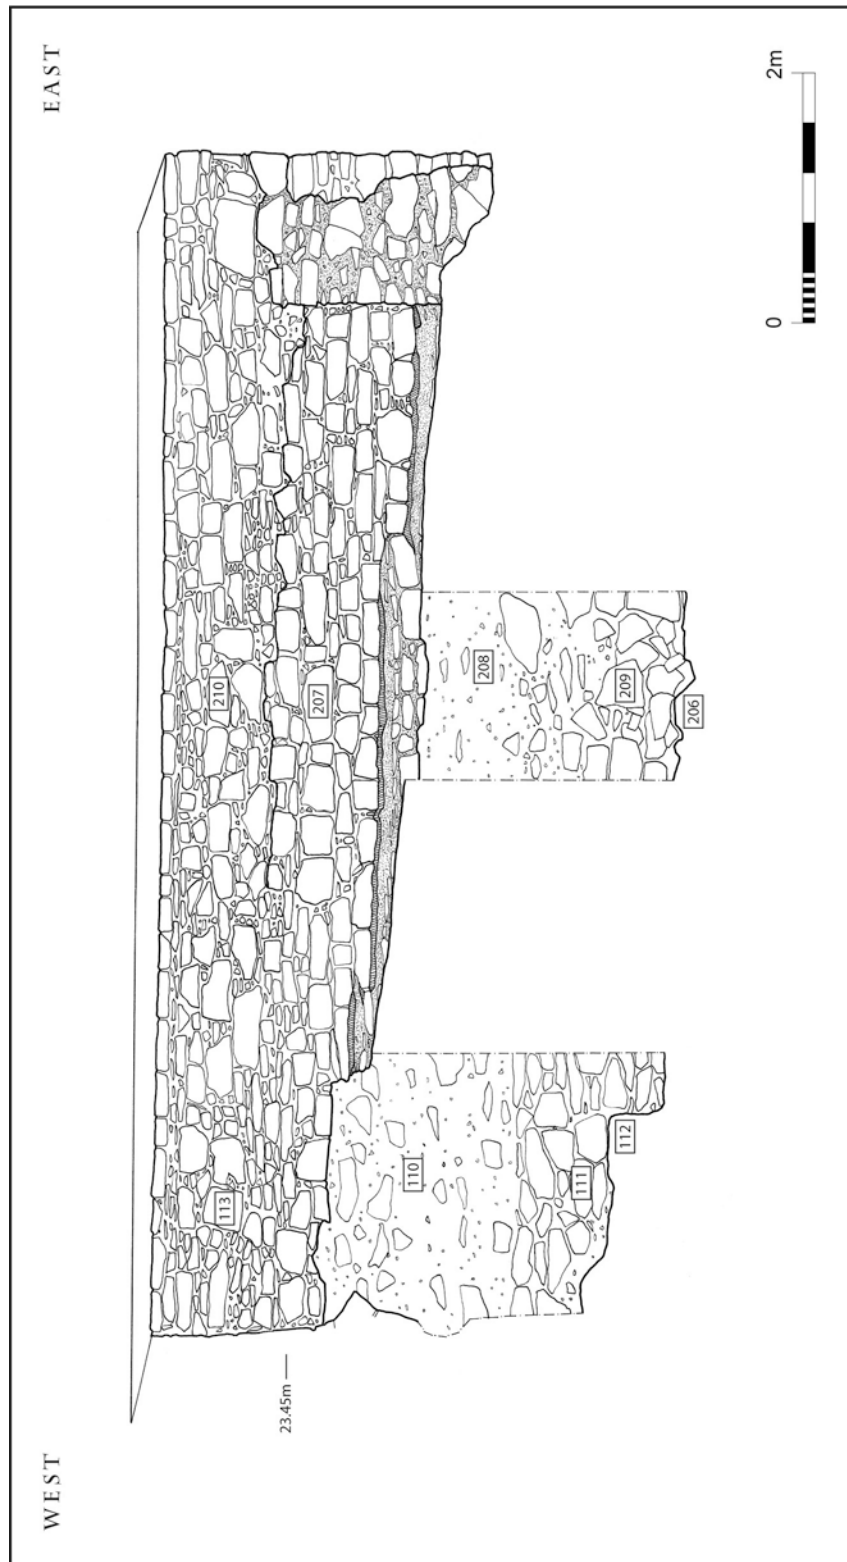
Figure 4: S-facing elevation of N wall with Trench 1 and Trench 2.

The N wall again consisted of a rough upper build **113** composed of angular pieces of different stone types, ranging from buff-coloured sandstone (sometimes containing pink or white quartz cobbles and rounded pebbles), grey angular granite/dolerite blocks, mid-brown conglomerate and greenish-grey breccia. The larger pieces of stone had smaller angular pinnars of similar rock types in between them. Several of the sandstone pieces again showed signs of a vertical drill scar, c.2cm wide. The wall was heavily re-pointed and carried a wide angled course of copes (1.05m wide compared to 1.70m in the W wall) at its apex, slanting upwards from E to W. The wall stood approximately 2.10 - 2.15m high internally (at least 4.20m externally) and was affected by a structural crack, up to 3cm wide in places, running in a ragged course from E to W, approximately 0.20m - 0.30m above the ground.

On the N wall a clear division became visible when the peat layer **103** was excavated. The wall layer **110** associated with the build up of the peat was heavily pointed with lime mortar, again with a build of angular rock pieces - although these were largely obscured by the pointing. The interface below the pointed wall and the peat had a layer of mixed lime pointing, silt and peat **104**, which was completely free of artefacts, and was up to 0.20m thick, thinning back from the wall itself. Below this and the turf **103**, was a further, more compact turf bank **105**, up to 0.90m thick. This layer was again a thick, heavy pungent-smelling organic layer. No artefacts were recovered from it. This is likely to be the original 17th century earthwork. Associated with it (and most easily observables on the N wall) was a build of angular pieces of sandstone and granitic rock up to 1.2m high, bonded in lime mortar **111**. The precise form of the fort of 1665 is not clear in terms of whether it originally had stone walls or whether these are a later addition. Typically there was enough of a void between the wall and peat layer **105** to make this relationship indistinct. The turf bank itself cleared on to an undulating layer of bedrock **112**, containing several natural clefts within which there was a mixture of sand and shale. No artefacts were recovered from this layer.

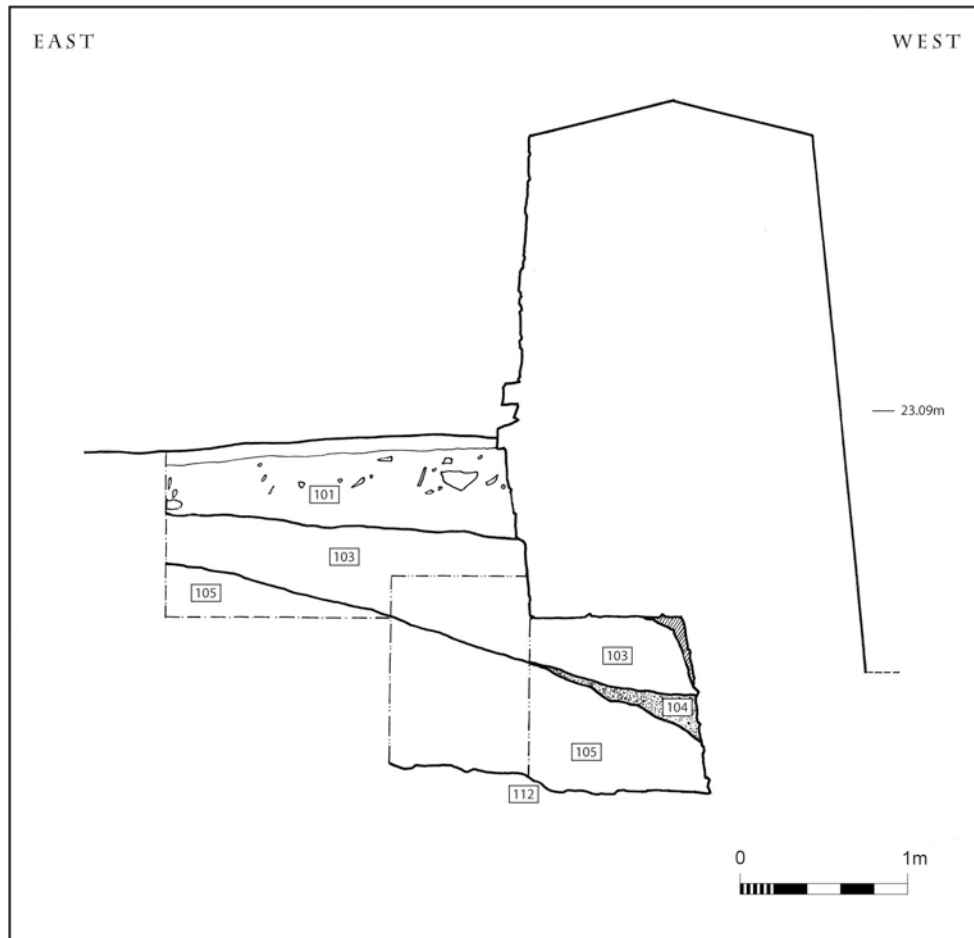
Figure 5: N-facing section and profile through the W wall (Trench 1).

The difficulties of working amongst the shoring in Trench 1 meant that after the initial excavation of 0.50m, the depth then dropped to 1m, and an L-shaped sondage was used to expose the relationship between the wall and the bedrock. This sondage was 0.70m wide against the W wall, and up to 0.85m wide against the N wall. The sondage was dug in spits and shored as it was excavated. The total excavated depth in Trench 1 was 2.35m. In addition, a portion of the N wall (20th century rebuild/repair **113**) that measured 1.80m E/W x 0.30m high had to be removed as part of the works. This was photographed beforehand, and was in such poor repair that the removal of the deposits below it would have rendered it unsafe to work beneath. After an on-site consultation with the Historic Scotland engineer, it was decided that the structural instability of the W wall could be solved by cutting two slots through the peat deposits **103** and **105**. Each slot was 0.30m wide and they were 0.40m apart. This allowed two brick pillars to be bedded on the exposed bedrock, immediately adjacent to the

battered internal wall, and up and under foundation **108**. Their installation should prevent further movement.

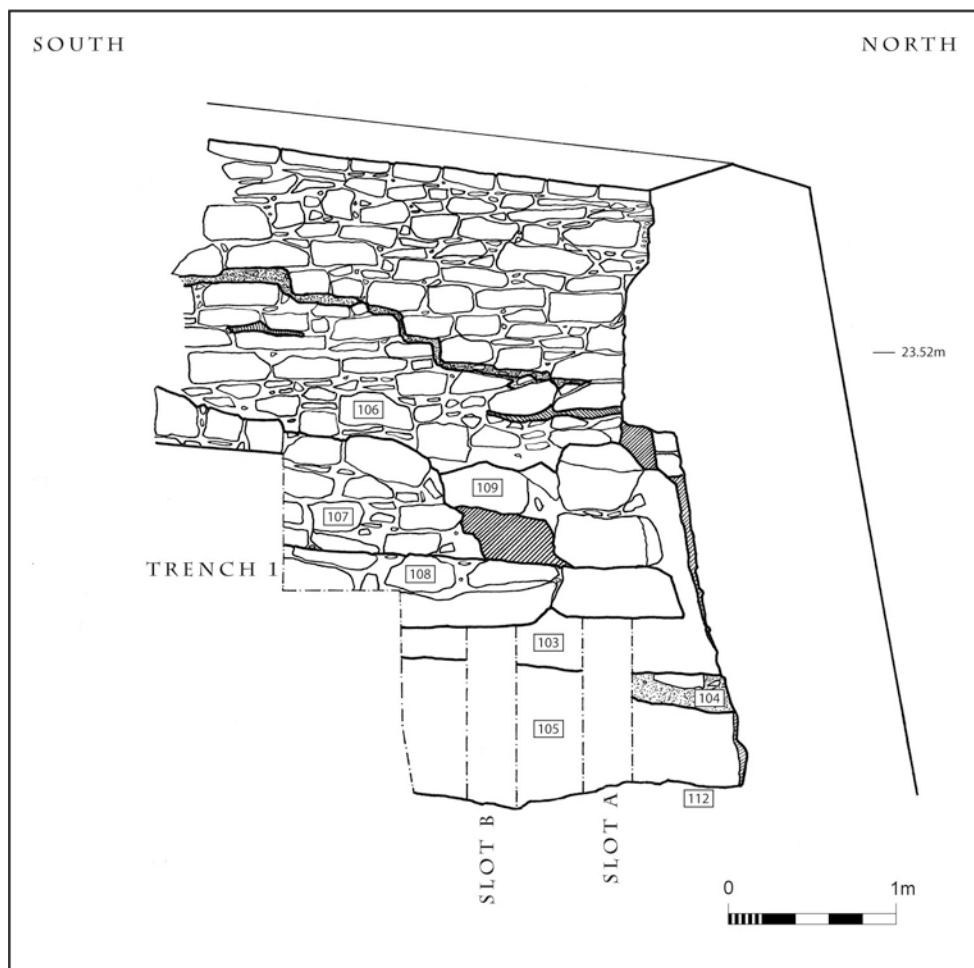
Figure 6: E-facing section and elevation of the W wall (Trench 1).

was heavily re-pointed and carried a wide angled course of copes (1.70m wide) at its apex, slanting upwards from N to S. The wall stood around 2.08m high internally (at least 3.45m externally) and was affected by a structural crack, up to 5cm wide in places, running in a ragged course from N to S, 0.3m - 1m above the ground. Earlier attempts had been made to seal the crack with mortar, but it had simply opened up again. A quick probe showed that a further wall face lay in behind, at a distance of 0.65m - 0.70m. Build 106 was carried on a 0.20m wide, poorly-bonded, projecting masonry foundation 107, consisting of angular blocks of buff-coloured sandstone and greyish granite. This build had either become heavily voided, or partially re-built to the N, where a further projecting area of masonry 109 carried build 106 above. Context 109 was in a state of near-collapse, its masonry held together by a loose matrix of mortar-flecked silt (one large stone slipped out of the wall at an early stage, reinforcing the need for adequate shoring). Contexts 107 and 109 were carried on a further masonry build 108, consisting of large angular basal sandstone blocks bonded with lime mortar. This course was up to 0.40m thick, and was recessed back from 107 by 5cm.

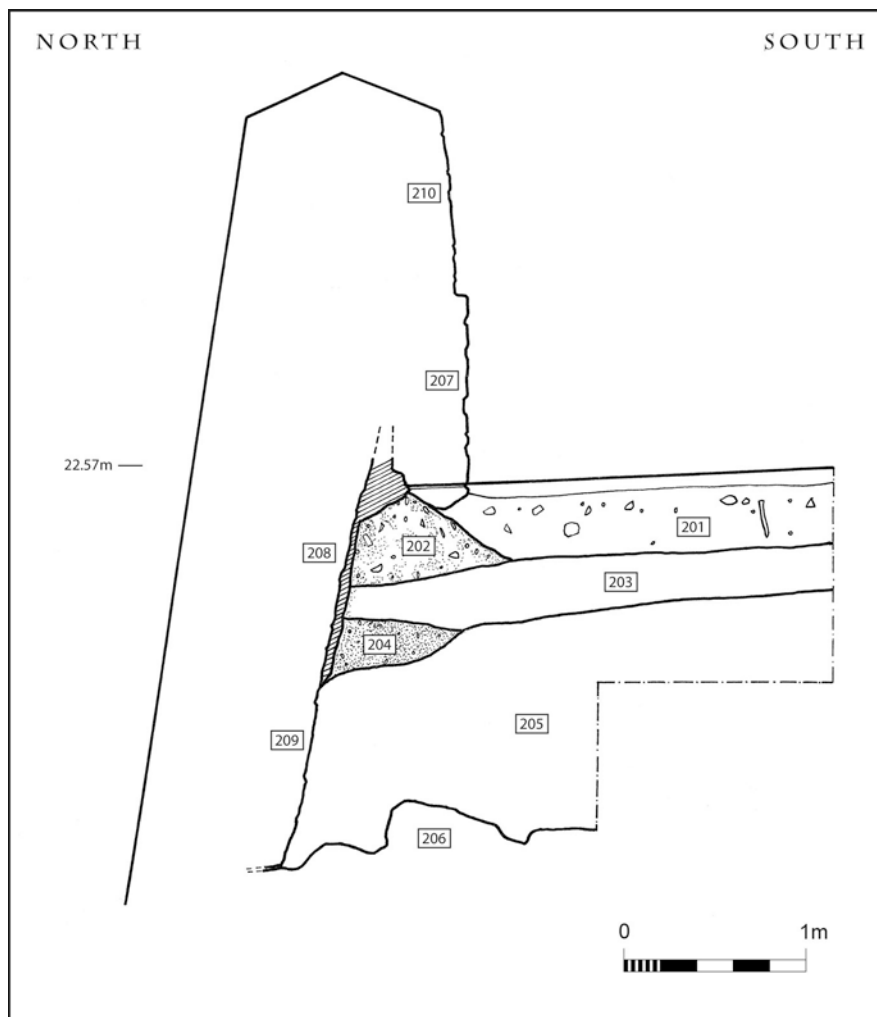
Figure 8: W-facing section and profile through the N wall (Trench 2).

On the N wall a clear division became visible when the peat layer **203** was excavated. The wall layer **208** associated with the build up of the peat was heavily pointed with lime mortar, again with a build of angular rock pieces, although these were largely obscured by the pointing. This was first exposed when the initial slots were cut in order to fit the primary shoring. The interface below the pointed wall and the peat had a layer of mixed lime pointing, silt and peat **204** which was completely free of artefacts and was up to 0.40m thick, thinning back from the wall itself. Below this and the turf **203** was a further, more compact turf bank, **205**, up to 1m thick.

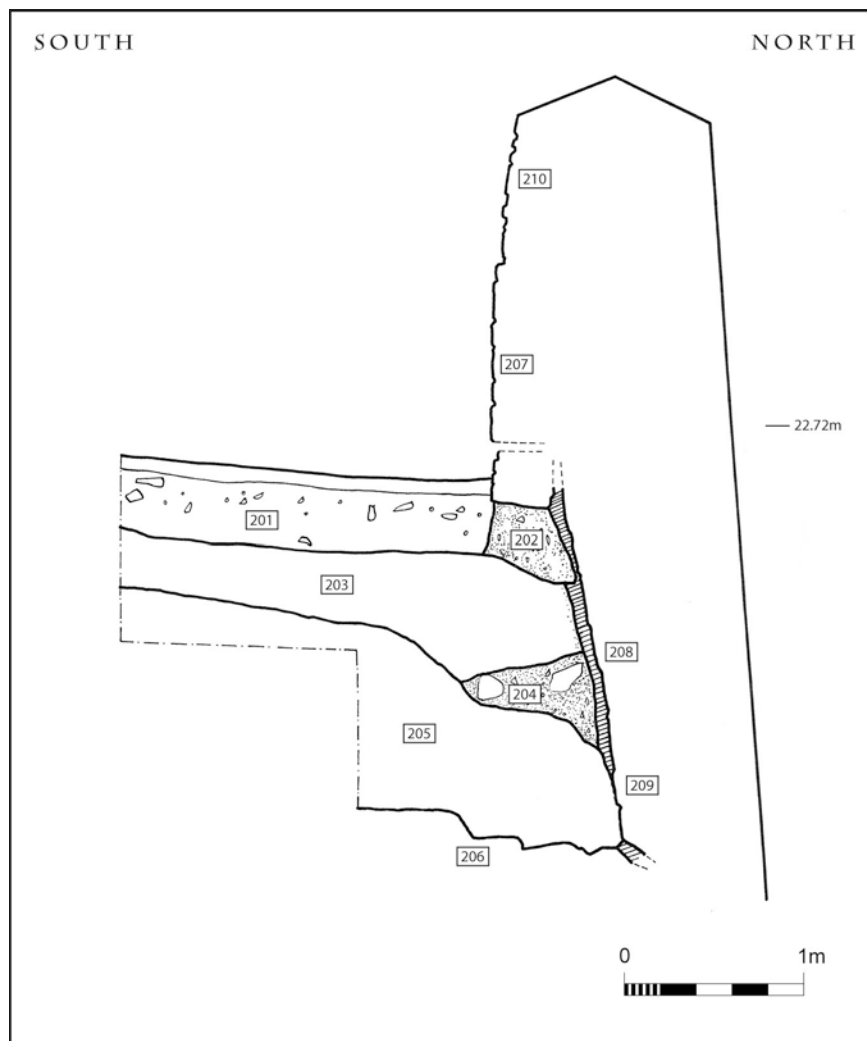
Figure 9: E-facing section and profile through the N wall (Trench 2).

Unfortunately, there was enough of a void between the wall and peat layer **205** to make this relationship indistinct – it is not clear if the fragments of mortar are falling from the wall to fill the void or whether they are part of the process of the wall and bank being brought up together and therefore being contemporary. The turf bank itself cleared on to an undulating layer of bedrock **206**, containing several natural clefts within which there was a mixture of sand and shale. Unfortunately no artefacts were recovered from this layer and although it was difficult (nearly impossible) to get clean, it was possible that the angular, clefted surface exposed indicated that the bedrock had been partially quarried prior to the installation of the earthwork. This may in turn suggest that the stone was either being quarried for a contemporary wall, or possibly for buildings within the fort.

After the removal of the initial 1.2m of fill, the Historic Scotland engineer requested that the work concentrated on the exposure of the relationship between the wall and the bedrock. Thus the southern 1.3m of the trench were excavated to a depth of c.1.2m, while the northern end of the trench was 2.2m deep. The exposure of the angled N wall and the bedrock in Trenches 1 and 2 allowed the instability problem to be solved by building a brick wall directly on the bedrock to support the bastion wall.
