HISTORIC SCOTLAND PROPERTIES IN CARE
MINOR ARCHAEOLOGICAL WORKS 2011

St Mungo's Cathedral, Glasgow: Damage Inspection, July 2011.

SITE: St Mungo's Cathedral, Glasgow.

DESCRIPTION: Inspection of an area of flood damage on the N side of the Nave.

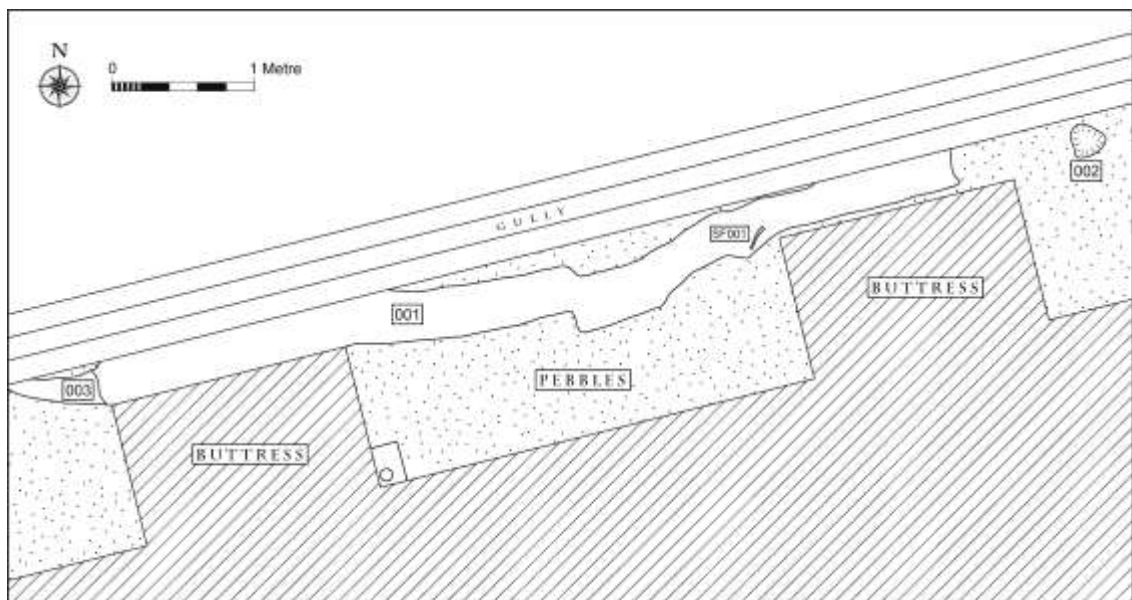
Figure 2: Plan of the flood damaged area.

The cuts to re-lay the gully and to backfill the down pipe channels appear to have been backfilled with a mixed, loose material. It is likely that the human bone became disarticulated during the backfilling work, and was reburied along with the backfill, only to be disturbed by the rainwater. There was no indication of further human remains being present. In some locales the concentration of pebbles is high, allowing them to sit above the level of the drain. This, coupled with their low weight, means that they will be washed into the channel during episodes of severe rain.

The area of damage (001) measured 6.80m long E/W x (up to) 0.40m wide x 0.15m - 0.40m deep. A further small sub-circular 'rut' (002) lay 0.80m to the E, with a width of 0.20m and a depth of 0.18m. A curved piece of ridged bone (SF001), 0.15m long - possibly a human rib bone - was recovered along with some modern iron artefacts.

The severe rain, while not unusual in Glasgow, was forceful enough to dislodge deposits which up until now had retained their integrity. The artefacts noted (modern glass, iron nails, scaffolding bolts) would appear to have derived from modern backfilling episodes. The area may benefit from formal shallow excavation in order to establish the ground make-up and secure any further archaeological contexts close to the surface. Continued exposure of the 'rut' to the elements will only lead to further erosion. The small, loose pebbles - especially those sitting above the drain - would not appear to be fit for purpose during episodes of extreme weather.
