**HISTORIC SCOTLAND PROPERTIES IN CARE  
MINOR ARCHAEOLOGICAL WORKS 2011**

**Cadzow Castle: Wall Reduction/Reinstatement, May 2011.**

**SITE:** Cadzow Castle, Chatelherault Country Park.

**DESCRIPTION:** Watching Brief during the down-taking of masonry in the inner ward, and during the clearance of soil from the masonry over the bedrock on the S side of the modern approach road to the castle.

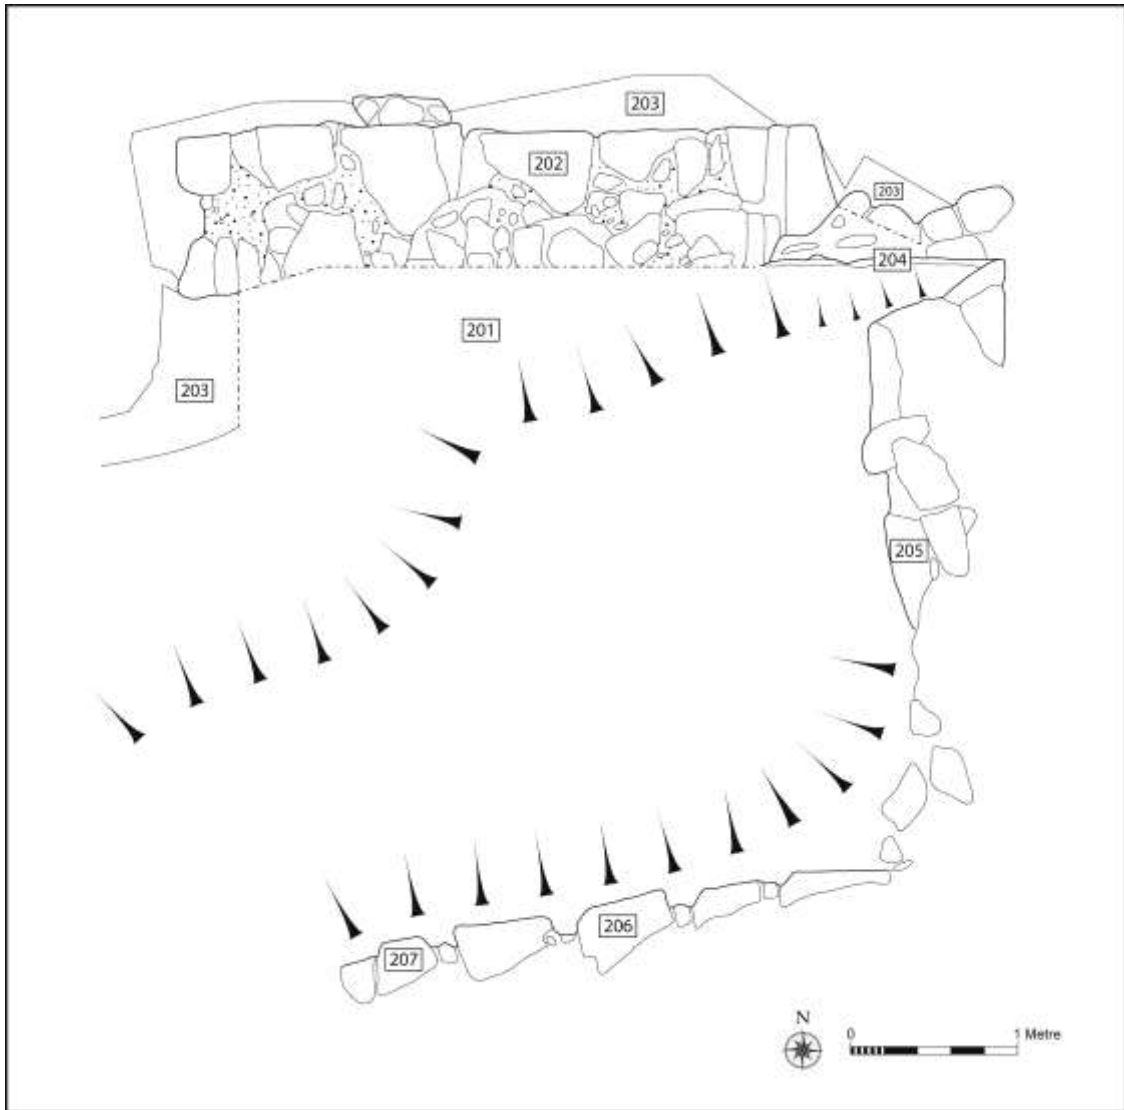
Figure 2: Plan of Site 2.

The overburden consisted of dark-brown loose silt **201** which had slumped over the masonry. The masonry itself was cleaned off, and the remains consisted of several elements. To the N, a wall **202** was exposed running E/W.

This consisted of a N face of two courses of horizontal rectangular dressed sandstone blocks bonded in a yellowish lime mortar and a S face which was less formalised and slightly higher, using occasional large sandstone blocks and largely composed of medium-sized sub-angular and sub-rounded sandstone pieces. The wall was 0.95m thick (N/S) where fully exposed, and c.5m long E/W. Neither end of the wall had a formal right-angled terminus, and there was no sign that the wall originally returned to the S. The wall itself sat on a natural red bedrock shelf 203 which protruded slightly to the NE. There was no sign of mortar on the bedrock outwith the confines of the wall itself. Within the bedrock cleft were repairs 208 dating to c.2002. It was also noted that there may have been some dressing of the bedrock at the NW corner. This comes in

the form of pecking of the outer face of the bedrock. While it is possibly natural, it could be that some localised shaping of the bedrock was necessary to make the face sheer.

Slightly behind (S) and to the E of wall **202** was a further wall of totally different character. This wall **204** consisted of un-jointed pieces of sub-angular bedrock in a state of near collapse. The dangerous condition of the wall meant that absolutely minimal earth removal was carried out. The overhanging nature of this loose rubble coupled with a general lack of access from the scaffold meant that the precise relationship between this wall and its neighbour **202** could not be properly established. Wall **204** was approximately 1.5m high x 1.4m E/W on its N face (the thickness could not be established). The inability to clear the loose earth from between the stones meant that it was not possible to get a clear look at how the wall was constructed internally. What was clear was that to the N, the wall face was flush and it returned to the S at its E corner. Above this wall, at a higher level to the S was a further wall running N/S **205** whose relationship to **204** could not be established. Wall **205** was constructed from large horizontal blocks of sandstone which did not appear to be bonded in lime mortar. Further to the S, and in a seeming return from wall **205** were three architectural fragments **206** dressed with a 0.09m wide chamfer with a 0.06m wide rebate cut in behind. The size of the chamfer was identical in each and it is likely that they originally sat one on top of each other as part of a door or window jamb until they were moved to their current position. To the W was a further line of un-dressed angular sandstone blocks **207**. These again seemed to be a later addition.
