**HISTORIC SCOTLAND PROPERTIES IN CARE
MINOR ARCHAEOLOGICAL WORKS 2011**

Melrose Abbey Priory Farm: Test Pit, August 2011.

SITE: Melrose Abbey Priory Farm, Melrose.

DESCRIPTION: Examination of the basal courses of the E courtyard wall.

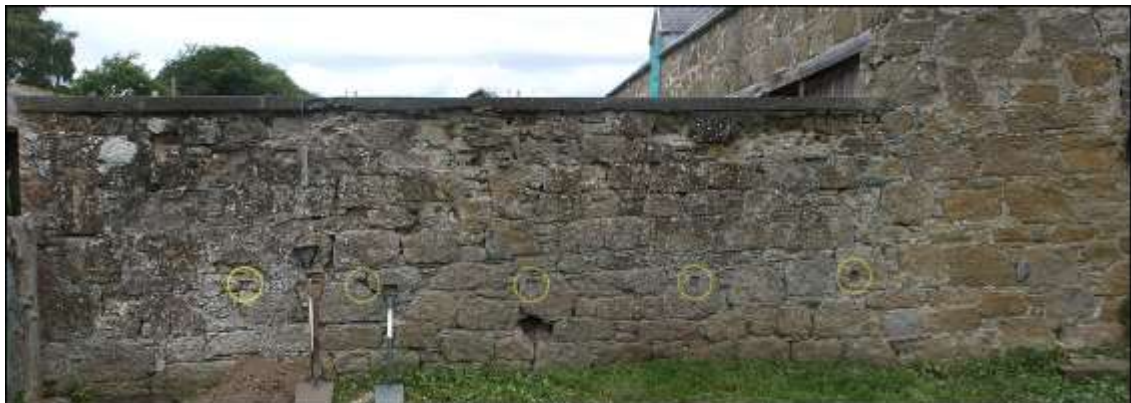
Observation of the E face of the E courtyard wall suggested that it may have been an addition to the E gable of the N range of structures, and it in turn it had featured a series of timber elements. These are reflected by a series of at least five shallow recesses in the wall face – perhaps reflecting a timber platform or fencing/stalls which extended E of the courtyard itself (Fig.2).

Figure 2: The E-facing, exterior elevation of the E wall of the courtyard. The shallow recesses are highlighted. The image is a composite and *not to scale*.

The origins of the distortion evident in the lean of the wall appear to be associated with the N range of structures with their wide open S facades and use of large timber elements. The pressure from this range appears to have pushed the E gable out (to the E), which in turn has pulled the associated E courtyard wall with it.
