British Waterways Scotland

**Union Canal, Redding:
Mooring Footings Watching Brief
October 2010**

Project Code: BW-UCR-2010-01

**19th-20th October 2010
Kirkdale Archaeology**

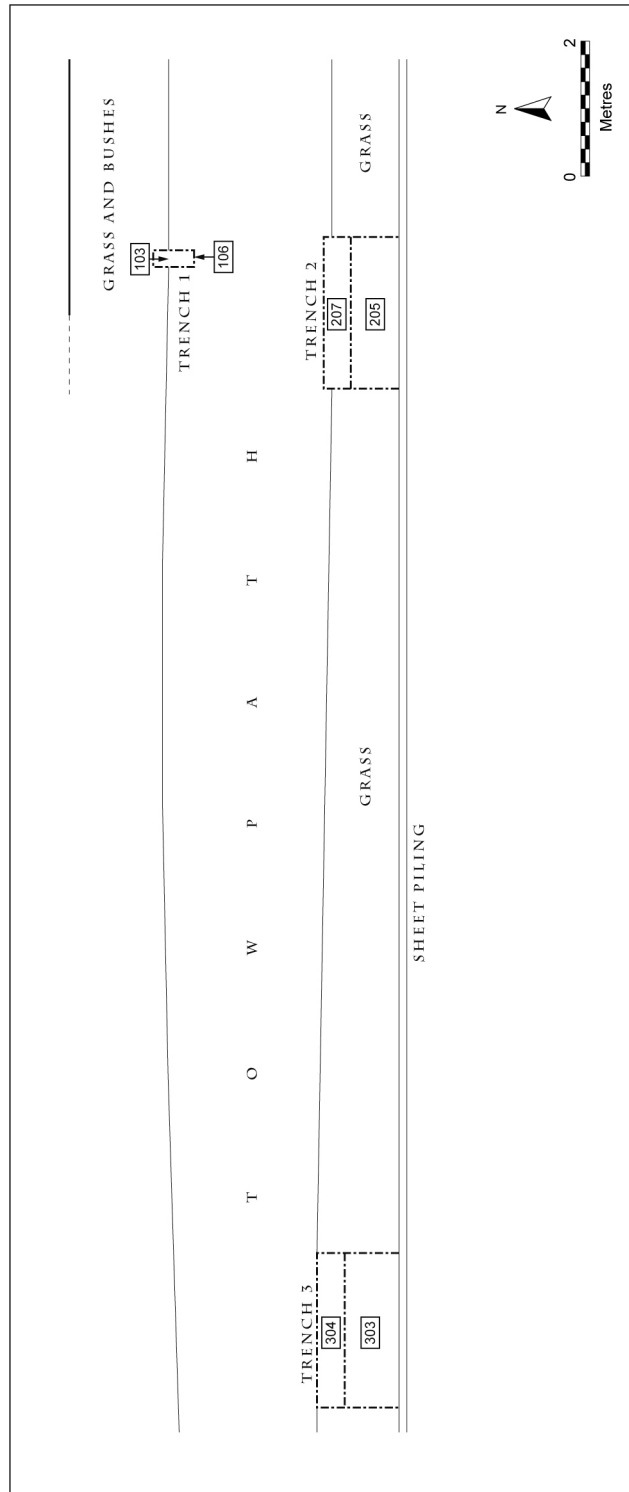
Figure 2: Plan showing the location of the trenches.

Trench 1 (see Fig. 2 and 5) was a small investigative trench excavated to locate the Easynet fibre optic cable. This was found 450mm from the N edge of the towpath running E/W at a depth of 530mm. The trench itself was 250mm E/W x 600 mm N/S. To the N it was 400mm deep, to the S, 530mm deep. The section was composed of an upper layer of type 1 whin dust and finings (**101**) some 35mm thick forming the path which was bedded on a 205mm thick bed of mottled grey and brown mixed re-deposited silt and type 1 stone (**102**). Contexts (**101**) and (**102**) had been laid over the cable trench after the excavation and as such were layers of modern landscaping. Context (**102**) had been built up over a moderately compact layer of dark brown silt and clay containing moderate sub-rounded stone inclusions (**103**). This may have been part of the original up cast forming the 1820s towpath, however it is more likely to relate to re-deposition of material after the insertion of the sheet piling (see Trench 2, below). To the S it was truncated by the vertical cut (**104**) for the fibre optic cable. The cut was 290mm below the silt (**102**) and was only partially exposed, as the cable was located without the need for further expansion of the trench. The trench had been backfilled with re-deposited silt, stone and clay (**105**) after the insertion of the fibre optic cable (**106**). The towpath was then restored by the introduction of (**101**) and (**102**). After exposure of the cable, the trench was planned and backfilled.

Trench 2 (see Fig. 2, 3 and 5) was excavated to form the footing on the E side of the mooring. The trench's E end sat 2.80m W of the E end of the sheet piling. The trench itself measured 2.40m E/W x 1.20m N/S. The N portion of the trench was excavated to a depth of 1m, while to the S it was only 320mm deep – due to the shape of the concrete footing. To the N, the S side of the towpath was partially excavated showing its make-up. The Type 1 path (**201**) was 80mm thick and lay on a cloth terram (**202**).

Trench 3 (see Fig. 2, 4 and 5) was excavated to form the footing on the E side of the mooring. The trench's W end sat 27.30m E of the W end of the sheet piling. Centre to centre, Trenches 2 and 3 were 16m apart. The trench itself measured 2.40m E/W x 1.20m N/S. The N portion of the trench was excavated to a depth of 800mm, while to the S it was only 320mm deep – this was due again to the shape of the concrete footing. The Type 1 path (301) was 100mm thick and lay on a cloth terram (302). The

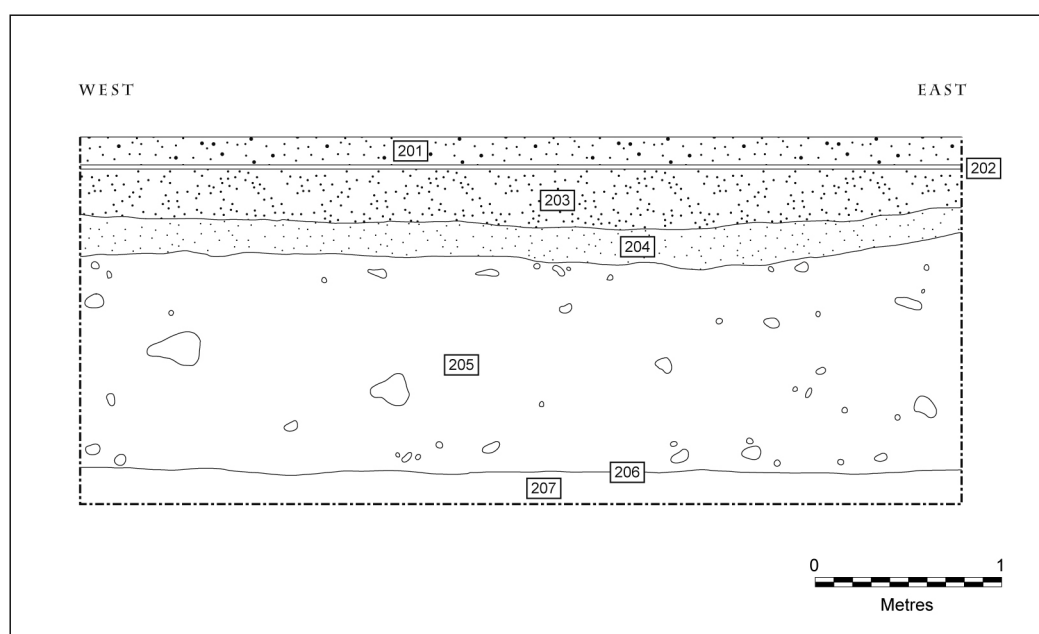
Figure 3: S-facing section in Trench 2.

The terram covered a levelling layer of whin dust and gravel (**203**) which was at least 140mm thick over an undulating bed of Type 2 stone (**204**) some 100mm thick.

Context (204) covered an extremely compacted layer of mixed mottled re-deposited material (205) including stone, silt, clay, gravel and off-cuts of sheet pile. This showed that layers (201) to (205) post-dated the insertion of the sheet piles and revealed that when they were inserted, the towpath had to be cut back in order to facilitate their construction. A layer of yellowish brown highly compacted but quite clean silty clay (207) at the foot of the section is likely to represent the surviving original section of towpath up cast from the 1820's. As such, the layers above it sit within a cut (206) where the towpath was cut back in order to fit the sheet piling (208). As the S side of the trench was quite shallow, it was not possible to see any evidence of the original canal wall.

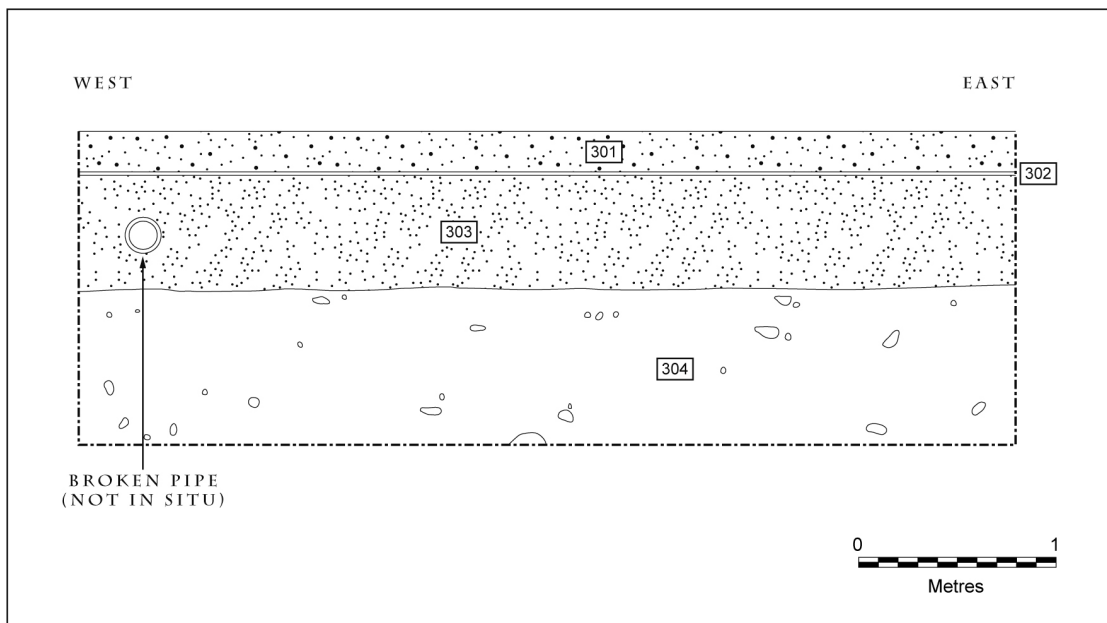
Figure 4: S-facing section in Trench 3.

terram covered a 300mm thick layer of quite loose mixed re-deposited material (303) including silt, gravel, lead pipes, sweet wrappers and working debris throughout. This had been used as levelling material overlying a further re-deposited layer of mixed clay, silt and stones (304). Throughout (304) were lots of pieces of corroded metal and enough sheet-pile off-cuts to suggest that the layer was made up after the insertion of the sheet piles. None of the original towpath make-up was revealed in this trench – however the trench was 200mm shallower than Trench 2.
