**Historic Scotland  
Properties in Care  
Minor Archaeological Works 2010**

**Craigmillar Castle:  
Test Trenches and Excavation  
November/December 2010**

**HS PIC Index Number: 90129  
Project Code: HSCO-90129-2010-01**

**Project Description :** Watching Brief during the excavation of three test trenches to ascertain the floor make-up and establish the height of the vaults prior to remedial works to prevent water inundation.

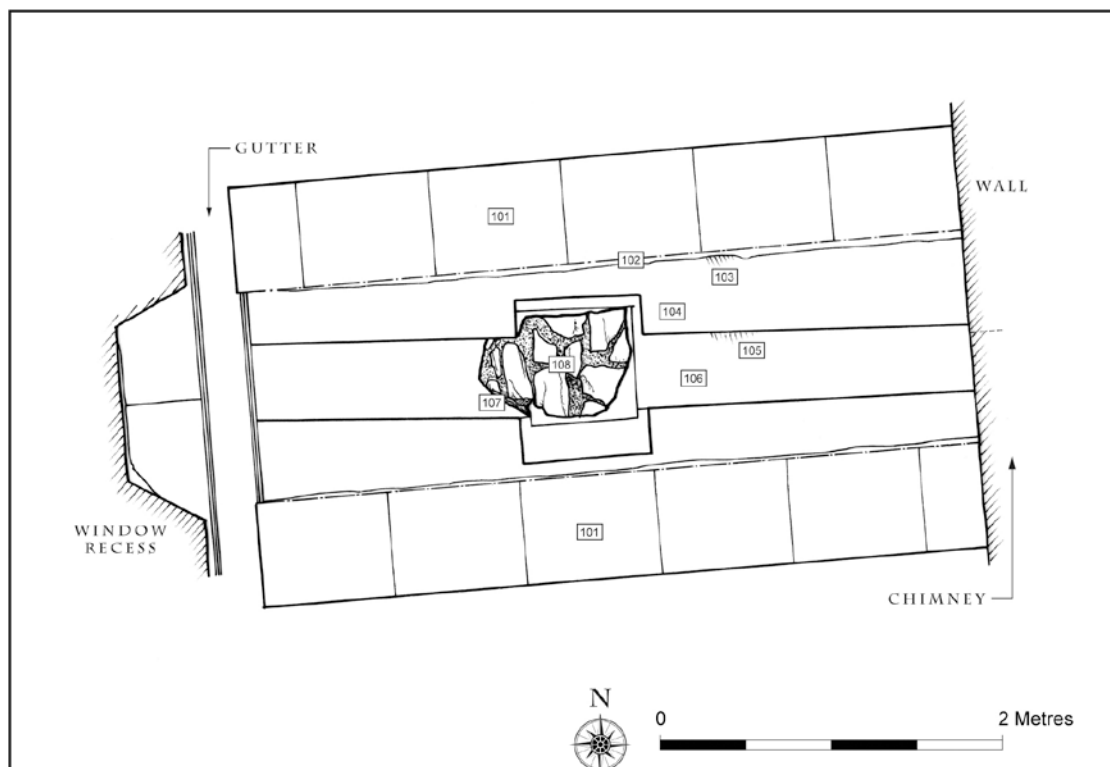
Figure 3: Plan of Trench 1.

Trench 1 was located at the N end of the second floor of the East Range. Two lines of slabs lying E/W were removed to open up a working platform. The slabs were modern, made of concrete (101) c.50mm thick and generally 780mm x 620mm in area.

These were bedded on a grey concrete screed (102) c.25mm thick. Under the screed lay a layer of bitumen sealant (103), though this was more akin to a painted coat (1-2

mm thick) than a protective layer. The bitumen sealed a layer of poured concrete (104) c.50mm thick. Below the concrete lay a further layer of bitumen (105), this time c.5 mm thick and sealing an undulating layer of reinforced concrete (106). The concrete was between 60 and 160mm thick and was strengthened with square-sectioned metal mesh. When this layer was broken out, a section of the extrados of the main vault was uncovered.

Between the reinforced concrete and the vault was a loose layer of mortar, stone, brick and bitumen fragments (107) up to 50mm thick. It appeared that when this (or the preceding) arrangement of concrete and bitumen was laid, the deposits over vaults had been removed. This was confirmed by a Ministry of Works plan from May 1960 labelled 'Proposed Strengthening to Arch at North East Corner' (Drawing No. 3804/1) on which there is an annotation 'Existing Fill on Top of Arch to be Completely Removed'. This particular phase of strengthening only extended as far as the area of the vault in the northernmost room on the first floor, and thus explains

why deposits remained *in situ* in Trench 3. There were therefore no *in situ* archaeological deposits at this particular juncture, although the deposits on the vault apex would be the most likely to require reduction when installing a floor. The extrados of the vault (108) itself was composed of cinked angular sandstone blocks running N/S, with the vault in the room below falling to the E and W. The stone was bonded in a whitish yellow lime mortar. Only a small section (600mm N/S x 900mm E/W) of the vault was exposed in its central portion.

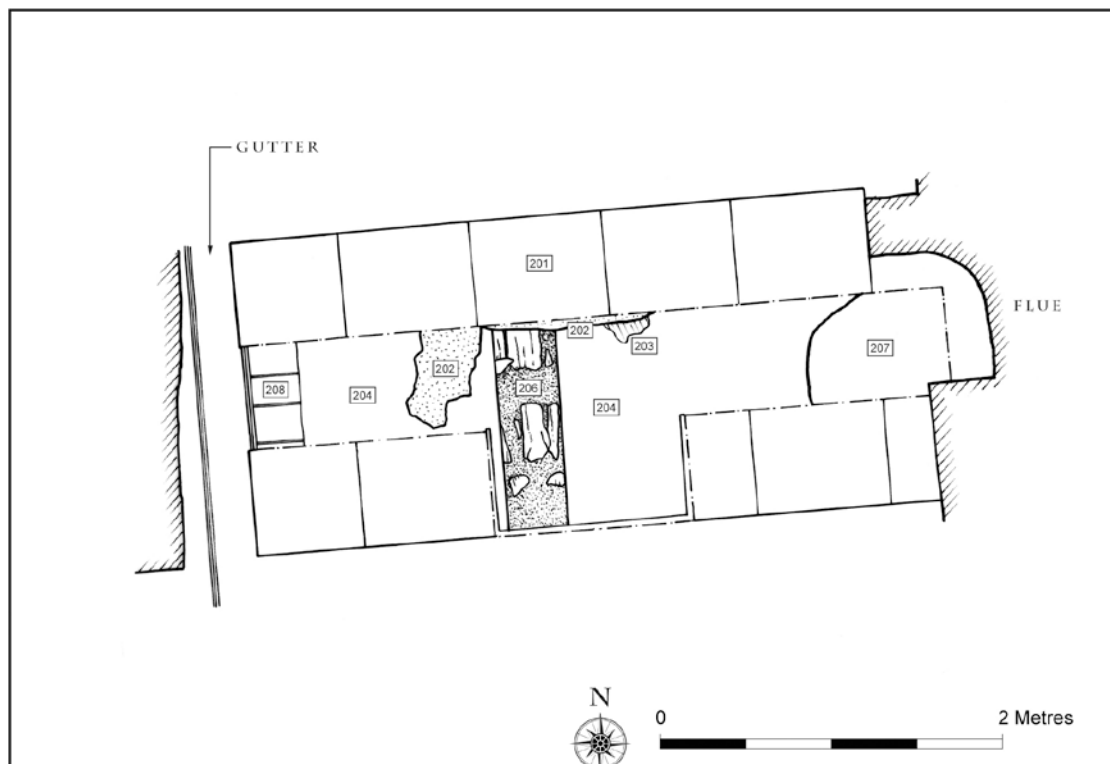
Figure 5: Plan of Trench 2.

The slabs were modern, made of concrete (201) 50mm thick and generally 780mm x 620mm in area. These were bedded on a grey concrete screed (202) c.25mm thick. Under the screed was a layer of bitumen sealant (203), though this was again more akin to a painted coat (1-2mm thick) than a protective layer. The bitumen sealed a layer of undulating poured concrete (204) 20-50mm thick. Below the concrete was a moderately compact light brown layer of stone and mortar (205) sealing the vault extrados. This appeared to be a truncated archaeological layer up to 45mm thick; it contained no artefacts. The installation of a succession of floors had left the *in situ* deposits severely truncated at the vault apex. Context (205) represented the original *in situ* levelling above the vault cap. The vault below was notably higher than that at the N end. The main vault extrados (206) was composed of clinked angular sandstone blocks running N/S, with the vault in the room below falling away to the E and W. The stone was bonded in a whitish yellow lime mortar. To the S, in the room below, was a side vault forming the soffit of the window recess.

To the E of Trench 2, a large semi-circular area of concrete with a bituminous seal may have been a capped flue (207). The feature, as exposed, was 620mm N/S x 800mm E/W. Upon investigation it transpired that it was indeed a flue running up from a fireplace in the vaulted basement below. The only further feature of note was the concrete edging blocks (208) forming the E side of the asphalt gutter.

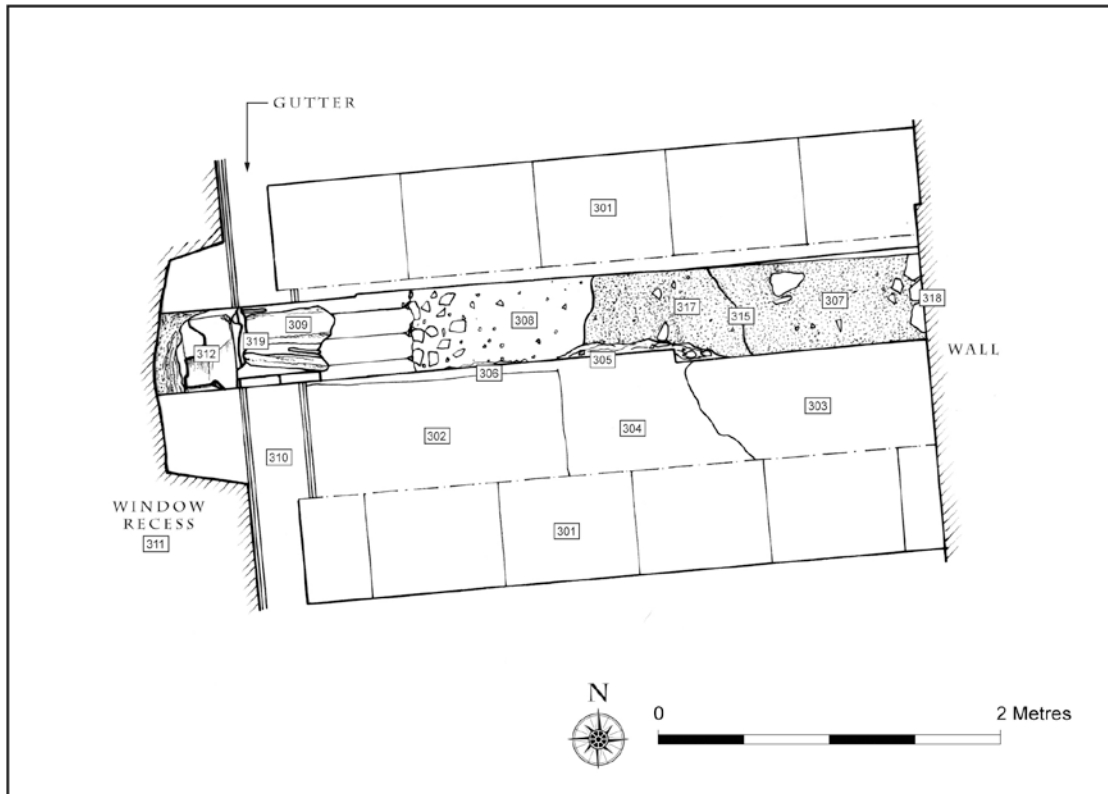
Figure 7: Pre-excitation plan of Trench 3.

Trench 3 was located centrally within the second floor of the East Range. Two lines of slabs lying E/W were removed to open up a working platform. The slabs were modern, made of concrete (301) 50mm thick and generally 780mm x 620mm in area. These were bedded on a grey concrete screed (302) 25mm thick. Under the screed was a layer of bitumen sealant (303), though this was again more akin to a painted coat (1-2mm thick) than a protective layer. The bitumen sealed a layer of poured concrete (304) 60-80 mm thick, which formed the gutter to the W. Underneath this was a layer of perished reinforced concrete (305) in very poor condition. This old concrete surface was up to 40mm thick, greyish brown in colour and containing heavily oxidised strengthening mesh. It was likely to date from the initial stages of consolidation in the 1950's or 1960's. Context (305) was truncated to the W by a cut (319) to insert the drain inlet (312). A patch of loose stone and mortar levelling (306) was found below (305) and probably indicated excavated material being re-deposited and used as levelling for the old reinforced floor.

It became apparent after the removal of the old reinforced concrete that there were *in situ* deposits sealing the vaults below. The archaeological deposits revealed had been truncated to the W by a cut to insert the drain inlet. The floor of the window recess (311) had been opened by cut (319), up to 260mm deep, which had cleared down onto the extrados of the W side vault serving the window recess in the first floor room below. The drain inlet (312) comprised a rectangular aperture formed from a mixture of brick, sandstone, concrete and smashed pieces of modern terracotta drain pipe. This inlet appeared to feed into a gully running S/N from this point – there were three small rectangular apertures in the exterior W wall facing the courtyard and these had the appearance of outlets. The age of this feature was not clear as it could not be examined in any detail, however there were three observations that are suggestive of a late date:

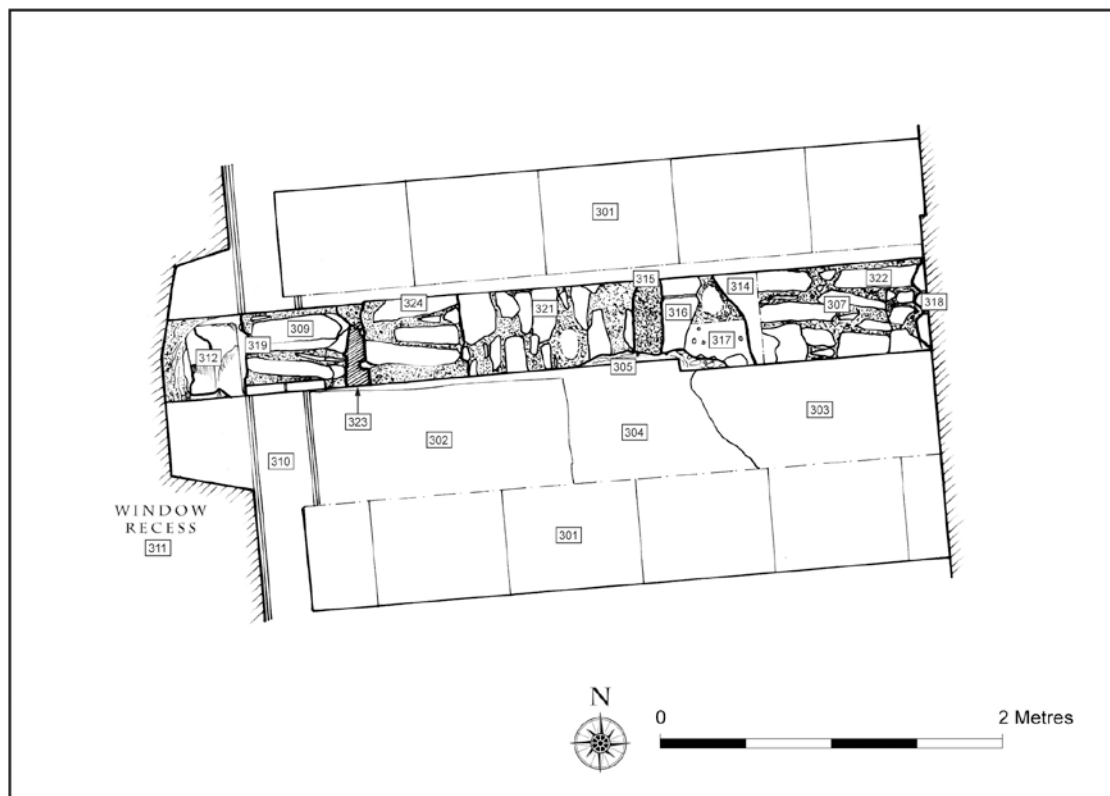
Figure 8: Post-excavation plan of Trench 3.

The feature had been backfilled with a mixture of whitish-yellow un-bonded lime mortar and silt (317) up to 100mm thick, probably a re-deposited mixture of (307) and (308) with added mortar. Over the E side vault (322), the mortar layer (307) cleared onto a charcoal and mortar-rich moderately compact layer of mid-brown silt (314). This represented the basal levelling layer over the vault with (307) above. Similarly, the upper levelling (308) over the main vault extrados cleared onto a thin layer of a charcoal and mortar-rich moderately compact mid-brown silt (313) very

similar to (314). It seemed likely that the two layers represent the same basal levelling event, with (307) and (308) representing different dumps of levelling material. The insertion of a succession of floors from the 1950's has also truncated any sign of the original floor. Hand-made iron nails were found within (308), (313) and (314). While those found within (308) could have belonged to a now-vanished planked floor, those within (313) and (314) were within a sealed deposit. It is likely that the upper floor levels may only survive in fragmentary form against the side walls as a result of this later truncation. The E side wall in Trench 3 could be seen to have a footing of angular sandstone pieces bonded in white mortar (318) laid over the E side vault extrados. The footings protruded from the wall face by 100mm.

Having cleared off the soft deposits, the vaults were exposed. The W side vault (309) was composed of clinked angular sandstone blocks running E-W, with the vault in the window recess below falling to the N and S. The stone was bonded in a whitish yellow lime mortar. The main vault extrados (321) was again composed of clinked angular sandstone blocks running N/S, with the vault in the room below falling to

the E and W to meet the side vaults. The stone was bonded in a whitish yellow lime mortar. Where the main vault (321) met the W side vault (309), a capping layer (324) of clinked angular sandstone blocks bonded in whitish-yellow lime mortar running E/W sealed the joint. This joint has failed, as there was a substantial structural crack (323) forming a void up to 140mm wide E/W between the two vaults. The limits of the crack were not visible within the confines of the trench, but could be located during future works. The age of the crack could not be determined, but it was substantial and likely to be one of the main conduits for water penetrating the vault and walls below.

If there is a requirement to expose more of the archaeological fabric as part of the remedial drainage works, it would be prudent and practical to carry out a pre-emptive building survey that would provide the framework for the phasing of all the structural elements within the East Range.
