**HISTORIC SCOTLAND PROPERTIES IN CARE
MINOR ARCHAEOLOGICAL WORKS 2013**

Meadowbank Lodge • Monitoring • October 2013

SITE: Meadowbank Lodge, Holyrood Park, Edinburgh

DESCRIPTION: Watching Brief during excavation over drains and services on the eastern and southern sides of the house

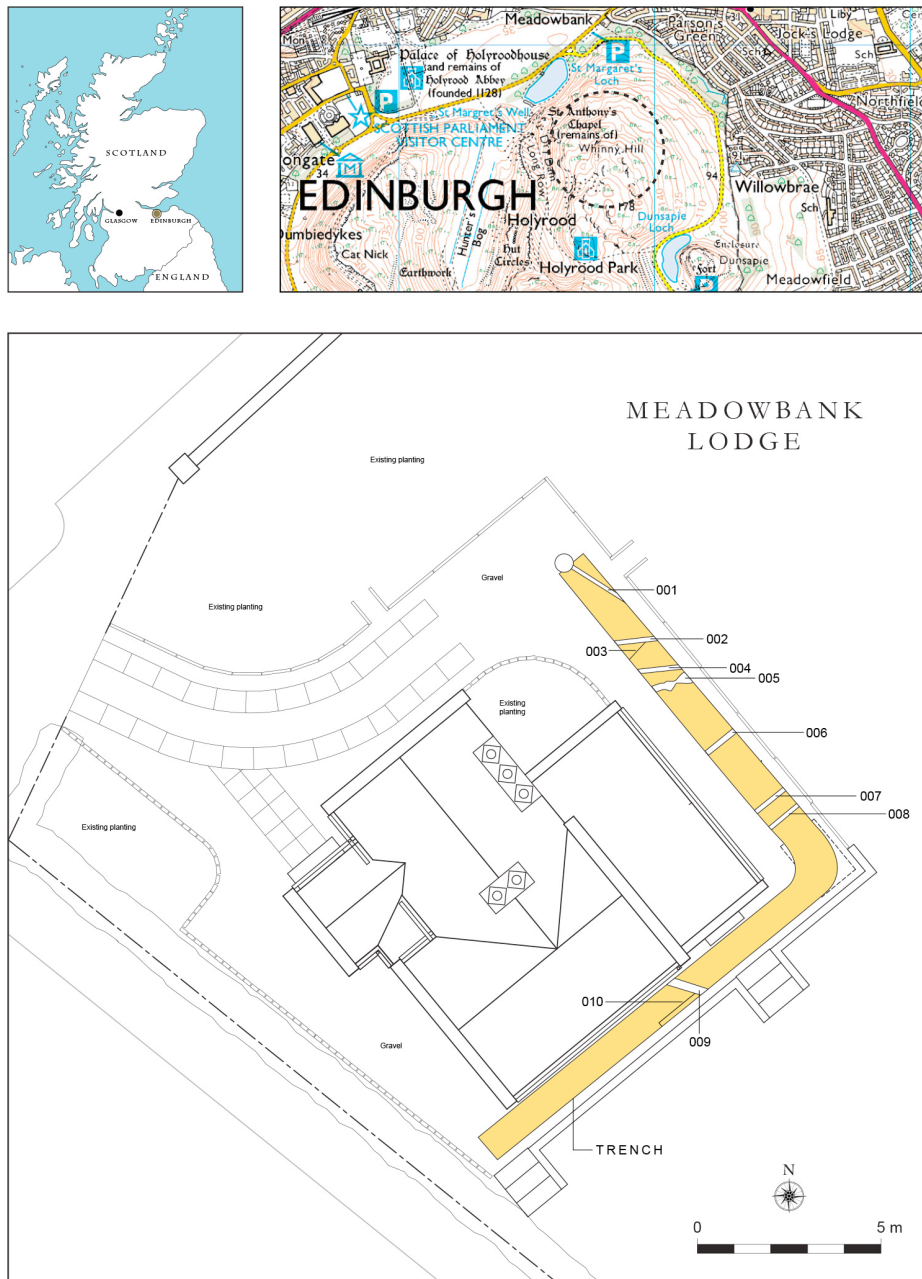
Figure 1: Plan showing the trench location and features described below.
All rights reserved 2013. Licence number 100036933.

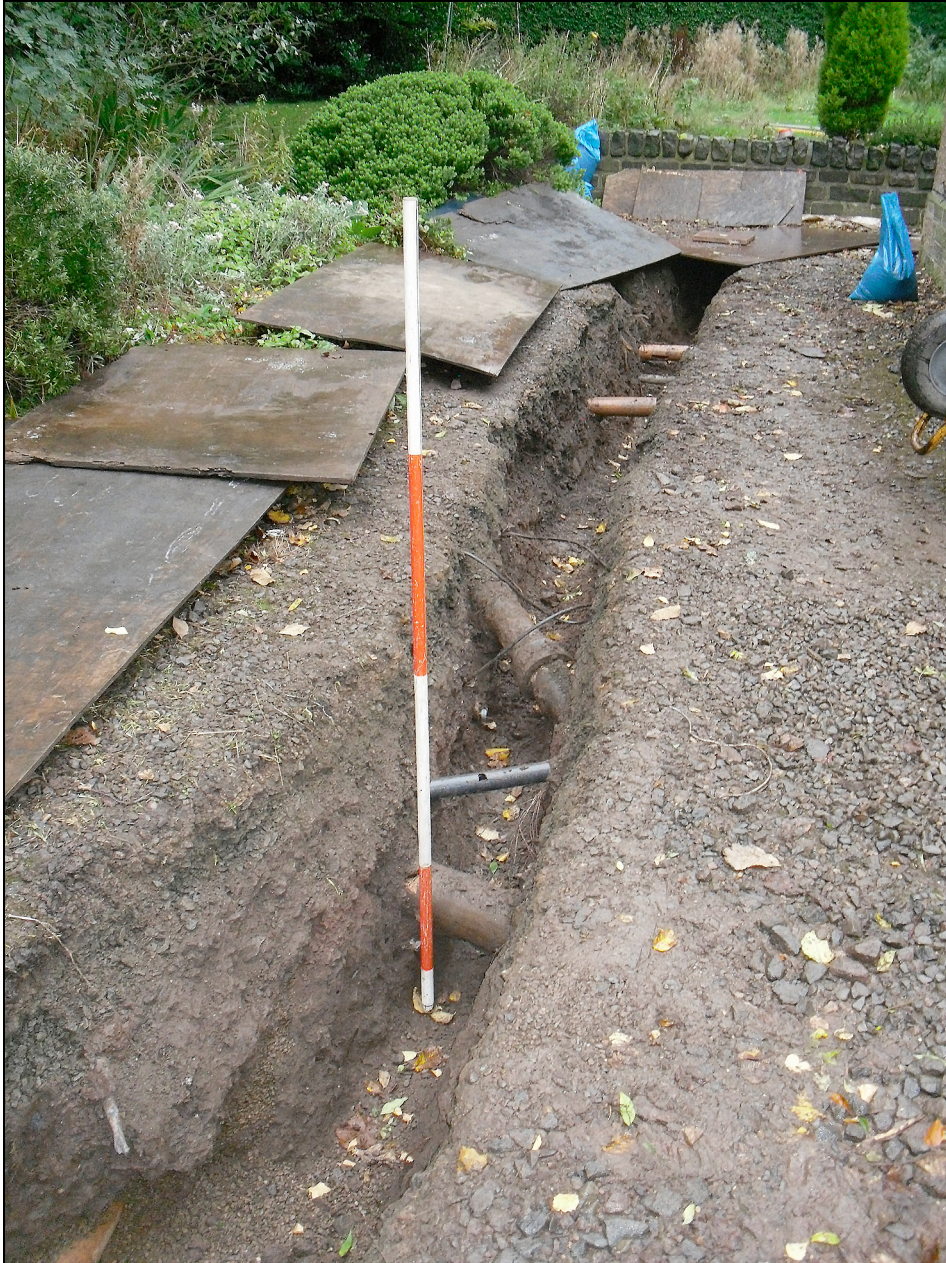
To the E of the property, various pipes were revealed. To the N, and linked with a small manhole, was a plastic pipe (001); c.2 m to the S was a ceramic pipe (002) and a narrow plastic pipe (003). Approximately 1m further to the S was an iron pipe (004) with two rubber coated wires (005) lying over it. Towards the S end of the E side of the property were three more services – a plastic pipe (006), a lead pipe(007) and a further plastic pipe (008).

The other service pipes reflect early domestic amenities, of at least 20th-century date, cut against the main landscaping deposits (012/013) – these comprised a waste pipe 002, water supply (004) and gas pipe (007).

Plate 1: Eastern trench, showing pipes 002, 003, 004 in foreground, 007 and 008 in background
