Historic Scotland  
Properties in Care  
Minor Archaeological Works 2009

# Holyrood Park (Boundary Wall): Archaeological Monitoring and Recording, June & September 2009

Project codes: HSCO-90131-2009-03, HSCO-90131-2009-04

20 March 2010  
Kirkdale Archaeology

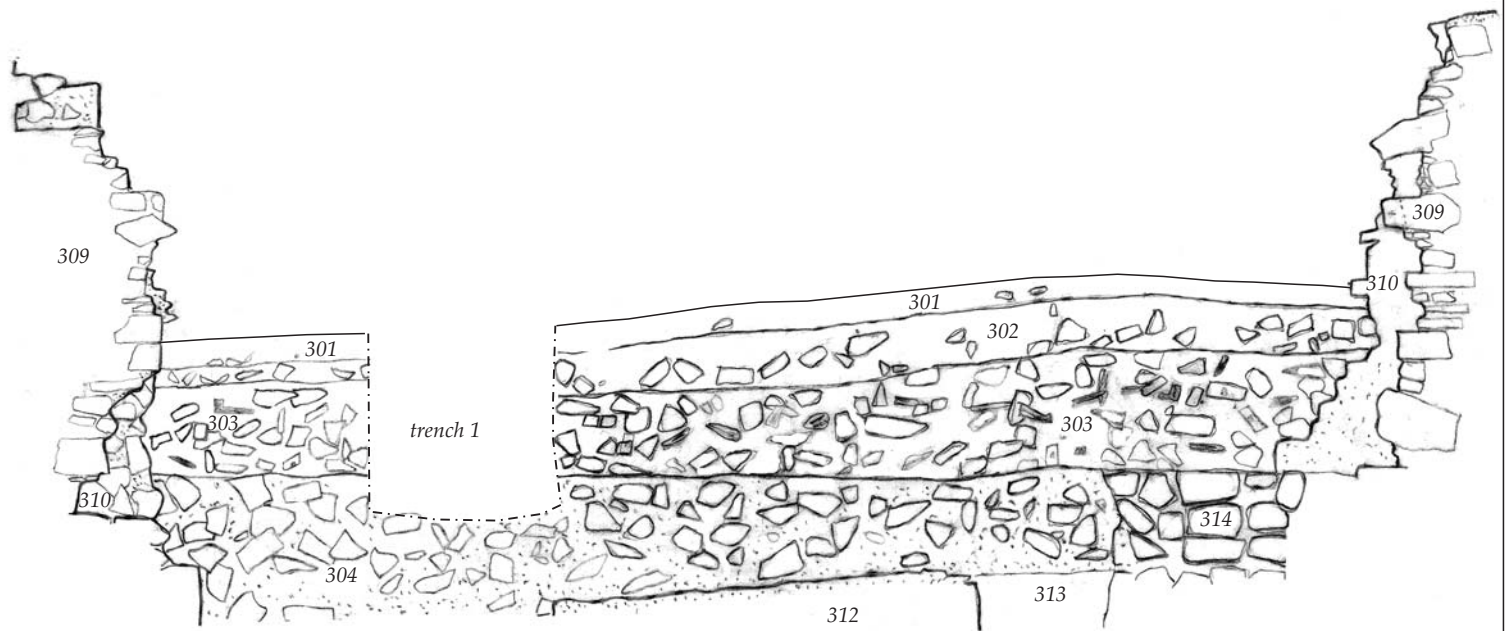
**Fig. 2: Trench 3, N facing section**

The upper deposit, **301**, seen in the south section was turf and mid-dark brown silty loam topsoil measuring roughly 150 mm in depth. **301** sealed **302**, a fairly compact deposit of mid grey sandy silt and stones, 25-30% stones measuring 60 mm by 100 mm on average. **302** measured 250 mm in thickness in the area west of the trench and between 80 and 100 mm east of it.

Under **302**, **303** comprised stones and quite compact mid brown sandy silt, 65-70% stones measuring 120 mm by 80 mm on average, and measured up to 600 mm in depth. There were mortar flecks and many pan-tile and brick fragments throughout **303**.

In the bottom 500 to 700 mm of the elevation, **304** was a fairly loose deposit of light brown silty sand and mortar with 30-35% angular sandstone fragments measuring 80 mm by 120 mm on average.

The north face of the wall was constructed with **309**, un-coursed, mainly sandstone, but also some basalt, blocks pointed with light grey mortar. There were occasional cement repairs in the demolished part of the wall and smaller patches of the same material could be seen continuing to both the east and west. The wall core, **310**, was un-coursed rubble infill with some hard pale grey mortar.

The deposits seen in the south section appear to have been built up against the face of the phase 2 wall construction.

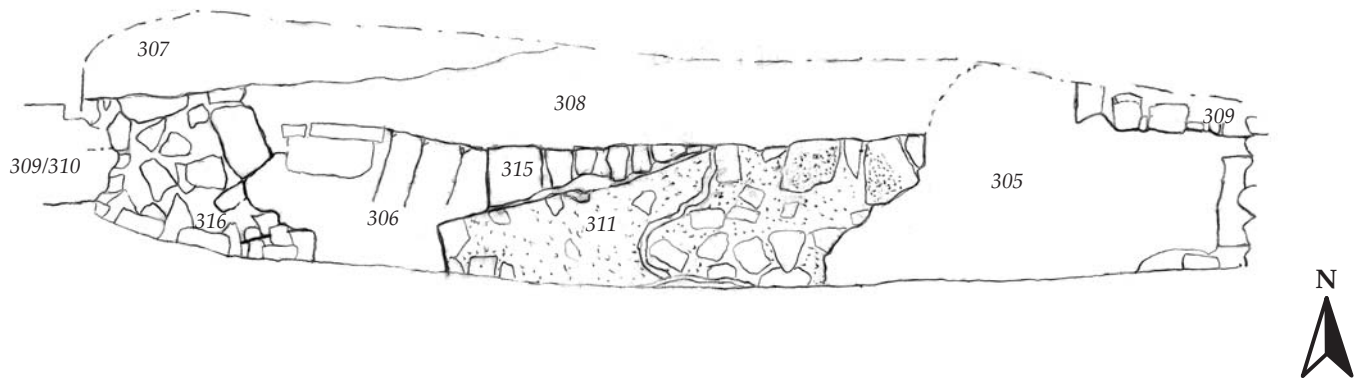
**Fig. 3: Trench 3, post-excavation plan**

In the NW corner of the trench, **312** was an E-W line of five rectangular sandstone blocks, measuring 150 mm by 200 mm on average. It was notable that these stones were placed on **308** and that they tipped down from the north edge to the south.

At the north edge of the west end of **311**, **315** comprised six stones, generally increasing in size as they continue west. The westernmost of these stones measured 320 mm N-S and 280 mm E-W, the easternmost 80 mm N-S and 120 mm E-W. **315** had been placed against **311**.

In the west end of the trench, under **309** & **310**, **314** was an area of stone rubble with no mortar visible. **314** was seen in an area of 1.00 m E-W and 1.00 m N-S but appeared to continue out of the trench to the south, under **307** to the N, under **309/310** to the west and it had been cut by **306** to the east. The stones within **314** were usually rectangular, 150 mm by 100 mm on average, and un-coursed. It is noted that **314** continues at least 500 mm under **309/310**.

Towards the limit of excavation in the central part of the trench, **311** was a wall constructed mainly with basalt blocks heavily pointed with hard light brown mortar containing many stone grits. **311** was seen in an area of 2.50 m N-S, disturbed by **305** and **306** to the east and west respectively, and 800 mm N-S, continuing under the south baulk. It was notable that the west half of **311** turned to the south quite sharply.

Seen under wall **309/310** at the east end of the demolished area, **316** was walling

constructed with basalt blocks pointed with light brown sandy mortar. It was notable that while **309/310** sloped toward the north at the base, **316** sloped the opposite way. It was also observed that **309/310** was placed against the edge of **316**.
