Historic Scotland  
Properties in Care  
Minor Archaeological Works 2008

# Kilchurn Castle: Archaeological Monitoring, October 2008

HS PIC Index number: 90179  
Project code: HSCO-90179-2008-01

<b><u>Site</u></b>	Kilchurn Castle
<b><u>N.G.R</u></b>	NN 132 276
<b><u>Project Description</u></b>	Archaeological monitoring
<b><u>Project code</u></b>	HSCO-90179-2008-01

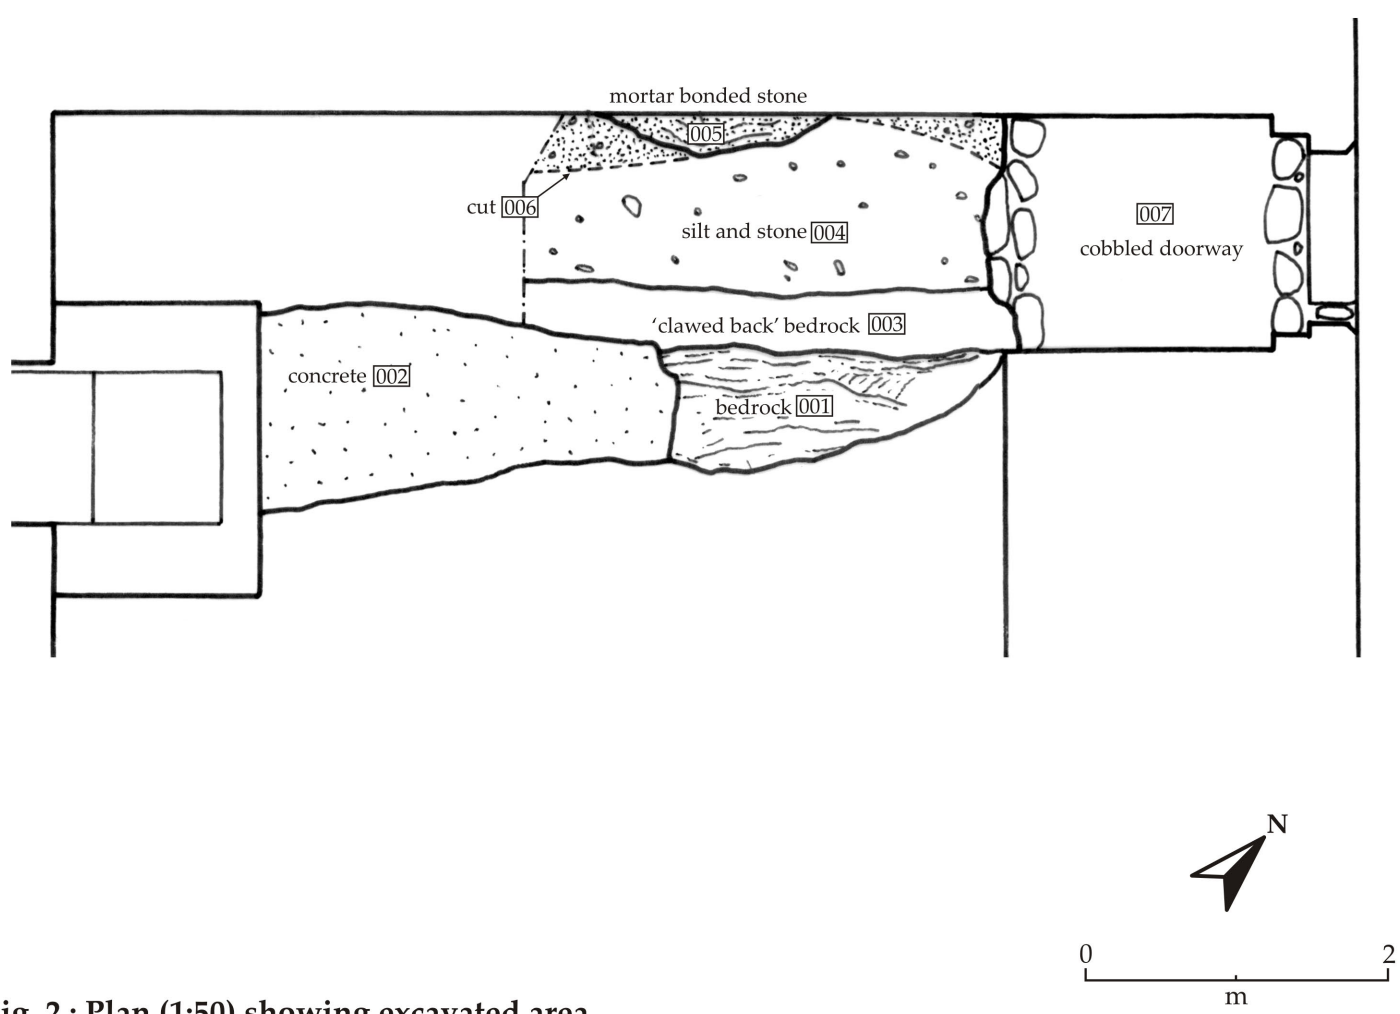
Fig. 2 : Plan (1:50) showing excavated area

Upon the removal of layer **004**, two things became apparent- The bedrock, **001**, to the SE had been partially clawed back on its NW face (its reduced portion is **003** on the plan) and there was a stone and yellow lime mortar bonded layer, **005**, running down the side of the NW wall. **005** was higher to the W, it then sloped down and ran under layer **004**. This layer had also been clawed back, **006**, on its SE side. It was no coincidence that the clawing back of both the bedrock and the mortared layer respected the position of the door in the N angle. The area to be cleared lay inside the current main castle entrance – a doorway with a chamfered surround carrying a carved lintel bearing the date 1693. The evidence from the internal clearance work appears to confirm that this doorway is a late 17<sup>th</sup>-century insertion.

Upon entering the doorway the floor sloped up to the SW to the steps serving the doorway to the courtyard. The first thing noted was that the floor level in the rest of the basement was considerably (600-800 mm) higher than the surface of the cobbled entrance. The floor level in the room was dictated by the height of the peaking bedrock (the castle is built on an undulating ridge of schist) however this slope did not appear to conform to this. The doorway in the S angle worked with the original floor level. It seems likely that the bonded mortar surface, **005**, is the remains of the original mid 15<sup>th</sup>-century levelling layer used to fill the clefts in the bedrock to create a flat surface. If the doorway was original then this clawed-back layer wouldn't make sense. The ground level outside the door is c.1m below the assumed original internal floor level. When the doorway was slapped out the bedrock and mortar infill would've been waist height- the deposits were therefore cut back and a slope

was formed to resolve the height difference between the internal and external ground levels. It was this slope that was causing the water run-off from the courtyard to rut the ground surface and pool at the entrance.

Any further ground-breaking works within the basement should include a watching brief.
