Discovery and Excavation in Scotland

**HISTORIC SCOTLAND PROPERTIES IN CARE
MINOR ARCHAEOLOGICAL WORKS 2014/2015**

Kinnaird Head Castle Lighthouse • Monitoring • March 2014

DESCRIPTION: Watching Brief during excavations associated with the renewal of corroded water pipes running from the Engine House into the generator engines.

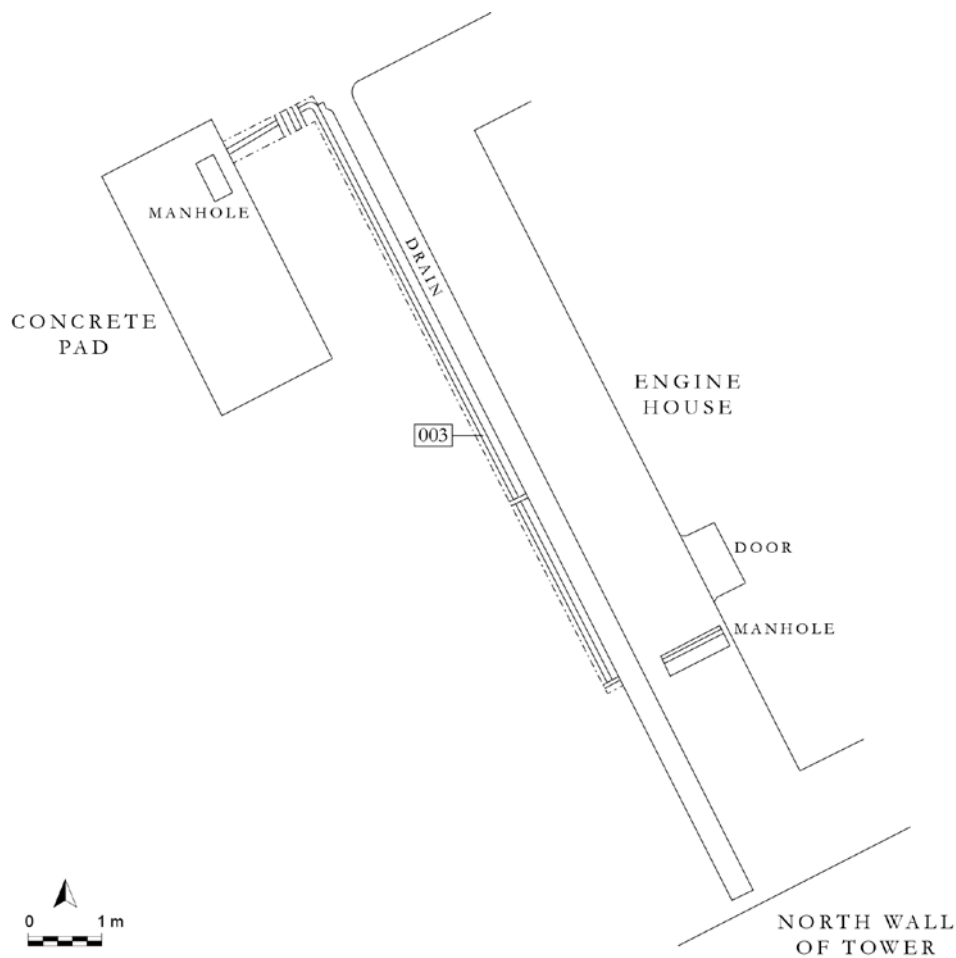
Figure 2: Post-excavation plan of the trench.

The ground was heavily disturbed, with a simple section of mixed-re-deposited silt and stony gravel **001** some 25cm thick overlying a 15cm thick layer of sand **002** over the corroded iron pipe **003**. The pipe sat to the SE on a layer of concrete **004** which contained a piece of newspaper dated 1972, suggesting that

this was when the pipe was last renewed. Other pipes were noted running over (and therefore post-dating) pipe **003** during the excavation, but nothing of archaeological interest was uncovered.

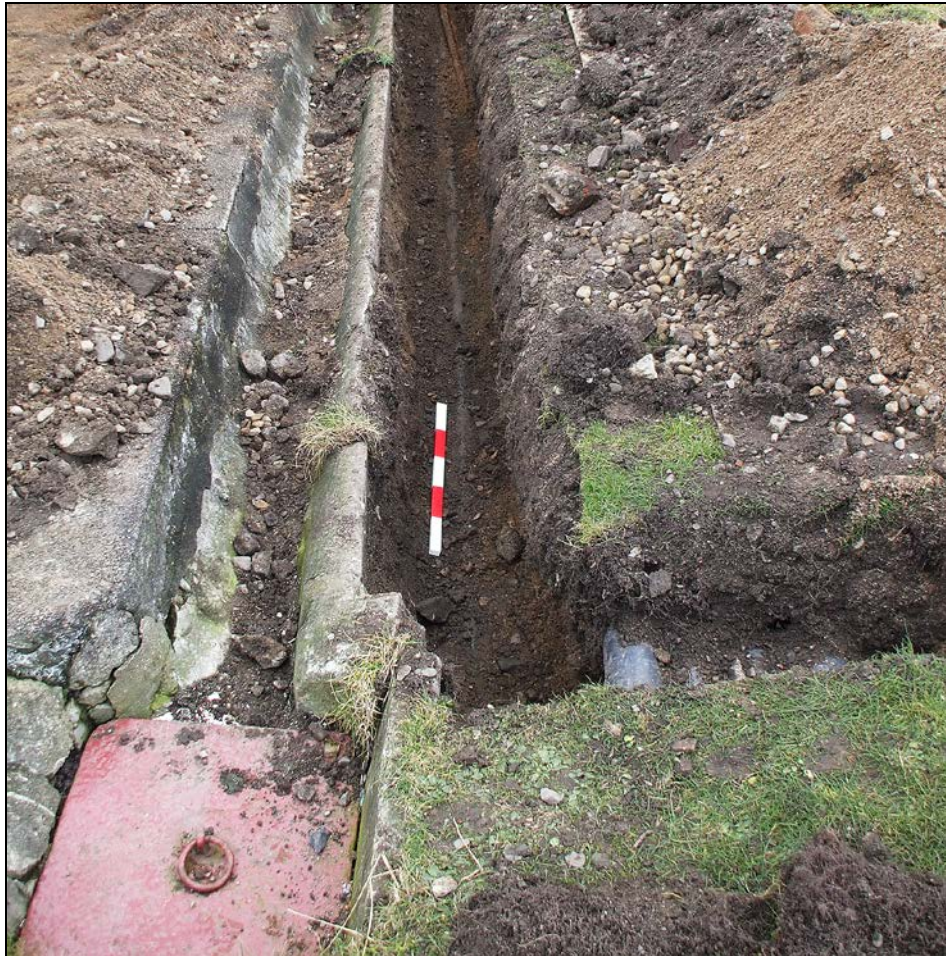
Plate 1: The work in progress.
