# **Glasgow Cathedral: Pipe Blockage Watching Brief August 2010**

**HS PIC Index Number: 90150  
Project Code: HSCO-90150-2010-01**

**10<sup>th</sup>-13<sup>th</sup> August 2010  
Kirkdale Archaeology**

<b><u>Site</u></b>	St Mungo's Cathedral, Glasgow.
<b><u>N.G.R</u></b>	NS 603 656.
<b><u>Project Description</u></b>	Watching Brief during the excavation of a trench to locate and remove a blockage within the waste pipe serving the toilets in the Treasury/Sacristy.
<b><u>Project Code</u></b>	HSCO-90150-2010-01.

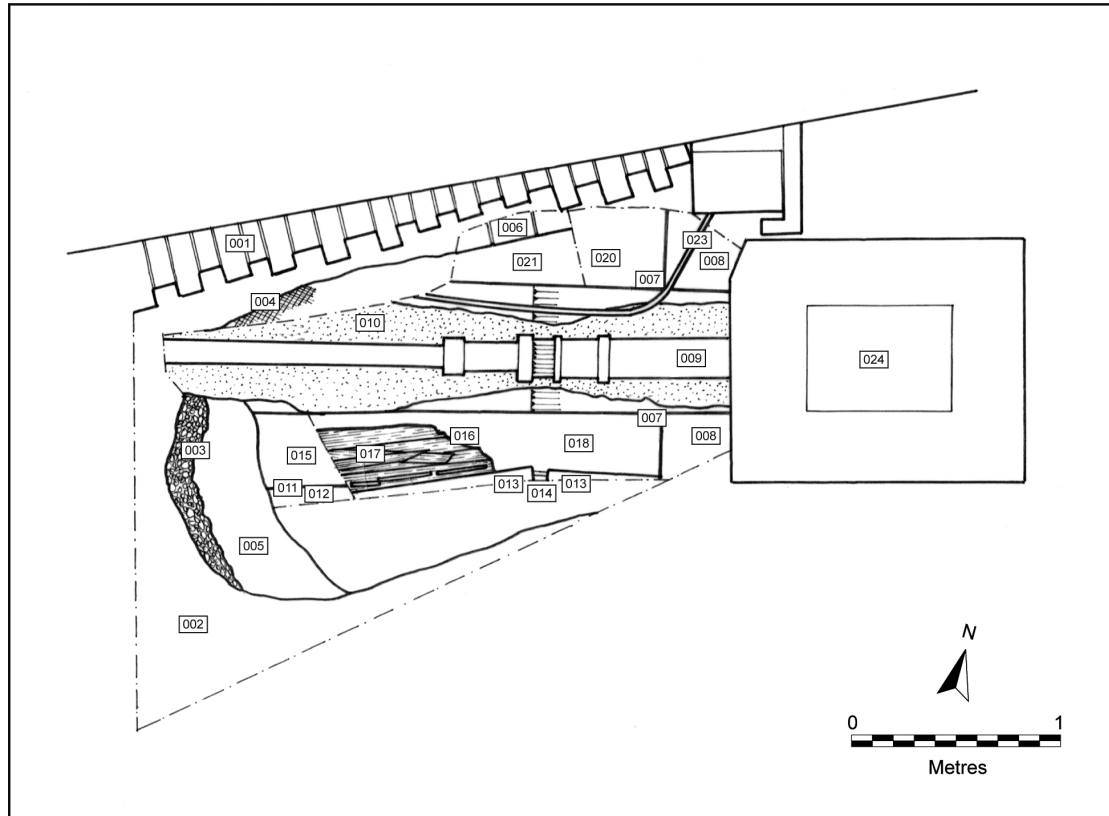
Figure 4: Post-excavation plan of the trench.

The dimensions of the trench (see Figures 4 and 5) were 2m wide N/S to the W, 1.2m wide N/S to the E, 2.85m long N/S and up to 1.2m deep.

In advance of the excavation, the current path of granite setts (001) had been partially cleared, leaving only a line of them along the N kerb so that they could be set back into place. The setts were of rectangular grey granite, generally 130mm deep and of varying dimensions. These were set on a base of whin dust and cement (002) generally 120mm thick with a sub-base of Type 1 crushed whin stone with finings (003) up to 100mm deep. On the N side of the trench (003) sat on a mixture of terram and plastic mesh (004). The terram sat over a layer of tar macadam (005) up to 70mm thick. Layers (001) to (005) represented the re-instatement of the path after the insertion of the various services that were uncovered. To the E of the setts was a

small layer of turf and sand landscaping (027) some 150mm thick. A further discreet section of make-up consisted of a row of three granite setts (006) on the N side of the trench, and these lay over a live lead water main (023). The water main respected and fed into the main cut for the waste pipe and manhole. Although a cut number (022) was initially assigned to the water main, it transpired that it was likely to be part of the larger insertion of services characterised by cut (007). On the S side of the trench sections of a further pipe (013) were uncovered.

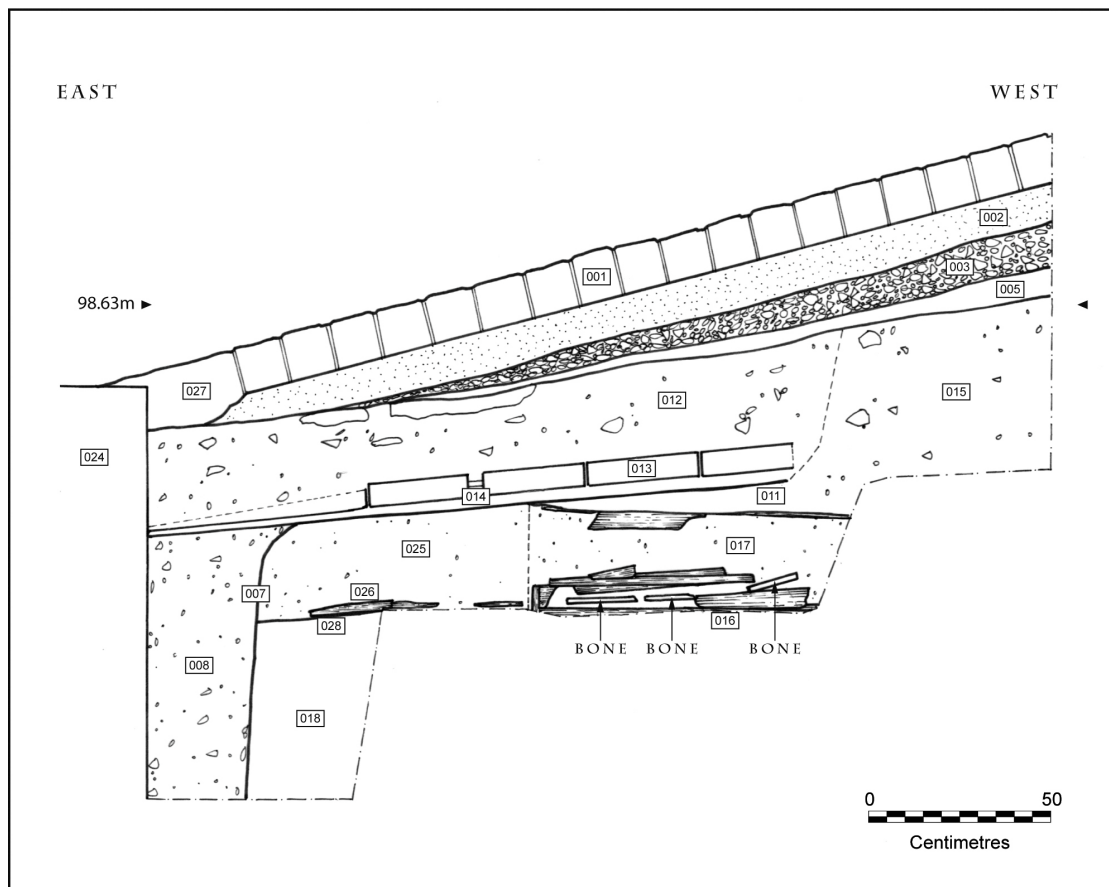
**Figure 5:** N-facing section through the trench.

It would appear from the consistency of the path fills overlying (013), (023) and the large main cut (007) for the waste pipe (009) and manhole (024) that these services were inserted at the same time. The cut (011) for the insertion of electricity pipe (013) was 390mm beneath the tar macadam (005). The cut disappeared in section as it was

heading towards the SW. It had been backfilled with a re-deposited mixed mottled fill of yellowish-brown silt and clay (012). The most notable cut was that for the insertion of the waste pipe and manhole, (007). This was 0.6m wide N/S for the waste pipe itself, opening out to at least 1.30m N/S for the manhole (though it was not fully exposed). The cut reached a depth of at least 1.10 m to the E. The cut had been backfilled with a re-deposited mixed mottled fill of yellowish-brown silt and clay full of red bricks (probably waste from the building of the manhole) (008). After removal of the backfill, the waste pipe (009), set on a bed of concrete (010), was exposed. This (009) was composed of ceramic pipe sections of graduated size. To the E was a 4 inch diameter ceramic pipe which jointed into a section of 6 inch ceramic pipe. This took a practically vertical drop down into an 8" pipe which then ran straight towards the brick-built manhole (024). The result was a pipe which had a tight 90 degree bend near to its outlet. When the pipe was smashed, the bend contained solid waste which had not been allowed to flow out due to the presence of two large stones and a piece of slate.

An examination of the sections of pipe showed that these relatively modern interventions (within the last 20 or 30 years) had truncated, at least partially, an earlier sequence of activity. Within the S-facing section a series of individual homogenous clay layers could be seen. These had been truncated to the S by the modern interventions. Context (021) was a layer of compact pinkish clay 150mm thick immediately below the tar macadam (005). This was likely to have been truncated in its upper portion by the preparation of the ground when the services were inserted. Below (021) was a slightly more elastic layer of greyish clay (020) c.150mm thick, overlying a distinctive layer of compact olive-brown clay (019), again c.150mm thick.

The same upper sequence of clay layers could not be seen in the N-facing section. Instead, two graves had been cut through them onto the top of clean yellow clay (018). To the W, cut (016) was at least 850mm E/W but was not fully exposed. Within the cut was (017) a collapsed coffin of plain wooden planks (although no associated metal work could be seen). To the E, three sections of leg long bones were observed.

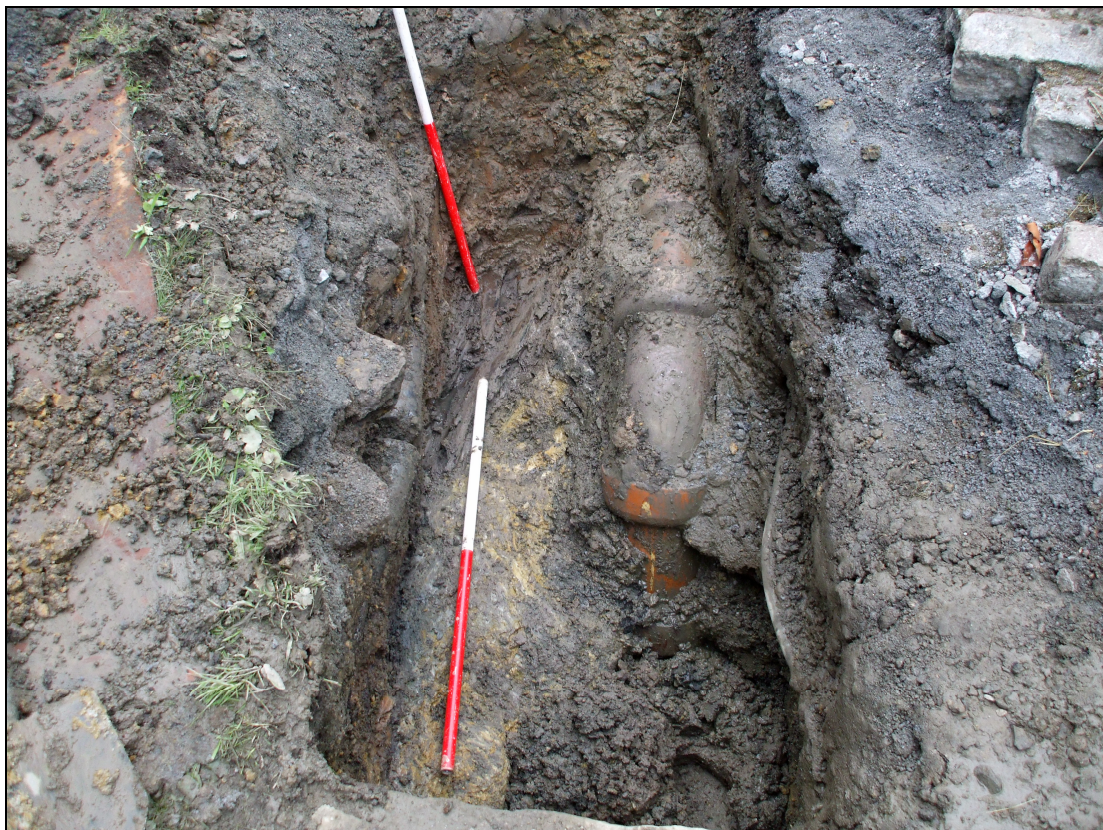
**Figure 6:** Clay natural (018), grave cut (016), coffin (017) and pipe cut (007) [Photograph No. 26].

Cut (017) had been backfilled with a mottled pinkish-grey clay backfill (015) which had been truncated by an electricity cable cut (011) to the E, and the main cut (007) for the insertion of the waste pipe to the N - which had obviously disturbed the

coffin at the time. A detached section of coffin planking was kept for possible dating. It was also noted during the excavation of the backfill of the main waste pipe cut, that pieces of human bone had been thrown back in with the fill. These may have come from coffin (017) or possibly from further disturbed burials to the E or W. The backfill (015) of the coffin may have been a re-deposited mixture of the clays (019) to (021). To the E of coffin (017), a further cut (028) had been made in the upper part of the yellow clean clay (018). Although not as clearly defined as (017), wood could be seen at the base of cut (028), suggesting that a further burial (026) (characterised by the presence of the wood) had been placed here. Over the burial was a mottled pinkish-grey clay backfill (025) 300mm deep, which had been truncated by the electricity cable cut (011) in its upper portion. A relationship between the two burials could not be established.

As the trench had reached the required width and depth it was decided that a policy of minimal disturbance was the most appropriate way of dealing with the burials. As such they were planned, photographed and quickly covered by terram and carefully resealed with a little backfill.
