HISTORIC ENVIRONMENT SCOTLAND  
PROPERTIES IN CARE  
MINOR ARCHAEOLOGICAL WORKS 2015/2016

Edinburgh Castle • Standing Building Recording • March 2016

**DESCRIPTION:** A small program of standing building recording in St. Margaret's Chapel.

**PROJECT CODE:** HSCO-90130-2016-02

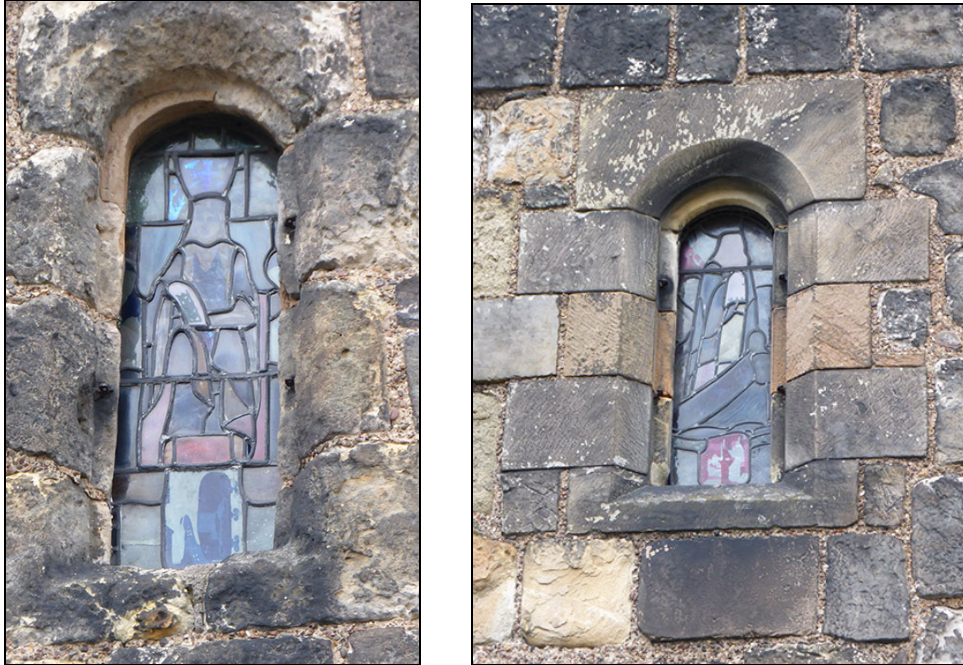
There are two windows in the south wall of the nave (**091** and **092**), both are tall and narrow and deeply splayed internally, their heads formed by a single arched block of stone. The original stonework of the western window survives on the exterior (**S004 - 008**<sup>1</sup>), although the window head (**105**) in the interior has

**Plate 1:** South windows of the nave. Left: unrestored west window, right restored east window.

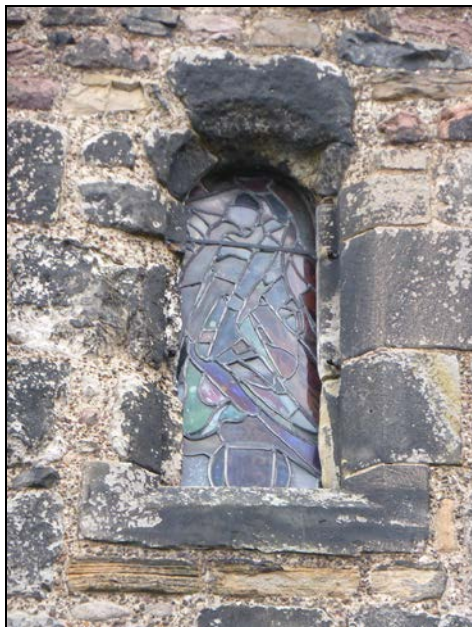
been replaced. There is a similar window, in a slightly higher position, in the west wall (125). The original head and northern margin of this window survive on the exterior but its southern margin and base have been replaced (W007). The original window head survives on the interior (129), the rest has been replaced. The windows of the apse are considered under Phase 2.

**Plate 2:** West window exterior.

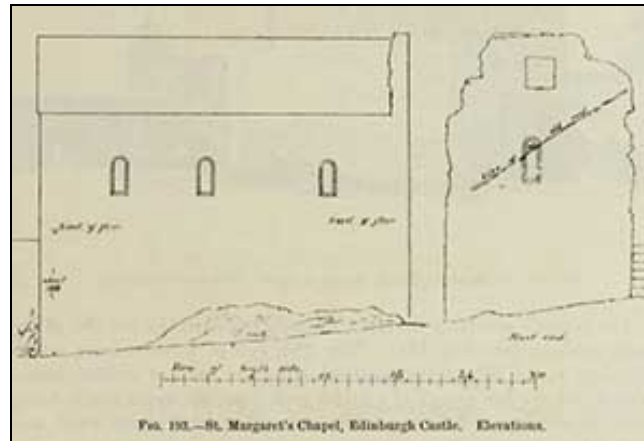
Figure 2: Drawing of 1866 by Dryden, later published in Macgibbon and Ross (1896, I, 225), showing the diagonal scar on the east elevation.

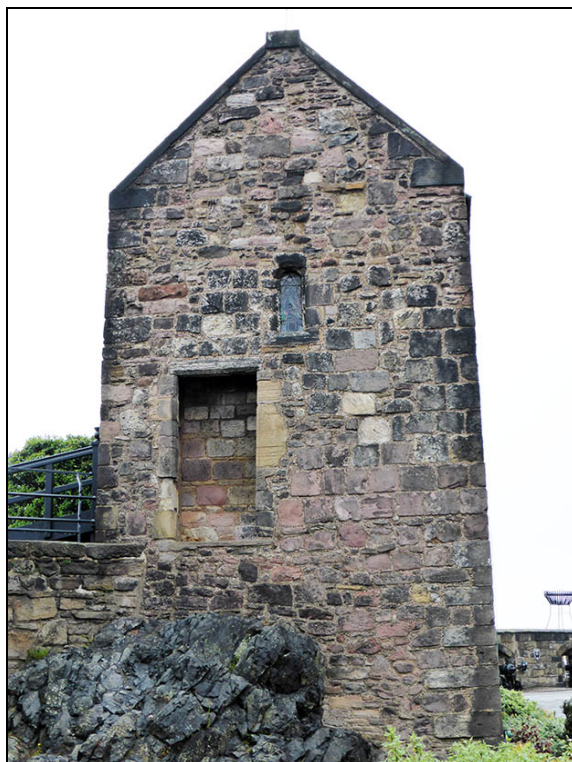
**Plate 6:** West exterior of the chapel showing the now blocked doorway to the blast yard.

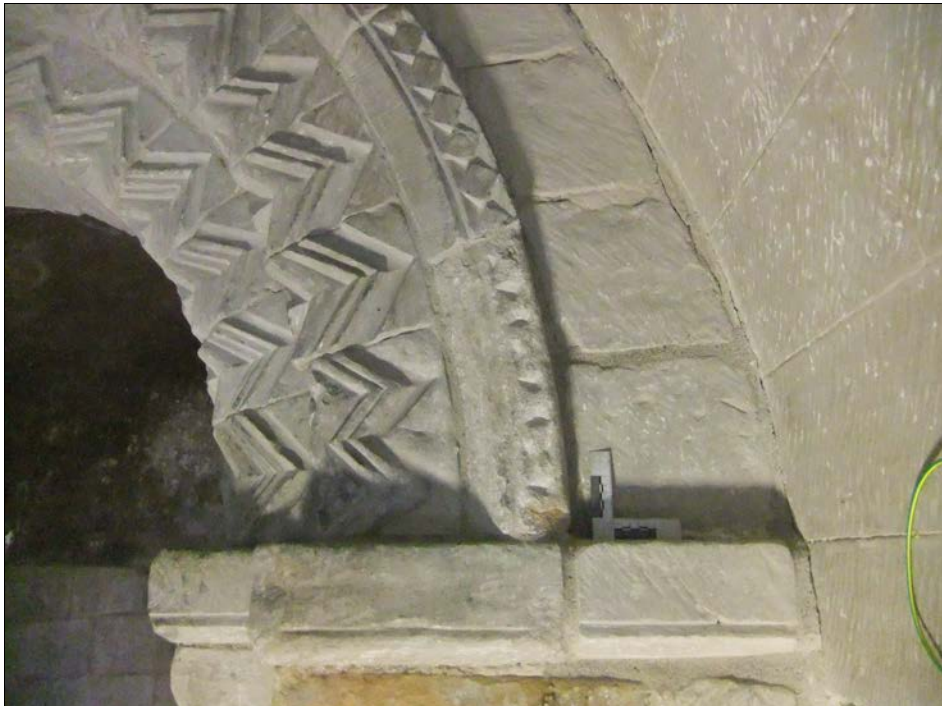
**Plate 8:** Detail of the base of the south end of arch 068, showing stone 065 and plinth 061.

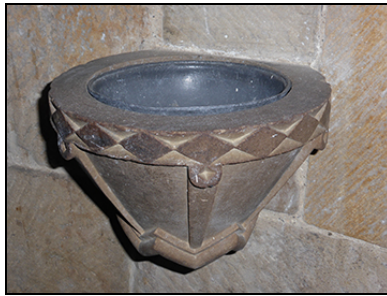
There is no record of what evidence existed for a piscina, although it is likely that one existed up to the Reformation, if not in a Romanesque form. The present piscina is a creation of the mid-19<sup>th</sup> century antiquarian imagination. Its rim ornament is inspired by the lozenge design of the label of the chancel arch.

**Plate 10:** The piscina.

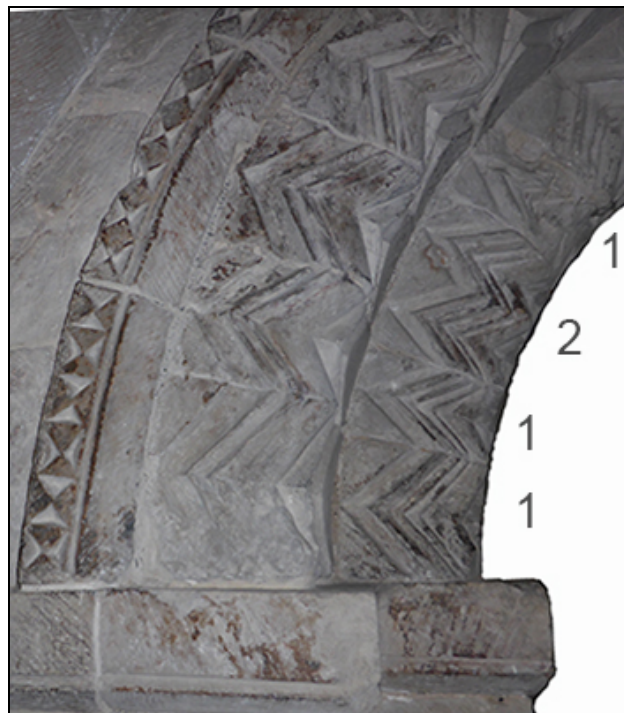
**Plate 11:** The north side of the chancel arch showing the irregularity of the chevron ornament (numbers indicates the number of chevrons per stone) and the change in the decoration of the label.
