Historic Scotland

Newark Castle

Job No. HSCO-90230-2007-01

Archaeological monitoring
March 2007

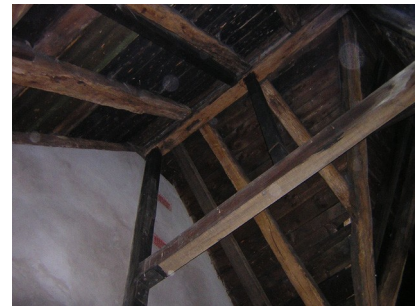
Plate 4

Purlin roof in the north range.

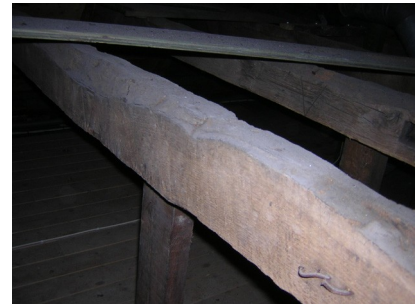
Plate 5

Pit-sawn collarbeam in the roof of the east-range.

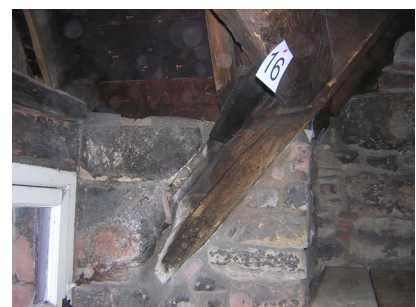
Plate 6

Original sarking-boards at the north-range.

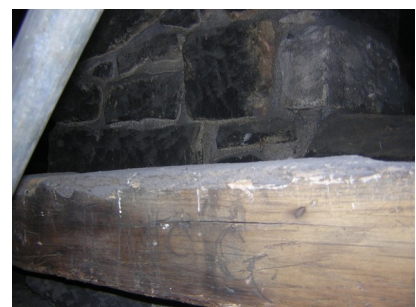
Plate 7

Unusual marks at a collarbeam at the north range.
