<b>LOCAL AUTHORITY:</b>	Stirling
<b>PROJECT TITLE/SITE NAME:</b>	Stirling Castle: The King's Old Buildings
<b>PROJECT CODE:</b>	HSCO-90291-2017-02
<b>PARISH:</b>	Stirling
<b>NAME OF CONTRIBUTOR:</b>	Paul Fox
<b>NAME OF ORGANISATION:</b>	Kirkdale Archaeology
<b>TYPE(S) OF PROJECT:</b>	Standing Building Recording
<b>NMRS NO(S):</b>	NS79SE 6.06
<b>SITE/MONUMENT TYPE(S):</b>	Castle
<b>SIGNIFICANT FINDS:</b>	None
<b>NGR (2 letters, 8 or 10 figures)</b>	NS 7898 9407
<b>START DATE (this season)</b>	23 August 2017
<b>END DATE (this season)</b>	23 August 2017
<b>PREVIOUS WORK (incl. <i>DES</i> ref.)</b>	
<b>MAIN (NARRATIVE) DESCRIPTION:</b> (May include information from other fields)	<p>Standing building recording was undertaken on a section of the lower external eastern façade of the King's Old Buildings at Stirling Castle. The façade contained a window which was to be removed during conversion into a doorway.</p> <p>The King's Old Building is a complex structure which been subject to considerable modification over the last five centuries. The insertion of an additional floor required significant alteration to floor levels and subsequently to the external façades. The fire in the north qua

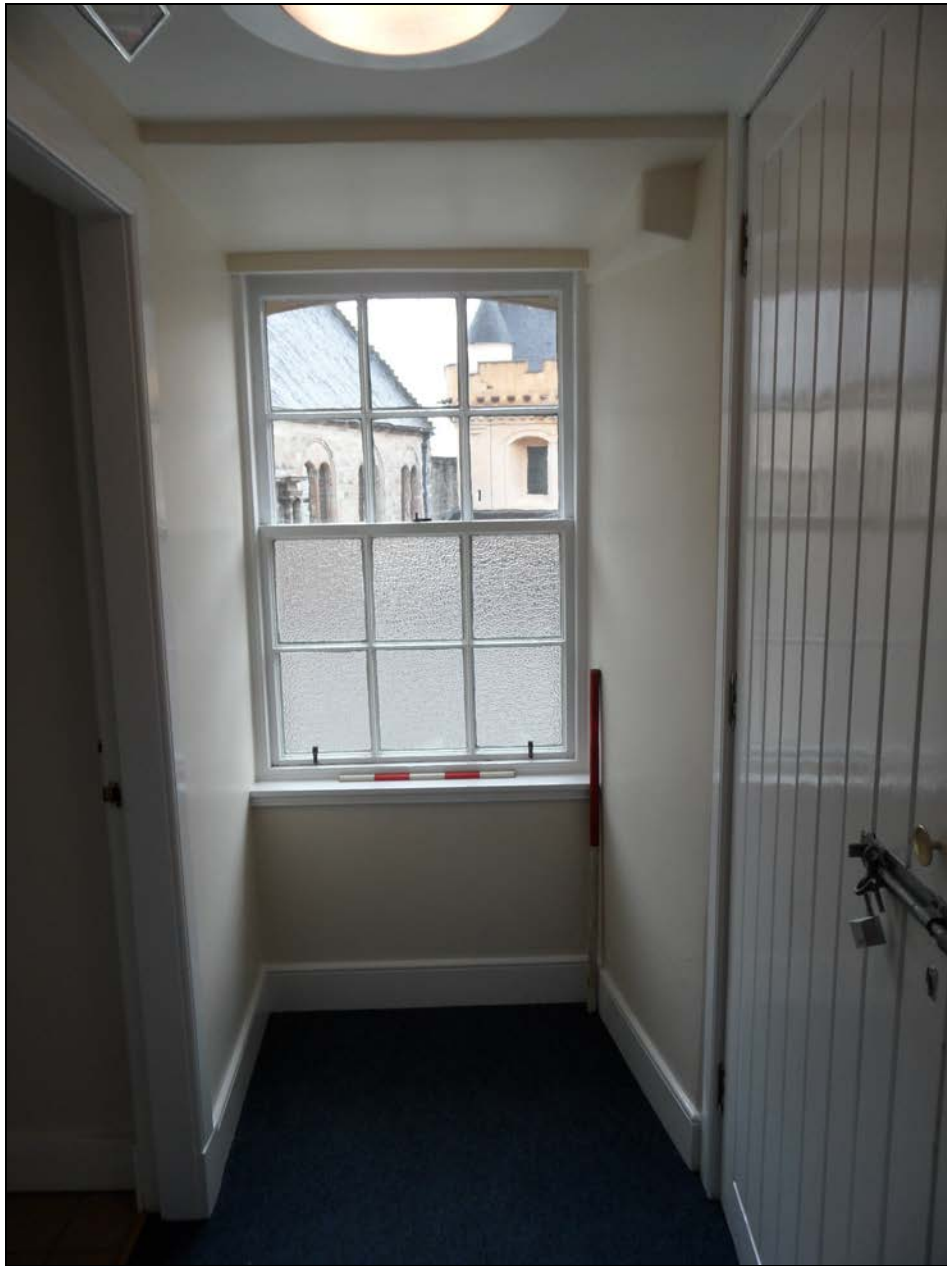
Internally, there is little of indication of the nature of the preceding doorway prior to the insertion of the window, as the parallel-sided corridor which served the door has been sheeted, although it was noted that there is a piece of angled masonry against the upper southern portion of the soffit – this is itself obscured by modern painted render (Plate 1).

**Plate 1:** The internal portion of the window.

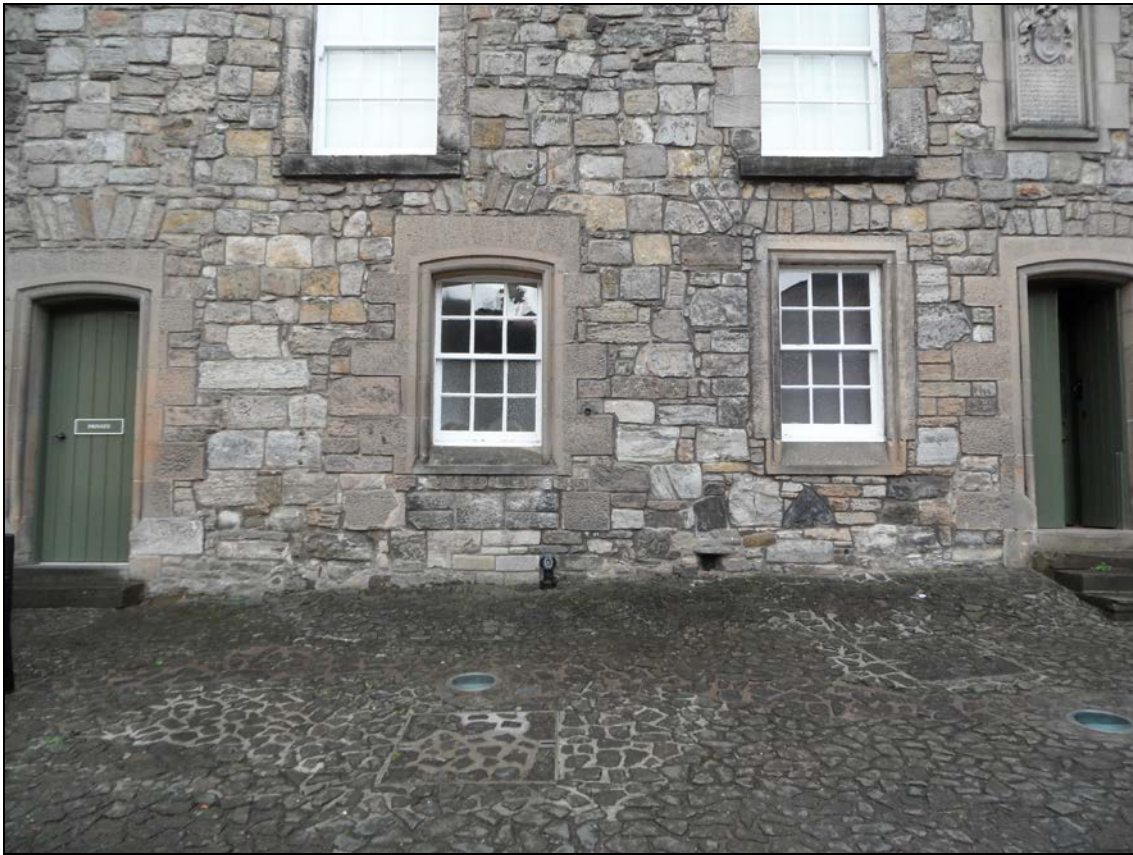
Plate 2: The external eastern façade showing the inserted window (centre left).

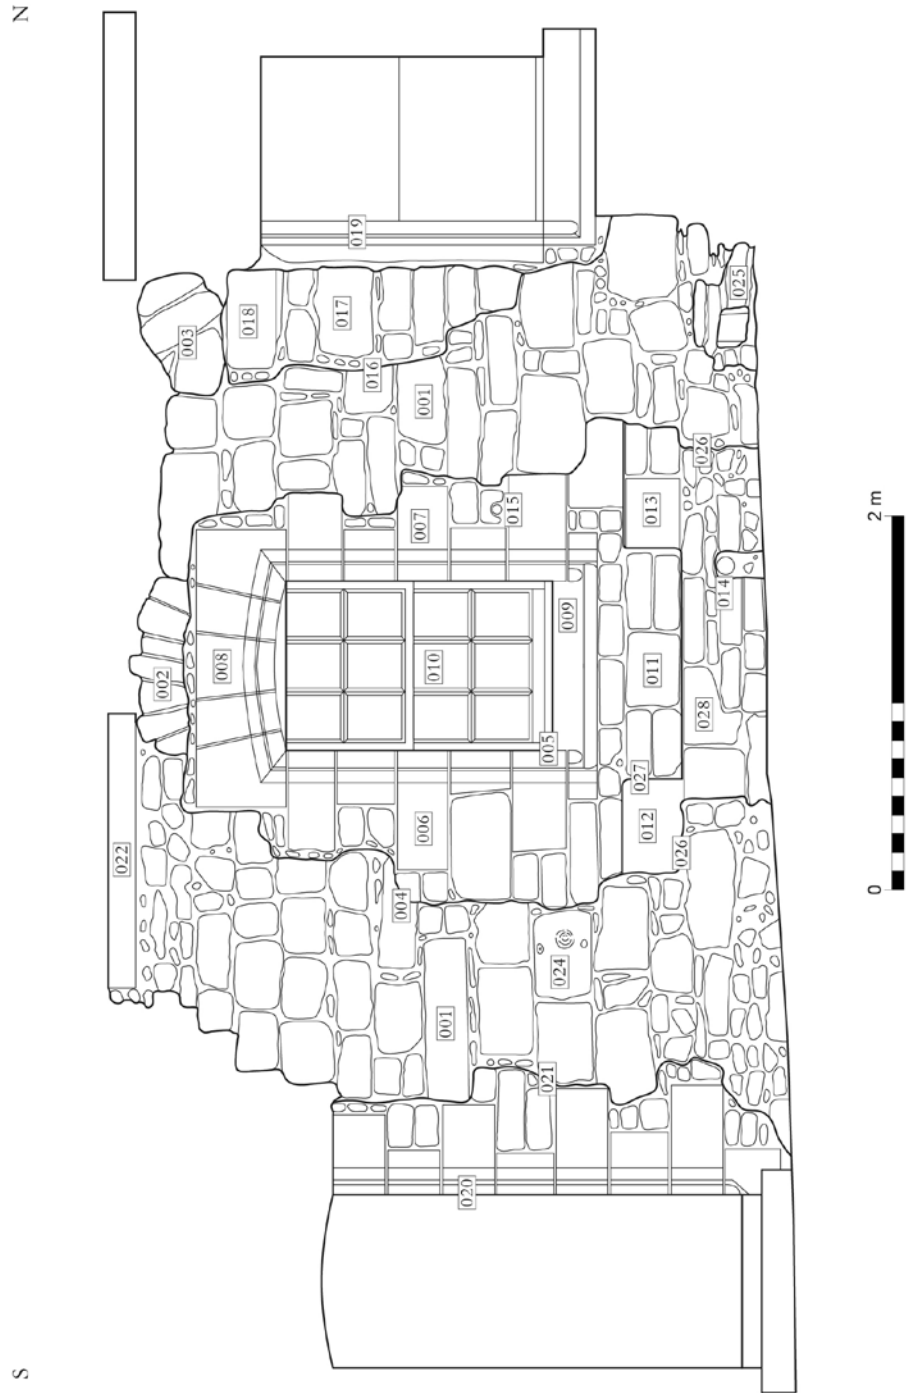
Window aperture **005** sits within a large ragged cut through wall fabric **001** and forms a rectangular aperture with a lightly arched top. The southern margins **006** are built of five yellowish sandstone blocks in an 'in-build-out' build pattern. The margins carry a roll-mould (with a chamfer to the south) to the aperture. The roll mould and its chamfered exterior are framed by a 0.06m thick carved frame polished smooth without tooling. To the south of this smooth frame, the margins have pecked tooling on their surface. The northern margins **007** have the same configuration (but mirrored) as **006**.

The decoration of the window margins is carried up and over the lightly-arched lintel **008** and down onto the sloping window sill **009**, which are both in yellowish sandstone. The window is separated from its cut **004** by sandstone blocking **011**, some of which (below the window and within door aperture **027**) carries horizontal tooling and may be re-used stone from elsewhere. The sash and case window **010** may be contemporary with the insertion of the window and comprise upper and lower sashes with vertical rectangular lights in a 'three columns by two rows' configuration.

Figure 2: E-facing elevation of window 005 in the exterior eastern façade of the King's Old Building.

The King's Old Building is a complex structure which has been through considerable change over the last five centuries. The insertion of an additional floor turned the building from a two storey into a three storey structure, something that would have required significant alteration to floor levels and subsequently to the external façades. The fire in the north quarter led to a massive rebuild and it is here that we see the introduction of the distinctive roll moulded and chamfered surrounds with pecking. It would appear that the introduction of this style of aperture led to the replacement of the door and window surrounds at ground floor level within the portion of the building which is the subject of this report. It is possible that further details of apertures which previously occupied this position could be exposed during the works to convert the window back into a doorway, so it is recommended that some form of archaeological monitoring accompanies such work.
