**HISTORIC SCOTLAND PROPERTIES IN CARE
MINOR ARCHAEOLOGICAL WORKS 2012**

Dirleton Castle: Watching Brief, May 2012

SITE: Dirleton Castle, near North Berwick, East Lothian

DESCRIPTION: Watching Brief during the excavation of three test trenches to establish the nature of the deposits/make-up between the slabbed floor and the vault crown below, in the Great Hall of the Haliburton Range, ahead of remedial works to prevent water ingress

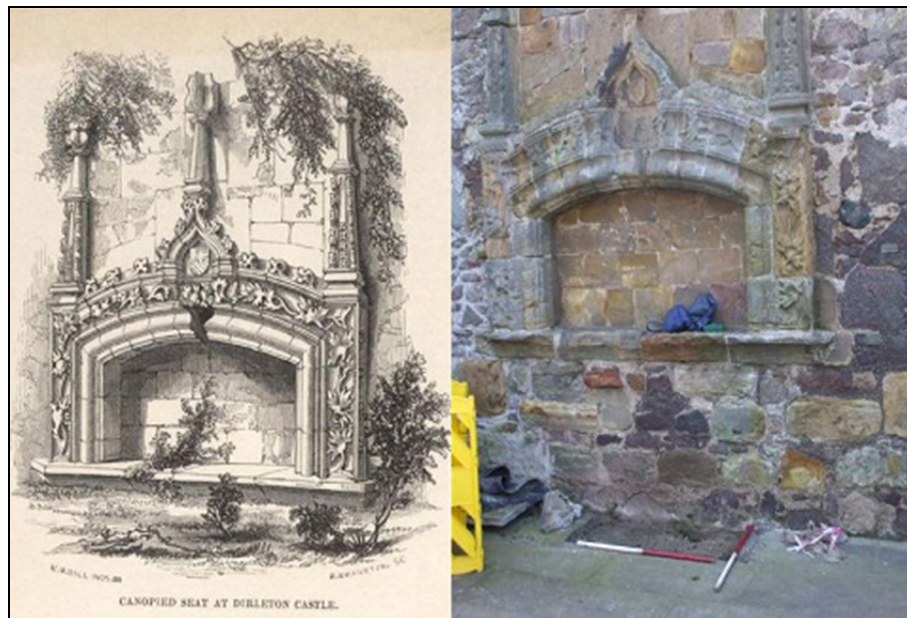
The architect Robert Billings had drawn the carved buffet (which he called a 'canopied seat') on the SE wall of the Great Hall in the 1840s. The ground level is clearly shown as being up to the level of the hollow-chamfered sill base. This can be contrasted with a photo of the current floor level (Fig.2).

Figure 2: Robert Billings' drawing of the 'canopied seat' (left) alongside a current view, showing the dramatically altered level of the floor

It is apparent then that a large amount of material (up to 1.5m) must have been removed in order to re-instate the original floor level. When this work was carried out, the post-abandonment overburden, as well as the *in situ* archaeological deposits, were removed in order to expose the vault *extrados*. This was then rendered with cement in order to seal it against water penetration. The rubble, presumably retained from the excavation, was then put back over the vault leaving gaps between to allow air circulation. The voided rubble was sealed with two concrete pours, and the walls were pointed-up. In effect, the damp proof

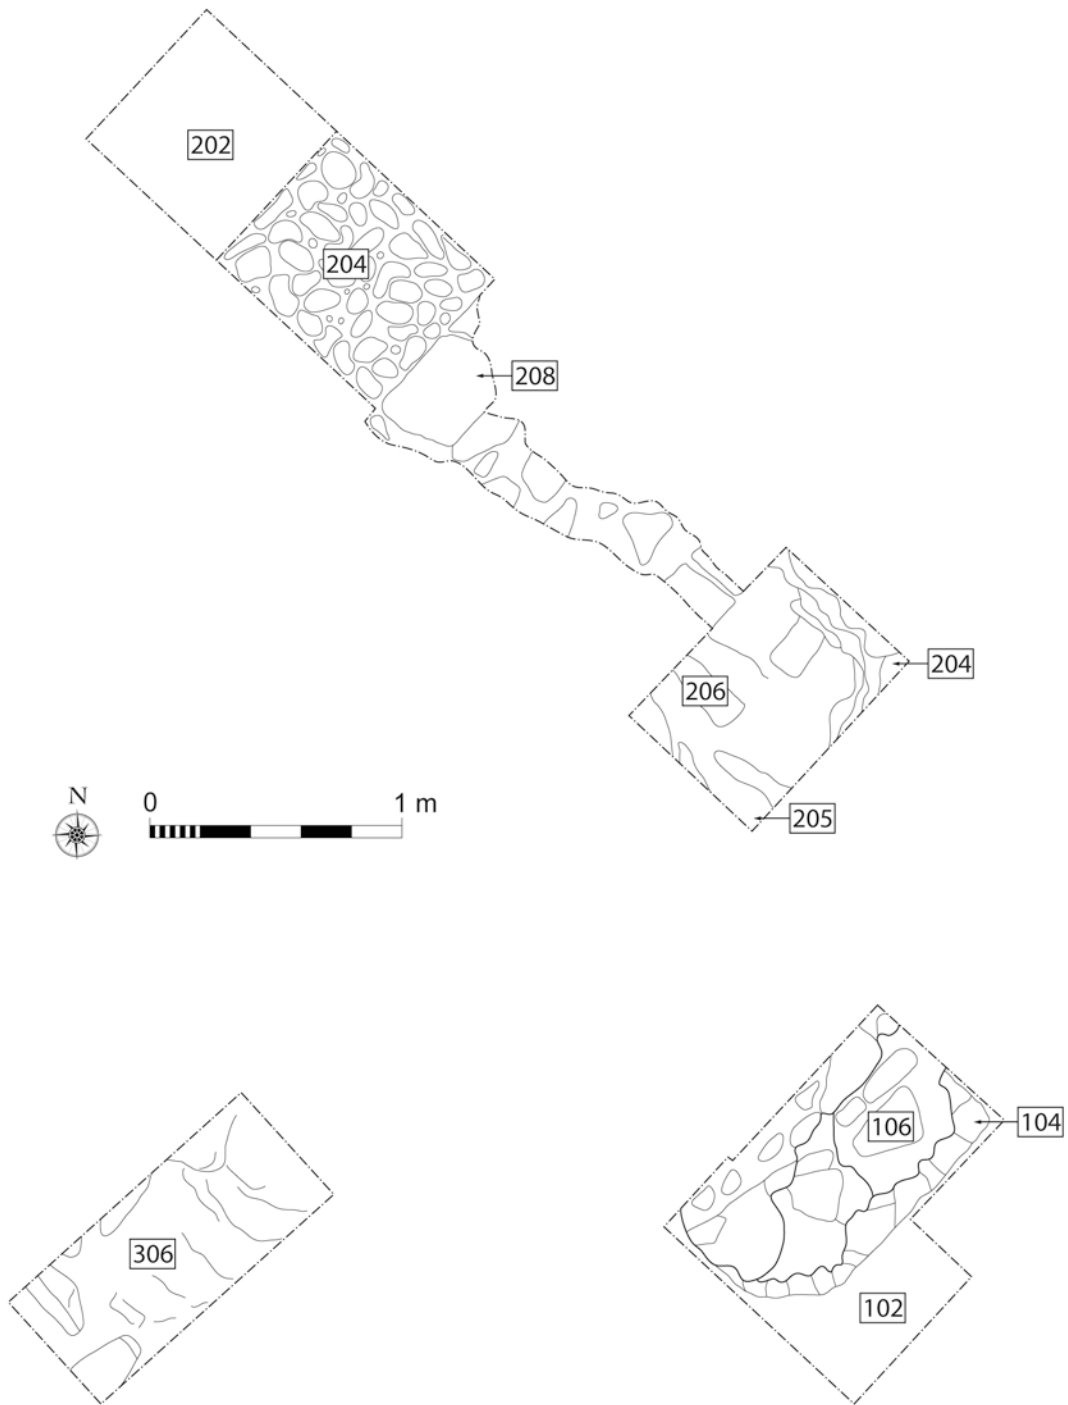
Trench 1 measured 0.7m SW/NE x 1.20m SE/NW x up to 1.13m deep. The trench was located at the E corner of the window recess in the NW wall of the withdrawing room. The nature of the voided deposits encountered meant that a single slab removal did not allow enough room to clear the trench. A second slab was therefore lifted to provide adequate safe working room and access. Below the modern floor slabs **101** (0.05m thick) was a 0.05m thick layer of cement screed **102** without inclusions. This in turn sat over a slightly undulating (basally) layer of concrete **103** with inclusions, the layer being around 0.1m thick. These three elements made up the solid 20th century floor. Concrete **103** had been spread over a vast raft of re-deposited voided rubble **104** containing some finer material. As discussed earlier, this is likely to be selected rubble derived from the excavation of original material over the vaults – there were a few pieces of animal bone within the layer. As the trench was located over the junction of the window bay and main vault of the cellars below, the side vault (running NW/SE) **107**, and main vault (running SW/NE) **106**, could both be seen in the trench. Both appear to have been skimmed with cement **105** as part of the consolidation and waterproofing works. The side vault **107** sat at least 0.14m higher than the main vault **106**.

Figure 3: Post-excitation plans of Trenches 1 - 3 (Trench 2, top; Trench 1, lower-right)

Trench 1 had revealed enough about the make-up over the vaults. This portion of Trench 2 therefore simply sought to confirm that the rubble was present below the concrete – which it was. The Great Hall portion of Trench 2 measured 0.86m NW/SE x 0.70m NE/SW x up to 0.52m deep. Below the modern floor slabs **201** (0.05m thick) was a 0.05m thick layer of

cement screed **202** without inclusions. This in turn sat over a slightly undulating (basally) layer of concrete **203** with inclusions, the layer being around 0.18m thick. These three elements made up the solid 20th century floor. Concrete **203** had been spread over a vast raft of re-deposited voided rubble **204** containing some finer material. Again, this is likely to be selected rubble derived from the excavation of original material over the vaults – there were a few pieces of animal bone within the layer. The rubble cleared onto the NW/SE running main vault **206**, which been skimmed with cement **205** as part of the consolidation and waterproofing works. The cross wall separating the Great Hall from the Withdrawing Room had been dressed-off with a 0.20m - 0.40m thick layer of rough racking **207**. The relict wall stub to the NE of the trench had been skimmed on its rear with modern cement such as that found on the rough racking. The racking covered a reduced wall of roughly dressed masonry bonded in lime mortar **208**.

Trench 3 measured 1.22m SW/NE x 0.54m SE/NW x up to 0.46m deep. The trench was located against the SE wall of the Great Hall below the carved buffet. Below the modern floor slabs **301** (0.05m thick) was a 0.08m thick layer of cement screed **302** without inclusions. This in turn sat over a slightly undulating (basally) layer of concrete **303** with inclusions, the layer being around 0.10m thick. These three elements made up the solid 20th century floor. Concrete **303** had been spread over a vast raft of re-deposited voided rubble **304** containing some finer material. Once again, this is likely to be selected rubble derived from the excavation of original material over the vaults – there were a few pieces of animal bone within the layer. The rubble cleared onto the NW/SE running main vault **306** which had been skimmed with cement **305** as part of the consolidation and waterproofing works.

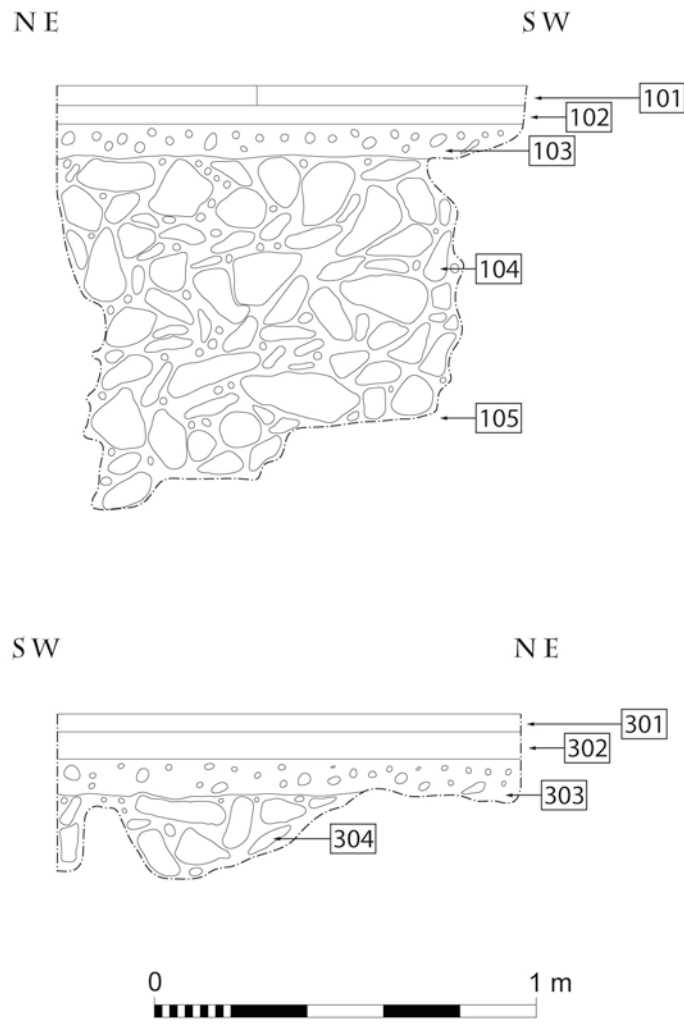
Figure 4: NW-facing section in Trench 1 (top) and SE-facing section in Trench 3

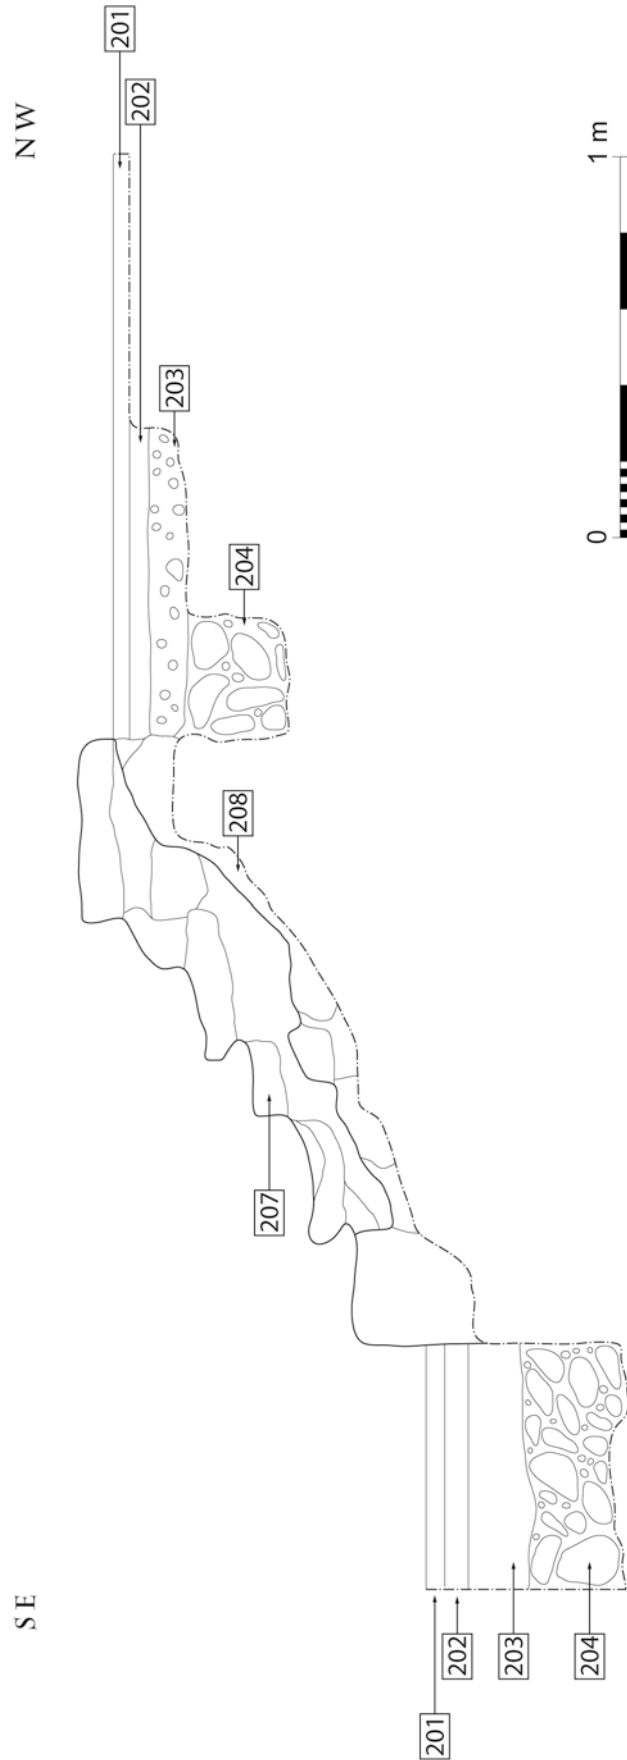
Figure 5: NE-facing section in Trench 2
