**HISTORIC SCOTLAND PROPERTIES IN CARE
MINOR ARCHAEOLOGICAL WORKS 2014/2015**

New Abbey Corn Mill • Standing Building Recording • January 2015

SITE: New Abbey Corn Mill, Dumfries and Galloway.

DESCRIPTION: A program of standing building recording prior to an upgrade of the mill's ventilation system.

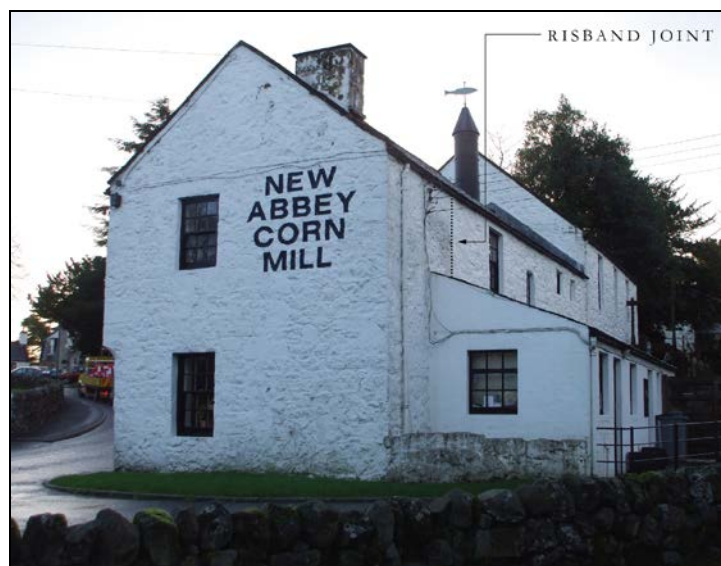
Plate 1: The risband joint in the west wall.

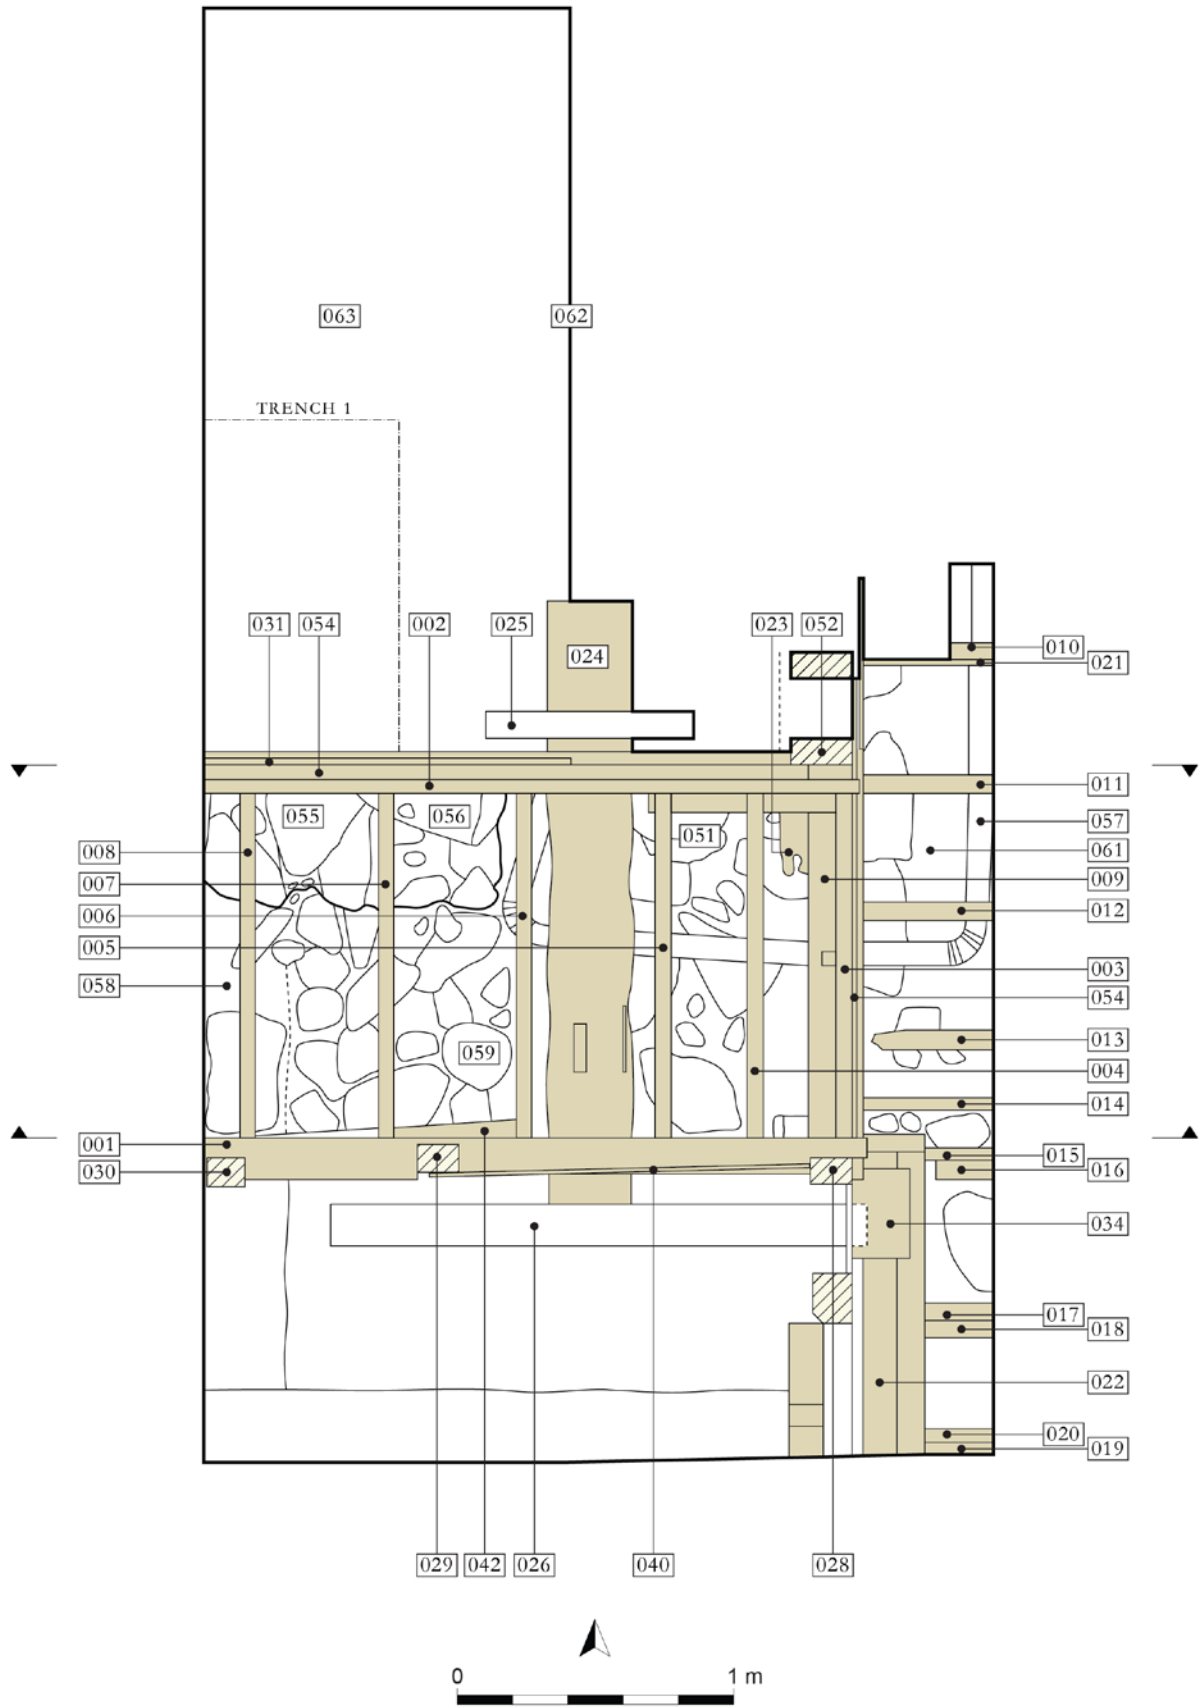
Figure 2: Cupboard and features below.

It was clear upon the removal of the cupboard base planks (and floor boards to the east of the cupboard) that extensive remodelling and re-building had previously taken place. The timber components were a mixture of modern replacements and timbers which clearly had some age to them. It appeared that the selection of an older piece of timber to be part of the panelling/framing of the cupboard may not have been based on the fact that it originally derived from that position, but rather that its condition allowed it to be re-used. The historic timber may therefore have derived from elsewhere in the mill. In addition it was clear that several of the beam timbers for framing-up the cupboard were themselves re-used, as attested by the presence of mortises which had no function in their present configuration (likely to be re-used ceiling timbers¹).

The cupboard base had a superstructure of six modern pine joists, numbered **003 – 008**. Joists **006 – 008** were carried to the south on a modern timber **042** running E/W and tied to uprights **029** and **030**; to the north **006 – 008** were attached to a modern E/W timber **066**. Timber **066** was bedded over the rear face of the south wall **055** of the water wheel pit **062**. The wall **055** was composed of large irregularly-shaped, mainly sub-rounded granite boulders bonded in lime mortar. The thickness of the wall N/S could not be determined (it was at least 55cm thick) as it was obscured to the south by a layer of loose large sub-rounded granite boulders **059**. The wall **055** had previously been breached by an irregular cut **056**, 30 – 60cm wide N/S, for the insertion of a ventilation pipe **057**. The ventilation pipe then returned to the east and north where it was bedded below timber floor joists **010 – 012**, and the timber bracer **021** (attached to joist **010**).

To the east, joists **003 – 005** were carried on a modern E/W timber **049** which was bedded (to the east) on a N/S modern timber **009**, itself supported by a large hand-cut timber **023**, possibly a re-used ceiling timber. To the west, timber **049** (carrying joists **003 – 005**) was bedded on a modern wooden pad **050**, which was supported by a crude column **051** of granite rubble bonded in lime mortar. The shaft **024** of the large toothed wheel **026** driving the oat bruiser was also revealed during the works. This had been fashioned (by hand) from a tree trunk, but had clearly once been part of a roof as it carried mortises which indicated its original function. The shaft measured *c.*30cm in diameter.

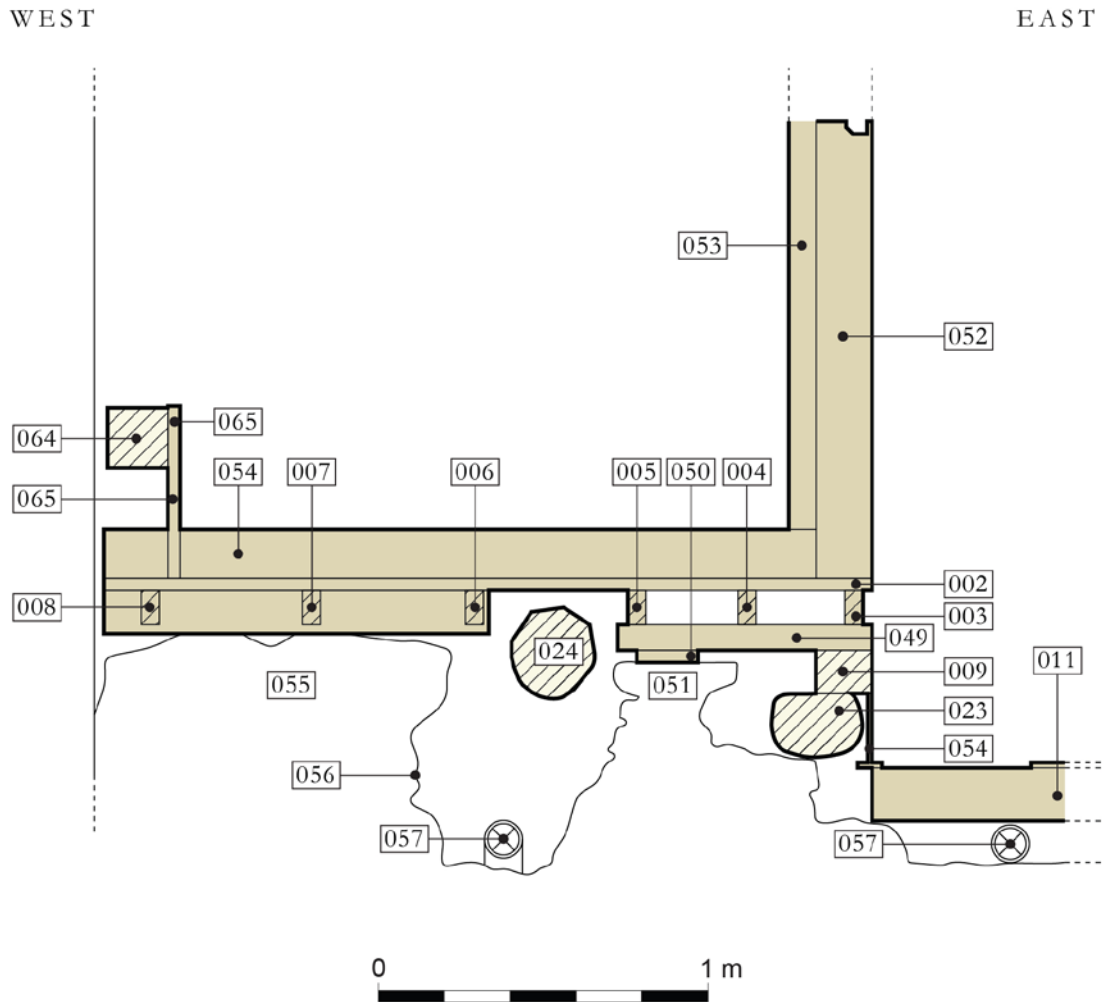
Figure 4: South-facing view through the cupboard.

On the south side of the cupboard, joists **003 – 005** were carried on an arrangement of two modern beams **048** and **049**, which had been secured together with two modern planks **045** and **046**. The cupboard was supported to the south by a large re-used hand-cut beam **027** with a modern timber **043**

and plank **044** above. Beam **027** rested to the west on a projecting stone shelf 35cm wide, an original feature contrived to carry beams and joists. To the east, beam **027** rested on a modern brick plinth **060**. The loose rubble **059** covering the area under the cupboard was interspersed with a thick deposit of grain dust and casings **061**.

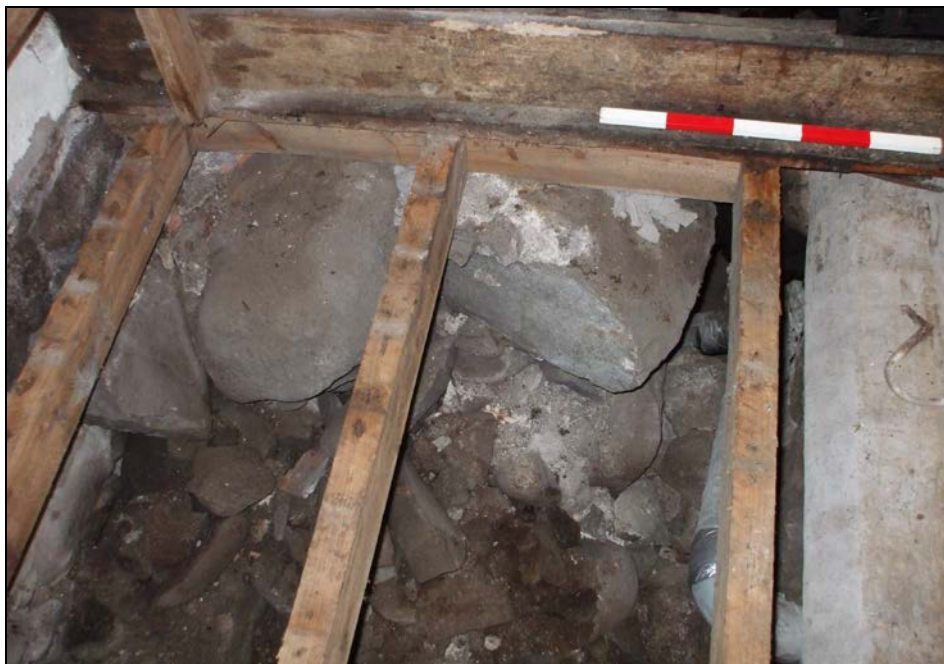
Plate 2: Ventilation pipe 057, wall 055 and cut 056.
