**HISTORIC SCOTLAND PROPERTIES IN CARE
MINOR ARCHAEOLOGICAL WORKS 2014/2015**

Ring of Brodgar • Monitoring • October 2014

SITE: Ring of Brodgar, Mainland, Orkney Islands.

DESCRIPTION: Watching brief during the installation of drainage pipes and new turf.

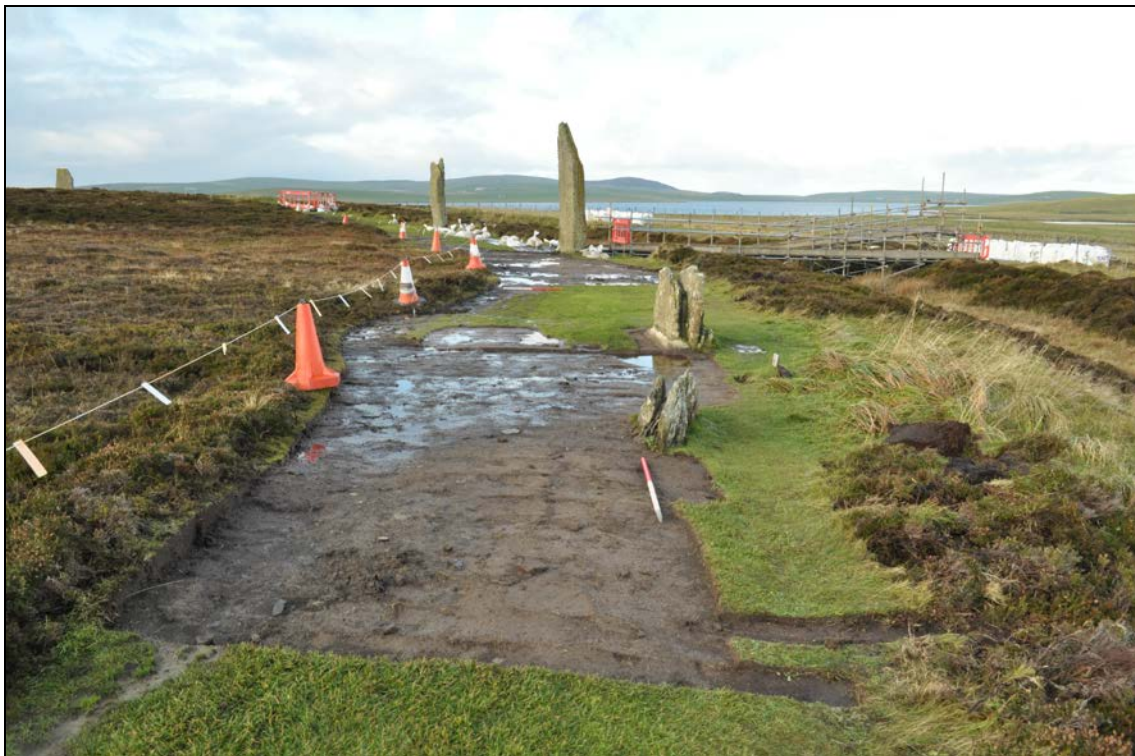
Plate 1: Post-excitation photograph of the east end of the excavated area, looking west.
