**HISTORIC SCOTLAND PROPERTIES IN CARE  
MINOR ARCHAEOLOGICAL WORKS 2012**

**Kirkhill Roman Signal Station • Site Inspection • November 2012**

**DESCRIPTION:** An assessment of trample damage to the monument caused by the incursion of farm animals (pigs)

**PROJECT CODE:** HSCO-90332-2012-01

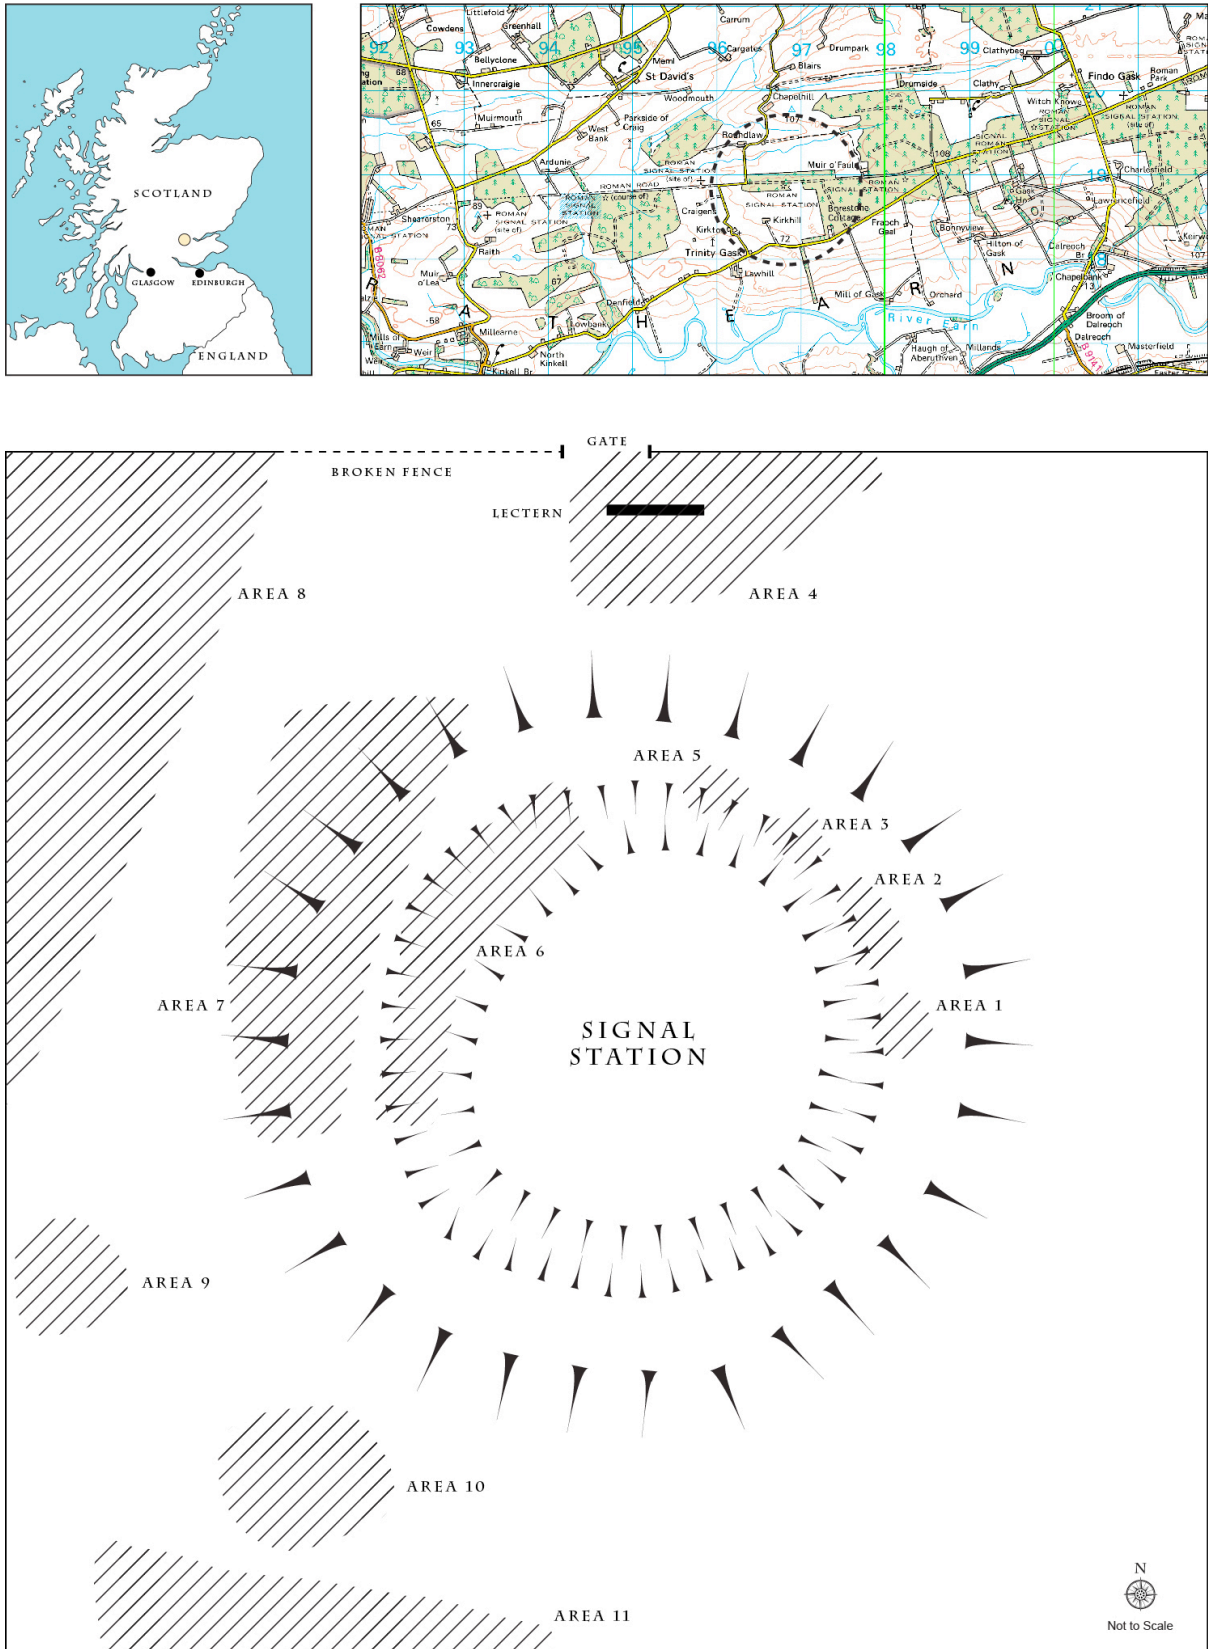
The damage is described in terms of the following areas (Fig.1):

A small, discrete patch of disturbance on the upper surface / outer face of the outer bank. The turf was lifted to depth of 100mm - 150mm. The subsoil was intact over an area up to 1m in diameter.

**Figure 1:** Plan showing the location of Kirkhill Roman Signal Station and the areas of damage.  
Inset No. 2 © Crown copyright. All rights reserved 2012. Licence number 100036933.

An extensive area of trample and turf uplifted in the vicinity of the lectern. The broken ground was up to 150mm deep in parts.

An extensive area of significant damage to the E face of the ditch and NW edge and surface of the inner platform in the NW quadrant of the site. The result of deep rooting, trample and collapse of soft turf and subsoil deposits on the slope, up to 150mm – 200mm deep in parts.

As per Area 6, located on the NW area of the outer bank and W face of the ditch.

An extensive area of rooting and trample, located across an area of pine tree plantation towards the NW and W edge of the fenced area.

The damage is worst towards the NW quadrant of the bank, ditch and inner platform. Despite the extent of turf damage, it has had a patchy, inconsistent effect on the buried archaeology, with clods of turf still *in situ*.

1. Simply replace turf where possible and carefully flatten / tamp down the disturbed areas, or
2. Remove the broken turf across Areas 6 and 7, clean the exposed surface, record archaeologically and returf. Elsewhere, simply replace turf clods and tamp down / stabilise the ground
