## **Trinity House**

# **Excavations and Standing Building Recording**

## December 2007 & March 2008

26 March 2008 Kirkdale Archaeology

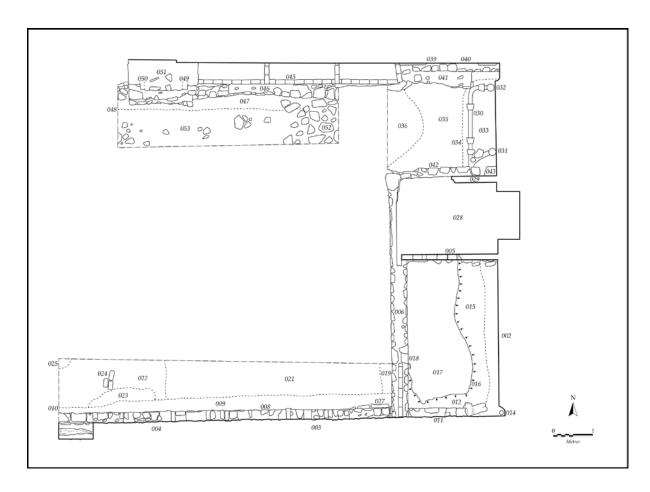
Figure 2: Plan of excavations

The limited work undertaken in the N range of Trinity House produced a complicated range of features, many of which cannot be physically related to each other. In spite of this a number of similarities are evident across the excavated area. A horizon of often crushed sandstone and mortar was found across much of the site: **F021**; **F035** and **F053**. These deposits had the appearance of demolition or construction debris, and perhaps the likeliest source for this is the construction of Trinity House itself in 1816. These deposits were not encountered in the S and central parts of the E trench, where they were presumably sealed below surfaces **F017** and **F023** in these areas.

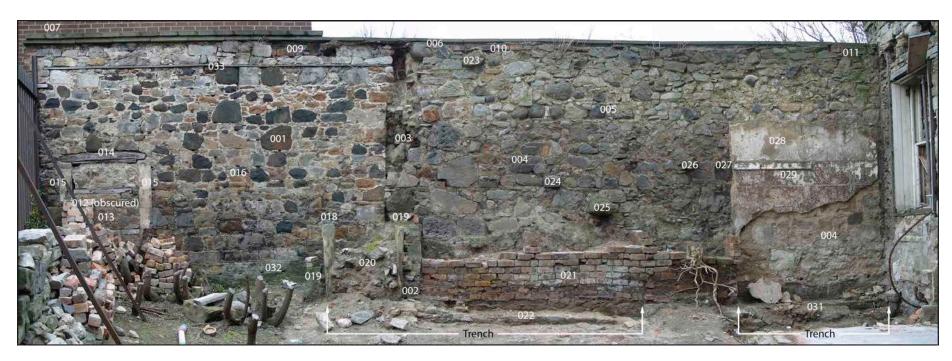
Figure 3: TH.1 - North Elevation Annotated Photograph

The N elevation of the N pavilion comprises two main builds. The W half of the wall is roughly coursed rubble build **TH.1.001** containing several black round igneous boulders and below **TH.1.001** there is a foundation or possibly an earlier build of coursed roughly rectangular blocks of sandstone **TH.1.032**. The E half of the wall is random sandstone rubble build **TH.1.004** with protruding stones **TH.1.023**-**TH.1.026** jutting out to the S. The whole of build **TH.1.004** sits out slightly of **TH.1.001/TH.1.032** and the builds are separated by a prominent vertical scar **TH.1.003** down the W edge of **TH.1.004**. The E edge of **TH.1.001/TH.1.032** appears to respect scar **TH.1.003** indicating that **TH.1.001/TH.1.032** was built against the structure or fixture once occupying the scar.

The top of the N elevation is covered with coping slabs **TH.1.006** extending the whole length of the wall with brick repairs **TH.1.009-TH.1.011** inserted to create a level course to hold the coping slabs. It is likely that the elevation has been reduced in height, since there is no evidence of the roofline seen in the E and S elevation slightly above the height of coping stones **TH.1.006**.

At the W end of the elevation, aperture **TH.1.012** is build into **TH.1.001**. This aperture may be a door or a cupboard; it is not possible to check the reverse of the wall for evidence of the aperture because 20<sup>th</sup> Century flats are built up against it. The base of the aperture was also obscured by rubble at the time of recording. The top of the recess is a wooden lintel **TH.1.014**, most likely original, with strips of wood visible along the underside of the lintel, extending into the interior of the aperture, possibly to hold plaster. The E and W margins of the aperture are covered with coarse yellow plaster **TH.1.015** with small shell and pebble inclusions. Aperture **TH.1.012** is blocked with rubble blocking **TH.1.013** which seals plaster **TH.1.015**. The blocking has horizontal wooden strips built into it. The wooden strips are related to a series of dooks **TH.1.016** extending across the W two-thirds of **TH.1.001/TH.1.032** to hold panelling.

At the E end of build **TH.1.001/TH.1.032** there is a structure or fixture built against the base of the wall, abutting **TH.1.001/TH.1.032** and scar **TH.1.003**. The structure comprises two upright slabs of stone **TH.1.018** and **TH.1.019** approximately 1.00m high by up to 500mm deep by approximately 60mm thick placed approximately 1.00m apart, flanked to the W by a smaller block of stone abutting **TH.1.032** and to the W by a stub of wall which appears to be protruding from scar **TH.1.003**. The gap between the uprights is filled with rubble and debris **TH.1.020**. Continuing to the E of this structure is a brick construction **TH.1.021** with three bays built onto the E side of stub wall **TH.1.002** and built against

**TH.1.004**. It is not clear whether or how the structures are related since the purpose of each is unknown. To the S of both structures a continuous dwarf wall **TH.1.022** runs along the length of the brick bays **TH.1.021** and the flanked uprights **TH.1.018/TH.1.019**.

The E end wall of the brick bays **TH.1.021** is also the W partition wall for the NE room in the pavilion. The scar **(TH.1.027)** of the brick partition is marked along the W edge of plaster **TH.1.028**.

The NE room of the pavilion is defined by plaster **TH.1.028** with wooden dado **TH.1.029** and white and brown paint scheme. At the base of the wall is a dwarf wall built against **TH.1.004** and a horizontal series of 4 dook holes above the dwarf wall most likely for a skirting board. There is no N-S dwarf wall at the W end of the NE room.

There is potentially a break in build or blocked linear horizontal feature running the whole length of **TH.1.004** above the top of plaster **TH.1.028**. It is not particularly prominent but a definite line **TH.1.005** can be seen in the build, characterised by a rough course approximately 300mm thick with more rounded stones that the rest of the wall. Most likely this is just a break in the build since the protruding stone characteristic of build **TH.1.004** continue above this level.

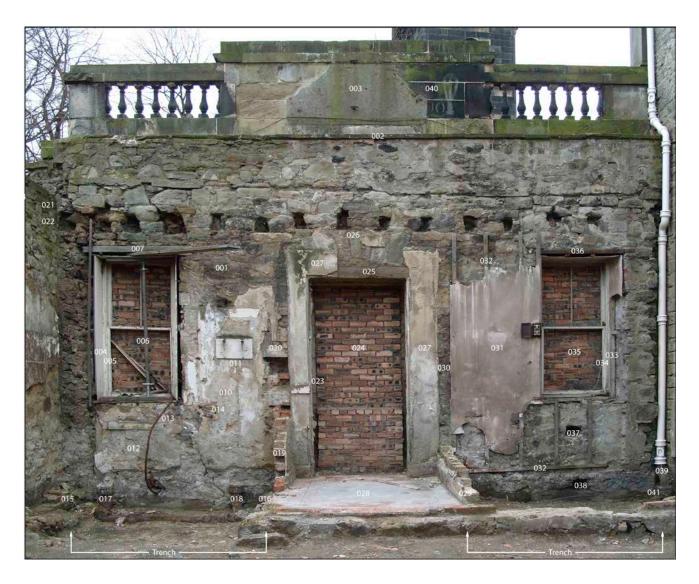
Figure 4: TH.2 - East Elevation Annotated Photograph

The E wall of the N pavilion comprises two builds. The main wall build is TH.2.001; random rubble sandstone topped with coping slabs TH.2.002. Above this is a decorative parapet TH.2.003 of ashlar with moulded balustrades. TH.2.001 has a central door aperture built into it TH.2.023, a N window aperture TH.2.004 and a S aperture TH.2.033. The N and S dressed quoin margins of the door are just visible behind plaster TH.2.027. Above the door aperture is a dressed sandstone lintel TH.2.025, and a relieving arch TH.2.026. The door is blocked with bricks TH.2.024. The window apertures appear to be cut into TH.2.001 but they are original features so this may just be how they were constructed. Both the window apertures contain white painted sash and case window frames TH.2.005 and TH.2.034 but both are blocked with bricks TH.3.006 and TH.3.036. The N window has a wooden sill TH.2.007 and the margins are line with tongue and groove painted white. The S window has and iron lintel TH.2.036, possibly a replacement, and the margins are lined with pink plaster TH.2.031 on a wooden frame TH.2.032.

The elevation is divided into three by two brick partition walls **TH.2.019/TH.2.020** and **TH.2.019/TH.2.030**. The partitions create a NE room with N window **TH.2.004**; a central entrance hall with door **TH.2.024** and red clay, lead inlaid floor **TH.2.028**; and a SE room with S window **TH.2.033**.

The NE room has several features which indicate that it may have been a toilet, such as iron plumbing **TH.2.017** and **TH.2.018**, iron pipes **TH.2.013** and square scar **TH.2.012** which could have been created by a cistern, and iron hoop fixture **TH.3.014**.

Near the top of the elevation approximately 600mm below coping slabs there **TH.2.002**, there is a horizontal scar **TH.2.021** marking the roof level and approximately 200mm below the scar is a series of 14 joist holes **TH.2.022** for the roof.

At the S side of the wall a ragged vertical cut **TH.2.041** has been made down the length of **TH.2.001** to insert drainpipe **TH.2.039**. This must have occurred following the removal of the roof.

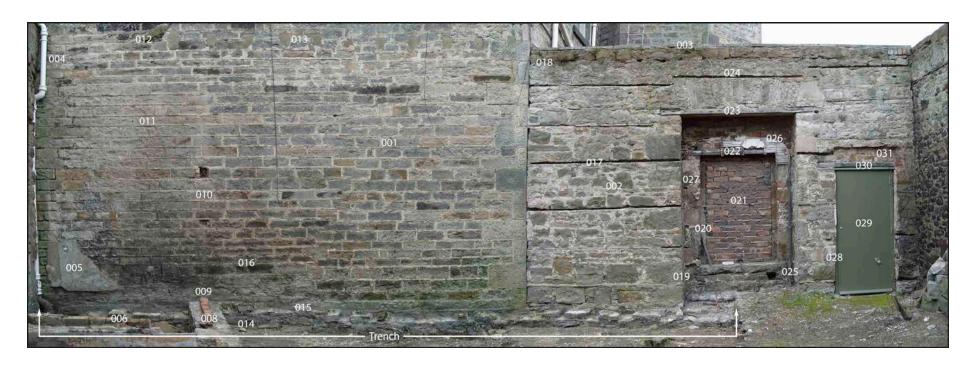
Figure 5: TH.3 - South Elevation Annotated Photograph

The S elevation comprises two main builds. The E half of the S elevation is the external N wall of the central house, a coursed build **TH.3.001** of rectangular blocks of grey sandstone. This build extends up to a second story but all the features related to the N pavilion are contained below this level. The W half of the elevation was built on to the W edge of **TH.3.001** and it is a roughly coursed sandstone rubble build **TH.3.002** with integral horizontal strips of wood **TH.3.017** for panelling.

The roofline of the N pavilion is marked by a sloping scar of render **TH.3.012** and a series of 11 joist holes **TH.3.013** cut into **TH.3.001** and blocked with light grey/buff cement. The joist holes probably continued across build **TH.3.002** but the wall may have been reduced and rebuilt across the top to create a level course for coping **TH.3.003**.

The elevation is divided into two by dwarf wall **TH.3.008** and brick partition **TH.3.009/TH.3.010**. The partition creates a small SE room with an E-W brick dwarf wall **TH.3.006** built against wall **TH.3.001** running up to N-S dwarf wall **TH.3.008**. Just above dwarf wall **TH.3.006** is a horizontal line of dook holes for a skirting board and above this is a patch of pink plaster **TH.3.005**. To the W of partition **TH.3.009**, **TH.3.001** is covered with a regular series of 8 horizontal lines of dook holes **TH.3.016** cut into **TH.3.001** now filled with light grey/buff cement. These dook holes are a continuation of the wooden strips **TH.3.017** built into the W half of the wall **TH.3.002** to hold panelling. E-W rubble dwarf wall **TH.3.015** runs along the base of **TH.3.001** and **TH.3.002** to the W of N-S dwarf wall **TH.3.008**. It is just possible to see two slabs below the E end of **TH.3.015** which may be the top of the 16th Century vaulted cellars below.

At the W end of the elevation there is a window bay **TH.3.019** with window aperture **TH.3.020** built into **TH.3.002**. The window aperture has sandstone margins with rebate and an internal wooden lintel **TH.3.022**. The aperture is blocked with bricks **TH.3.021**. The remains of wooden frame **TH.3.025** and laths **TH.3.026** and dooks **TH.3.027** where the frame is missing. The window recess margins are rubble built but contain large blocks of grey sandstone with a wooden lintel **TH.3.023** and above this a relieving arch **TH.3.024**.

To the W of the window recess there is a door aperture **TH.3.028** with modern door frame and door **TH.3.029**. It is not clear whether the door is built into **TH.3.028** or a later insertion. The proportions of the door aperture look odd next to the large window recess. This is the only access to the N pavilion not blocked with bricks.

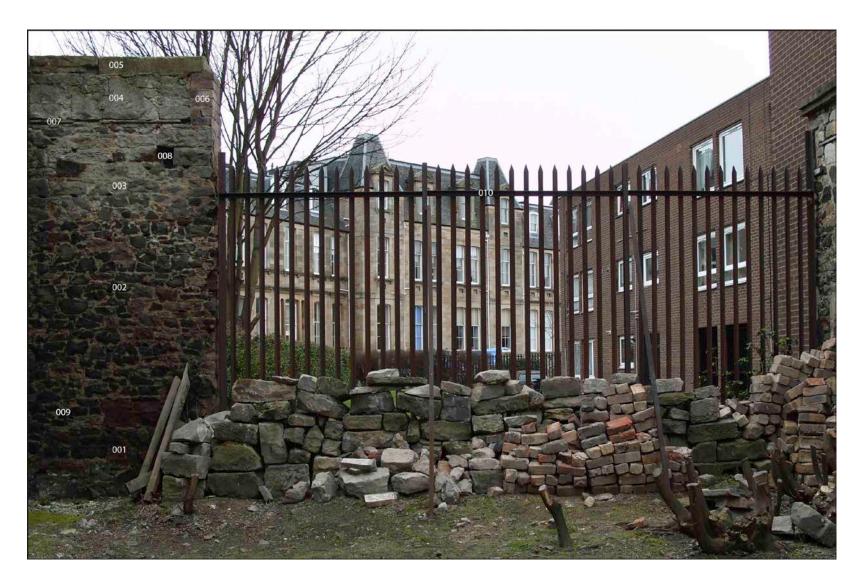
Figure 6: TH.4 - West Elevation Annotated Photograph

Most the W elevation has been removed and replaced with fencing **TH.4.010**, but the a portion of the S end of the wall remains. This wall continues to the S behind S wall **TH.3.002** and along the back of Trinity House. It is much repaired and the exterior (Lidl car park side) appears to be supported with buttresses. Four builds are visible in the W elevation of the N pavilion. Lower wall build **TH.4.001** is roughly coursed rectangular blocks; above this is **TH.4.002**, a random rubble build of small pieces of black igneous rock; above this is **TH.4.003**, a random rubble build of grey sandstone; and the upper wall build is a possible rebuild of sandstone rubble **TH.4.004** to create a level course for coping slabs **TH.4.005**. **TH.4.004** may also have been rebuilt to insert a horizontal strip of wood **TH.4.007** into the elevation. The strip of wood is related to a series of dooks **TH.4.009** cut into builds **TH.4.001**, **TH.4.002**, and **TH.4.003** to hold panelling. A brick repair TH.4.006 has been made to the upper N edge of the wall which may also include the reuse of two sandstone blocks below the bricks to stabilise the top edge of the wall. This repair may have created what looks like a joist hole **TH.4.008** but what is more likely to be a void since it occurs below the top of the panelling and is too low to be the equivalent of any of the joists on the E or S elevation.
