**Newark Castle Roof 2008
Standing Building Survey**

**Kirkdale Archaeology
on behalf of Historic Scotland
28 November 2008**

Site Newark Castle, Port Glasgow

Project Description Archaeological Survey of the roofs above the E and W portion of the 2nd Floor of the North Range, the roof above the 2nd floor of the gatehouse, the roofs above the E, NE, Central, NW and W turrets and the loft roofs above the 2nd floor of the E range.

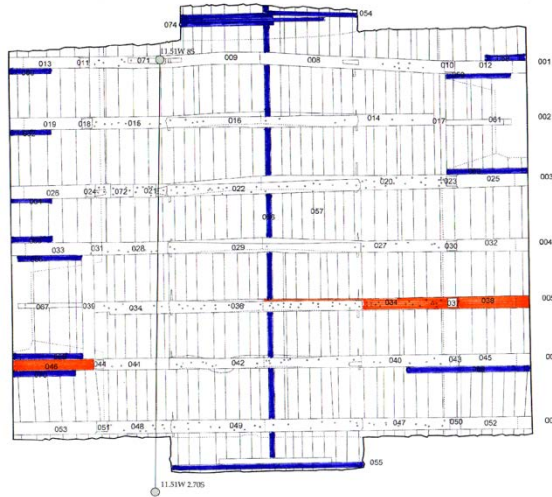
³¹ Much of the original timber used is in poor physical condition and it is difficult to identify holes and fixings.

Plates 10 and 11
The rafter-single roof over
the Gatehouse

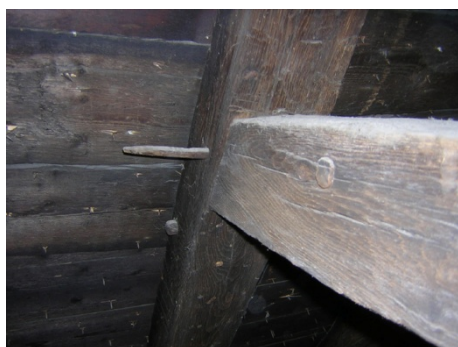
Plate 21
Conjunction of rafter and collarbeam.

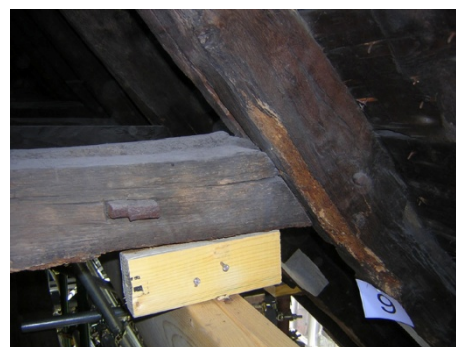
The fragility the south-wall, which fails to provide sufficient counteraction for neutralising the horizontal roof thrust, causes fundamental difficulties. The large apertures form the very core of this problem, indicating that the architect was not yet aware of appropriate structural solutions.⁴⁵ The horizontal thrust, resulting from the geometry of the roof as well as wind pressure, exerts an undue pressure on the pierced south wall and forces the latter to splay. Consequently, the trusses heavily deflect and the structural stability of the roof entirely relies on the pegs fixing the joints between the rafters and collarbeams.⁴⁶ A previous generation of builders was aware of this problem, and seemingly responding to critical movement, they dismantled the entire roof and reinforced the lower set of collarbeams with iron tiebacks. This measure shows that the roof was failing already in earlier times.

Plate 22
Iron tieback.

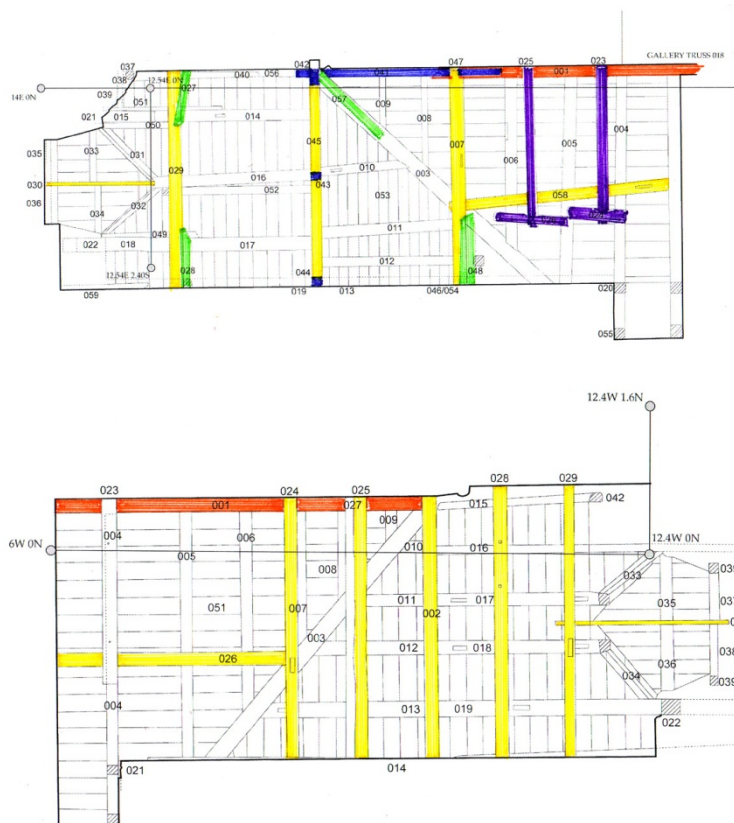
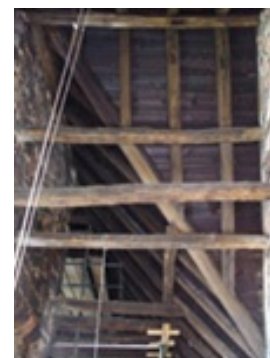
Plates 35, 36 and 37
Rafters and purlins at
the eastern and
western bedchamber.
