Historic Scotland
Properties in Care
Minor Archaeological Works 2008

Dryburgh Abbey:

Archaeological excavations and
standing building recording,
June 2008

HS PIC Index number: 90103
Project code: HSCO-90103-2008-02

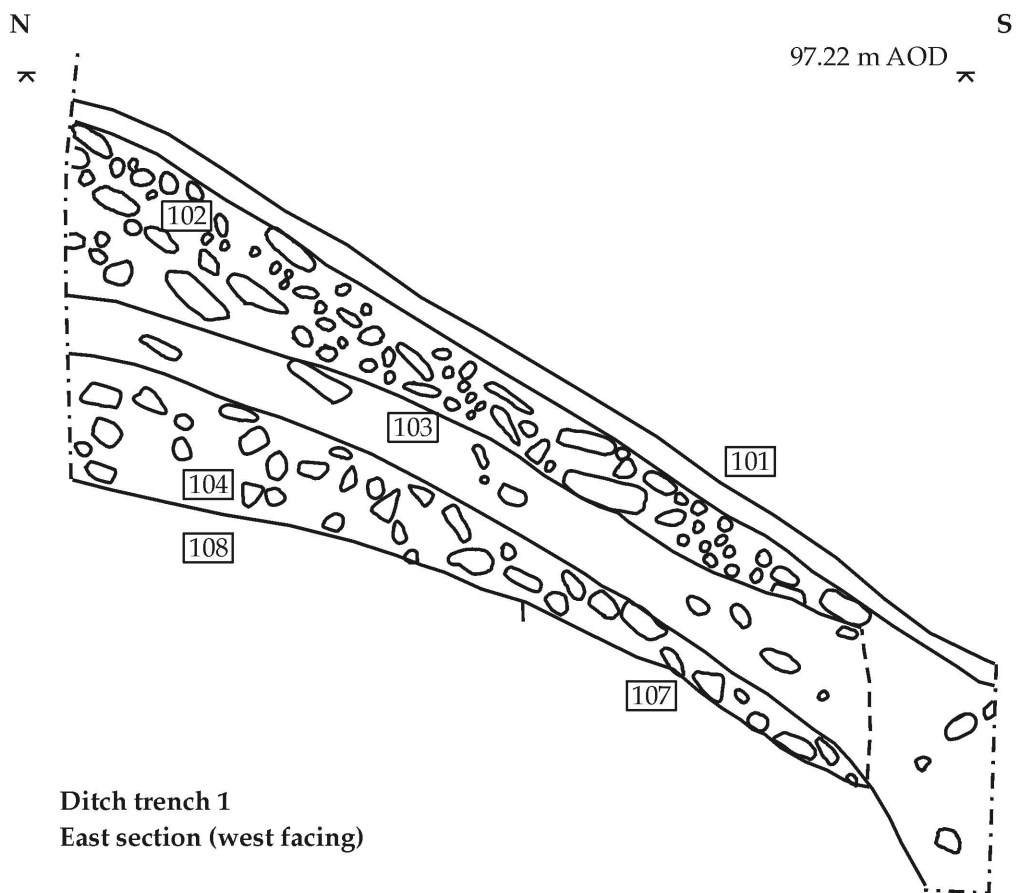
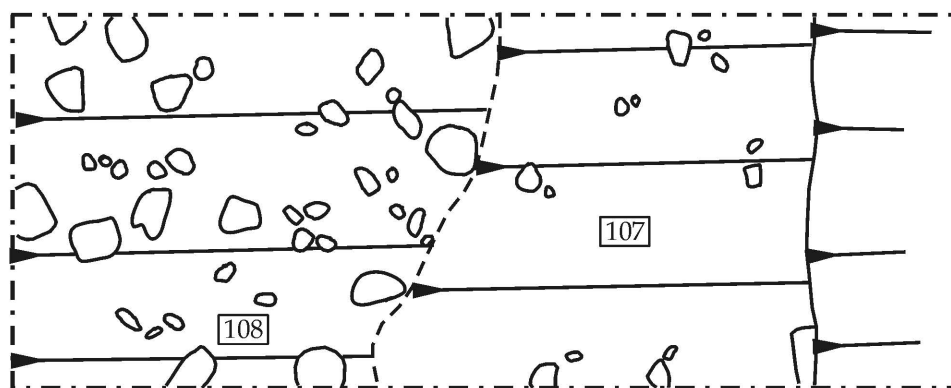
Fig. 2 : Trench 1

Exposed, but not excavated, deposits **F107** and **F108** appeared to be re-deposited subsoil. Neither **F107** nor **F108** were excavated within Trench 1 although a heavily diseased bone was recovered from **F108**. The bone was a long bone and it was not even possible to say, from the cursory examination of it during excavation, whether it was an animal or human bone.

Deposit **F104** was a mix of stones and brown clay; many of the stones were sub-angular. The mortar flecks and slate fragments also suggested that this may have been demolition or construction. The fairly small stones and small amounts of other

Ditch trench 1
Post excavation plan

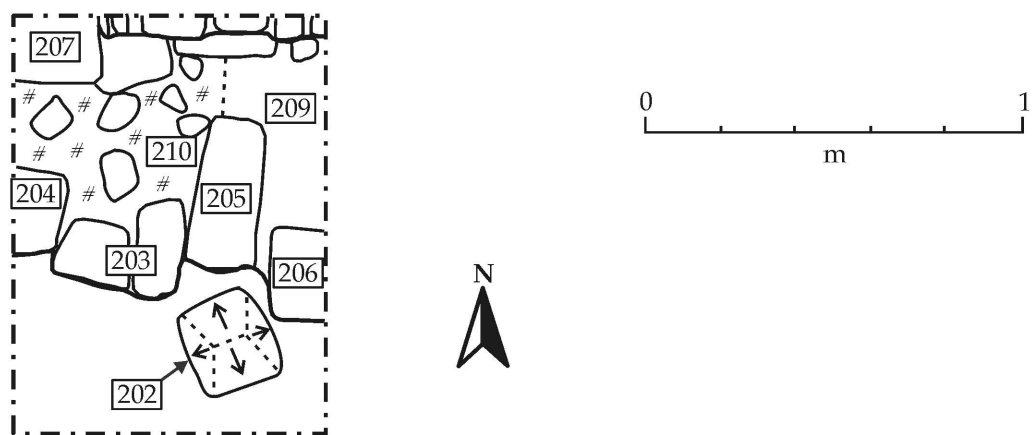
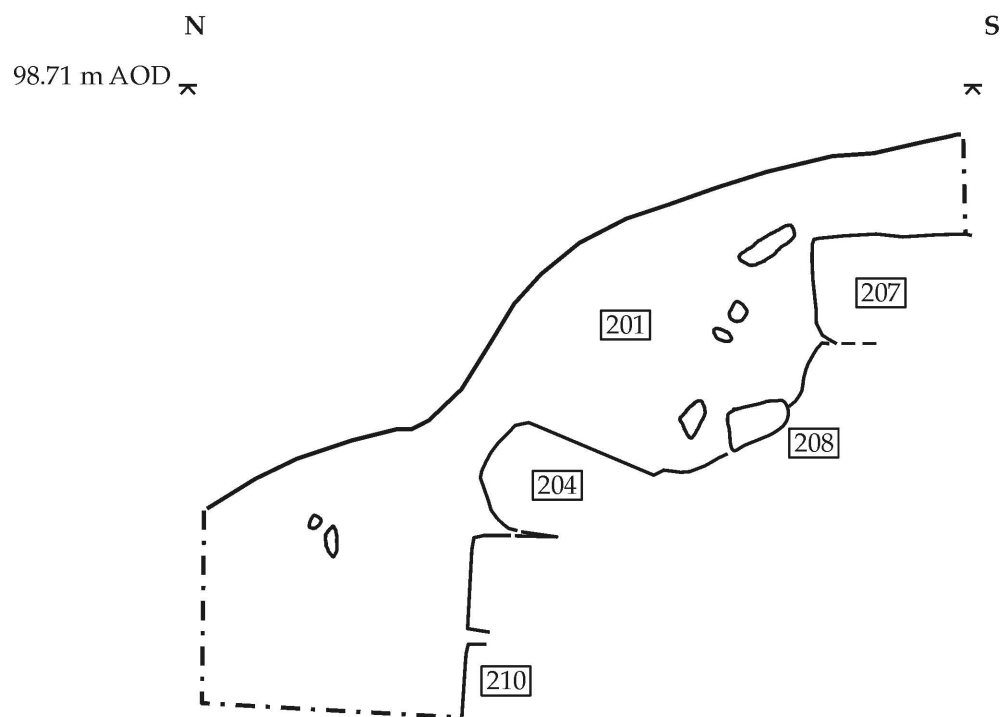
Fig. 3 : Trench 2

F205 was a rectangular red sandstone block forming part of the S face of the wall; it extended 400 mm S from the face showing a fairly substantial structure. Immediately E of **F205**, **F206** was part of the same structure but the outer face is 50 mm S of that at **F205**. It was noted that there was another block under **F206** so it appeared that either a section of wall had slipped forward (S) or there was a change in build. The S face of the wall, **F210**, was seen and probed to be at least three courses high and was thought to continue below this. This was a substantial construction near the current N edge of the ditch. It is possible that **F207** was the S end of the stones at the N face of the wall and **F211** the continuation of that feature, although there is a slight difference in alignment between the two it is the N face that would be important. Between all the various pieces of walling **F208** appeared to be small stone and clay infill forming the core. The wall that was seen in Trench 2 most likely belongs in this phase, although there is no stratigraphical link between the two trenches. The wall appeared to have been formed with facing stones at the N and S sides and in-filled with clay and rubble between. The N side of the wall was close to the present ground surface, suggesting that there has been a fair bit of collapse to the S, where the remains are lower.

The turf and topsoil, **F201**, had been continually disturbed and contained occasional flower bulbs. This deposit was only bottomed over the structural remnants and it may be that it has built up over a fairly long period. **F209** appeared to be root disturbance or an animal burrow. **F202** was tumble from **F210**, probably fallen from over **F205**, the fact that it sat where it did showed the ditch to be filled to that point when it fell. **F202** appeared to be within **F201**, perhaps suggesting that there should be a division in that deposit above and below this stone. The two blocks at **F203** appear to have slipped forward (S) slightly and had topsoil, **F201**, below them at the N end. This seemed to suggest a gradual deterioration of the wall rather than deliberate demolition. At the W baulk, **F204** was another block that had slipped from the S wall face.

Ditch trench 2
Post excavation plan

Ditch trench 2
West section (east facing)

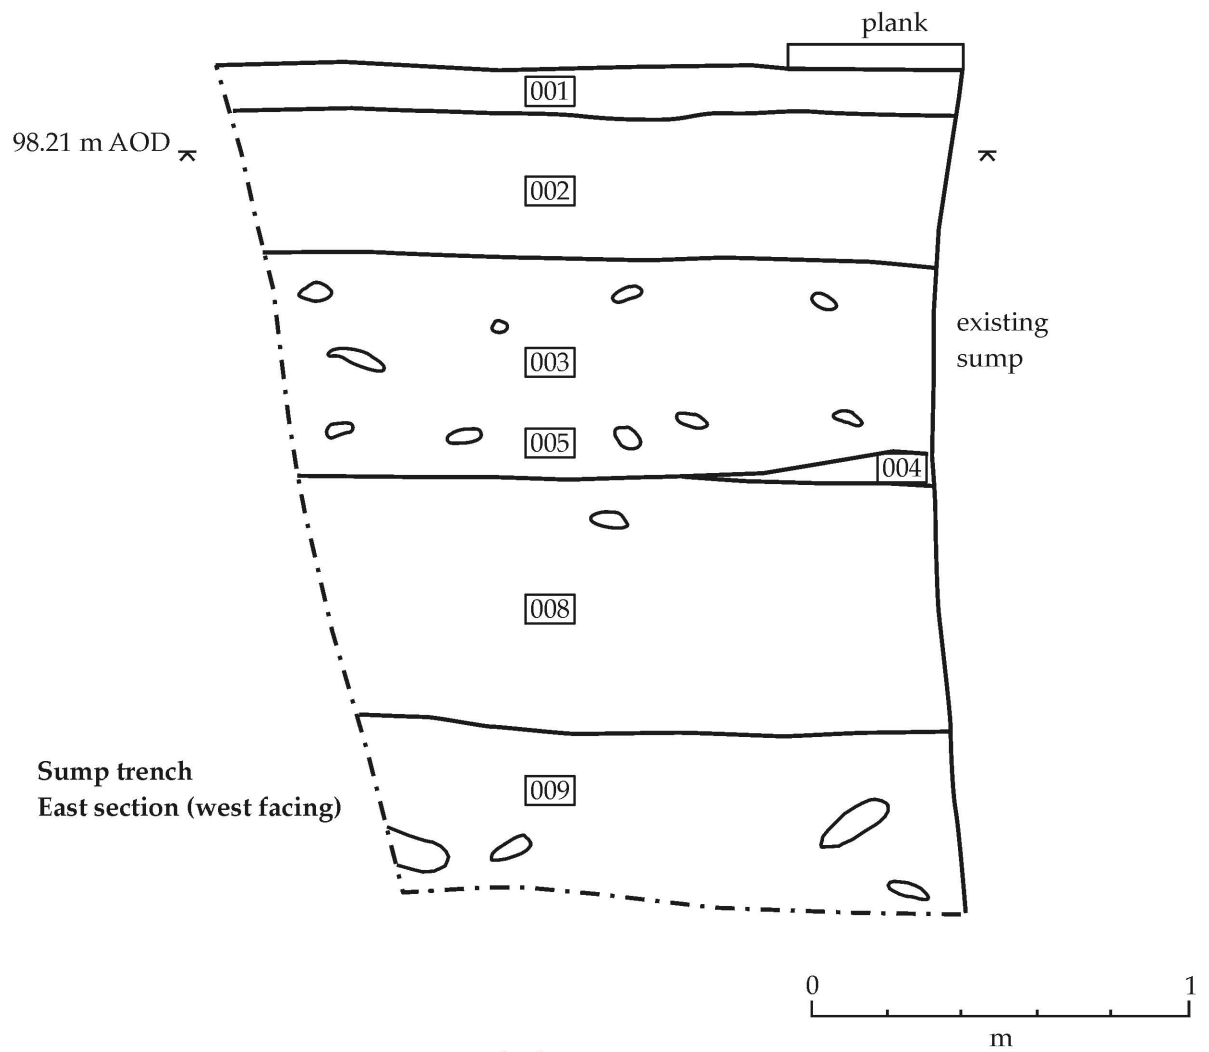
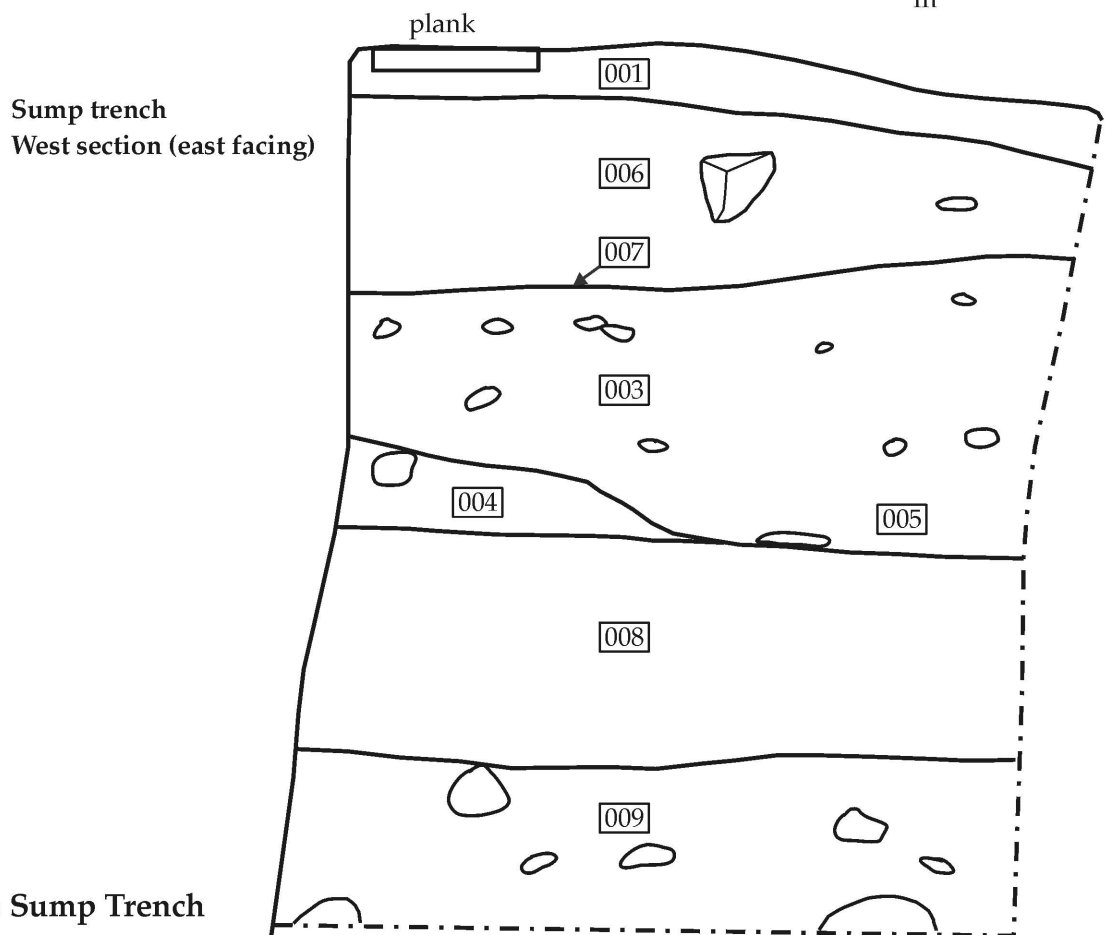
Fig. 4 : Sump Trench

This small excavation extended the known size of features already discovered in the 2006 excavation, without revealing any new archaeological deposits. The fill **F006** continued along the E edge of the trench in its cut **F007**. In 2006 this was interpreted

Cut **F005** also continued across the trench, with its very flat base, making it now at least 3.4 m N- S by 1 m wide, and at least 300 mm deep (450 mm if **F002** is an upper fill). At least N- S the full extent of 'industrial' deposit **F004** was revealed as 1.7 m. As noted in 2006 this appears to have been placed in cold, with no sign of heat damage to surrounding deposits. This makes it unlikely that **F005** is itself any kind of industrial feature; rather it seems to have been used to dump this material in. The discrete nature of the deposit, along with the presence of small diameter charcoal and fragments of probable furnace lining, indicate that it has not travelled far. Above this was **F003**, which appears to be re- deposited natural- remarkably similar in composition to **F009** some 350 mm below it. **F003** seems to have been used to infill and level off the top of cut **F005**, continuing outside the trench with it.

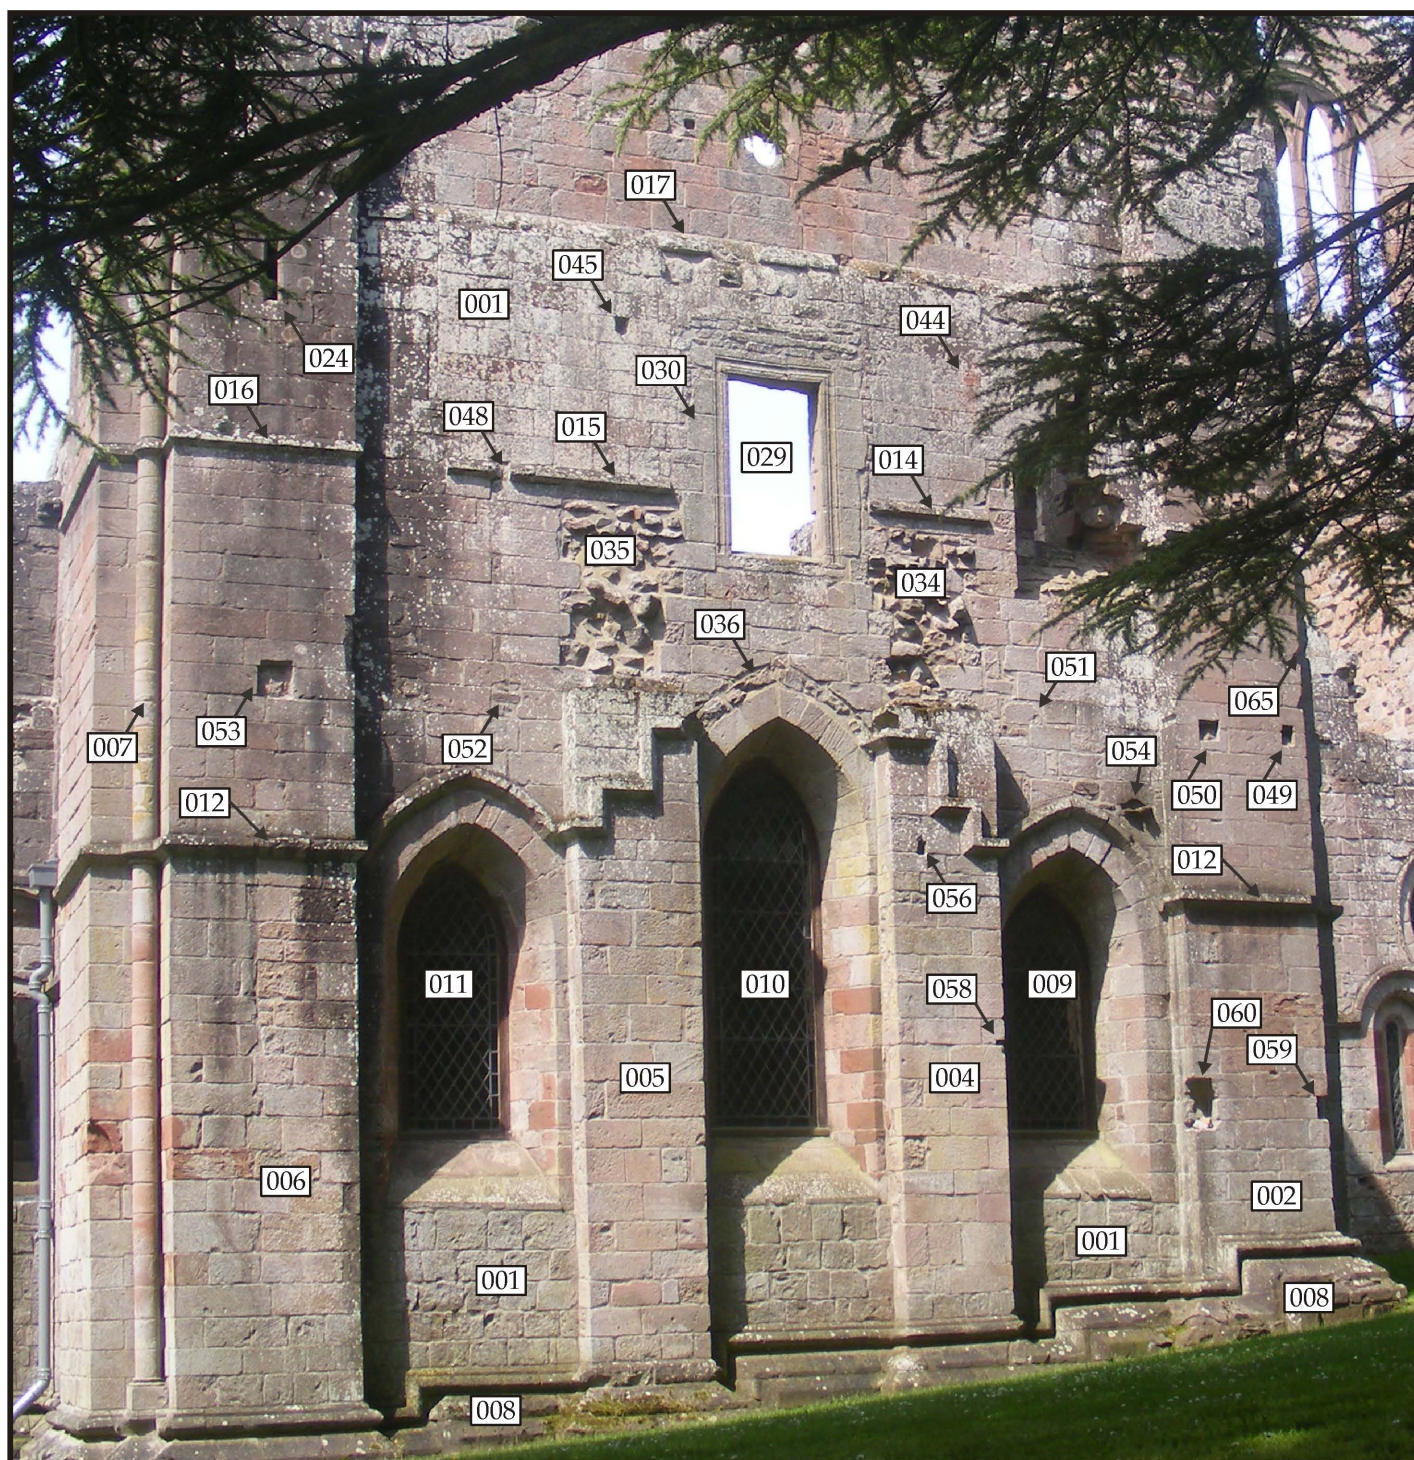
Below **CH.029** is a complex sequence of alterations, likely to be related to each other. A series of five shallow but large holes have been cut in a horizontal line across this face, numbered **CH.049- CH.053** from N- S. Just above the height of these the two pillars have been cut back to be flush with the wall face (**CH.004** by **CH.034** and **CH.005** by **CH.035**). The highest point of wash course **CH.012** has also been clawed back (**CH.036**), just above the central lancet window **CH.010**. A water spout **CH.054**

The most serious area of alteration is found just above the lancet windows **CH.009- CH.011**. The series of five holes running in a horizontal line above this face (**CH.049- CH.053**) are thought to have carried timbers providing the floor beams. All the

projecting stonework above these and below the middle wash course has been cut back to be flush with the rest of the face. This means that the two pillars **CH.004** (cut back by **CH.034**) and **CH.005** (**CH.035**), as well as the highest point of wash course **CH.012** (by **CH.036**) have all been reduced. Not only does this demonstrate the use of this space, it also shows that this is indeed an alteration to the original appearance of the Chapter House. Although the overall size of this hypothetical timber gallery remains unknown, there is a considerable difference in height between the presumed floor and rooflines. No good evidence for a second floor was noted, so if a pitched roofline is projected onto this it seems possible that a fairly wide (or simply tall) gallery was constructed.

Fig. 5 : E external elevation of Chapter House, lower part, showing feature numbers

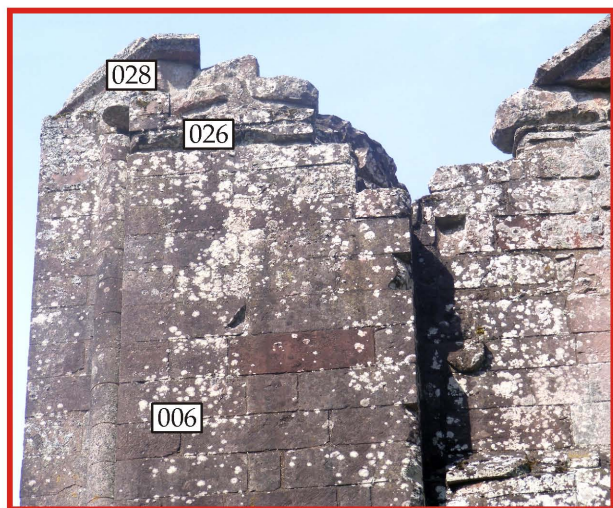
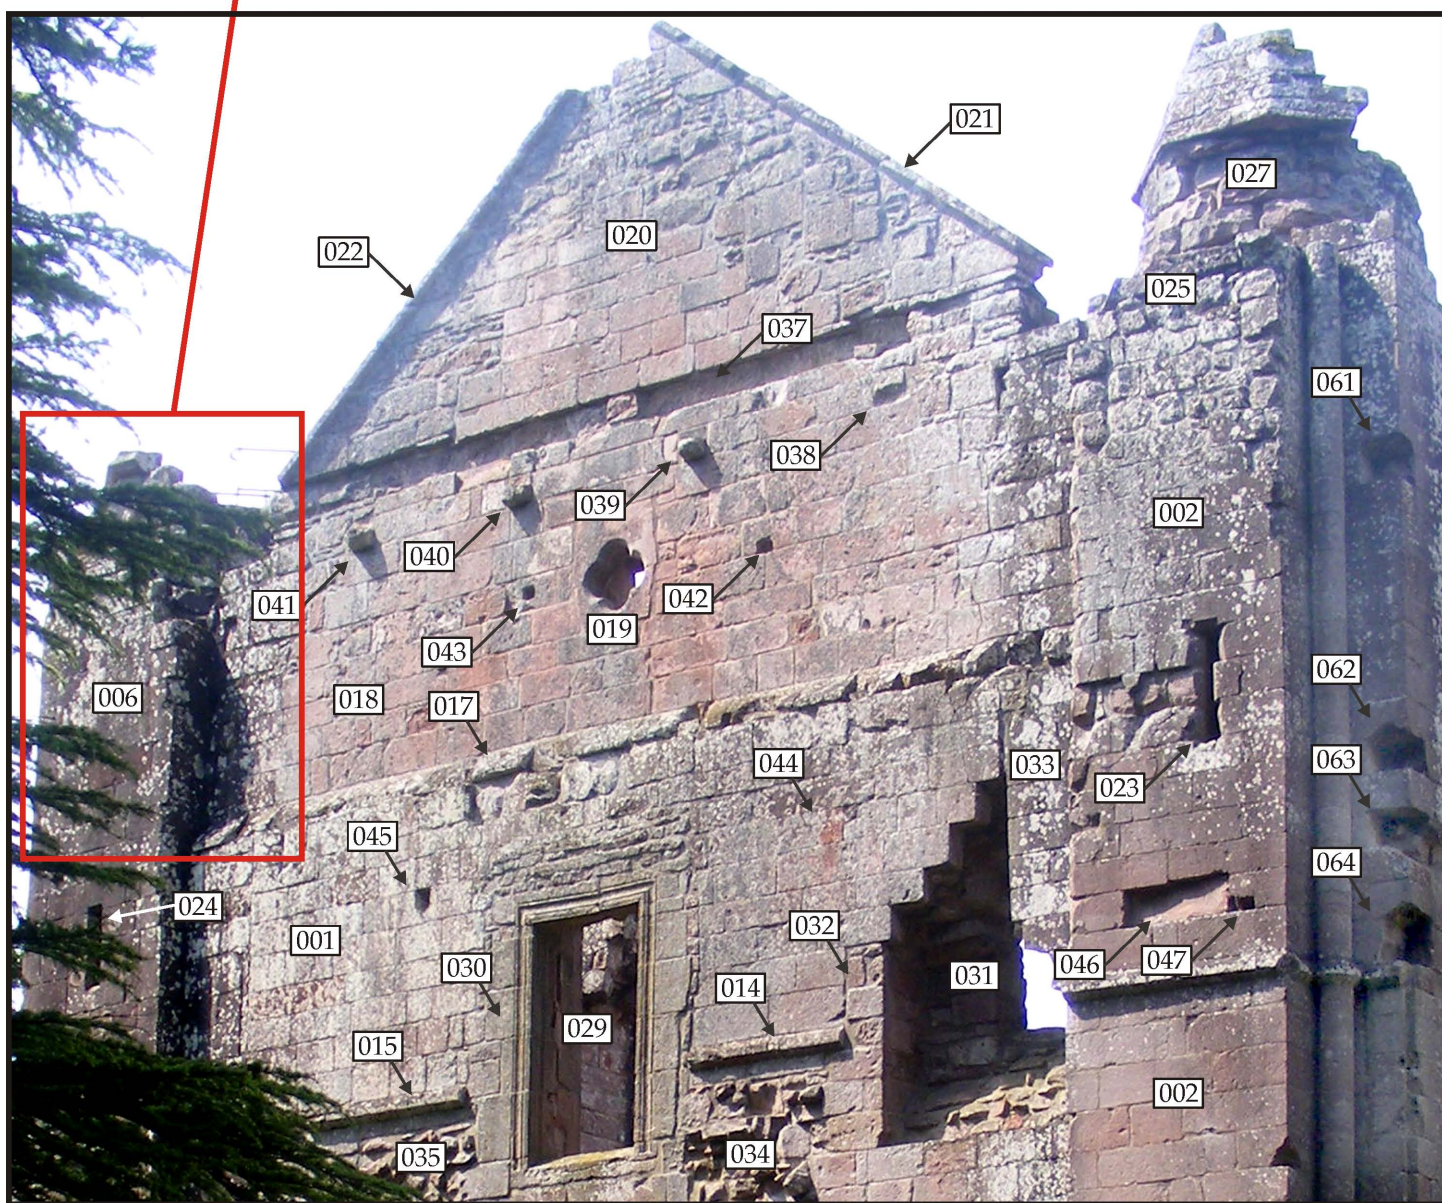
The aperture to the N of **CH.029**, **CH.031** is very hard to interpret. Vertical strips of masonry have been inserted to both N (**CH.033**) and S (**CH.032**) to create a straight edged aperture, although both now seem damaged. It is unclear if **CH.031** functioned as a door or a window. A significant crack runs up from the top of **CH.031** to the wall head.

The recessed strip of stonework **CH.037** is so far above the ground that detailed examination is impossible. It is thought to be an alteration, with a series of four corbels just below it (numbered **CH.038- CH.041** N to S) also believed to be inserted into masonry **CH.018**. Two vertical horizontal dooks (**CH.042** and **CH.043**) just below these corbels sit either side of the quatrefoil window **CH.019**, and are also cut into **CH.018**. A similar dook **CH.045** is cut in below these, on the S side of **CH.029**, with a possible in filled one **CH.044** on its N side. A vertical slot **CH.048** has been cut into wash course **CH.015**, again to the S of **CH.029**.

At the top of the E wall, although so high up that features are hard to examine, is the recessed strip **CH.037**, and just below this the four corbels **CH.038- CH.041**. These seem likely to relate to a timber roof, presumably pitched down to the E. The corbels could have carried a roof beam which fitted into the recessed strip above. The four small dooks below this, **CH.042- CH.045**, may have helped carry this roof.

Fig. 6 : E external elevation of Chapter House, upper part, showing feature numbers

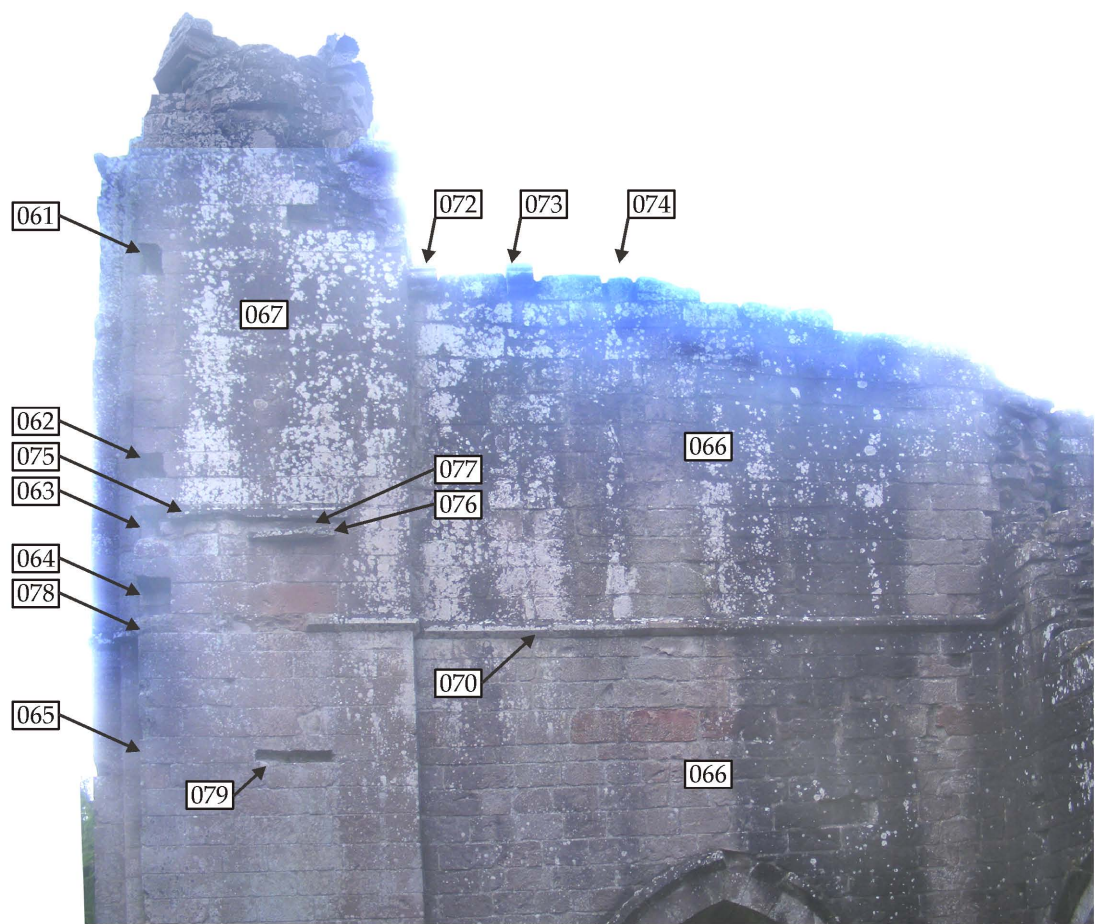
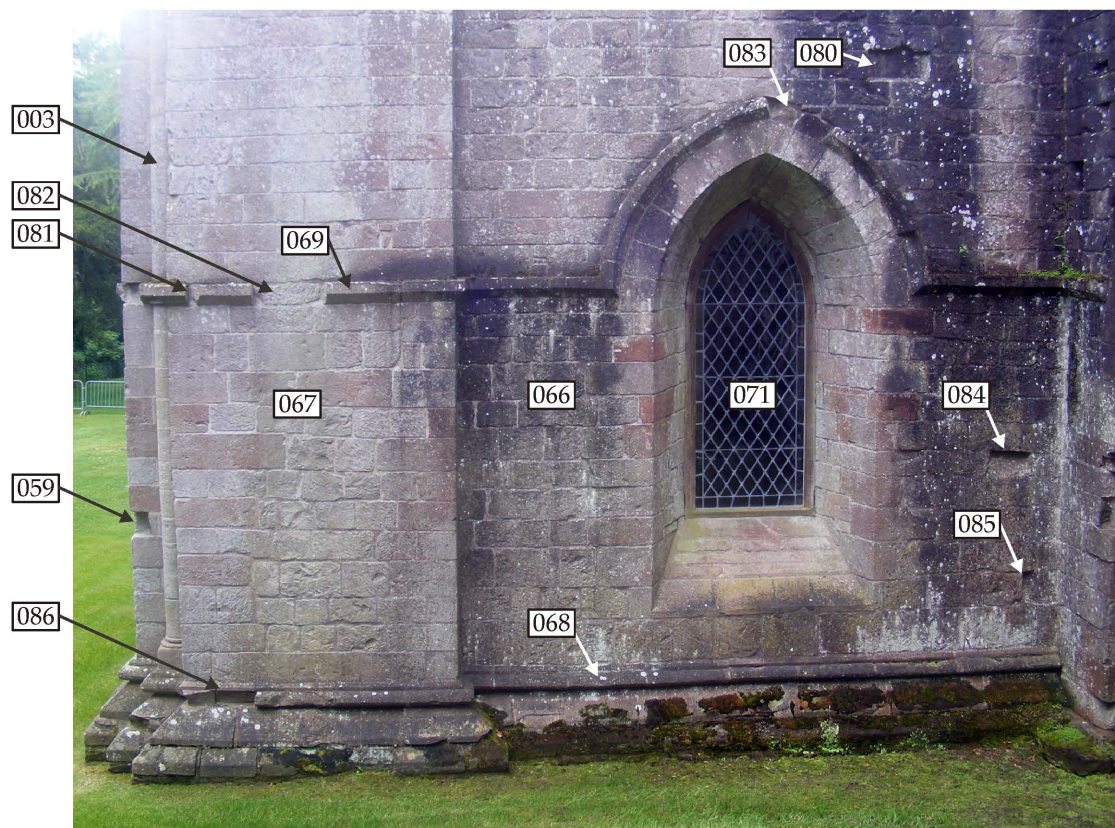
Most of the alterations noted on this side are found on the NE tower, and many of these are reflected in both the N and E face. At the bottom is **CH.059**, while above the upper wash course **CH.070** is the same sequence as noted on the E gable of four large holes **CH.061- CH.064** from top to bottom, with the same long, shallow but well cut vertical groove **CH.065** leading down from **CH.064**. The wash course

CH.070 has been trimmed back between **CH.064** and **CH.065** (numbered **CH.078**) over a substantial part of its length across the face of the tower. At the W end of **CH.065** is a unique feature, an apparent horizontal cut into the wall, mostly in filled by **CH.077**, to make it flush with the wall. Long thin horizontal projecting slabs have been added to top and bottom of **CH.077**. **CH.075** at the top runs the length of **CH.077** and projects only slightly, while **CH.076** at the bottom projects further, but is only found at the W end of **CH.077**.

Still within **CH.067**, the N face of the NE tower is **CH.079**, a long horizontal cut between wash courses **CH.069** and **CH.070**. There are two breaks in **CH.069** below **CH.079**, **CH.081** to the W being small and probably accidental, while **CH.082** is a larger cut that seems deliberate. At the base of the tower is a further area of damage, **CH.086** that has removed part of the base course moulding **CH.068**. This seems irregular enough that it has probably been caused accidentally.

On the N face is a further unique feature, running W from **CH.063**. This is the filled in slot **CH.077**, with its long thin projecting slabs **CH.075** and **CH.076** inserted at its top and bottom respectively. Below this is a large cut through wash course **CH.070** (**CH.078**), with a smaller one (**CH.082**) cut into the lower wash course **CH.069**. A single long cut (**CH.079**) has been made in the face of the NE tower between **CH.069** and **CH.070**.

The interpretation of these features in the NE tower is problematic. They do not seem to relate well to the features thought to be to do with the timber gallery on the E gable, however their depth and positioning seem to indicate that something substantial was carried round from the E to the N face. Although they may relate to an entirely separate episode, economy of hypothesis suggests that this gallery was carried at least part way round onto the N face of the Chapter House. This may have only been on the N face of the NE tower, as there is minimal evidence for alteration to the W of this on this side. The three holes noted at the W end of this wall (**CH.080**, **CH.084** and **CH.085**) are so shallow and so far removed from the NE tower that they seem unlikely to be related, they may in fact represent accidental damage.

Fig. 7 : N external elevation of Chapter House showing feature numbers
