Historic Scotland
Properties in Care
Minor Archaeological Works
2008

Biggar Gasworks
HS Index No.90322

Archaeological monitoring
February 2008

Site Biggar Gasworks
N.G.R NT 0388 3768
Project Description Archaeological monitoring

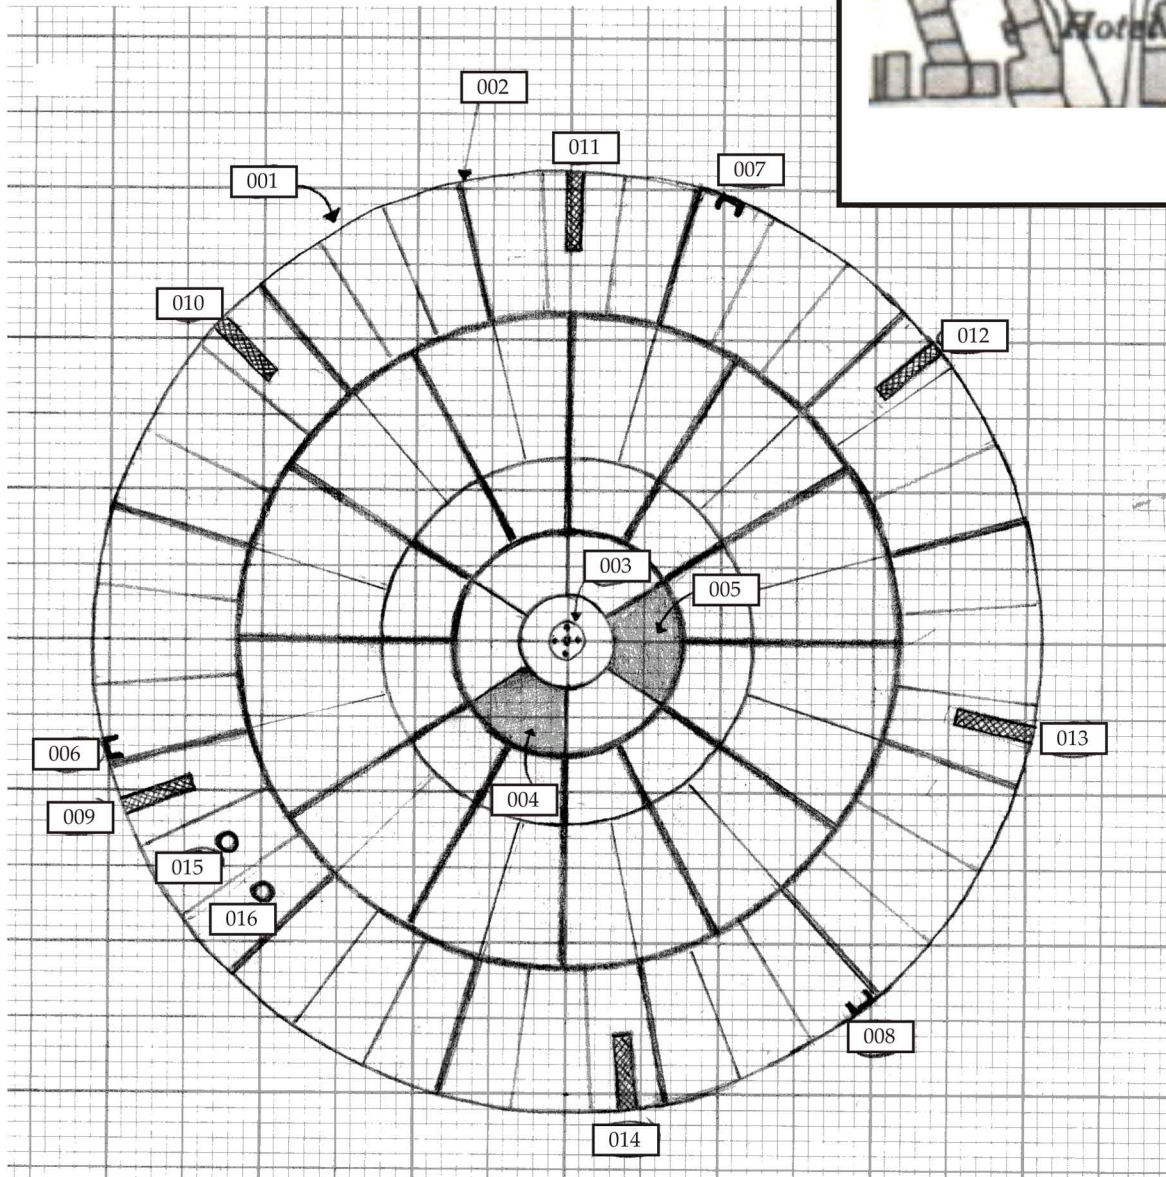
Fig. 1 : Plan showing base of tank (1:50)

The entire bottom of the tank is formed from radiating panels of iron riveted together along ridges forming the circular lattice like structure **002** observed at the initial draining of the semi-subterranean water tank. It consists of two thicknesses of iron ridges, distributed as shown in the plan. It is not clear why there are two thicknesses of ridge except that the thick ridges may form the basic layout and the

thin ridges were possibly secondary during construction. Two repairs are visible near the centre of **002**, these are two additional panels **004** and **005** bolted into the existing panel segments. A possible third repair is a disc of metal **003** bolted directly into the centre of **002**. There is a central upright iron projecting from **003**, it is not clear whether this is part of **003** or whether **003** fits around it. The purpose of this upright iron rod is unclear.

Around the edge of **001** and **002**, there are six equally spaced 'T' sectioned (or possibly 'I' sectioned) platforms **009-014**. They do not appear to be fixed to **001** or **002** hence the suggestion that they are 'I' sectioned even though the base is obscured by water and silt. These platforms probably support the base of the upper gas holder when it is empty.
