Stirling Castle
James V's Palace
Fireplaces

Fireplace Cleaning / Recording

SCPP 2008-1

Stirling Castle Palace
Collapsed Sash Window in the
Queen's Presence Chamber

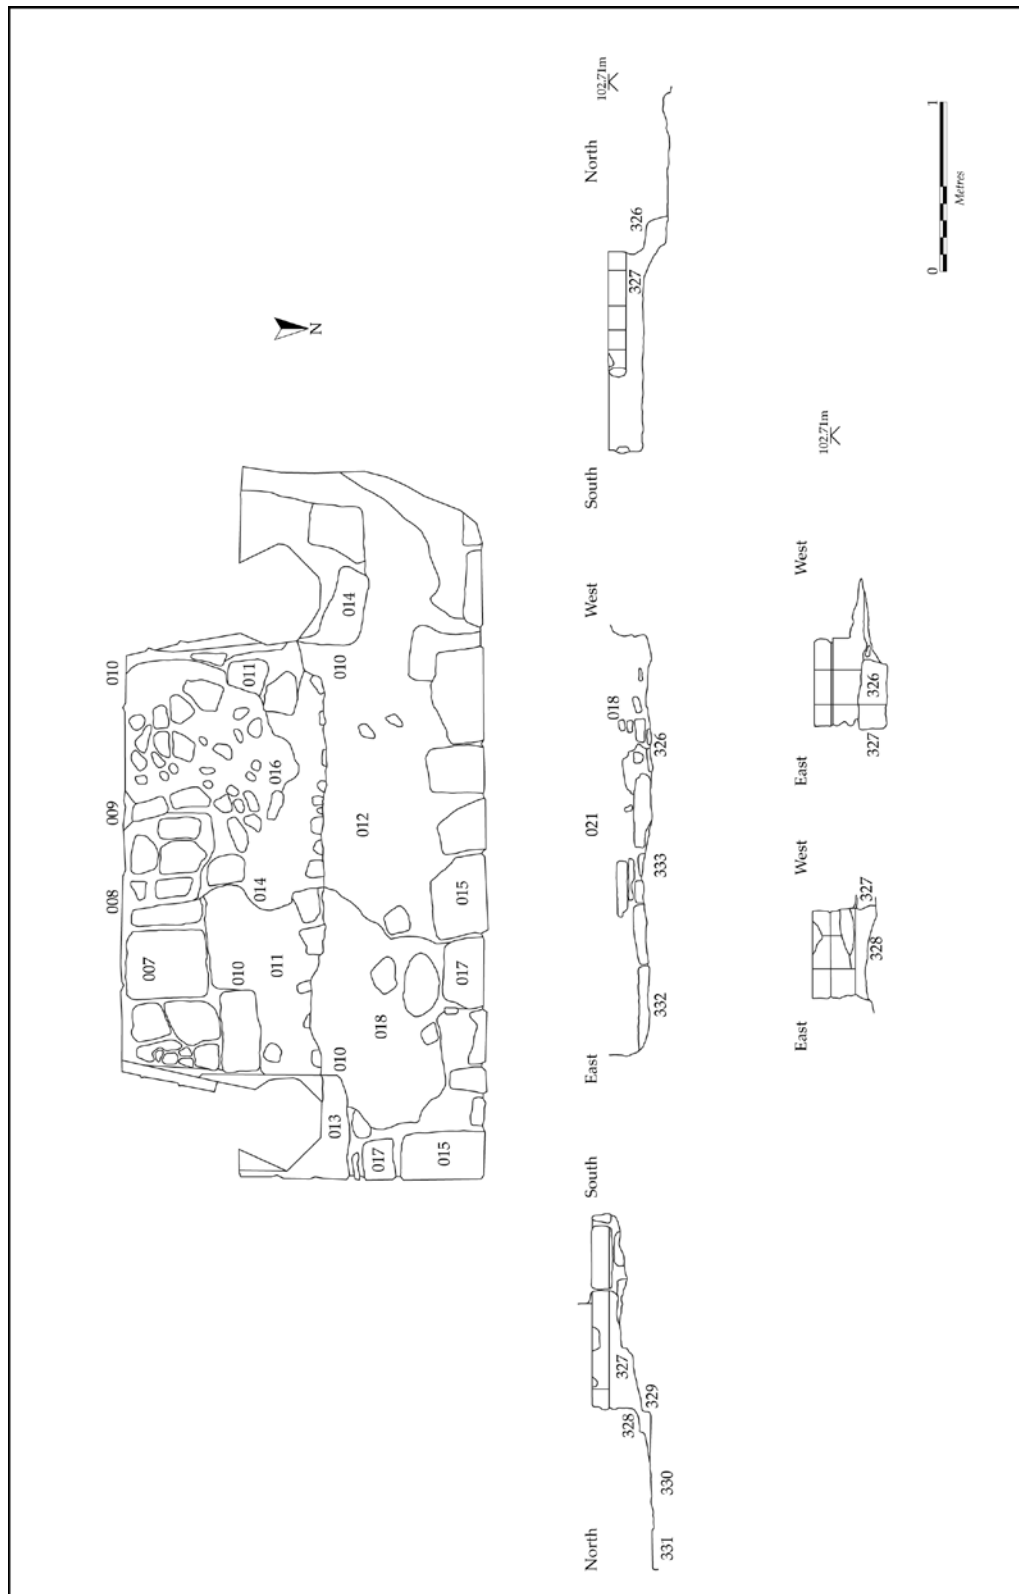
There were several original features noted within this fireplace (See Drg#1001). In the SE corner was **P02.5.007**, the remains of the yellow sandstone hearth slabs, generally rectangular in plan and up to 480 x 380 x 60mm thick. These slabs were carried on **P02.5.011**, a platform up to 100mm high of angular sandstone pieces up to 150mm across bonded in a whitish lime mortar. This layer formed the bedding for the inner hearth and was in turn carried on a layer of lime-mortared sandstone levelling **P02.5.018**, which together with original sandstone setting **P02.5.017** formed the bedding of the outer hearth. Other original elements noted were **P02.5.013** and **P02.5.014**, the yellow sandstone slabs supporting the bases of the E and W fireplace uprights respectively. All of these elements have been truncated by cut **P02.5.010**. There are 2 further phases within this fireplace that this cut could be attributable to- either army insertion of stoves –perhaps represented by brick setting **P02.5.009** or the insertion of the Caithness slate hearths in the later 20th century. In either case the cut seems radical, truncating and replacing more than 50% of the visible surface of the hearth. The clawing back of the sandstone bases of the E and W Reveals aligned with the fact that the clawing corresponds to the top level of the hearthstones suggests that much of the re-jigging work can be attributed to the insertion and bedding of the Caithness slabs. The installation of a brick base or back for a stove setting would be a far less intrusive process. This could perhaps explain why 600mm x 600mm brick setting **P02.5.009** (probably for a stove) sits within its own cut **P02.5.008**. Layers **P02.5.012** and **P02.5.016** could therefore be seen as redeposition of removed material in order to create the base for the later slabs.

Fireplace in P02 (The King's Guard Hall)

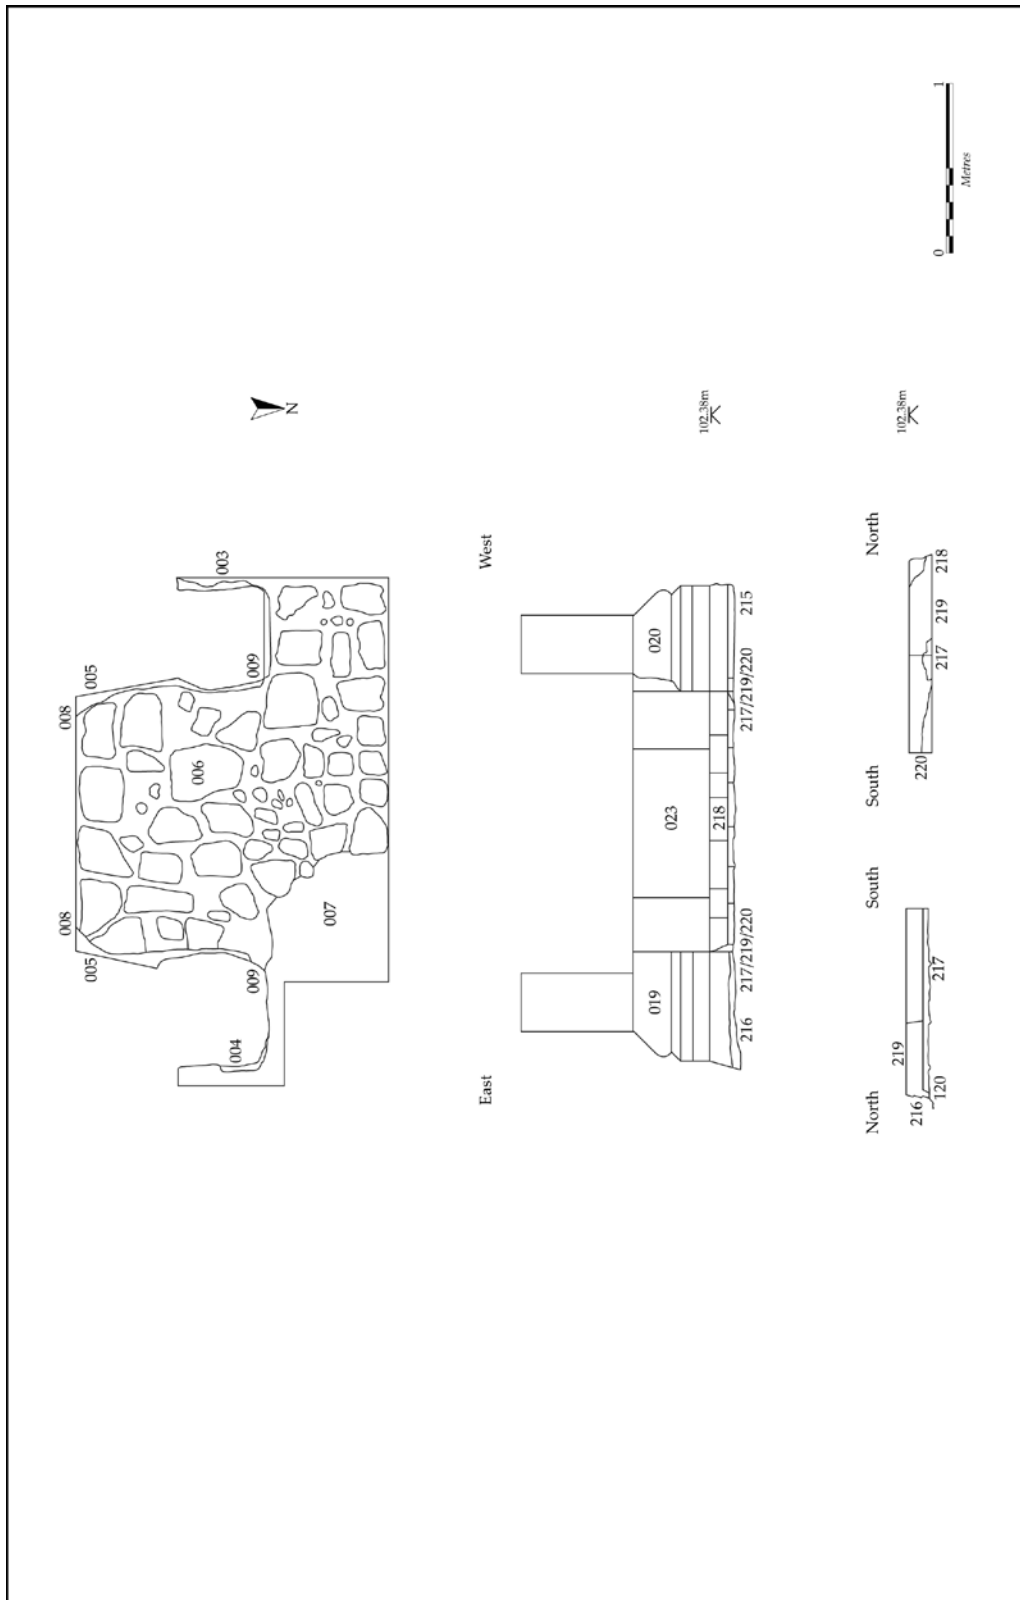
The original components of this fireplace are limited to the moulded bases, jambs, capitals and lintel. Below the moulded bases are W **P03.3.215** and E **P03.3.216** sandstone blocks, which would've formed part of the platform for the original hearthstones. The reveals and back of this fireplace have been completely refaced (the limit of this re-facing work is shown by the cusp between **P03.3.023** and **P03.3.218** on Drg#1000). The brick course **P03.3.218** carrying the inserted flat dressed ashlar **P03.3.023** shows the level at which the Caithness slabs would've sat. In order to insert the Caithness slabs, Cut **P03.3.219** cut back **P03.3.215** and **P03.3.216**. The laying of base **P03.5.006** (See Drg#1009) and the re-sleeving of the Reveals and Fireback appear to be contemporary with the insertion of the Caithness slabs. **P03.3.217** and **P03.3.220** are the cement remains of the Caithness slabs and the recent cut through them respectively. Little observation could therefore be made about the original form of the hearth. This may have had a stepped hearth like P02 but the current base is at a uniform height.

Fireplace in P03 (The King's Presence Chamber)

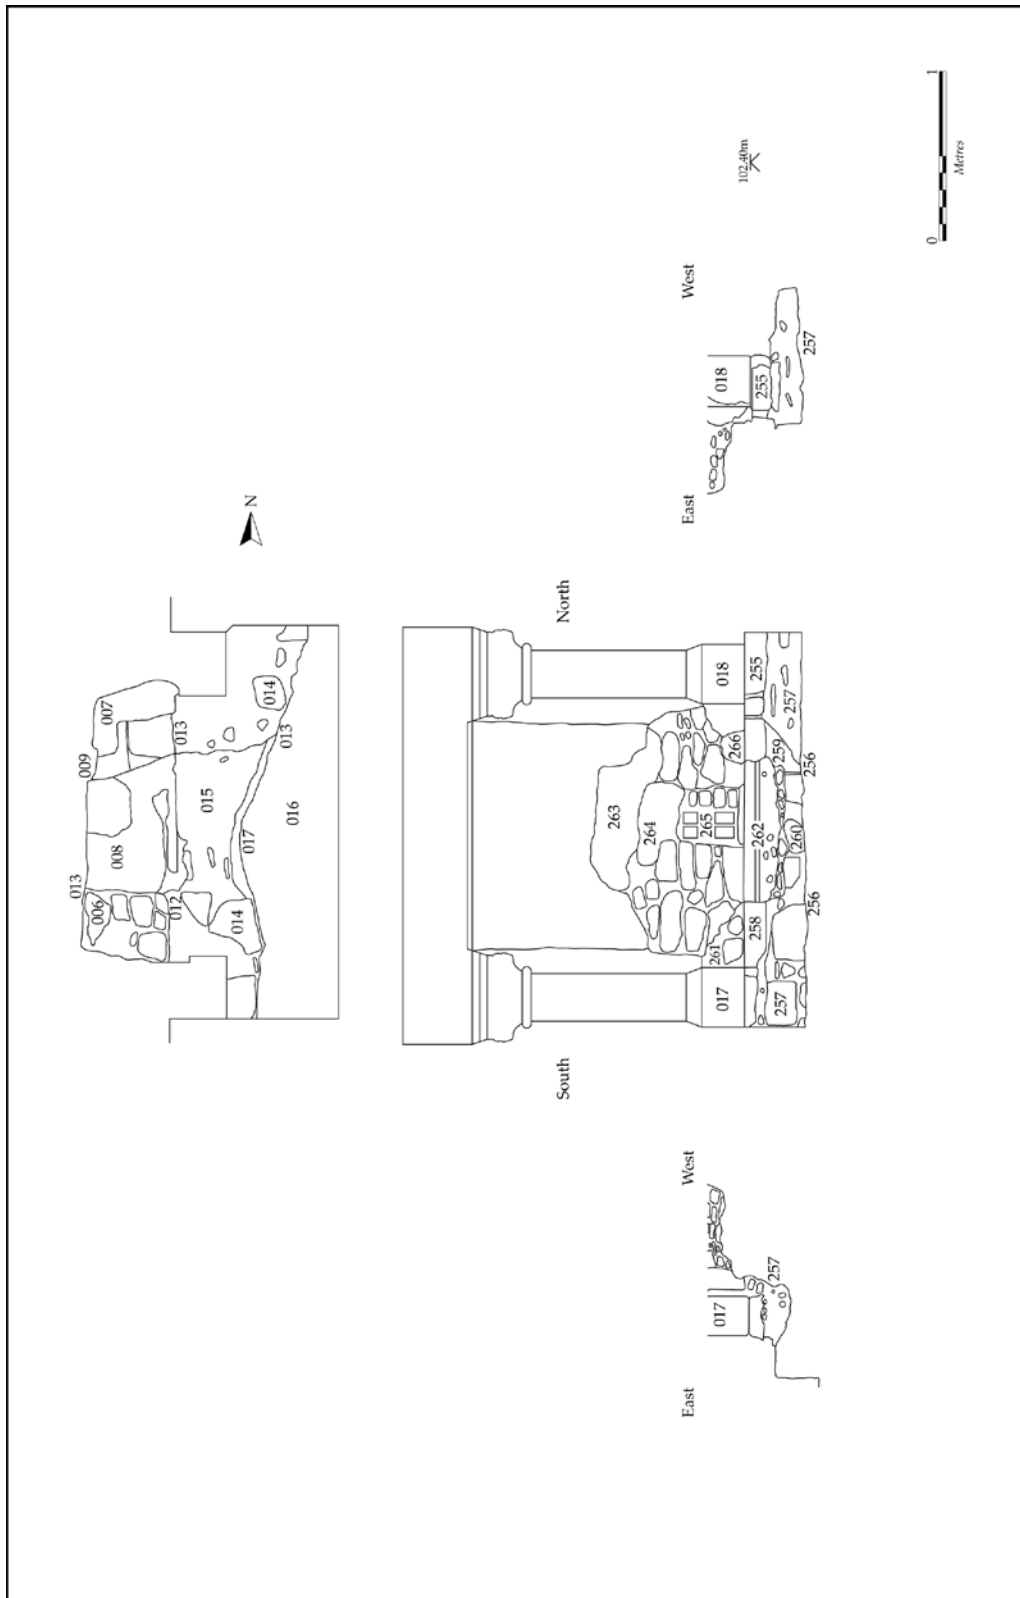
This fireplace shows an interesting development over time. After cleaning it became apparent that this fireplace was cut through a surface to the E. This was **P04.5.016**, a flat surface of dark orange brown sand with a greyish trampled surface strewn with bone. The fireplace itself appeared to be cut into this surface via a relatively amorphous cut **P04.5.012** (See Drg#1013). The sandy trampled surface seems likely to have been some form of original working platform levelled over the crown of the barrel-vaulted undercroft below. A platform of sandstone rubble bonded in whitish yellow lime mortar was emplaced into the cut to provide the base for the hearthstones and the bases of the S and N jambs. Relics of the original hearthstones 120mm high x up to 400mm across can be seen to the SW **P04.5.012** and NW **P04.5.009** corners of the fireplace (See Drg#1013). It appears that the truncation of these

original features by **P04.5.013** was carried out to insert the concrete base for an army period stove (removed)- the outer hearth may have been emplaced at the same time. **P04.5.015** represents the redeposition of the excavated material to provide the platform for this modification. This is a loose greyish brown mixture of brick fragments, sub-rounded and sub angular stones and wood fragments within a dusty matrix. Contemporary with the insertion of the army stove was a shortening of the sides through **P04.4.261** and **P04.4.266** (mortared randomly shaped pieces of sandstone rubble) as well as the filling of the heat damaged fire-back **P04.4.263** with **P04.4.264** (mortared randomly shaped pieces of sandstone rubble) and a central brick stove setting **P04.4.265** 400mm high x 360mm across (See Drg#1012)

Fireplace in P04 (The King's Bedchamber)

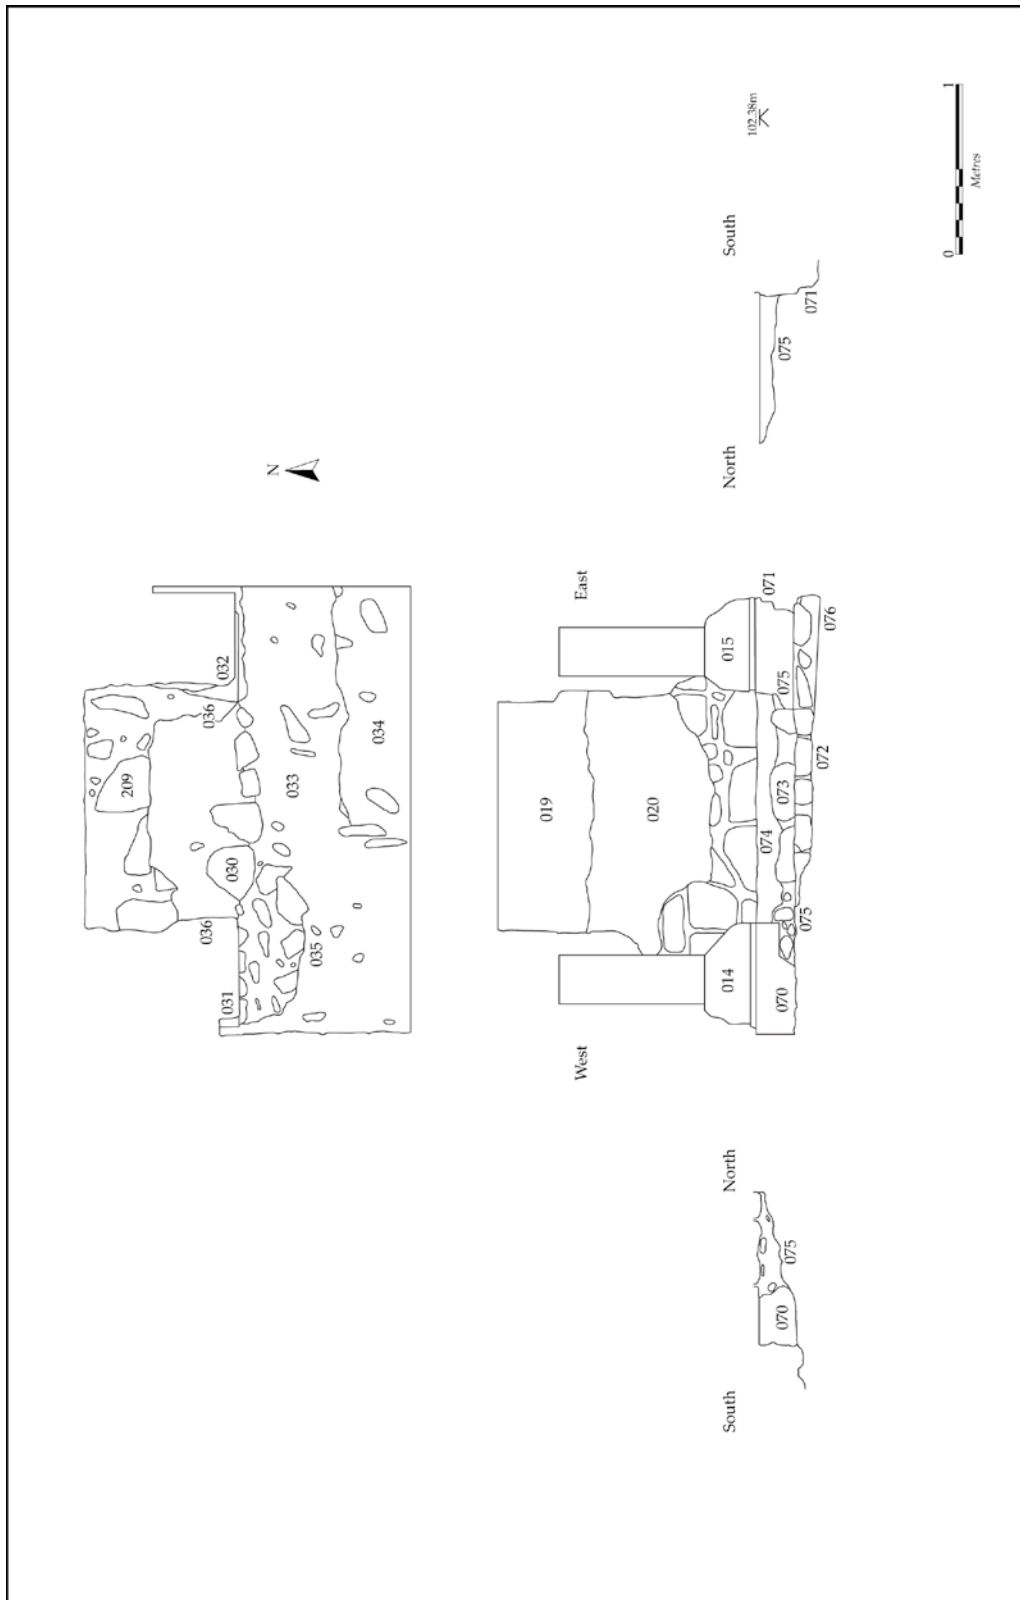
This fireplace is of similar dimensions to that in the King's Bedchamber but has had many of its original features truncated. There is no evidence of an army period stove within the fireplace, although this could potentially have been removed prior to the insertion of the Caithness slabs. The fireplace is formed over a lime-mortared setting of sandstone blocks **P07.5.029**, forming the base platform for the upright bases **P07.5.031** (W) and **P07.5.032** (E) (See Drg#1014). These are up to 220mm thick and have been truncated internally by cut **P07.5.036**. Also truncated by this cut is the remains of the original hearthstone levelling material **P07.5.029**. This is a further layer of lime-mortared sandstone pieces up to 300mm across. To the S of stone setting is **P07.5.033**, a layer of mid-brown mortar-rich, sandy material containing lots of sandstone fragments. This appears to be the primary levelling after the insertion of the fireplace. Later patches of secondary levelling **P07.5.034** and **P07.5.035** are perhaps associated with the insertion of the Caithness slabs- there is no evidence that there was an outer heart here originally. Cut **P07.5.036** truncated many of the original hearth features to emplace the later Caithness slabs.

Fireplace in P07 (The Queen's Bedchamber)

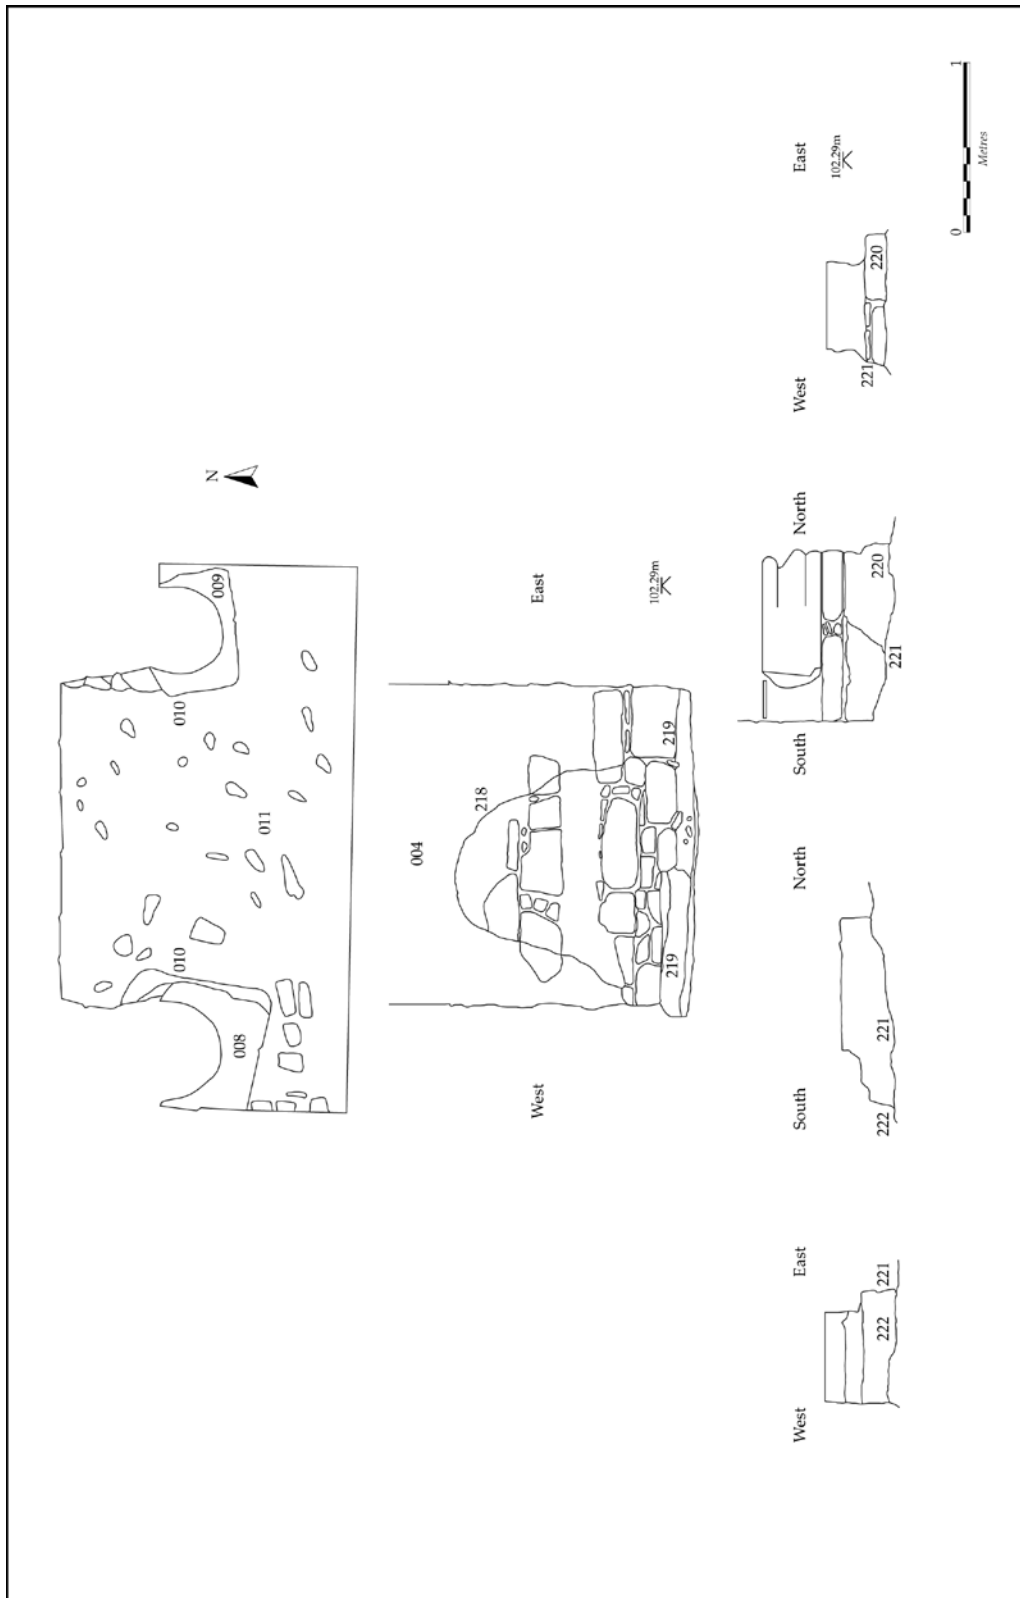
Very little remains of the original hearth of this fireplace. The bases of the moulded jambs are carried to the W **P09.5.008** and E **P09.5.009** by large sandstone slabs up to 220mm thick. These would have formed part of the original base course to hold the hearthstones but these have been truncated by Cut **P09.5.010**, which has also removed all of the original central features and obliterated any evidence of an outer hearth. The base is now formed by **P09.5.011**, a redeposited mixture of red and yellow bricks, sandstone pieces and smashed slate within a matrix of ash and mortar.

Fireplace in P09 (The Queen's Presence Chamber)

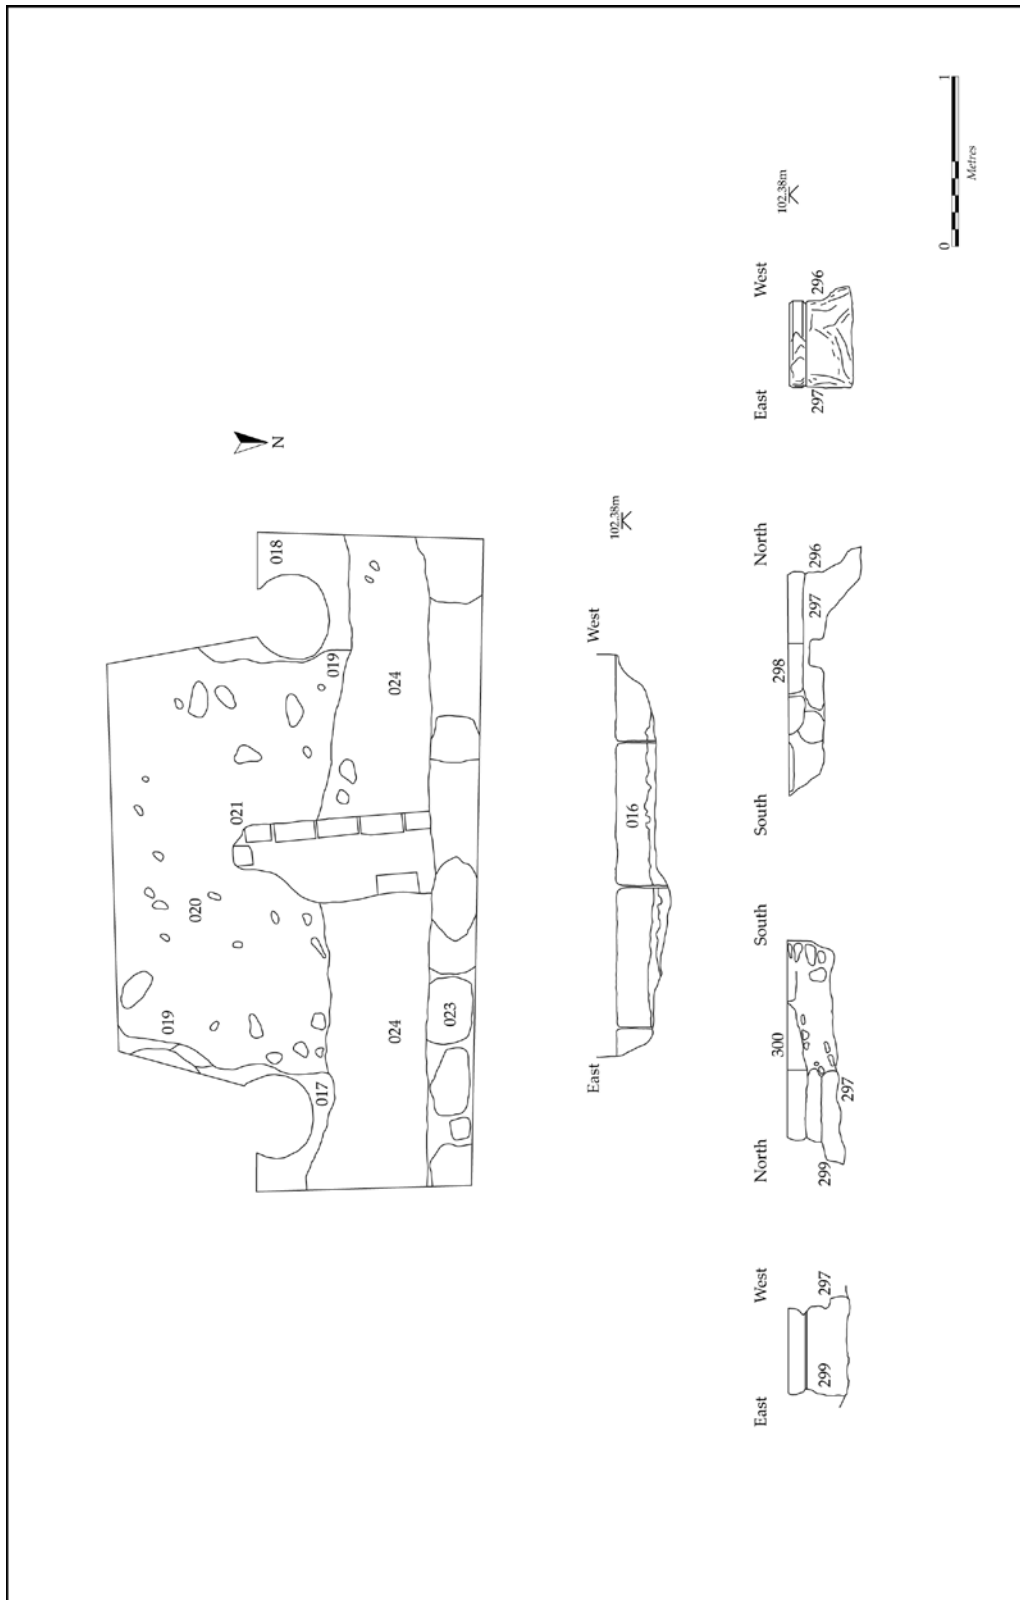
Original features include the sandstone base slabs underneath the E and W uprights **P11.5.017** and **P11.5.018** respectively and the reduced base platform **P11.5.020** which would've held the original hearthstones. These have been truncated by cut **P11.5.019**. This is a characteristically clawed cut to reduce original masonry to emplace the later Caithness slabs. It also appears that the insertion of the outer hearth represented by stone setting **P11.5.023** and redeposited backfill **P11.5.024** is contemporary with the insertion of the Caithness slabs. Both of these deposits correspond to the inserted layers **P02.5.012** and **P02.5.015** in the King's Guard Chamber. Rather more enigmatic is the rectangular brick setting sitting centrally W of **P11.5.023** (See Drg# 1024). This is either some form of stove setting pre-dating the insertion of the outer hearth or relates directly to the insertion of the Caithness slabs in which case it could be a central support for a 2-part arrangement of later Caithness slabs.

Fireplace in P11 (The Queen's Guard Hall)

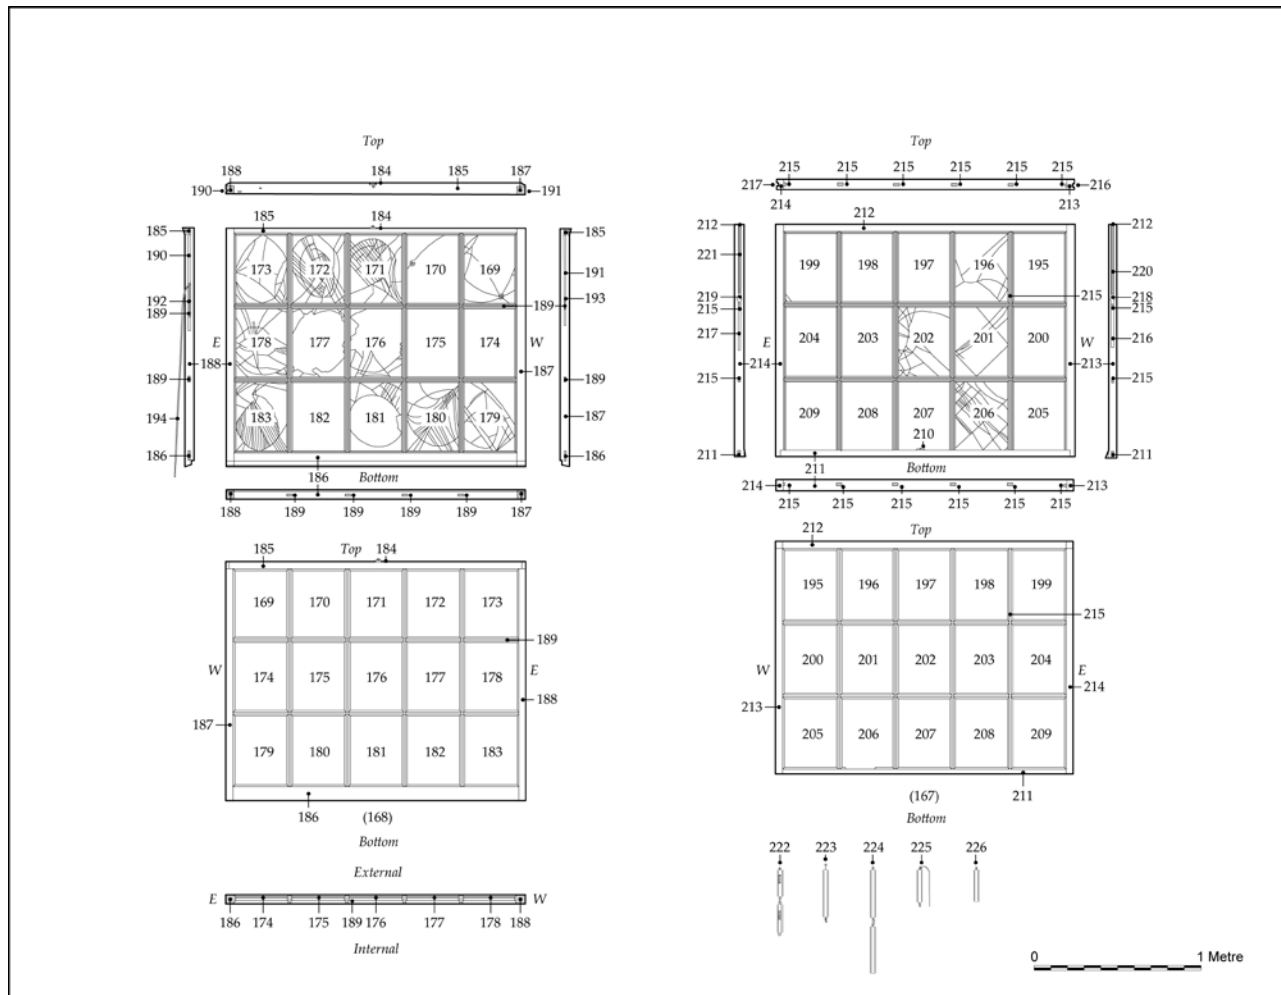
Figure 2: Drawings 11 to 16 (see Appendix 2 for descriptions of individual drawings)

Looking at the pattern of the damage suggests the top left hand of the internal elevation of the sash case took the impact. This infers that a combination of strong winds and the degraded dried-out putty put pressure on the E bracket which burst out allowing the E side of the window to swing inwards, pivoting on the one remaining bracket to the W which broke out allowing the window to fall forward onto its top E corner. This smashed 12 of the 15 window panes of the lower sash and 5 of the 15 panes of the upper sash. The panes of the upper and lower sashes had been covered by protective sheets of polycarbonate film so that although much of the glass was cracked, it still stayed in place. The wooden frames and window bars of the sashes escaped relatively unscathed – only a small section of window bar (beneath pane P09.3.206, Fig. 2 [Drawing 15]) became detached and is now lost.

Despite the fall from the aperture, the sash and case window survived considerably well. Because of the relatively late date of the window c.1900, it contained modern glass and not the irreplaceable hand made glass found in the earlier windows. The moulded astragals can be removed and the panes replaced and re-puttied. The damaged timber elements are simple to repair and their positions are indicated on the accompanying drawings. Of more concern is the method by which it is put back and fixed into its aperture and indeed a wider concern about the relative stability of the other principal level windows within the Palace. When this window was installed it was held on by only 2 brackets which is insufficient for a window of these dimensions. The drying out of the putty in combination with severe weather forced the window from its aperture. A far more robust fixing system is required to ensure that this doesn't happen again in future.
