Archaeological Watching Brief

Heacham River Resoration at At Caley Mill, Heacham

**Heather Wallis
March 2014
HW Report No. 142**

Project name	Heacham River Restoration, Heacham Mill
Client	Norfolk Rivers Trust
NHER Event No	ENF 133680
Grid reference	TF 6855 3748
Date of fieldwork	3rd March 2014

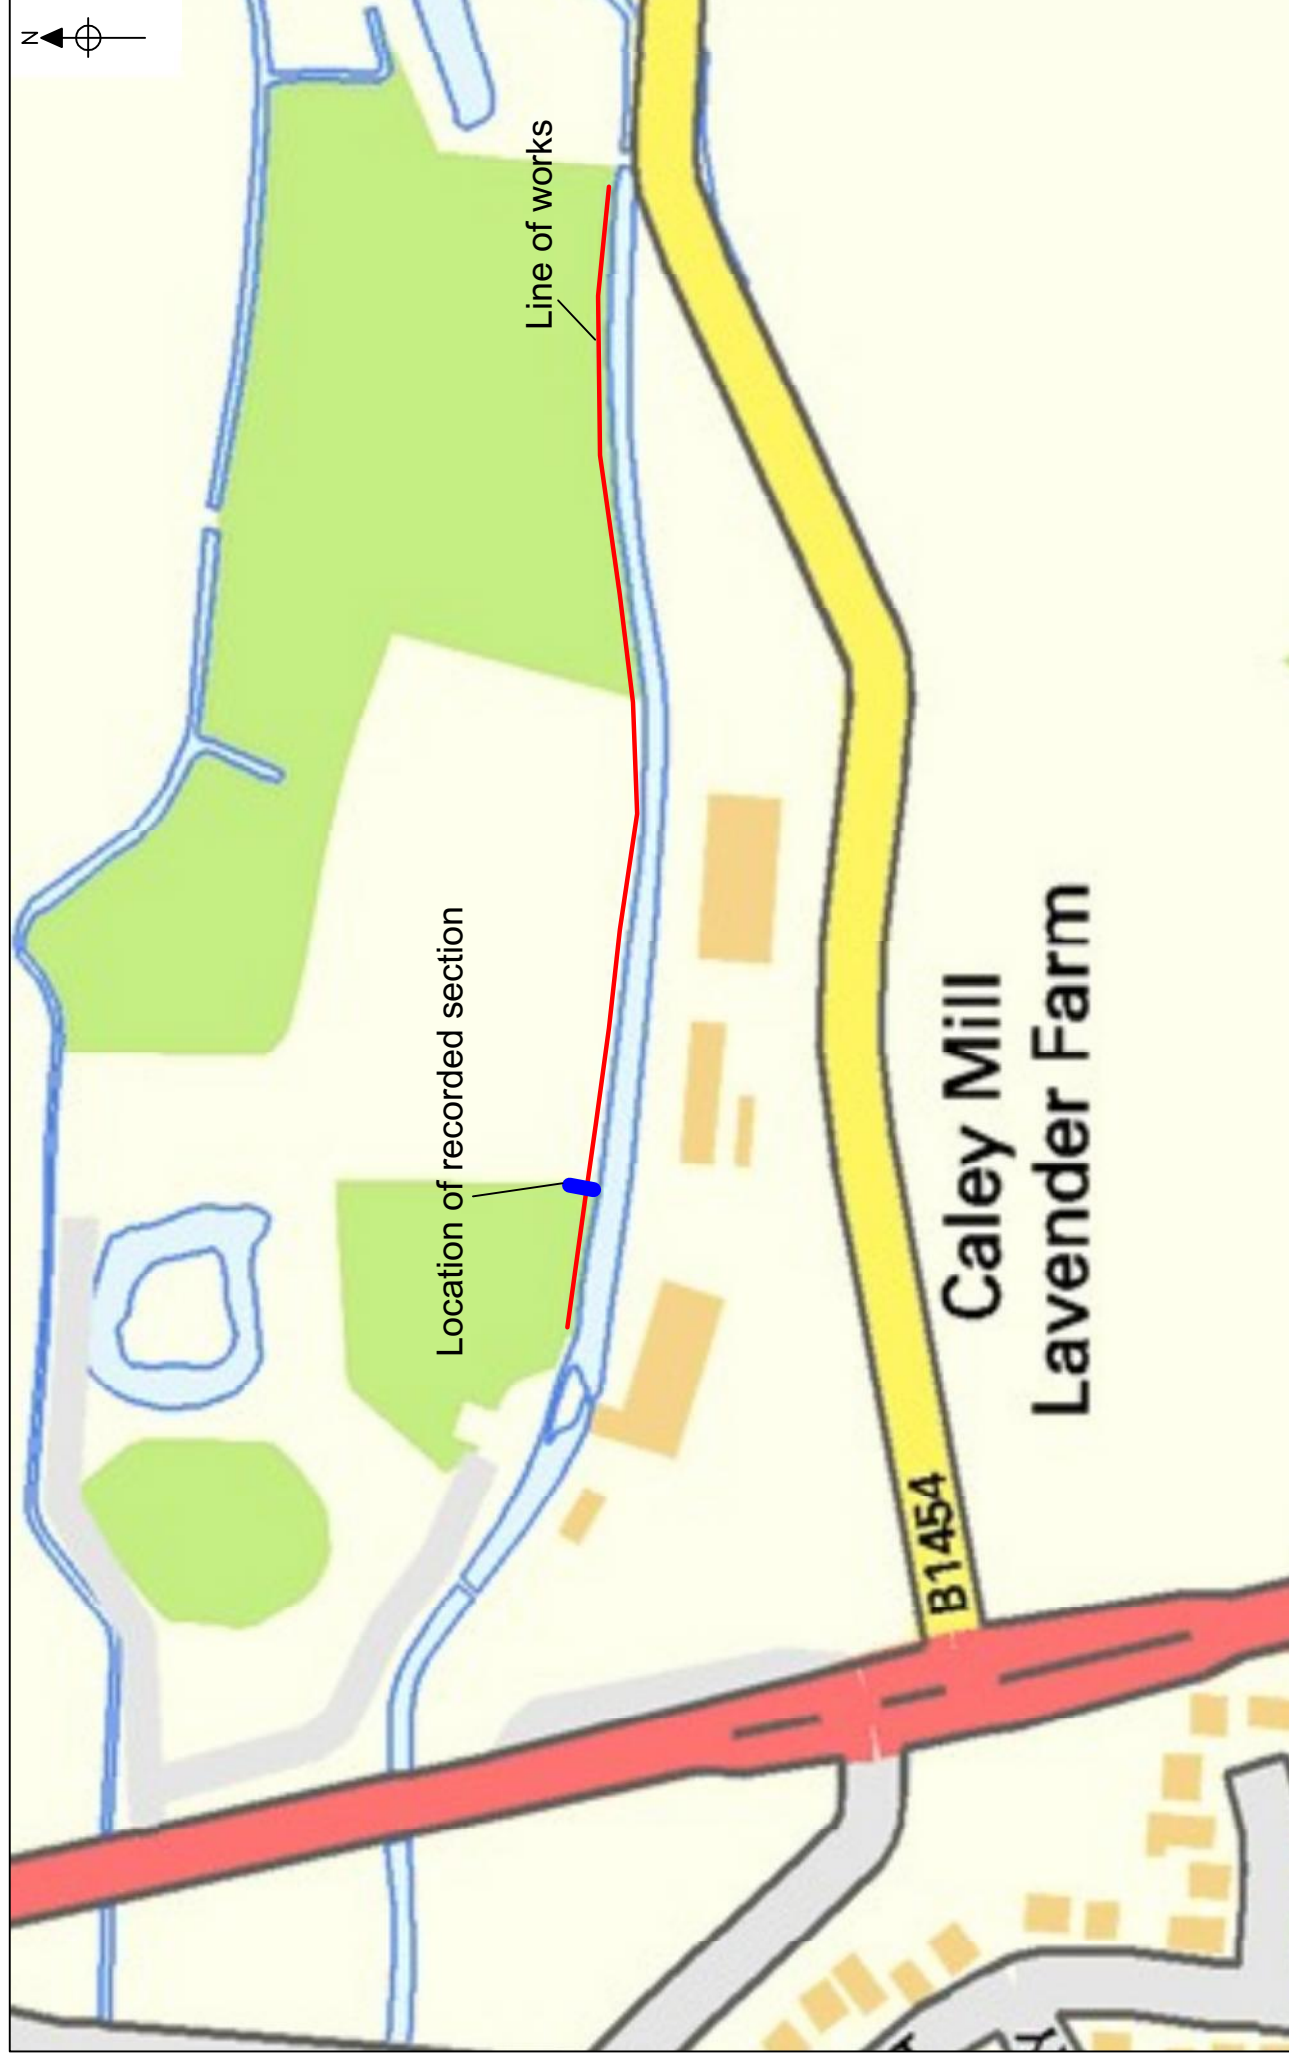
Figure 2. Plan showing line of works and location of recorded section.

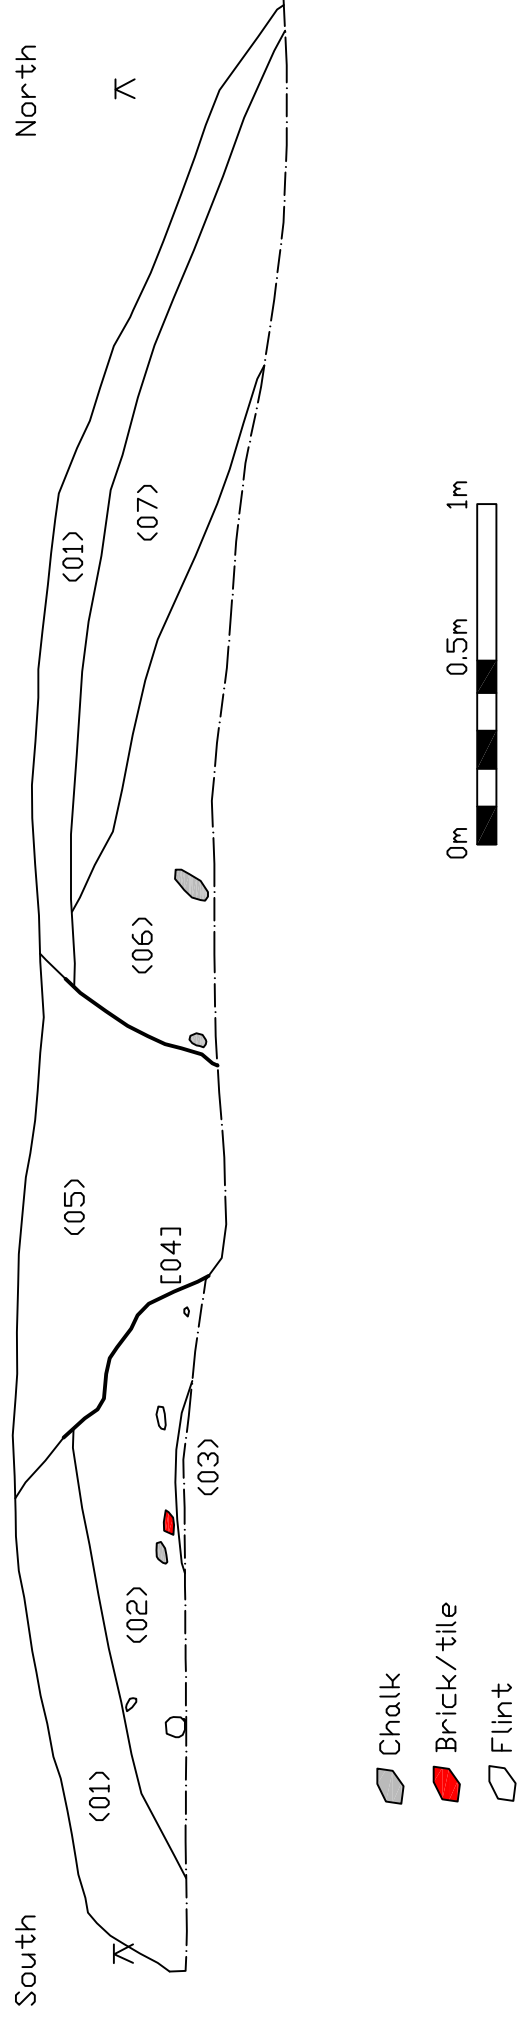
Figure 3. East facing section through bank.

The maximum depth of soils recorded was 0.65m and removed only the upper deposits of the bank. The lowest deposit revealed was a mid orange silty sand with moderate chalk flecks and occasional flint (03). This was only noted in a small area towards the leat side of the bank and is firmer than the overlying deposits. Above this lay a dark yellow brown slightly clayey silt with occasional chalk fragments, lumps of grey clay, brick/tile fragments and flints (02). To the north, and probably overlying this was a deposit of pale yellow brown clayey silt with occasional chalk lump (06). Above this on the north side of the bank was a deposit of crumbly light yellow brown clay/silt loam (07). The topsoil across the bank was a dark brown, inclusion free, silt (01). Cutting through the bank was a modern trench carrying an electricity cable (**04**). The cut for this was difficult to identify with certainty as the fill (05) was similar to, but slightly more mixed than the surrounding deposits. No artefacts were recovered.

Overall the excavations were not deep enough to reveal the core of the post-medieval leat bank. The recorded deposits formed the upper layers of the bank and were surprisingly soft and uncompacted in nature.

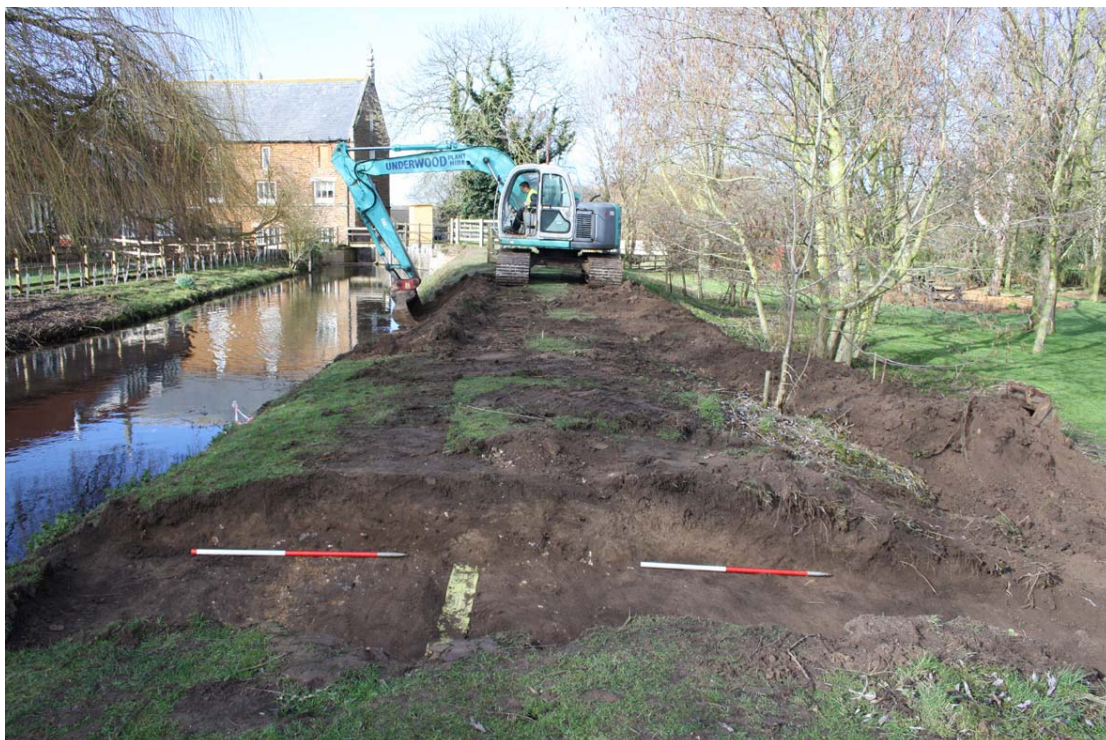
Plate 1. Work in progress. Recorded section in foreground.
Scale 2x1m, looking North.
