**Priory Farm
Hickling**

**Monitoring of Works under Archaeological
Supervision and Control**

ENF 146350

**Heather Wallis
November 2019**

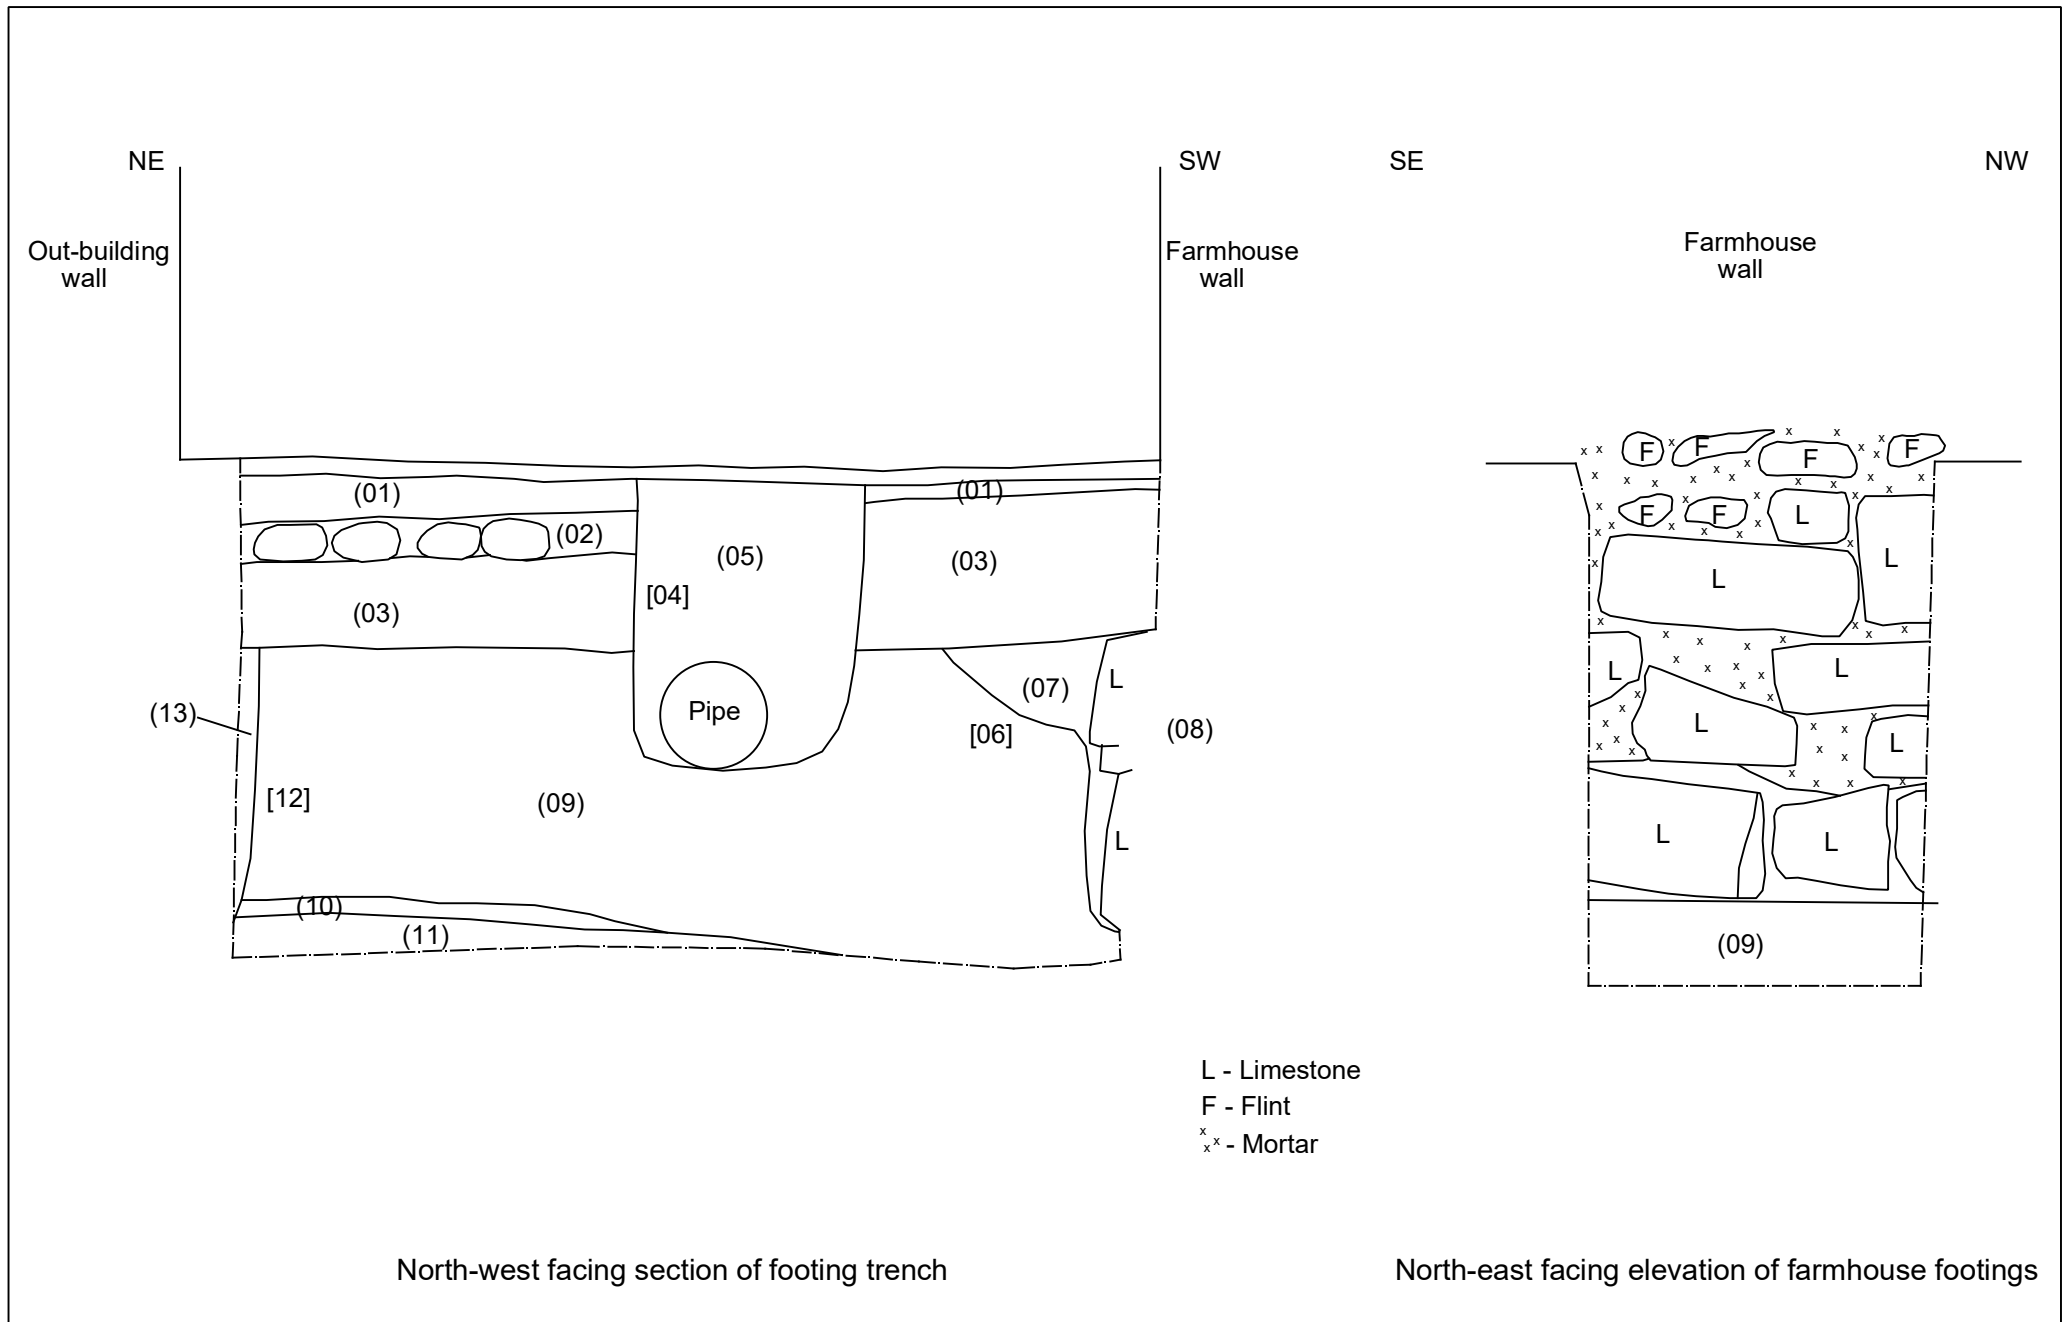
Figure 3. Sections of footing trench. Scale 1:10.

The lowest deposit revealed in the footing trench was a light brownish yellow sandy clay (11) above which was a thin deposit of uncompacted creamy mortar (10) which was probably a spread of demolition debris. Over this was c.0.35m of light orange brown sandy clay (09). This was soft and malleable and included occasional fragments of animal bone, mortar flecks and oyster shell. It is likely to represent a build up of material during the early post-medieval periods. The foundation trenches for the outbuilding and farmhouse cut through this deposit.

The footing trench (12) for the outbuilding was vertical sided and only seen in the edge of the trench. It contained large fragments of redbrick in a light brownish orange very sandy clay (13).

The lower part of the footing trench (06) for the farmhouse was almost vertical but flared outwards towards its upper edge. Within this, the footings (08) of the farmhouse were revealed and seen to be made up of limestone ashlar pieces reused from the Priory buildings. Some of these pieces still had remnants of mortar from their original medieval use adhering; this was a soft creamy lime mortar. The limestone making up the footing was roughly coursed. Packed between the lowest course was light brown sandy clay while the upper courses were infilled with a gravelly lime mortar. Above the limestone footing was the flint and mortar work which forms the visible wall of the farmhouse. The footing cut had been backfilled with sandy clay (07).

Sealing both footing trenches was a deposit of dark greyish brown clayey loam (03) with mortar, chalk and brick fleck inclusions. This is likely to be a deliberate raising of the ground level following construction of the buildings. Above this in the north-east part of the trench was a cobbled surface (02). The modern topsoil (01) sealed all deposits but was cut by a modern drainage trench (04) containing a ceramic pipe. This was backfilled with a dark grey brown sandy silt clay (05). A thin modern gravel surface lay across the whole area.

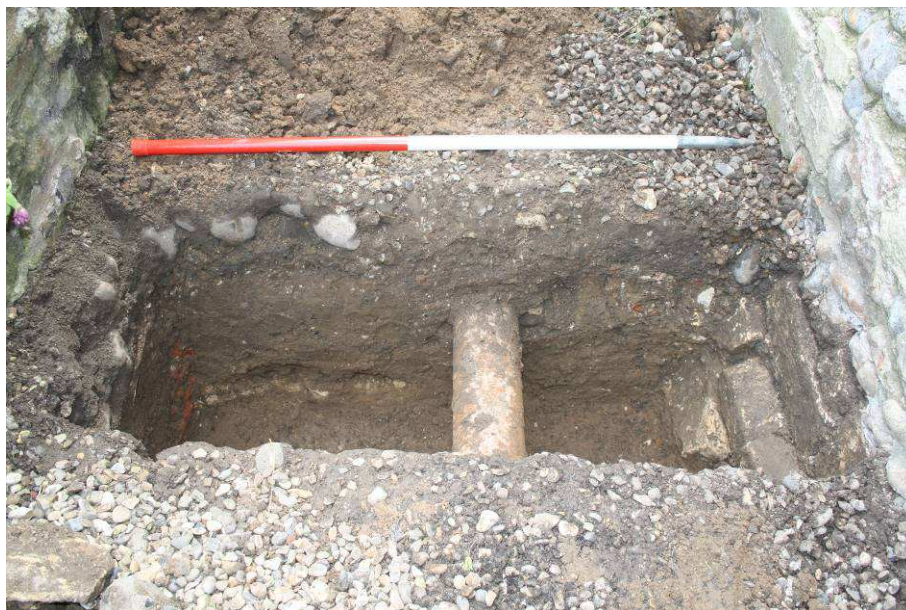
Plate 2. Trench section, looking south-east

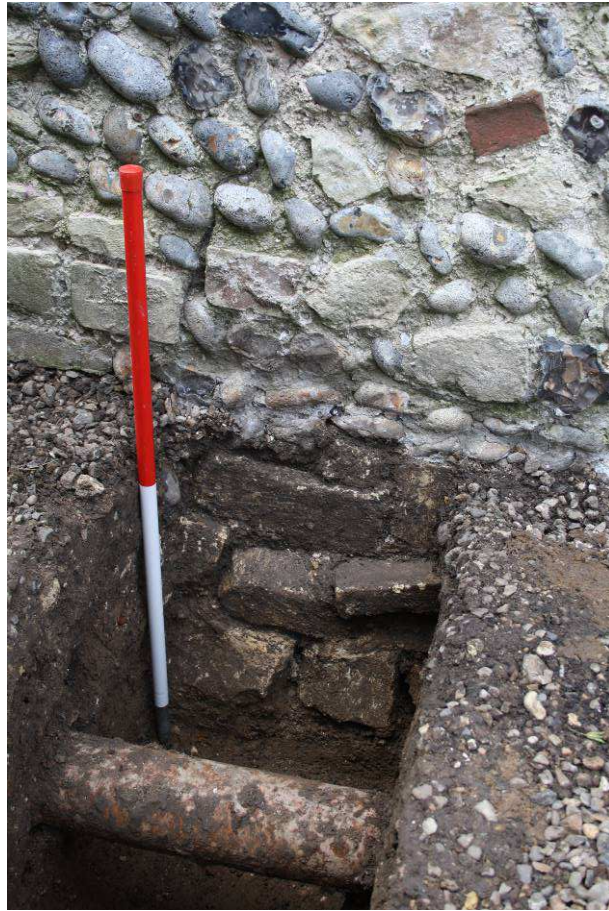
Plate 3. Footing of farmhouse, looking south-west.

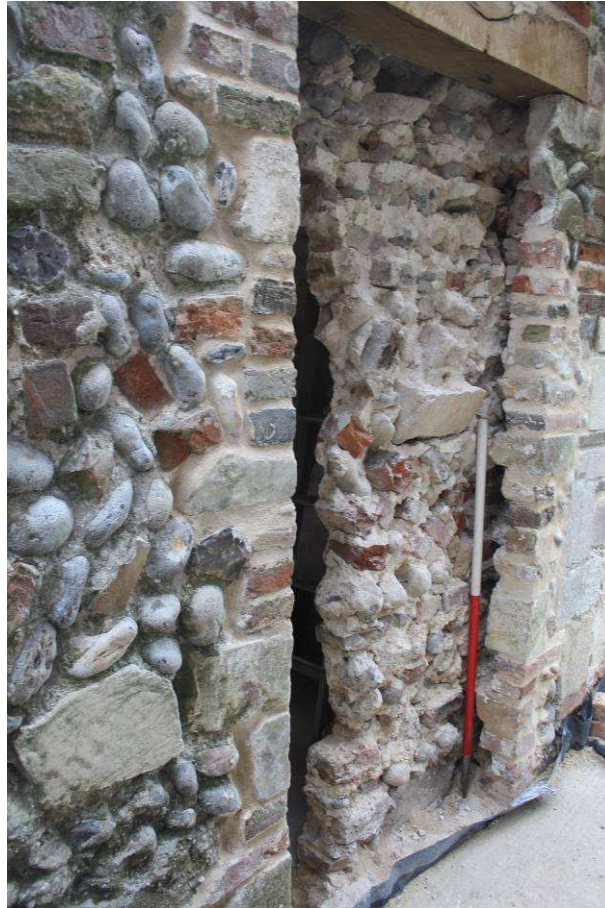
The building material removed from the outbuilding in order to create a new doorway was assessed. The vast majority of this was flint although a number of pieces of reused limestone was also present. These limestone pieces originated from the priory buildings but were mainly fragmentary without moulded features. Most of the limestone has been reused to form the jambs for the new doorway.

Plate 4. New doorway in outbuilding partially opened and new jamb (by ranging rod) partly built with re-used materials. Looking south-east.

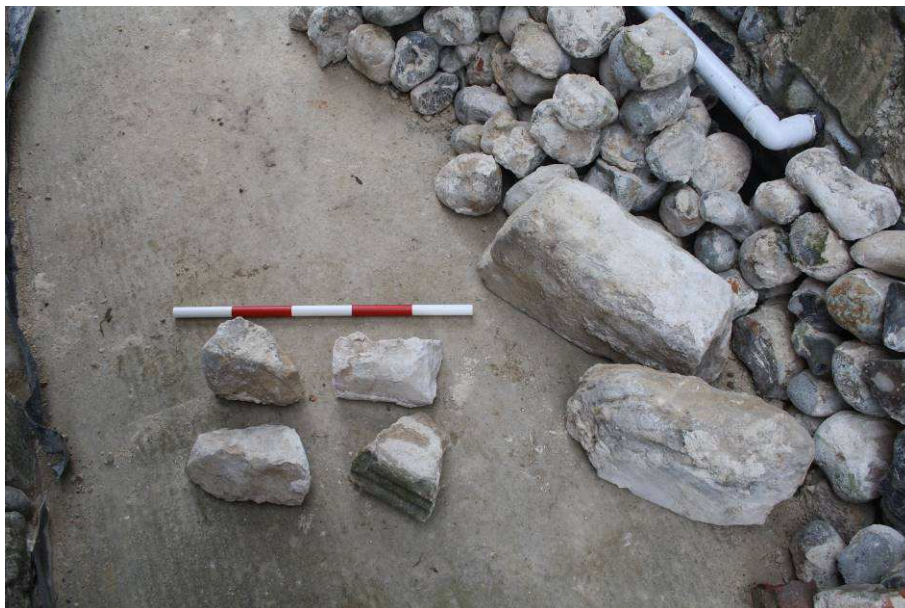
Plate 5. Other limestone pieces from outbuilding wall.
