**A Photographic Survey.
Grange Farm
Horton's Lane
Whissendine
Rutland.
(NGR SK 83095 14009)**

On Behalf of Rutland Building Services

ABRS Report No 2016-GFWR

August 2016

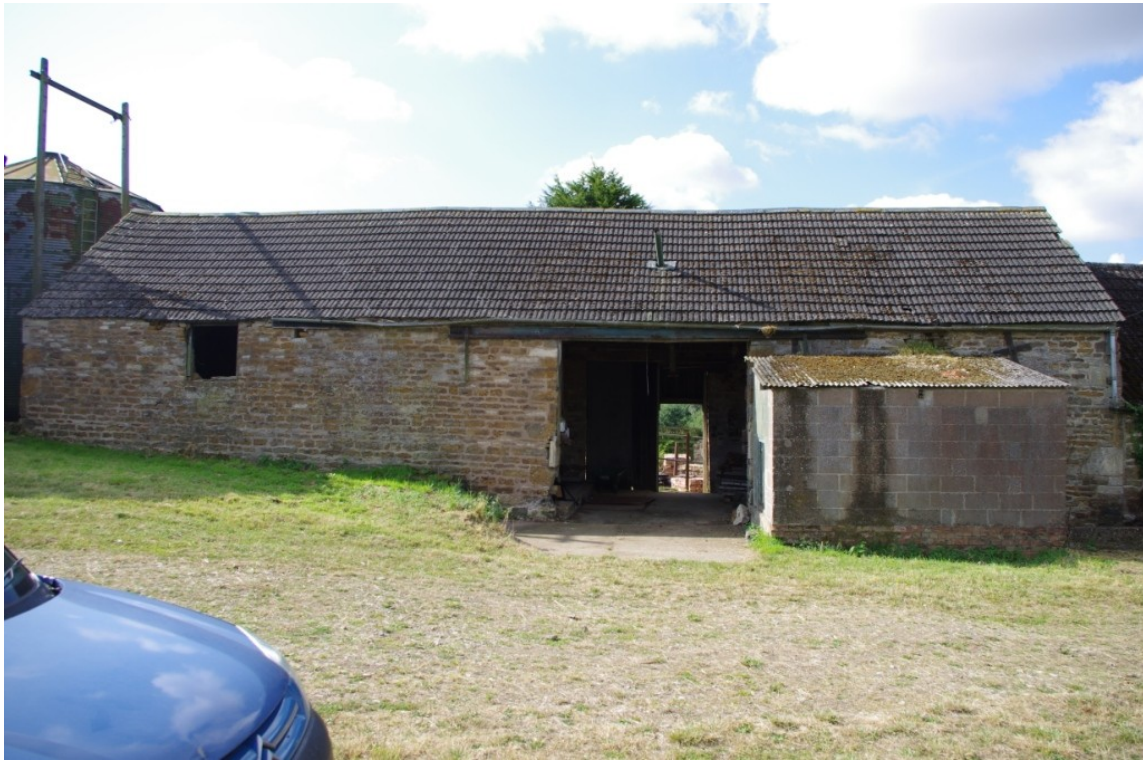
Building A is linear, stone-built in local roughly squared and coursed stone under a modern cement tile roof consisting of two bays, the easternmost being the taller of the two (*Figures 3 & 4*). There are off centre threshing doors with quoined reveals, with an attempt at a polychrome pattern (*Figure 5*) on each long elevation as well as a pitching door on the eastern end of the northern elevation as well as arrow slit vents on each elevation. There is small pedestrian door on the eastern most gable as well as evidence of a demolished building. As well as the threshing door, there are two pedestrian doors and a window on the south facing elevation. The window is original with timber “hit and miss” ventilation slots.

Figure 3
A, North Facing Elevation, East End (Looking South).

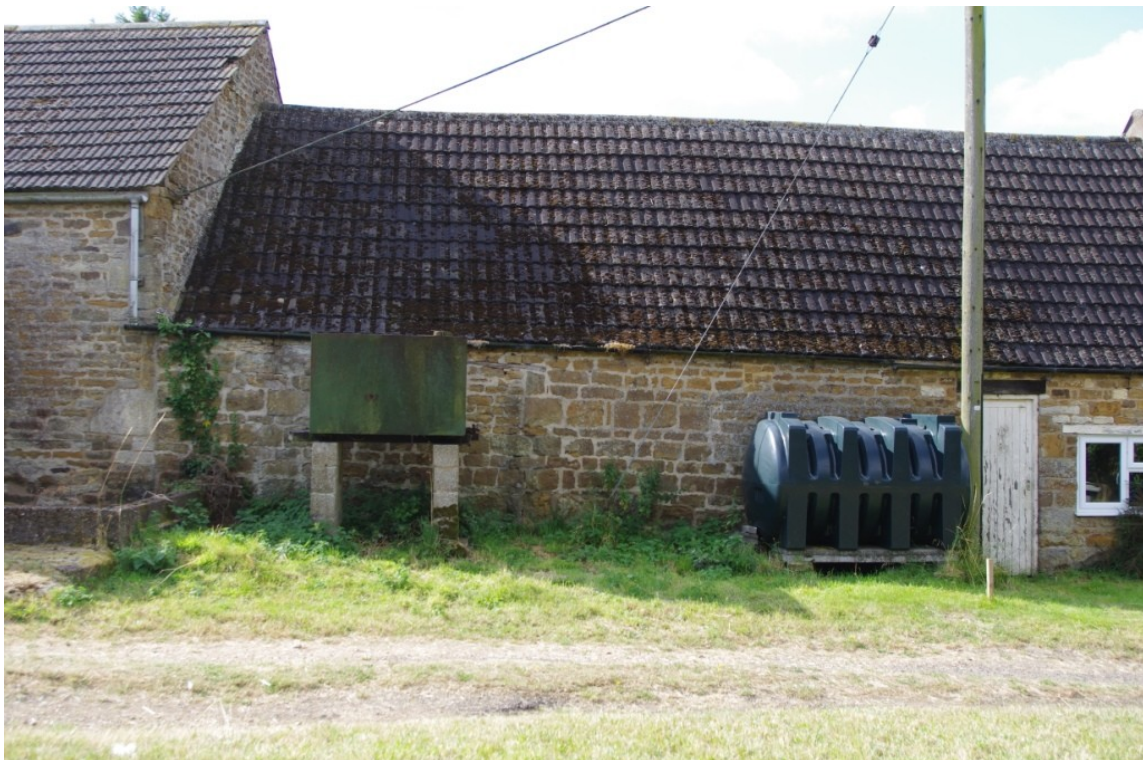
Figure 4
A, North Facing Elevation, West End (Looking South).

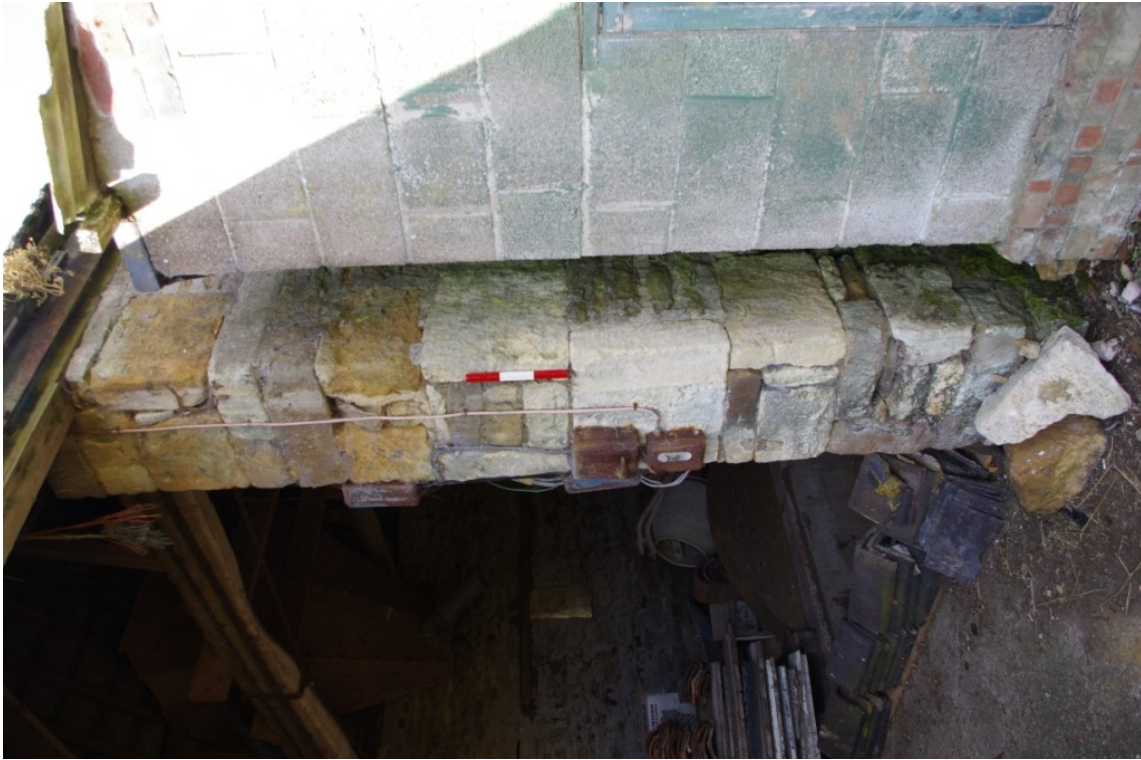
Figure 5
A Polychrome Threshing Door Quoins.

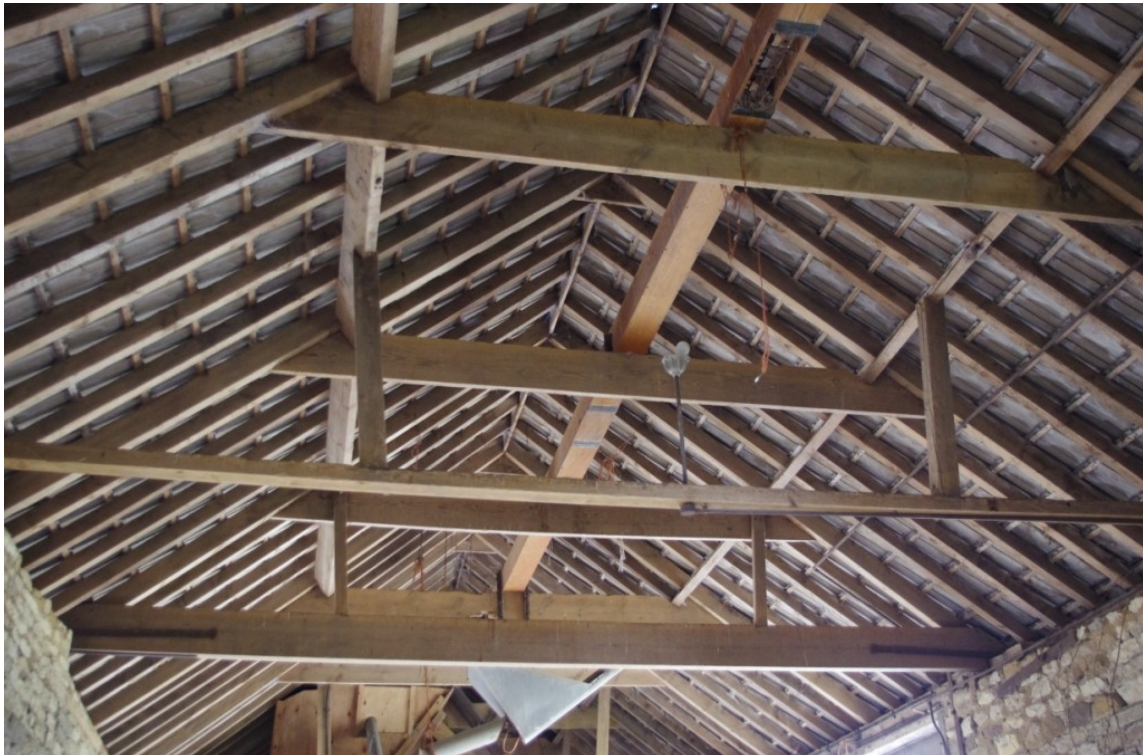
The roof is carried on plain deal trusses (*Figure 6*), most likely a later renewal. There are two curious pieces of timber projecting from the walls to the east of the threshing doors. The southern piece (*Figure 7*) could tentatively be described part of a cruck blade. Crucks are pairs of timbers raising from near ground level to meet at or near the apex of the roof, pairs of crucks are frequently cut from the same tree. Unfortunately not enough of the timber remains to confirm this, there is, however a scar in the stonework which suggests the timber was originally longer and may represent an earlier roof structure. The northernmost timber (*Figure 8*) is significantly smaller, but aligns with the southernmost timber and has the same scar in the stonework. It is almost certain the two are related.

Figure 6
A Roof Truss.

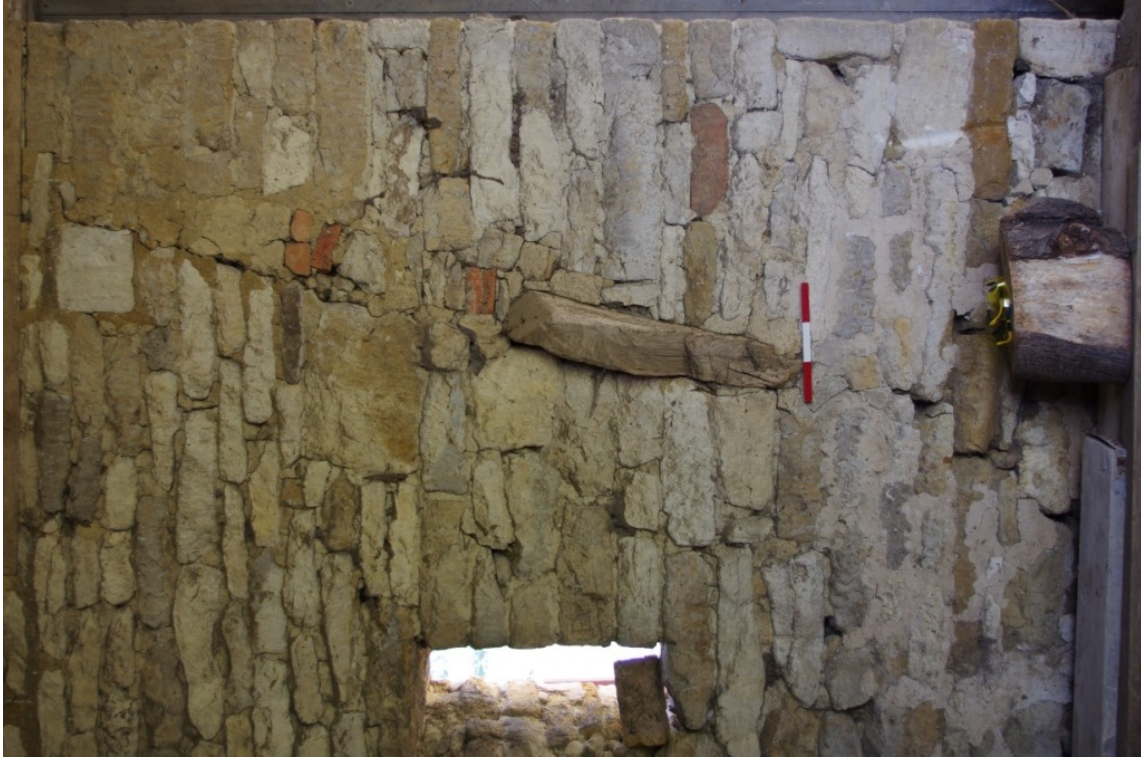
It is possible that evidence of an earlier cruck frame roof survives within building A, although the evidence is too ephemeral to be certain, but the building has clearly been re-roofed in the modern era.

Figure 7
A Possible Cruck Blade in South Wall
Adjacent to Threshing Door.

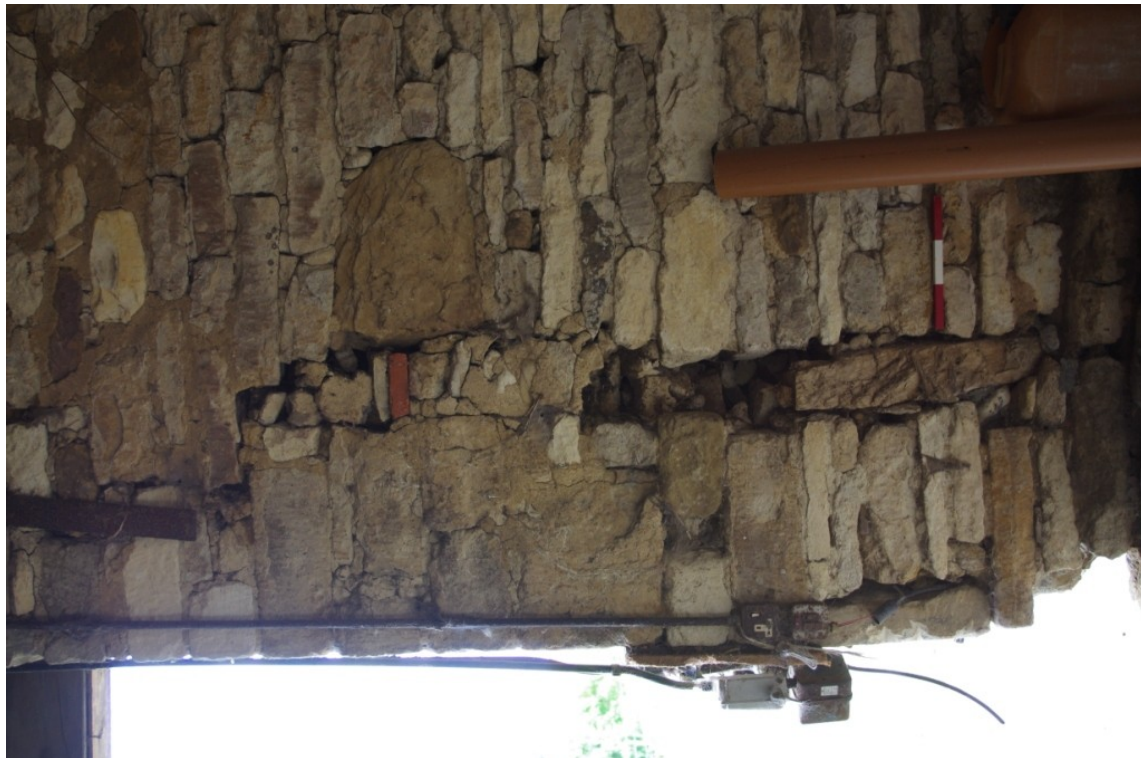
Figure 8
A Possible Cruck Blade in North Wall
Adjacent to Threshing Door.

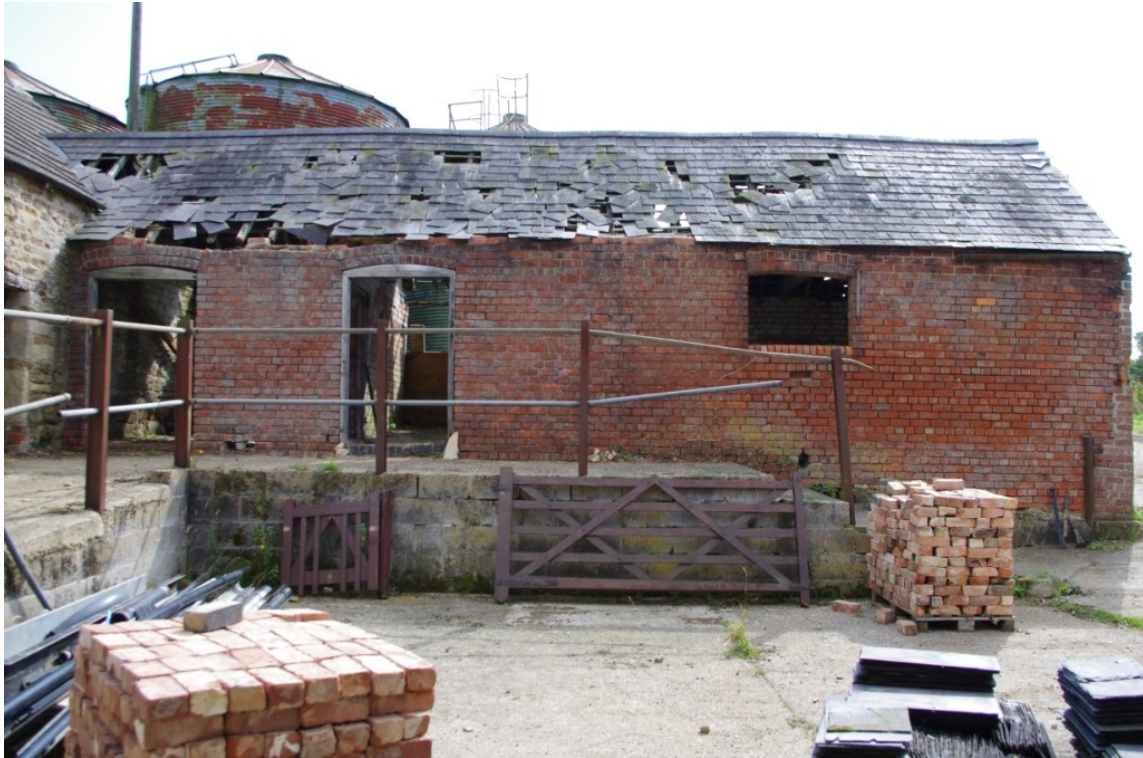
Building B is a brick-built building under a Welsh slate roof aligned north – south abutting the eastern end of the south face of building A (*Figure 9*). The bricks are locally made 9inch x 3inch x 4inch, which along with the Welsh slate roof indicates a later 19th century construction date. There are two doors on the principal (west) elevation, and another on the rear elevation, indicating a cross passage.

Figure 9
B General View (Looking East).

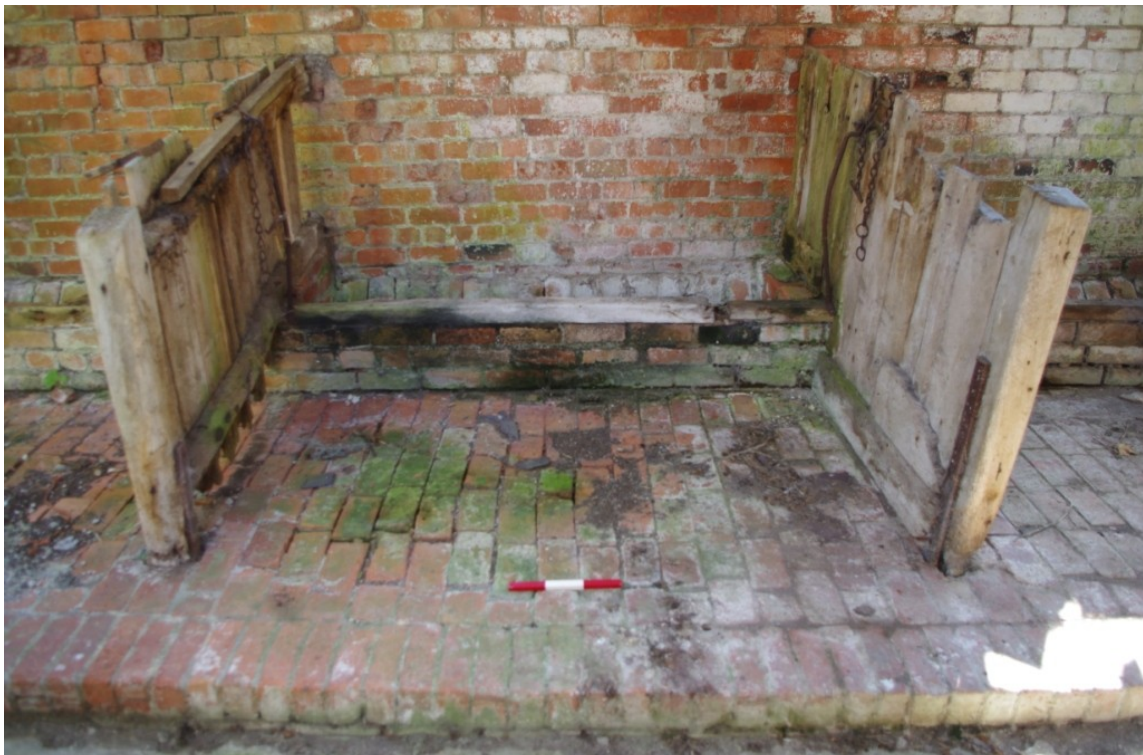
Internally, the building consists of two un-equal bays, the southern, (1) being the larger of the two. There are timber-built cattle stalls in (1), complete with tether bars (*Figure 10*). The survival of timber stalls is unusual as early 20th century legislation all but outlawed their use in favour of more hygienic concrete. (2) is a single bay at the northern end of the building, there is a tall, brick-built manger along the rear wall (*Figure 11*) indicating this was originally a stable.

Figure 10
B(1) Timber Cattle Stall.

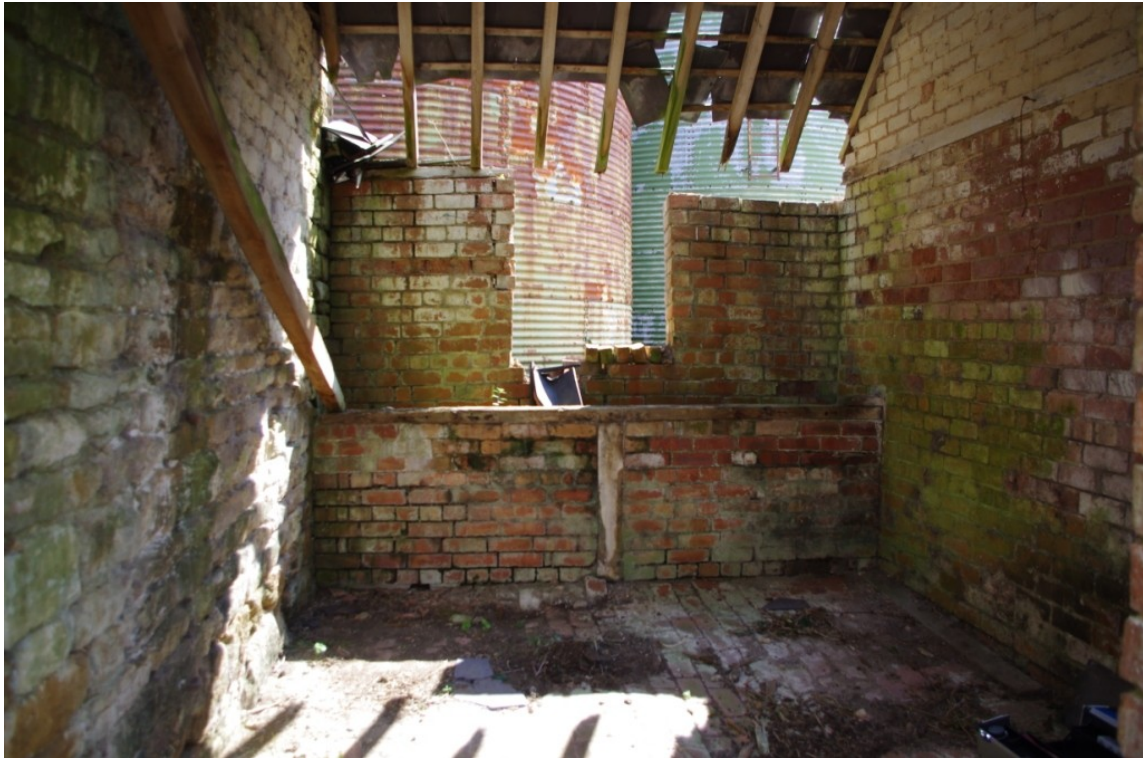
Figure 11
B(2) Stable.

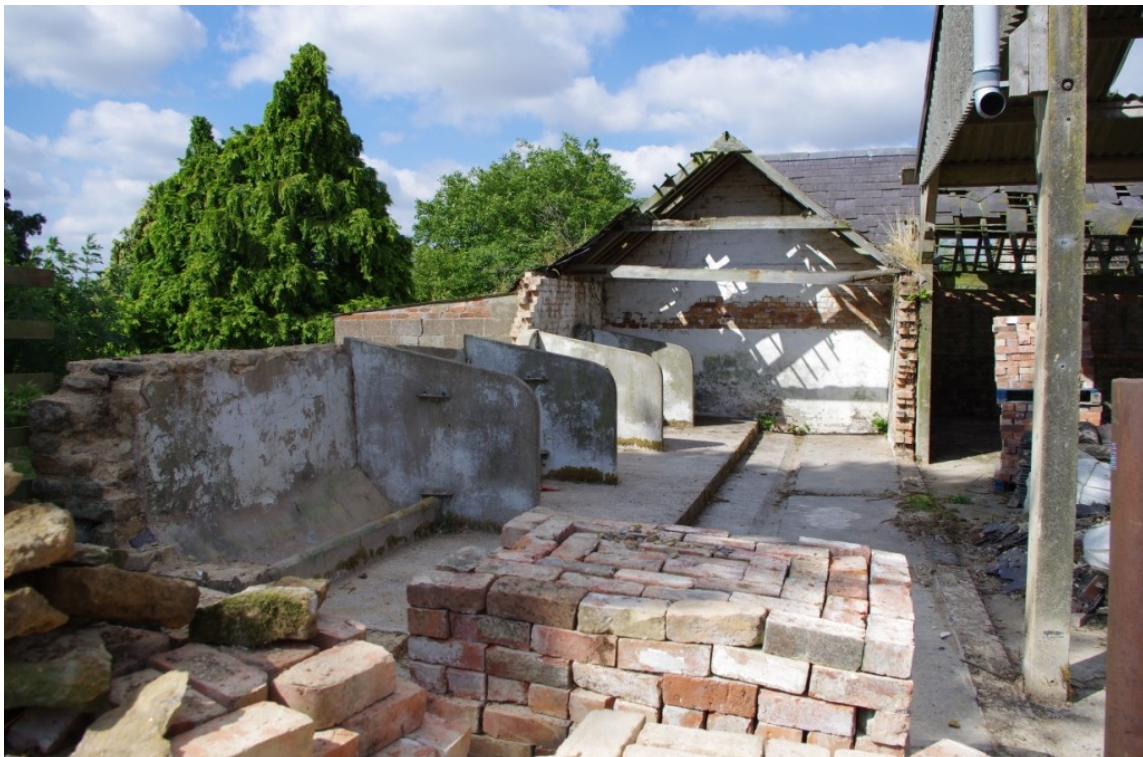
Building C is a largely derelict building forming the southernmost range of the yard (*Figure 12*). Limited evidence indicates the building was largely brick-built, although the rear (south) wall is rubble built (*Figure 13*). The limited remains of a roof at the western end (*Figure 14*) is identical to the roofs seen in buildings A and B suggesting the buildings are contemporary. Along the rear wall are concrete cattle stalls indicating the building was originally a cowhouse and the use of concrete for the stalls suggests it was in use well into the 20th century.

Figure 12
C General View (Looking West-South West).

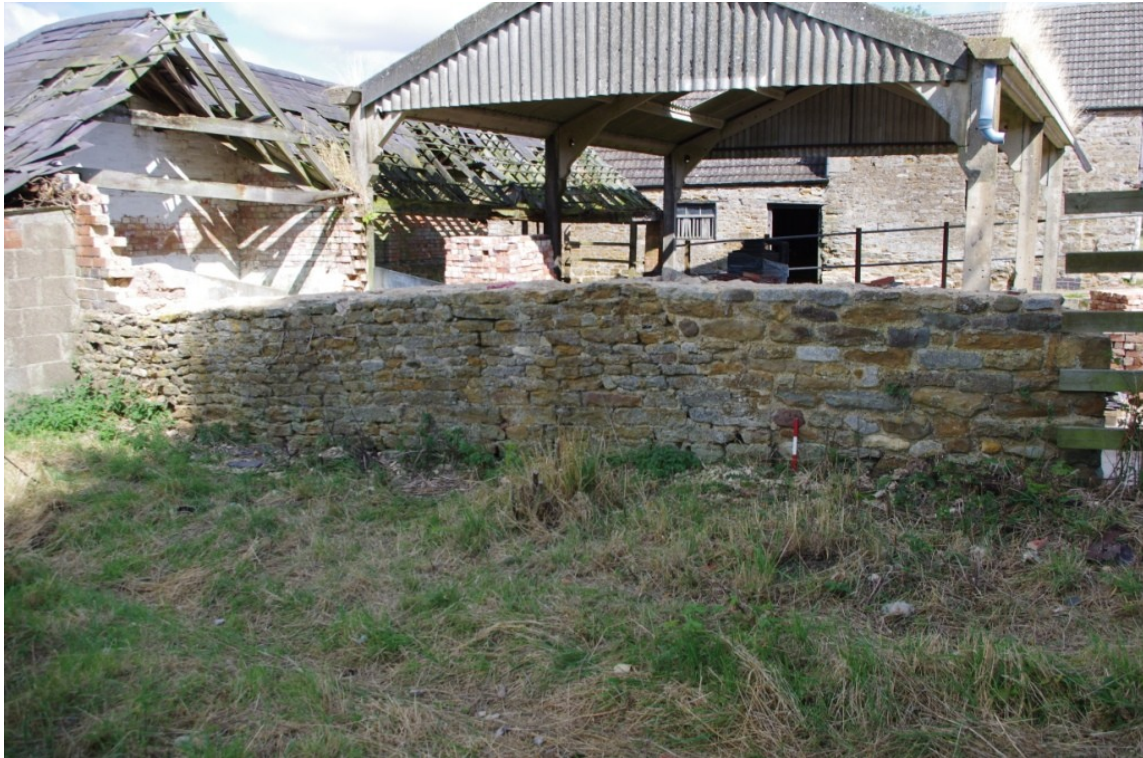
Figure 13
© External View of Rubble-Built Rear Wall (Looking North).

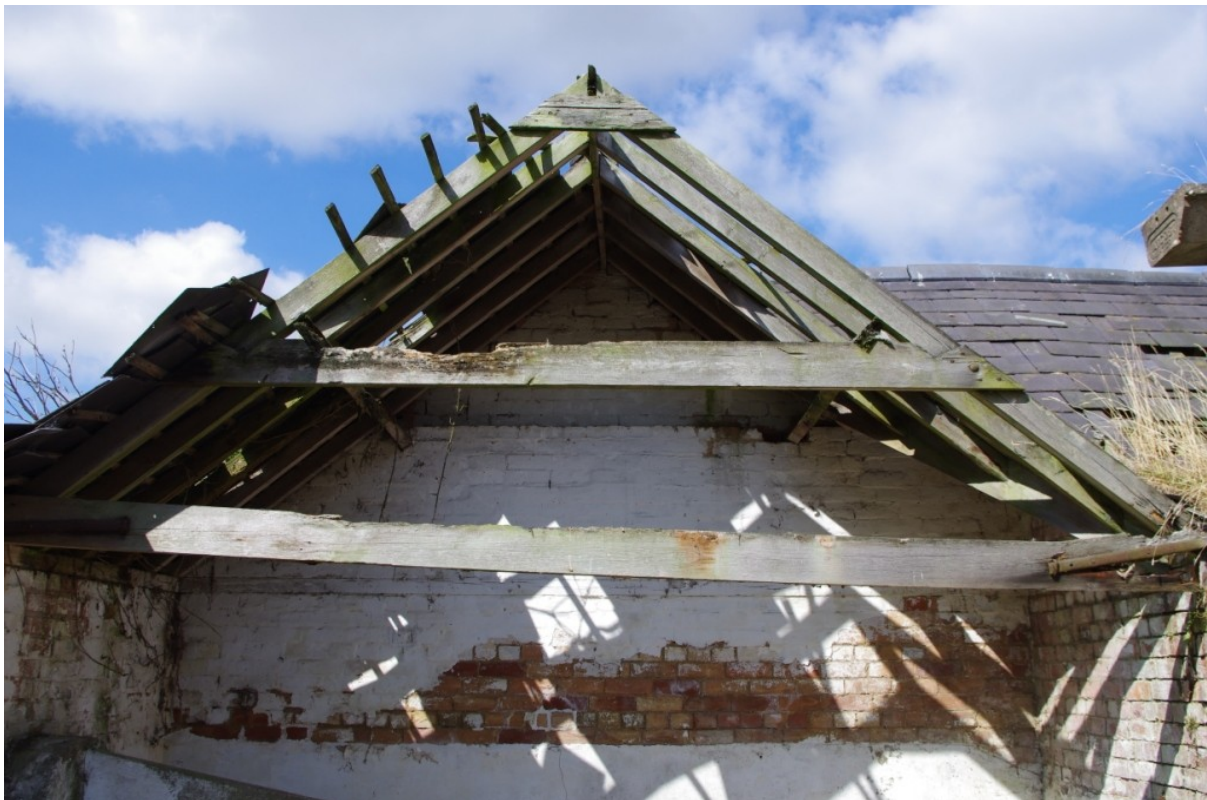
Figure 14
© Roof Structure (Looking West).

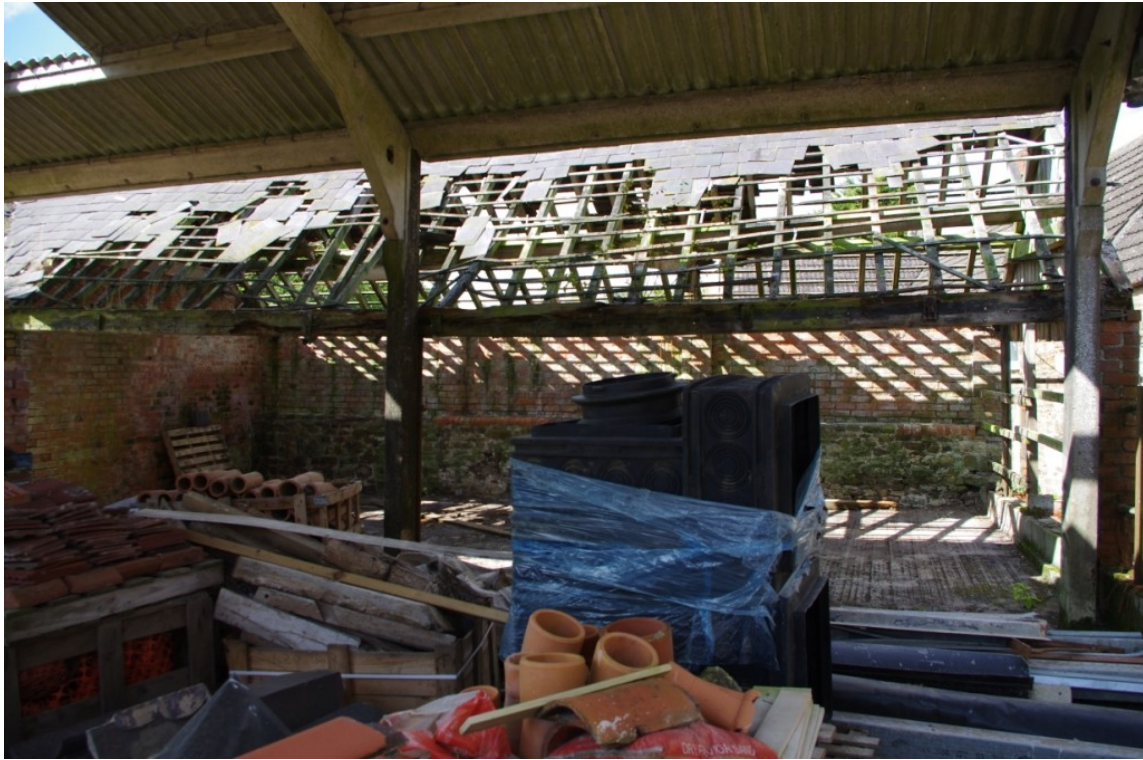
Building D is an open-fronted shelter shed forming the westernmost range of the yard (*Figure 15*). There is a small, enclosed bay consisting of two rooms, (1) and (2) at the southern end with a blocked access to (2) from the main bay (*Figure 16*), these were probably ancillary rooms, or feed preparation rooms. The rear (west) wall is brick and stone-built, with evidence of at least two blocked openings (*Figure 17*). The roof is again identical to the roofs in previous buildings.

Figure 15
D General View (Looking West).

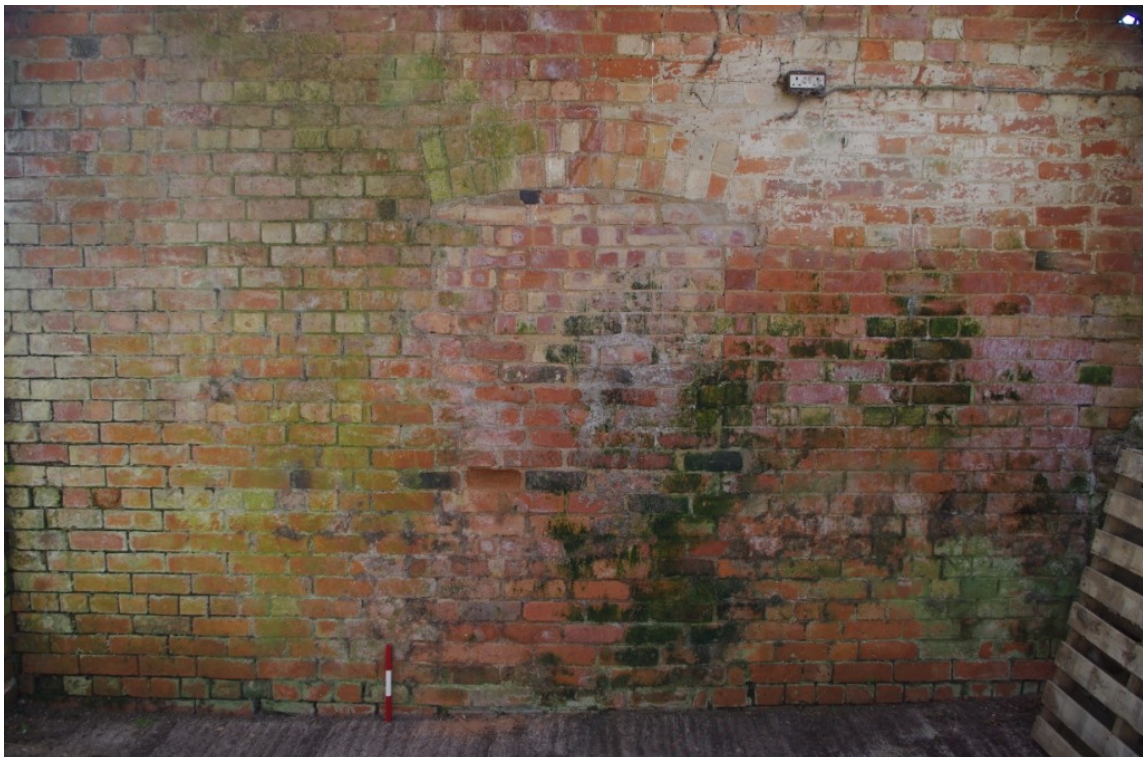
Figure 16
D Blocked Opening in South Wall.

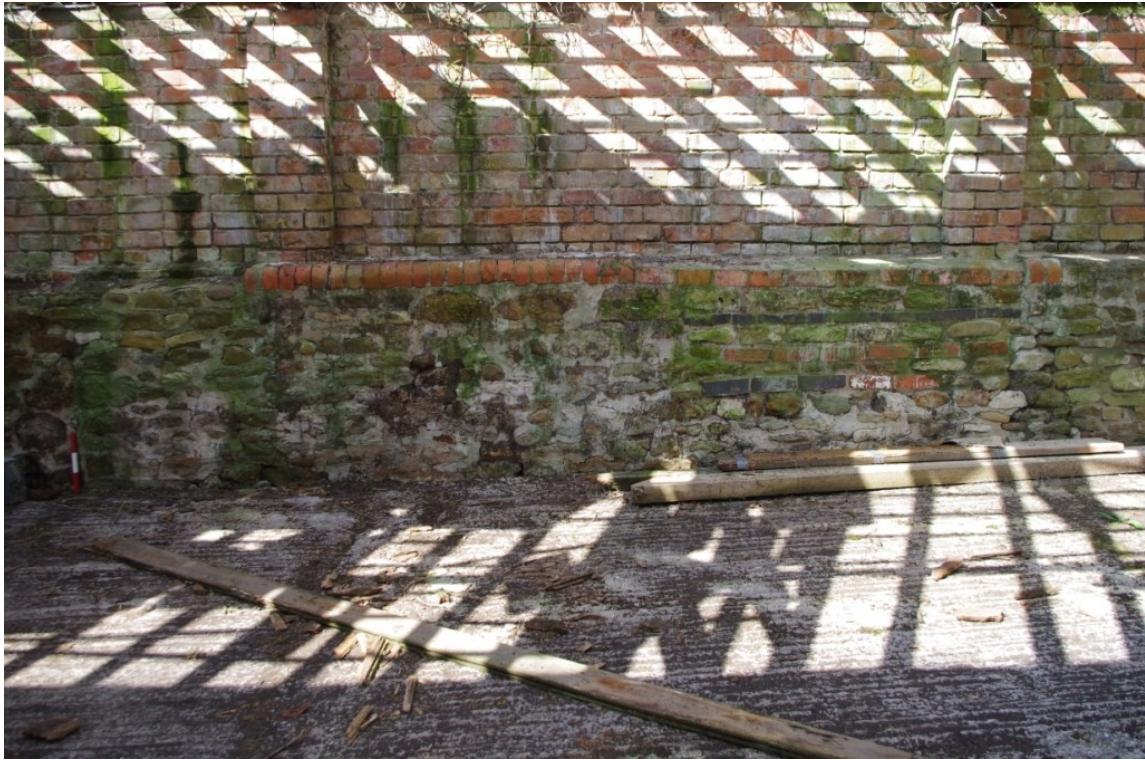
Figure 17
D Blocked Openings in Rear Wall (Looking West).

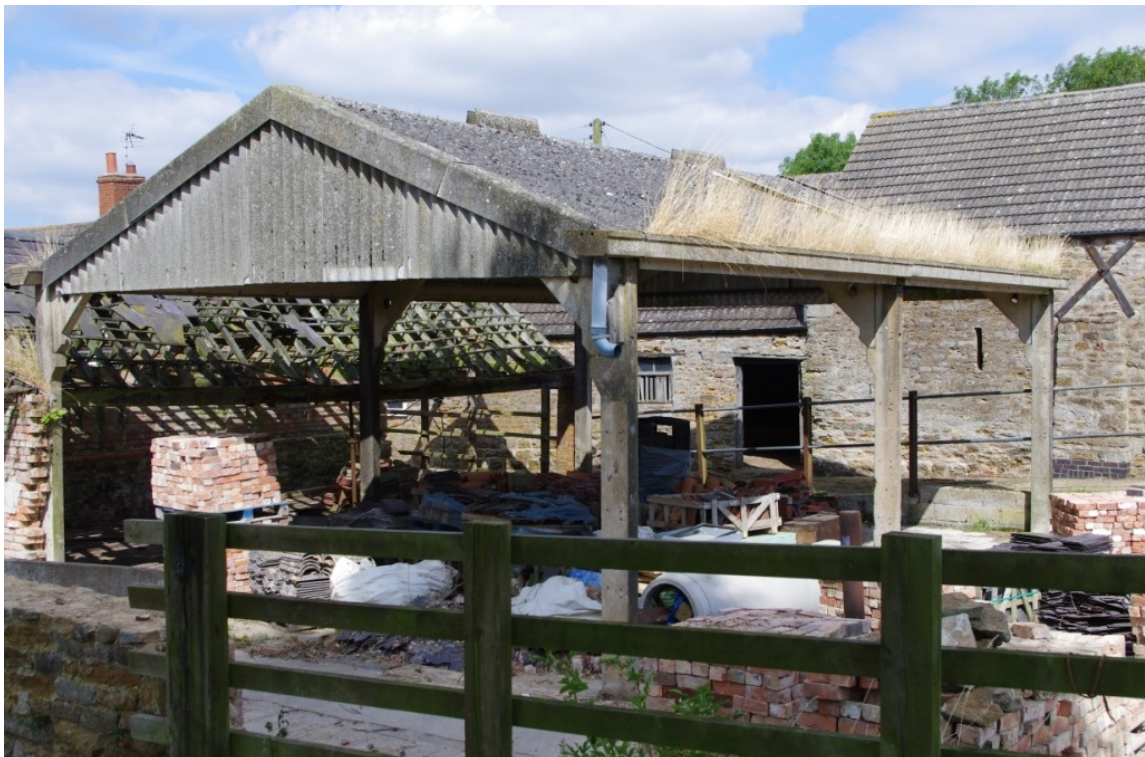
Part of the yard has been roofed with a pre-cast Atcost concrete and corrugated asbestos cement building (*Figure 18*). Such buildings are a common late 20th century addition to farms and in this case was used to create a covered yard, enlarging the existing shelter shed, building D to allow more cattle to be reared.

Figure 18
Covered Yard (Looking North West).

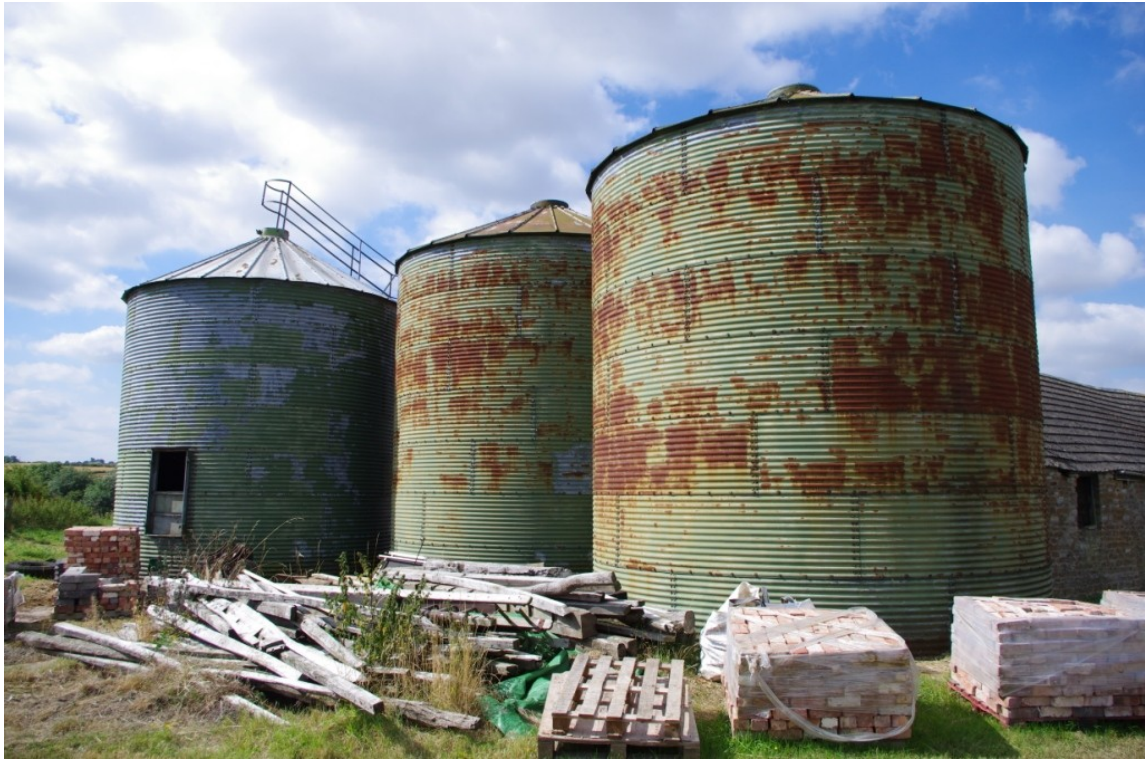
To the east of building A are three corrugated tinned steel grain silos (*Figure 19*). Cartographic evidence indicates these are also from the late 20th century.

Figure 19
Silos (Looking South West).
