**An Archaeological Standing Building Survey
Dowles Manor
Bewdley
Worcestershire
(NGR SO 77521 76419)**

ABRS Project No 2018-DMBW

**Worcestershire County Council
Historic Environment Record Event
No. WSM70433**

**An Archaeological Standing Building Survey of Dowles Manor, Dowles Lane, Bewdley,
Worcestershire (NGR SO 77521 76419).**

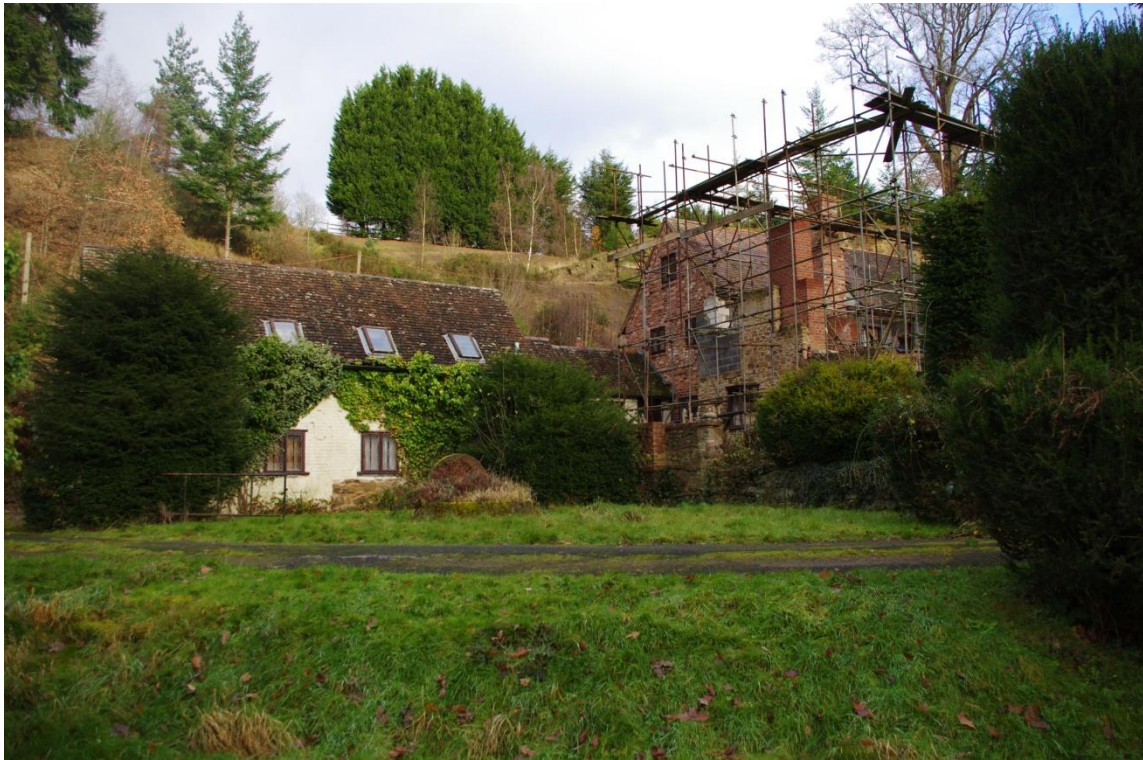
The Lodge consists of a single linear building to the north west of the former Manor House (*Figure 12*); it is joined to the shell of the “new Manor House” by a new build brick and tile link. It is a one and half storey building under a plain tile, unequally pitched roof. The building is largely brick-built with stone plinths on each gable and interrupted stone plinths on each long elevation. The gap in the stone plinth on the south facing elevation is in alignment with a straight joint in the brickwork above (*Figure 13*), it is possible that this represents what was originally a cart door on this elevation, unfortunately the westernmost extent of this elevation is covered with vegetation, so it is impossible to confirm whether there is another straight joint. The part-stucco rendered bricks appear to be largely locally made red bricks laid in a plain stretcher bond in cement mortar. The brick dimensions are difficult to establish, but appear to be 9inch x 2 ¾inch x 4 ¼inch, although not always correct, these dimensions would suggest an early to mid 19th century construction date as confirmed by cartographic sources. There is clear evidence of re-building on the west facing gable (*Figure 14*), it is not clear whether this was brought about by the insertion of the large double doors or by the mid 20th century demolition of the north westernmost extent of the building. Over the door is an attractively finished chamfered and stopped lintel (*Figure 15*), an un-expected flourish for a 20th century alteration.

Figure 12
The Lodge & “New Manor House” (Right) (Looking North East).

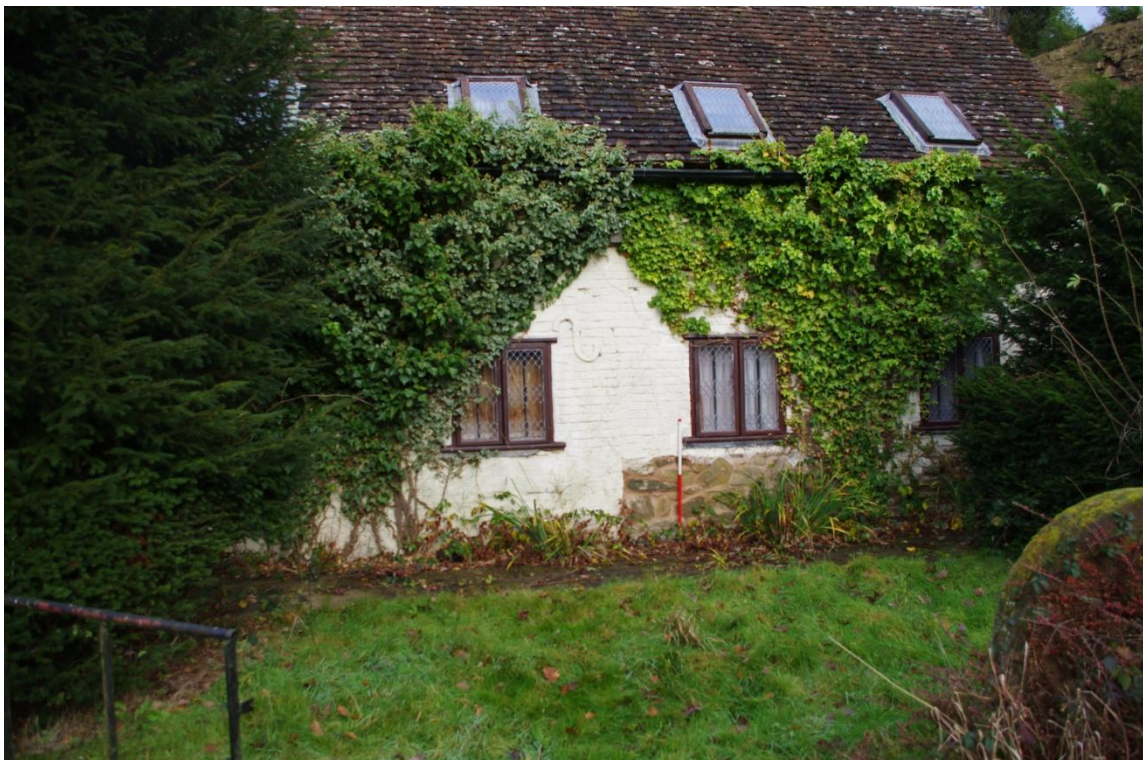
Figure 13
The Lodge, Principal Elevation, Showing Straight Joint in Brickwork (Looking North East).

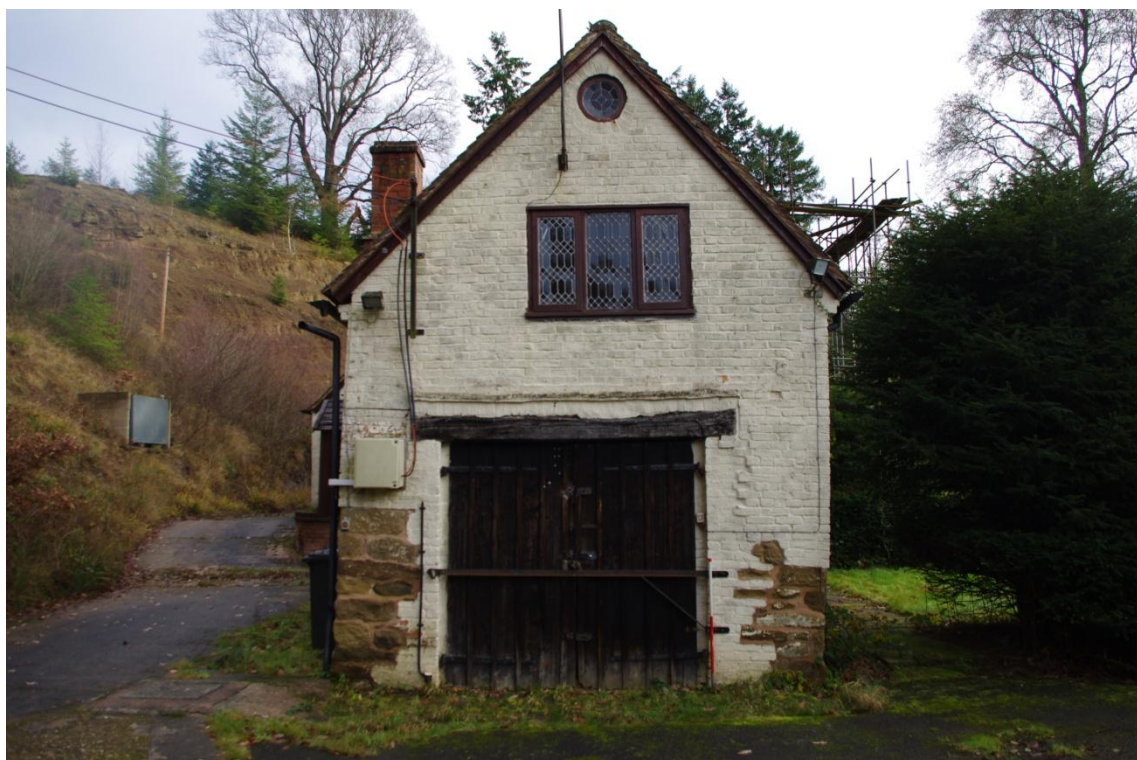
Figure 14
The Lodge, North West Facing Gable Showing Re-building.

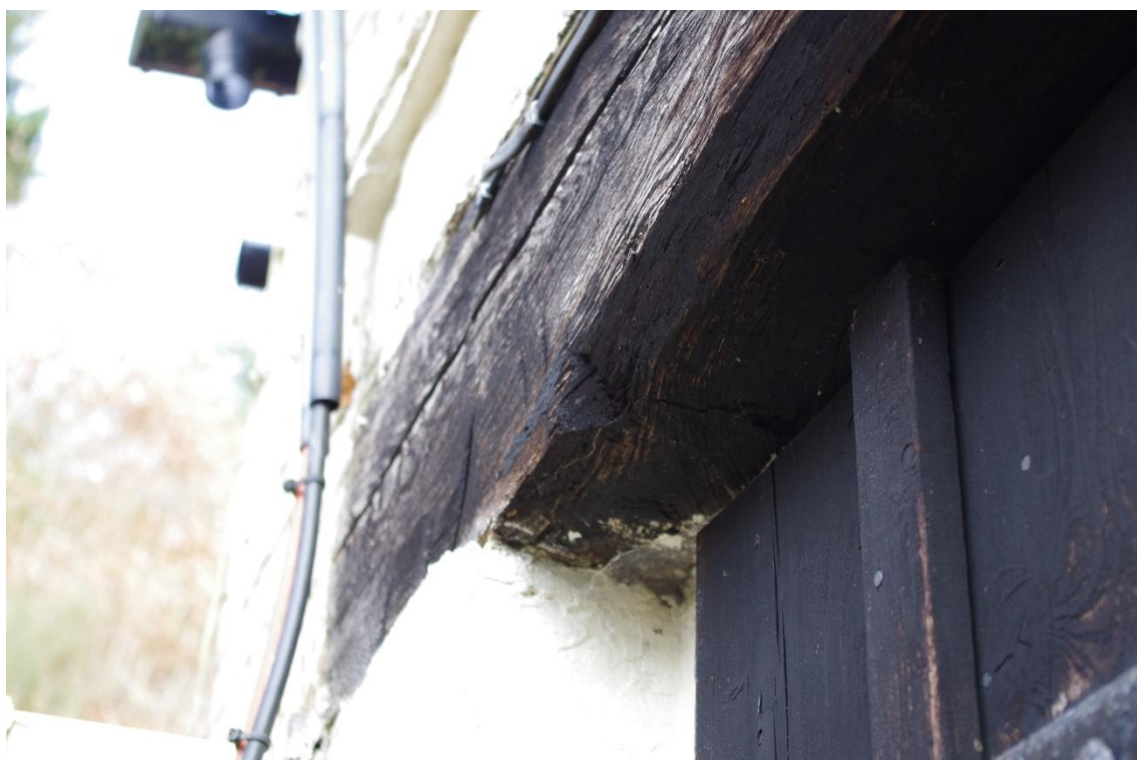
Figure 15
Stopped & Chamfered Beam on North West Facing Gable.

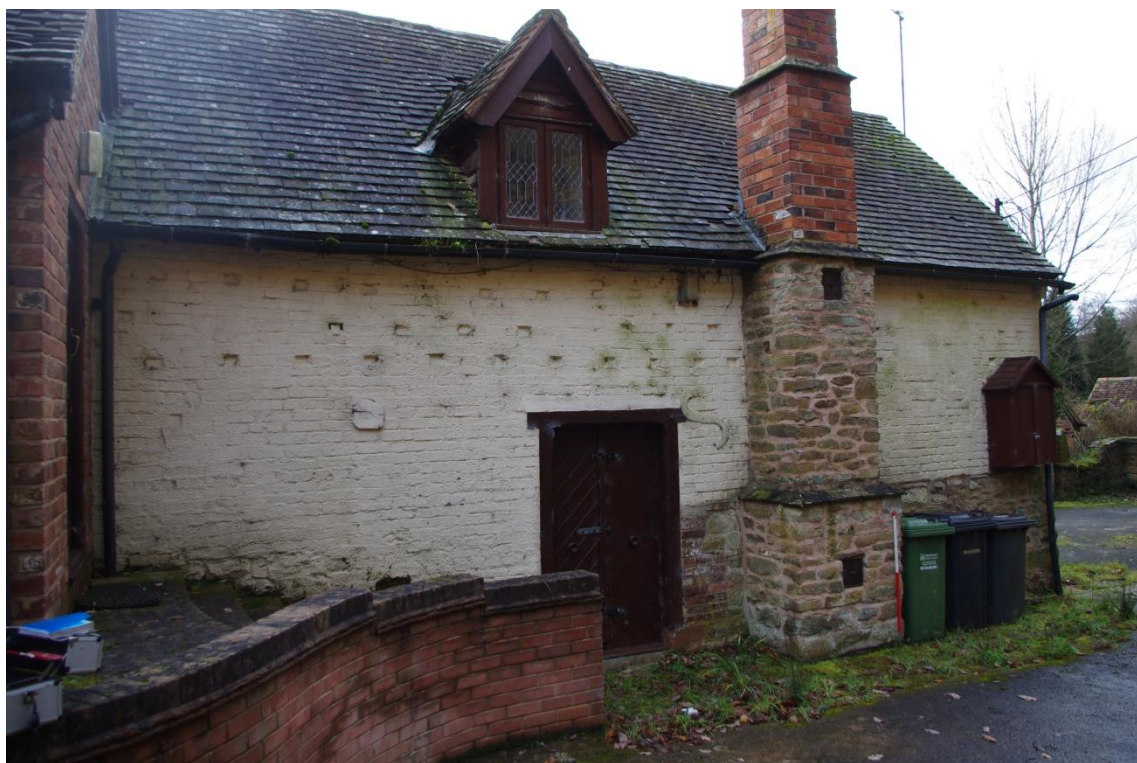
On the north east facing rear elevation is a substantial stone-built square chimneystack (*Figure 16*). Although appearing to be of some antiquity there is no cartographic evidence of the stack and the straight joint between it and the wall suggests it is a later addition, the removal of the clean out door confirmed that the visible brickwork is modern (*Figure 17*). This rear elevation also contains further evidence of the building’s agricultural origins with missing brick ventilation (*Figure 16*). There is also the stub of a beam projecting from this rear wall, the origins of which are unclear, but may represent an internal bridging beam. The windows are all 20th century timber casement windows, albeit attractively finished in heavy lead, probably Arts & Crafts or Tudor Revival inspired, both early 20th century architectural styles, work potentially carried out by Steele Elliott.

Figure 16
The Lodge, Rear Elevation Showing Modern Chimney & Missing Brick Ventilation (Looking South West).

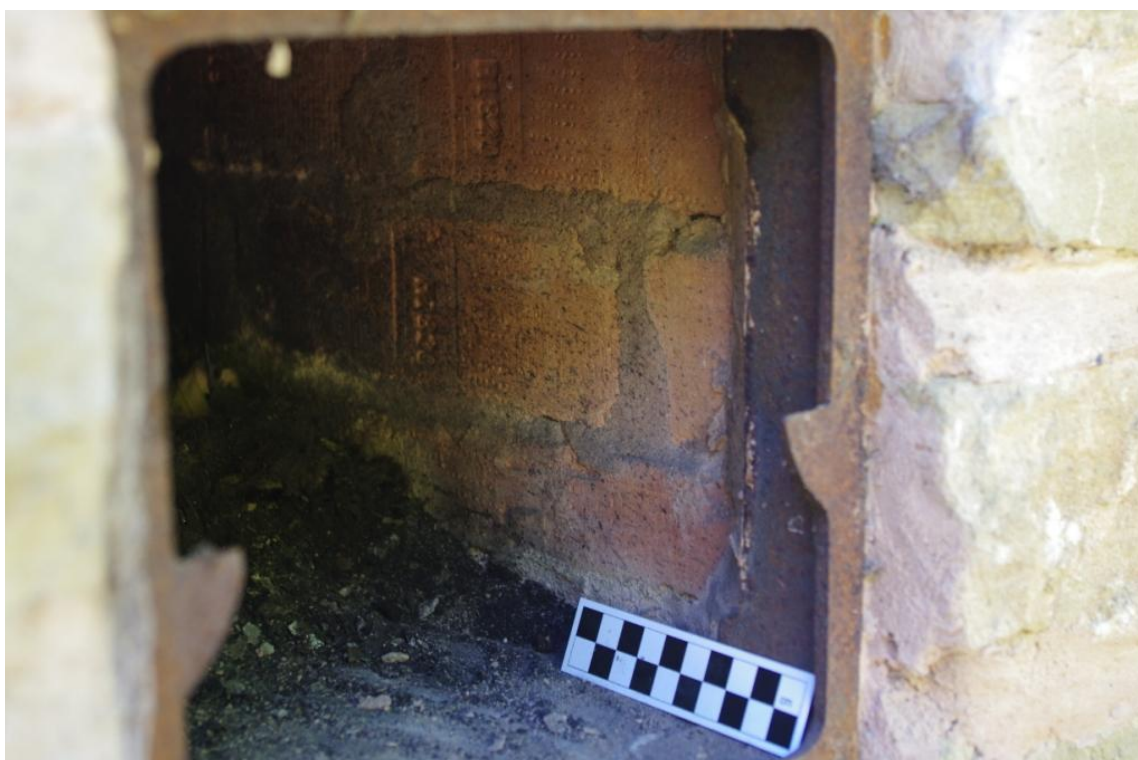
Figure 17
Modern Brickwork within the Chimney.

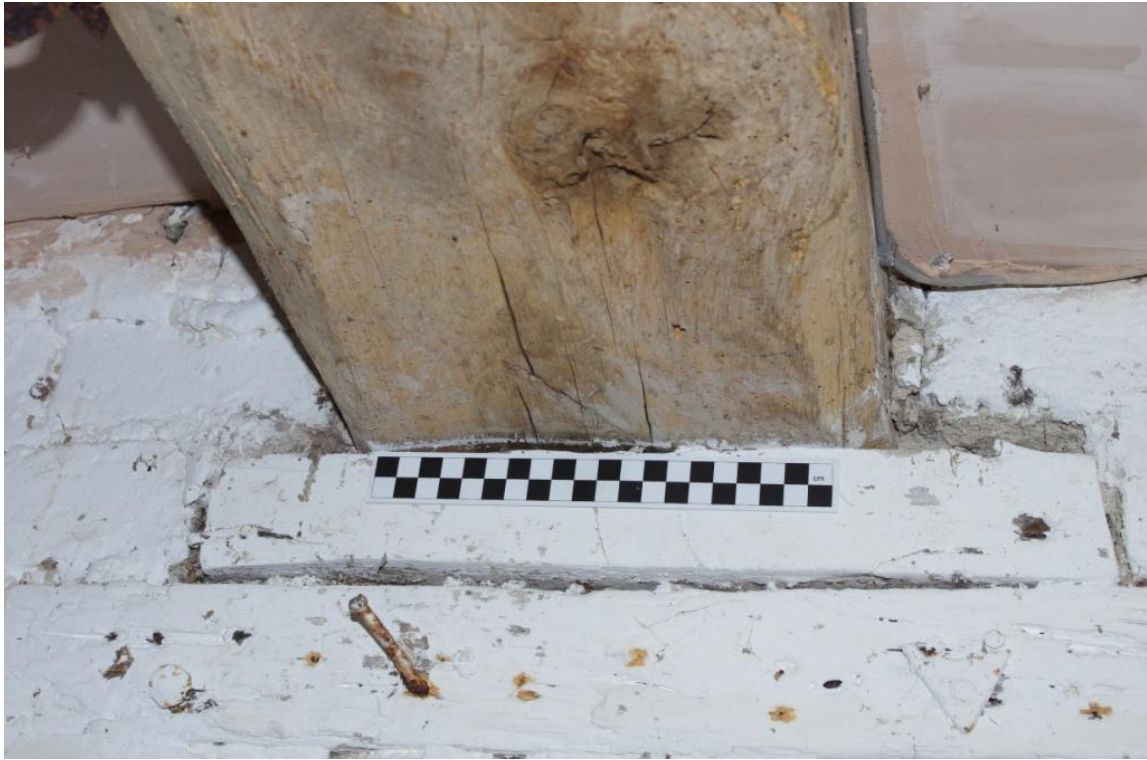
Internally, there is very little of architectural or historical interest. The building has apparently undergone extensive late 20th century re-modelling. It is unclear what, if any of the ground floor partitions are historic or modern. The thickness of the wall between (2) and (3) suggests this may be an earlier or possibly original wall. It is also unlikely that the wall between (1) and (2) is original as it leaves the current fireplace in the garage, (1), indeed, there is no evidence of an opening for the fireplace in (1), again confirming the chimney as modern. The apparently modern ceiling within (1) is carried on a single chamfered bridging beam, there is slight evidence of the southern end being stopped, but it is far from clear (*Figure 18*).

Figure 18
Chamfered Beam in (1) (Looking South).

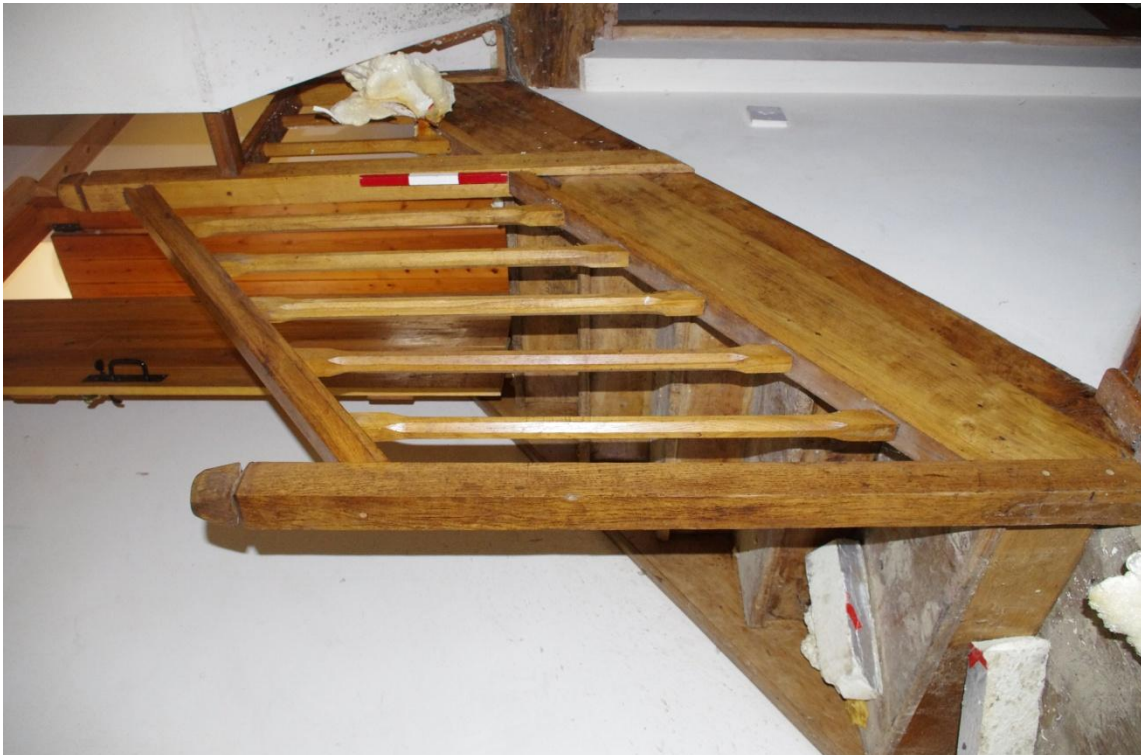
First floor access is via an attractive Arts & Crafts inspired dog leg stair with half landing, adjacent to which is a second chamfered bridging beam (*Figure 19*), it is likely that this is the beam which can be seen projecting from the rear wall. The first floor consists mainly of two bays, the easternmost being sub-divided by modern stud walling. There is a mutilated central

Figure 19
Arts & Crafts Inspired Staircase with
Bridging Beam to Right (Looking
West).

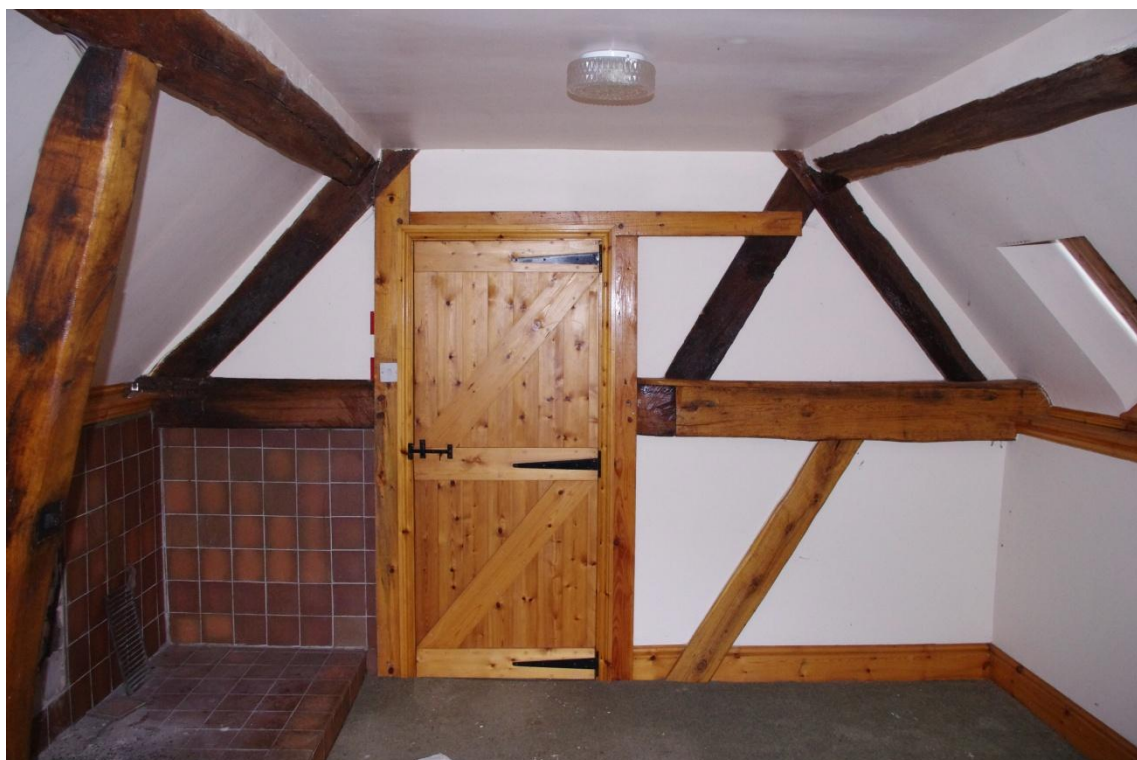
truss (*Figures 20 & 29*) consisting of principal rafters, a tie beam and there is a single remaining raking strut. Given the apparent mid 19th century construction date for the building it is likely that the truss originated as a King Post Truss with raking struts. King Post trusses have a wide date range, but became common in agricultural buildings in the middle to late 19th century. The truss carries two trenched purlins, both chamfered; there is no evidence of stops on either purlin, so dating either is nearly impossible. There is evidence that the southern purlin has been replaced to the west, this is confirmed to some extent by the excessive depth of the trench on the principal rafter and the use of metal bolts between the principal and the raking strut (*Figure 21*). The northernmost purlin appears to be original and un-altered. Each purlin is further supported by upright beams towards the centre of (4), these are clearly inserted and suggest the possible location of a removed truss. A limited view of the attic space indicates that the common rafters and ridge plank are modern deal (*Figure 22*).

Figure 20
Central Roof Truss (Looking South East).

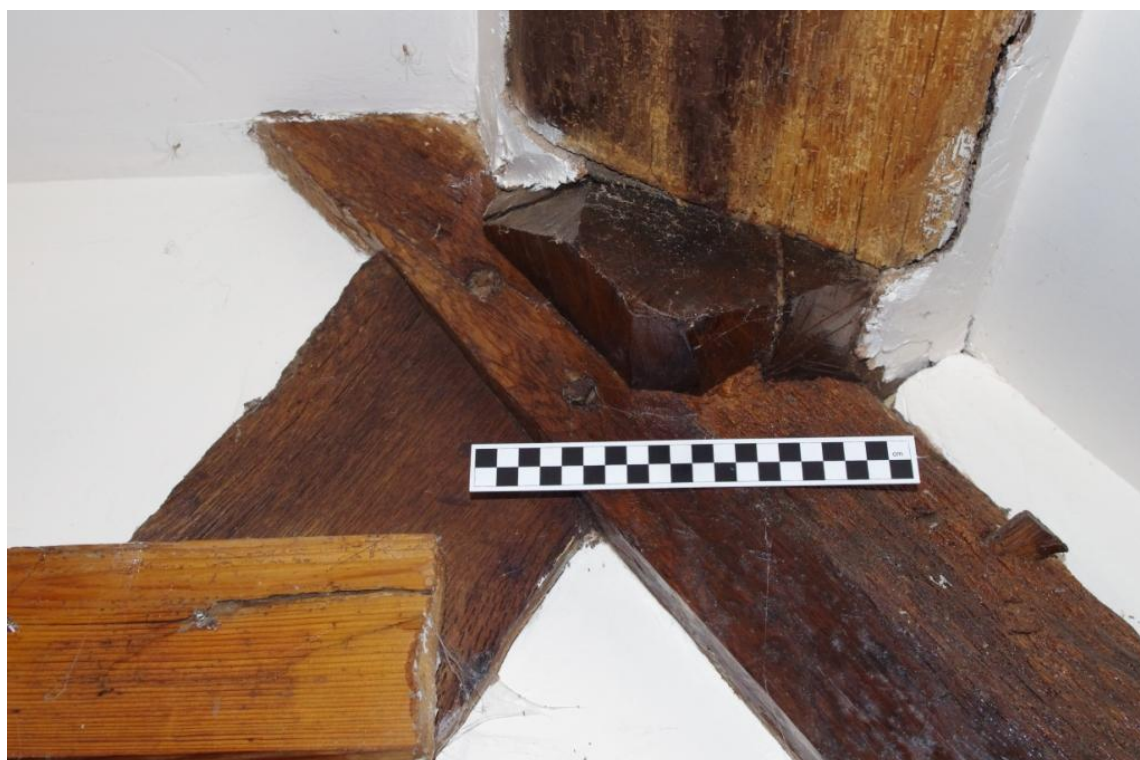
Figure 21
(4) Butt Purlin with Bolted Principal & Raking Strut.

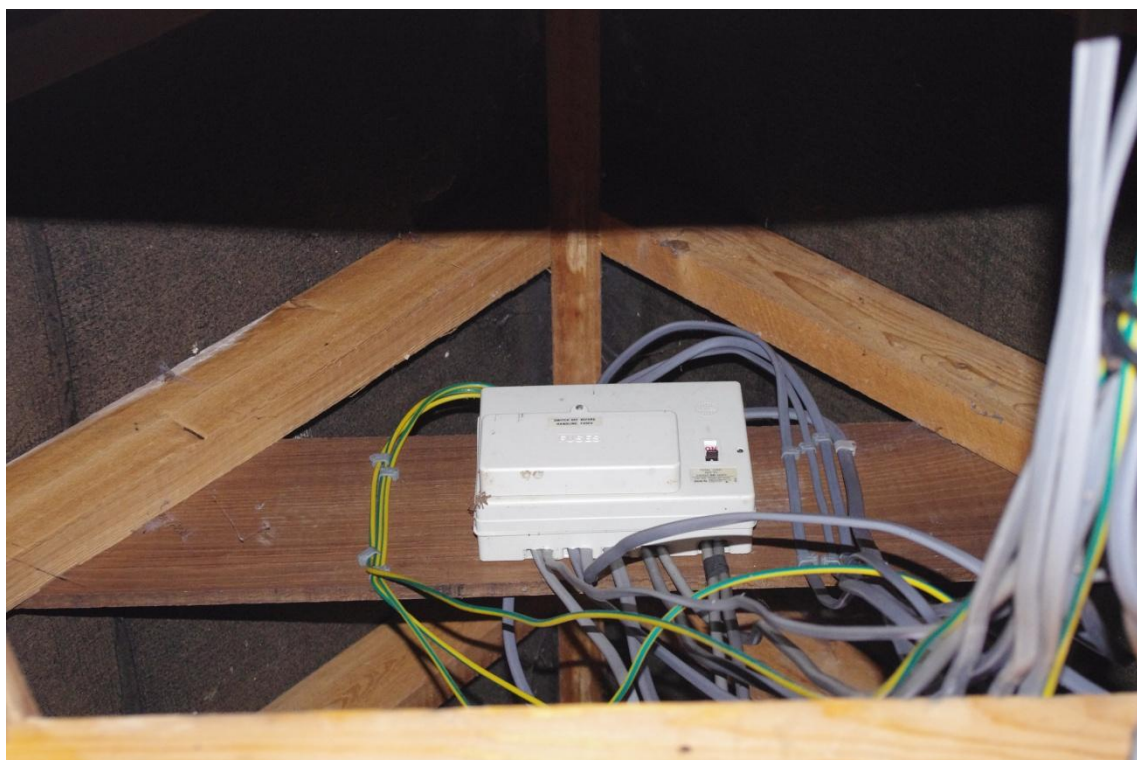
Figure 22
Modern Roof Structure in Attic.

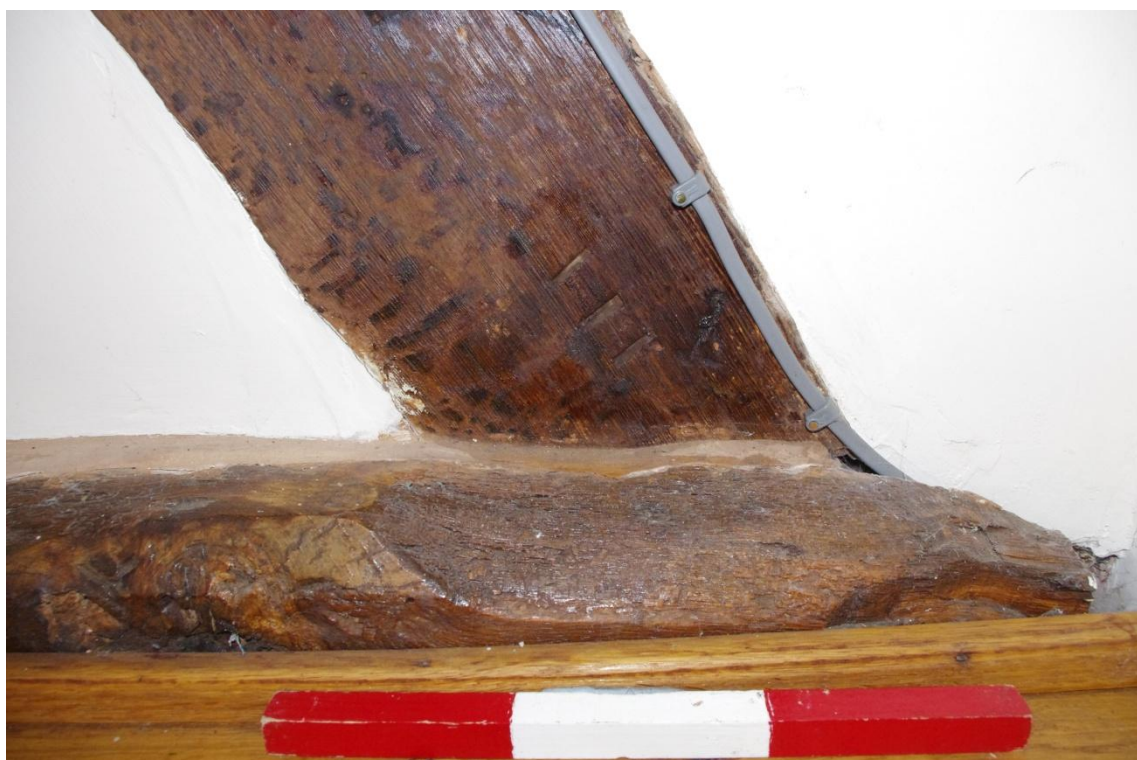
There are three examples of incised assembly marks visible on the exposed roof construction; the first are on the east face of the principal rafters (*Figures 23 & 24*). The northern principal is numbered three in Roman numerals and the southern principal is numbered four. Stylistically the incisions are identical, confirming that these elements of the truss, at least are original. There is a third, somewhat cruder example on the easternmost collar beam in (5) (*Figure 25*). This could potentially be XI denoting the Roman numeral eleven. This mark does, however resemble the assembly marks recorded by Steele Elliott in 1916 (pp13) and may therefore be a modified Roman numeral similar to that used during construction of the Manor House in the 16th or 17th century. It is possible, therefore that this collar beam is re-used from an earlier building.

Figure 23
Incised Assembly Marks on South East Face of Tie Beam in (6).

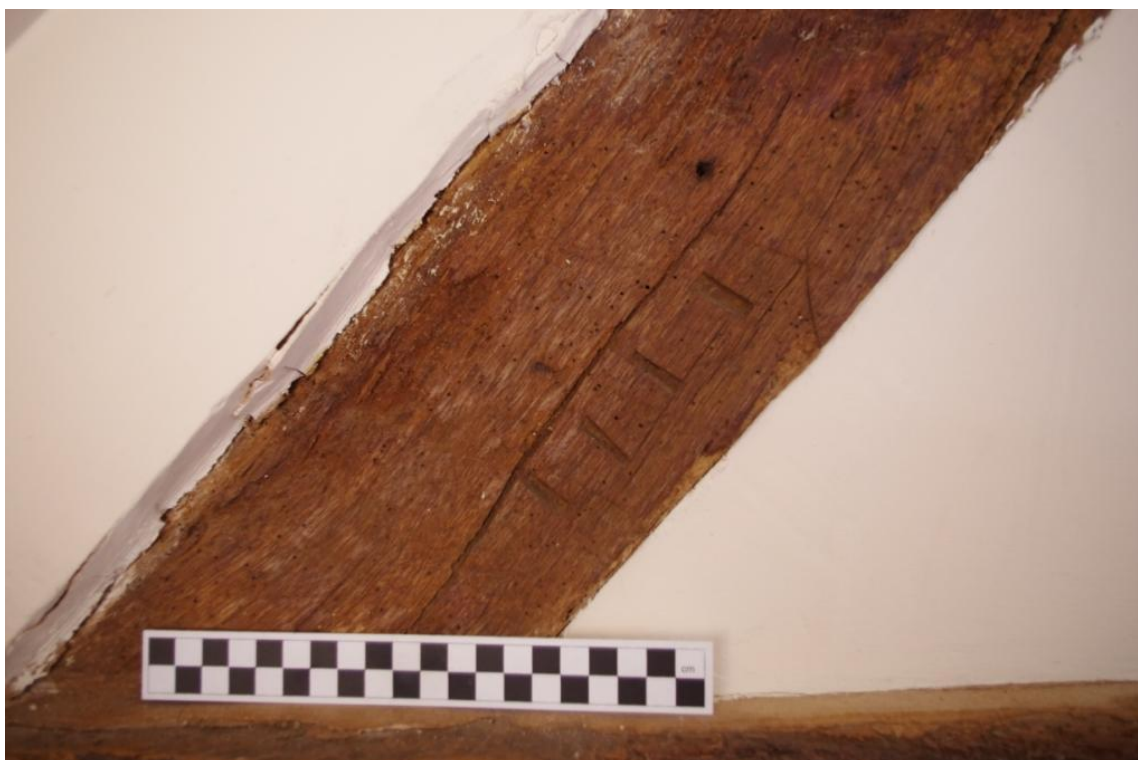
Figure 24
Incised Assembly Marks on South East Face of Tie Beam in (5).

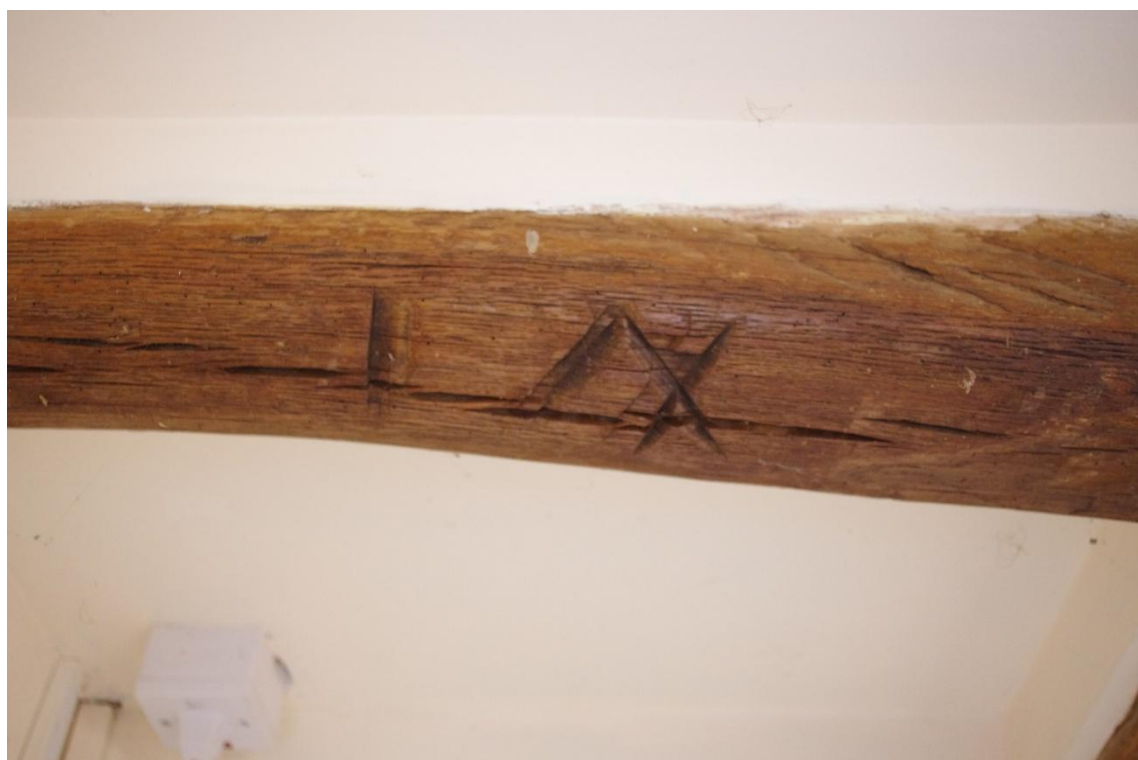
Figure 25
Incised Assembly Marks on Underside of Collar Beam in (5).

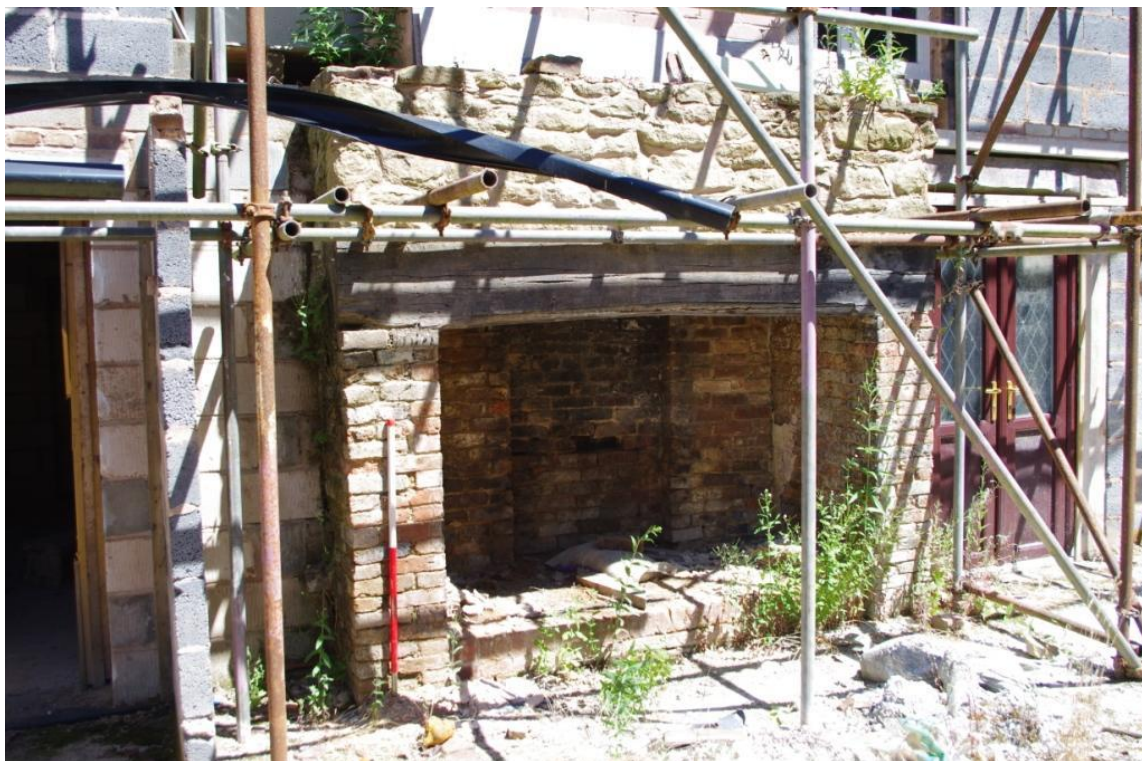
The only remaining feature of the original Manor House is the partially re-built fireplace (*Figure 26*). Steele Elliott writing in 1916 describes it as “cavernous” (*Figure 11*). The fireplace was originally located opposite the front (south facing) door in what would have originally been the hall, or “Houseplace” as Steele Elliott describes it. The remaining fireplace consists only of the lower courses of bricks carrying a wide, oak bressumer, the bressumer is finished in a flattened arch with a scrolled stop (*Figure 27*), stylistically mid 17th century in date, confirming the potential date range for the original construction of the Manor House.

Figure 26
Fireplace, Formerly in The Hall of manor House (Looking East – North East).

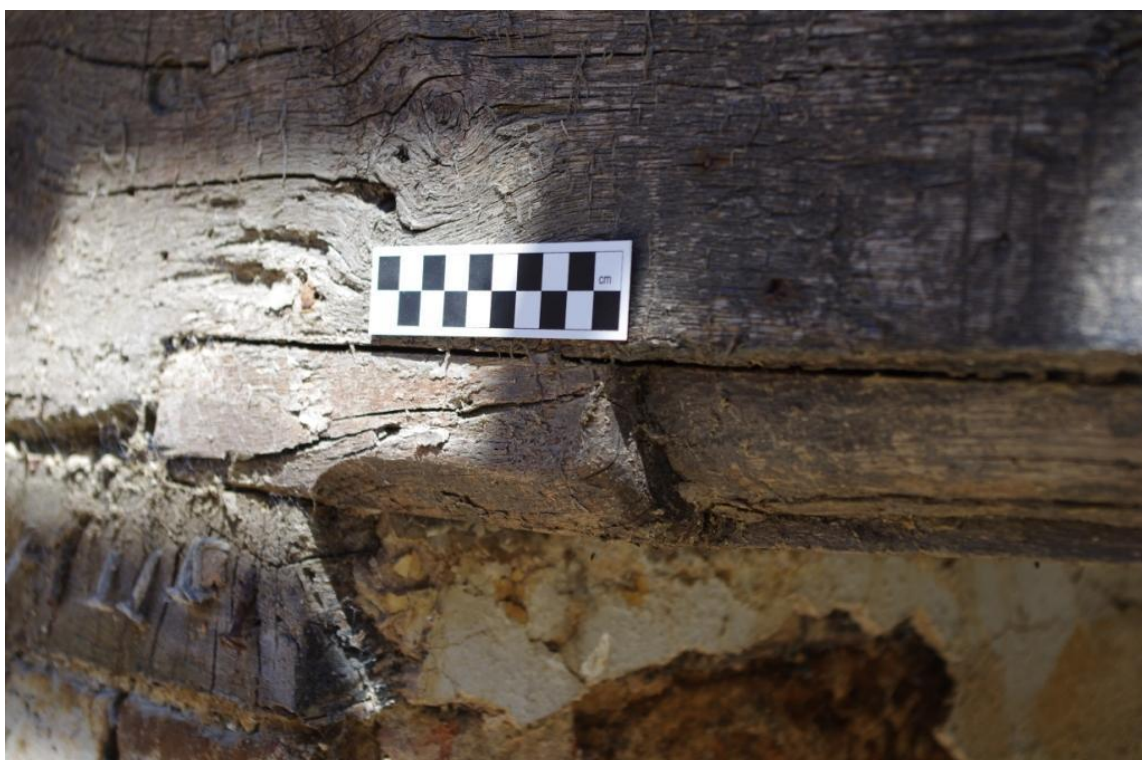
Figure 27
Fireplace Bressumer, Detail.
