**A Photographic Survey
The Old Cow Shed
Church Lane
Old Dalby
Leicestershire
(NGR SK 67250 23550)**

ABRS Project No 2021-CODL

Planning Permission 21/00398/FUL

**Leicestershire Museums &
Archaeology Collections Accession No:
X.A93.2021**

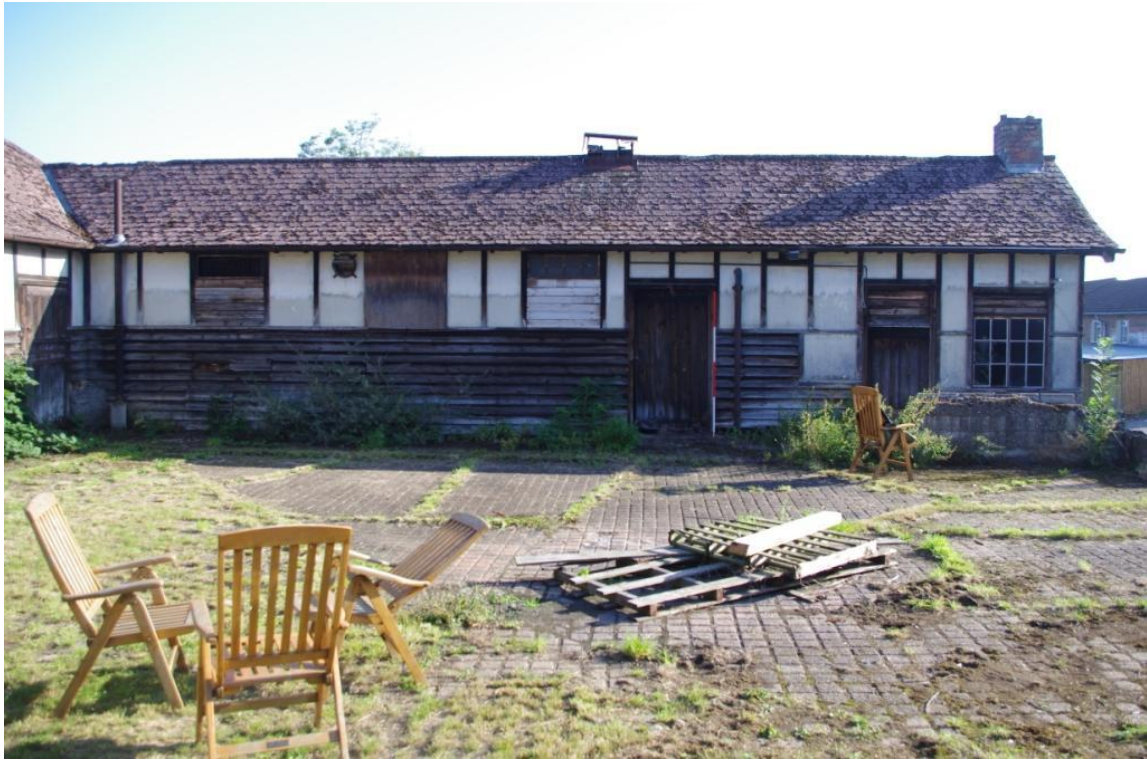
Figure 3
North East Range Principal Elevation, General View (Looking North East).

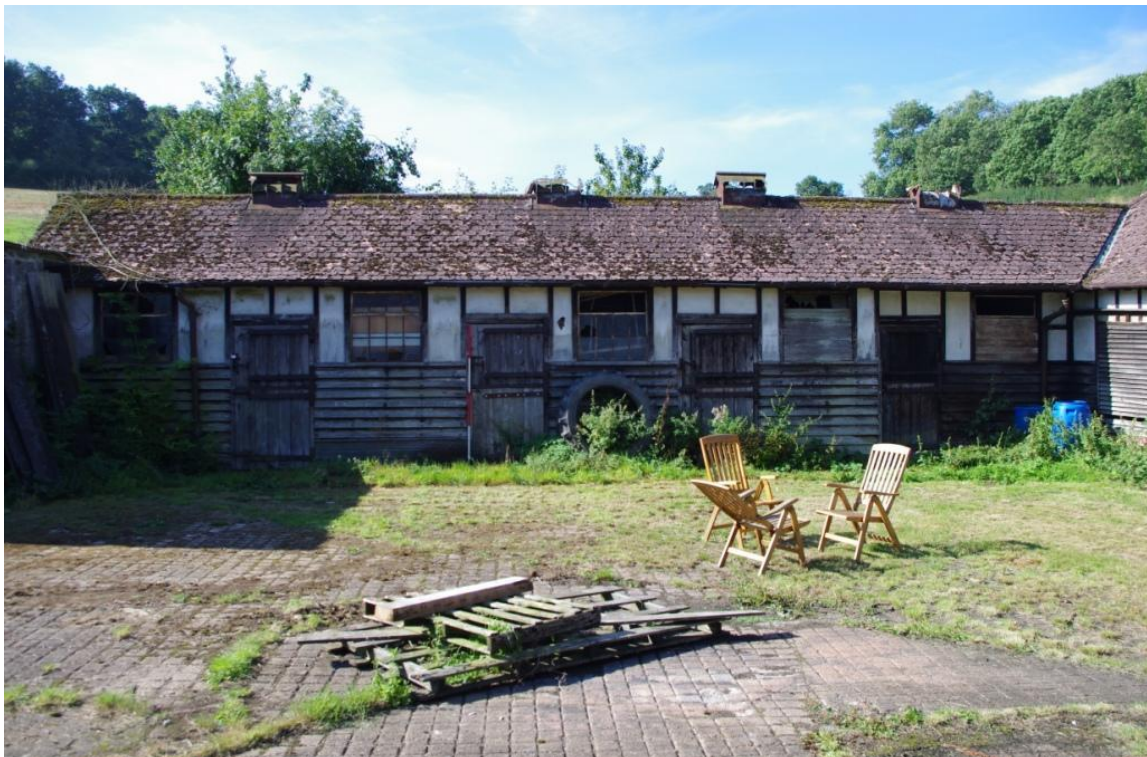
Figure 4
South West Range Principal Elevation, General View (Looking South East).

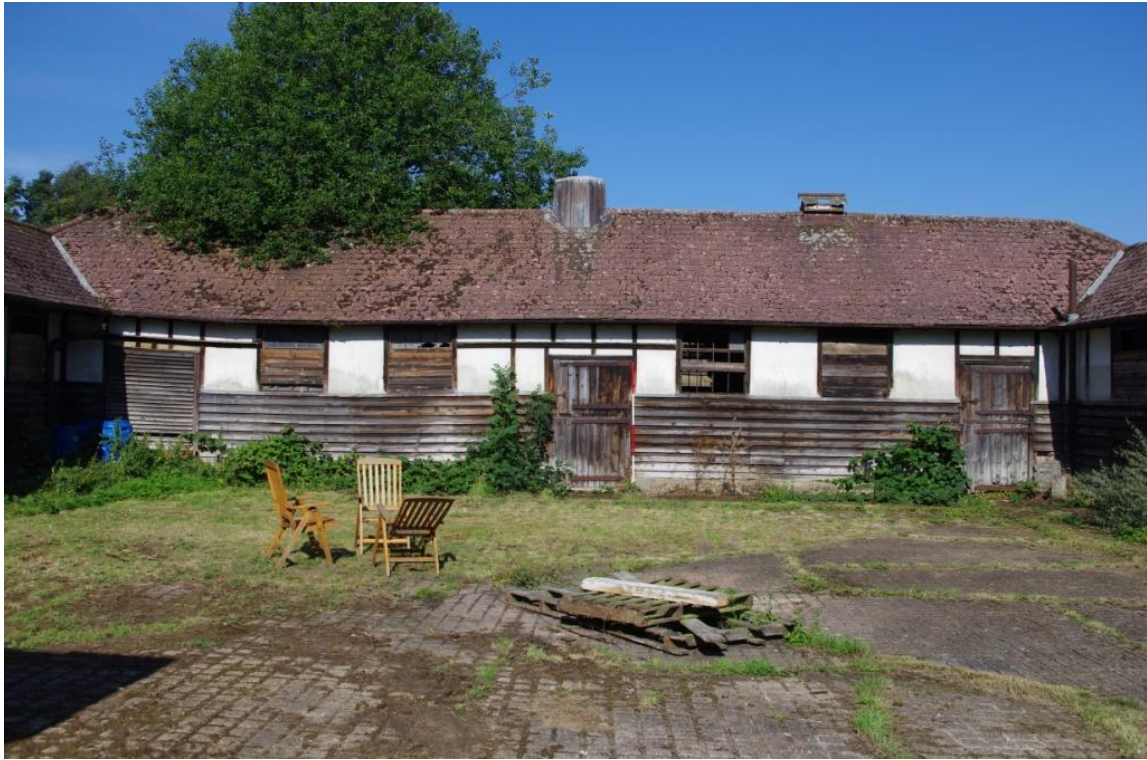
Figure 5
North West Range Principal Elevation, General View (Looking North West).

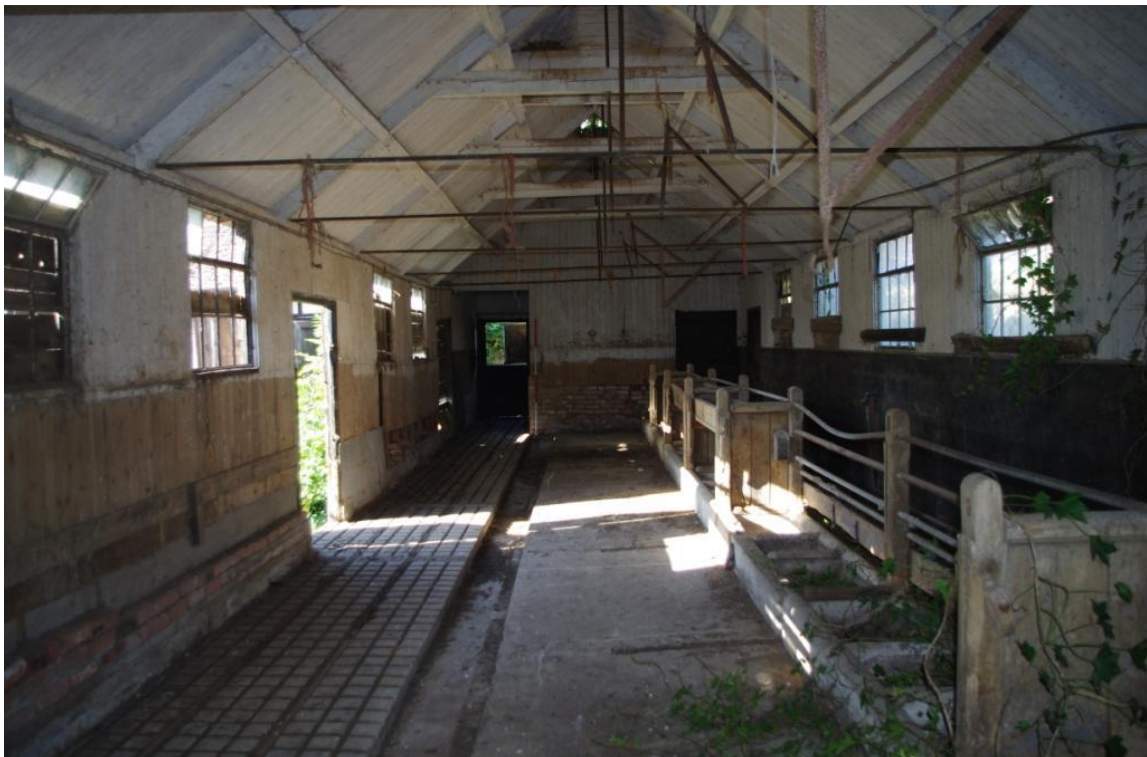
The north west range, (5) houses eight timber double cow stalls with a feeding passage (*Figure 6*). Interestingly, there are rails, most probably for mucking out along the south east wall (*Figure 7*); an innovative feature suggesting the building was well designed. The south west range, (8), (9) and (10) along the south westernmost bays of the north west range, (6) and (7) houses a series of loose boxes or calf/heifer pens. The north east range houses a series of processing rooms with tiled floors and storage tanks, (2) and (3). The south

Figure 6
(5), General View, Showing Stalls & Feeding Passage (Looking South West).

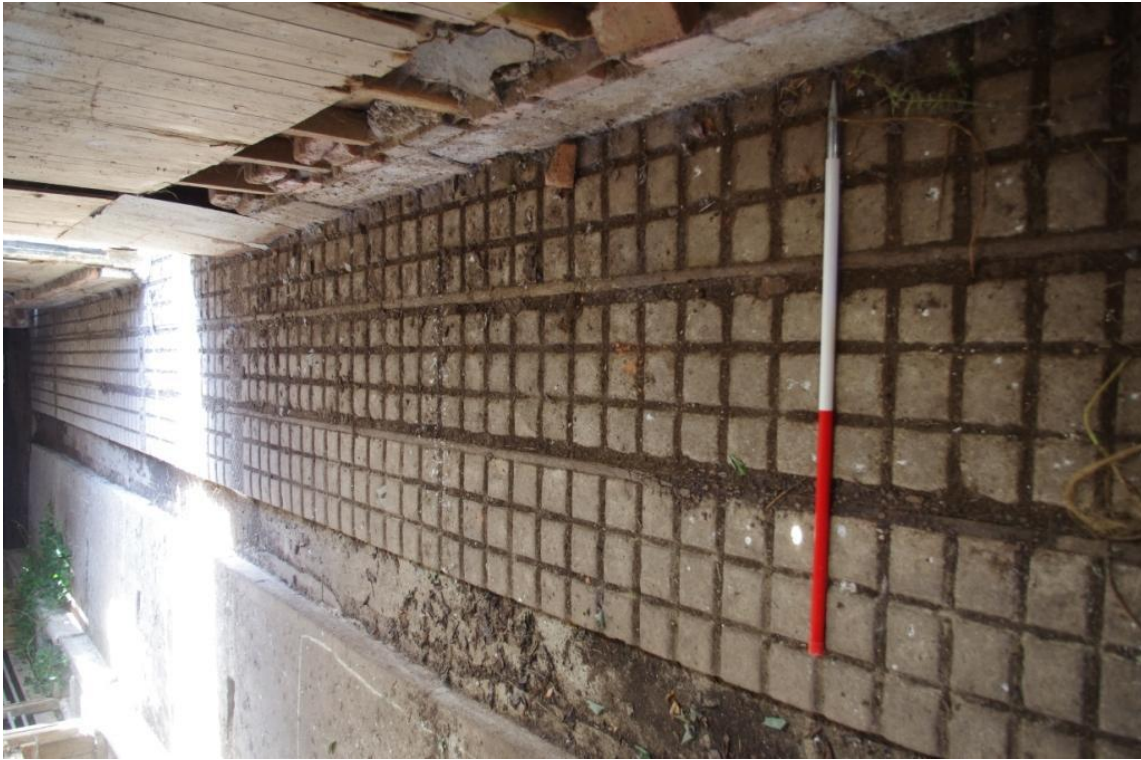
Figure 7
(5) Rails (Looking North East).

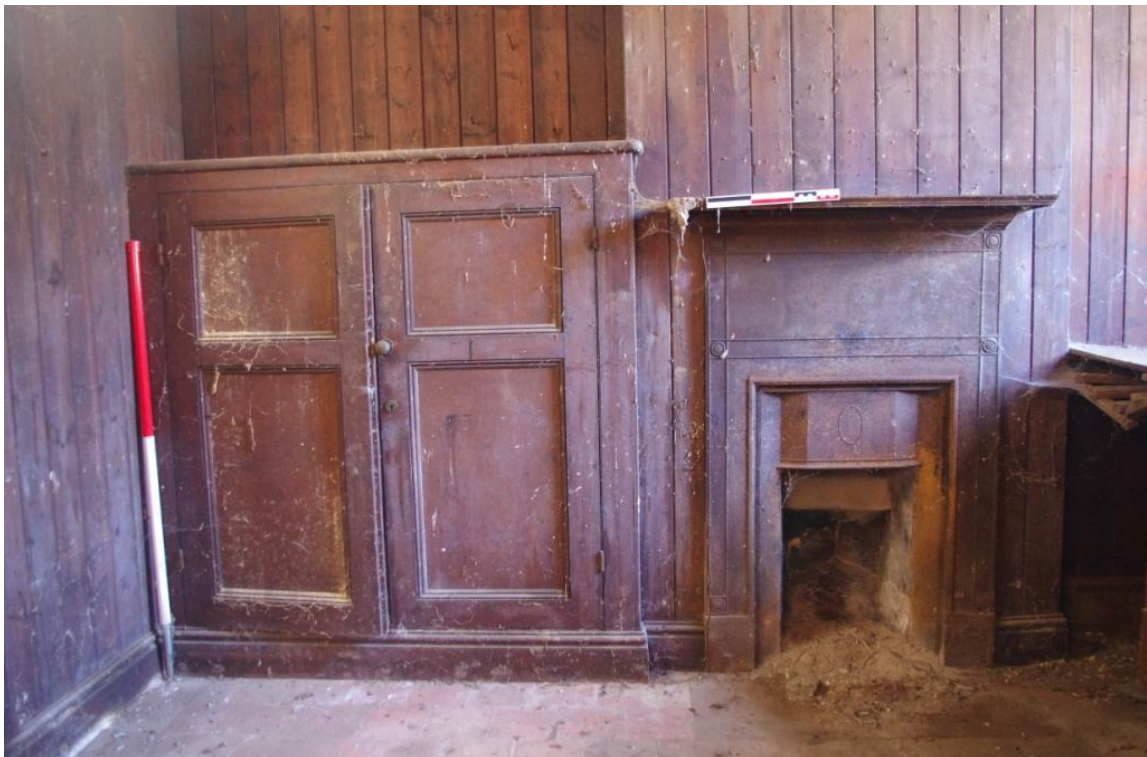
easternmost room, (1) is lined with matchboard cladding with a built in cupboard and cast iron fireplace (*Figure 8*) and domestic four panelled doors. The room clearly originally had a domestic purpose.

Figure 8
(1), Fireplace & Fitted Cupboard on South East Gable (Looking South East).
