Fristling Hall, Stock, Essex. Description and analysis of the farm buildings
at Fristling Hall. Surveyed 09 11 and 06 12 2011. CBC 10/01780/FUL.

The buildings are recorded to discharge a planning condition monitored by Essex County Council on Chelmsford Borough Council application 10/01780/FUL.

The buildings under study to EH Level 3 are:

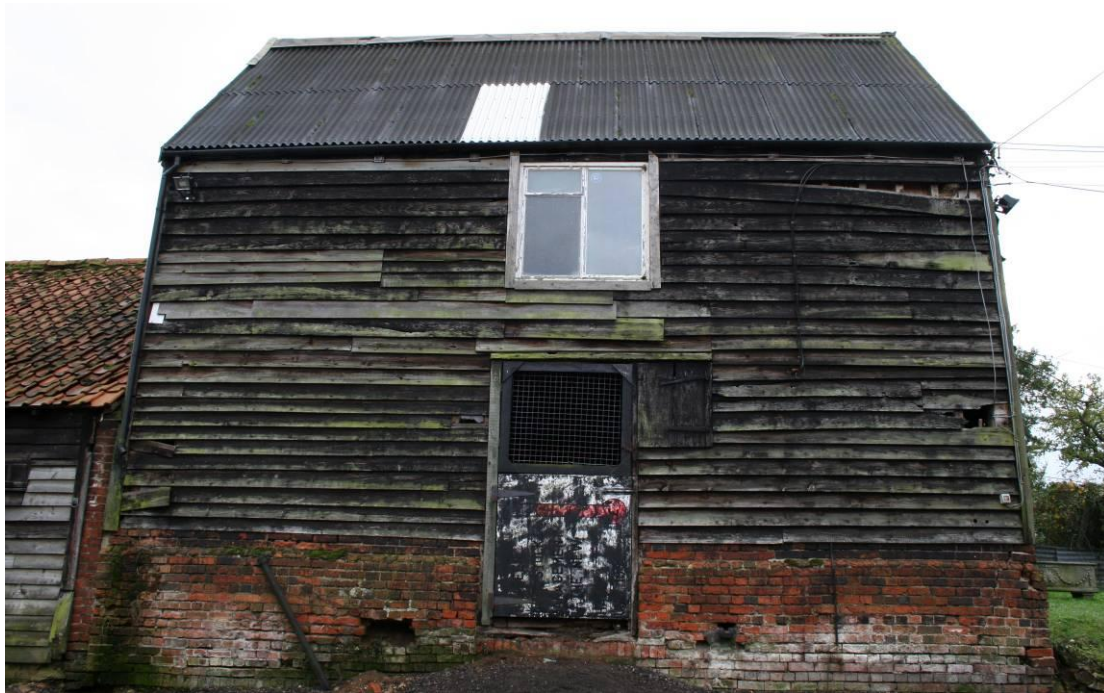
North Elevation.

The north elevation of the Granary.

The Granary is a 3 bayed, 2 storey timber-framed building clad with weather-boards of which nearly all are L20th replacements. These are characterised by their washed out and mouldy appearance, having been cold tar brushed long ago. They are bandsawn and fastened with French nails. There are some earlier hot-tarred boards under the eaves fastened with wrought iron nails. One has fallen exposing the scantling timber studs.

The frame sits on a deep plinth of 60x110x225mm red and purple bricks with creased faces, soft arrises, no pressure lines and no frogs. There are 13 courses exposed up from the ground to a moulded coping and then 2 more courses. The bricks are bedded in a beige sandy mortar in English bond. The quoins have no closer bricks and the door opening has closers on one side only implying it has been widened.

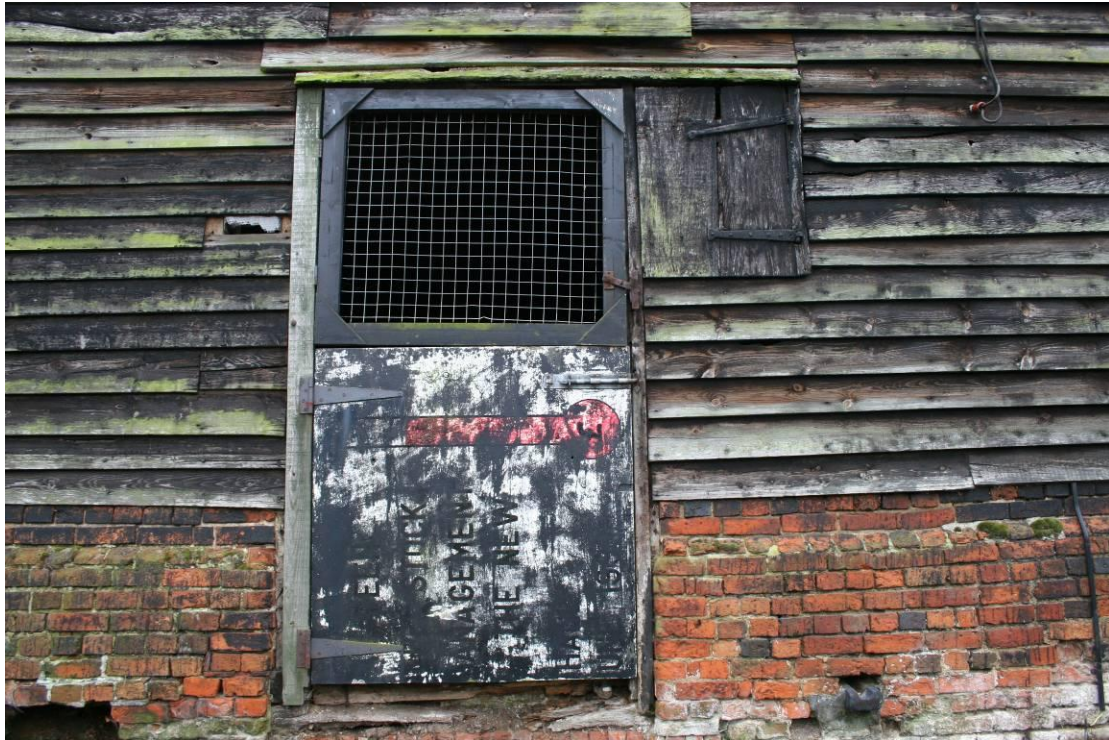
The central door into the Granary. The small hatch is specifically mentioned in the Listing.

Besides the main door is a small hatch door at head height. This is a 2 board gate and ledger construction with unmatched wrought iron pintles with spoon terminals. The timbers are nailed and clenched. However the opening can be seen inside to be inserted in the C20th so while the door appears older it is not in-situ.

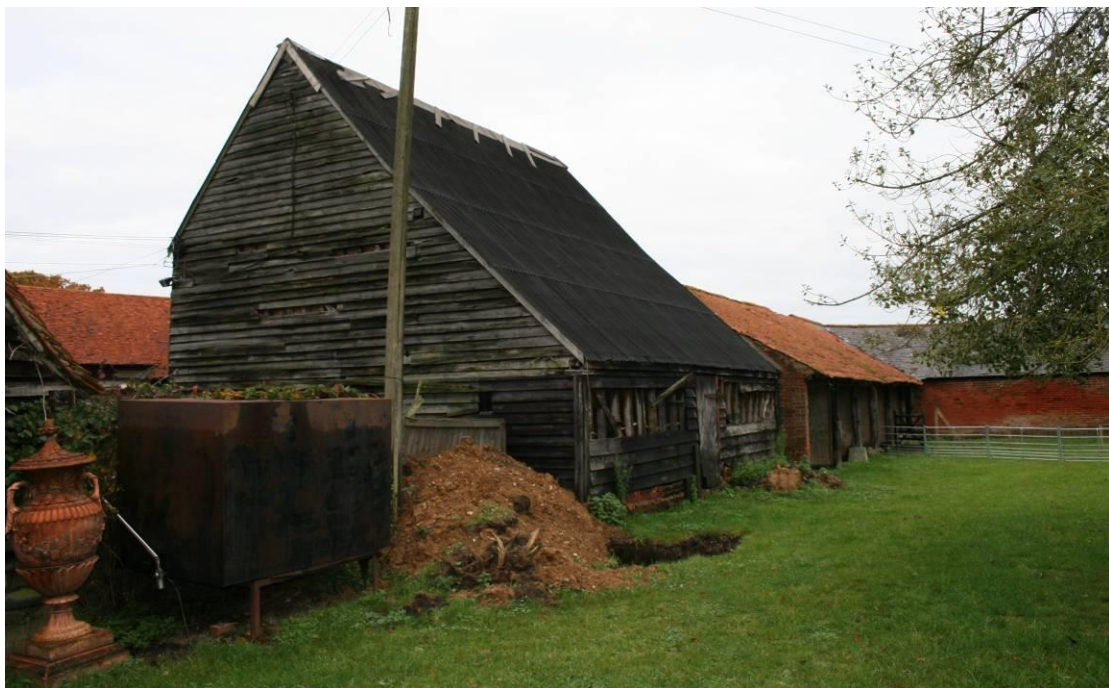
Western Elevation.

The western elevation is boarded with one tiny opening.

The western elevation is clad with C20th boards and presents the profile of a gabled end with a catslide roof to the south. There is no distinction in the cladding and the boards run across the two forms. A number of boards are missing and reveal the timber frame to have diagonal bracing with nailed interrupted studwork. There is a single small opening into the outshut. The roof is finished with narrow verge boards.

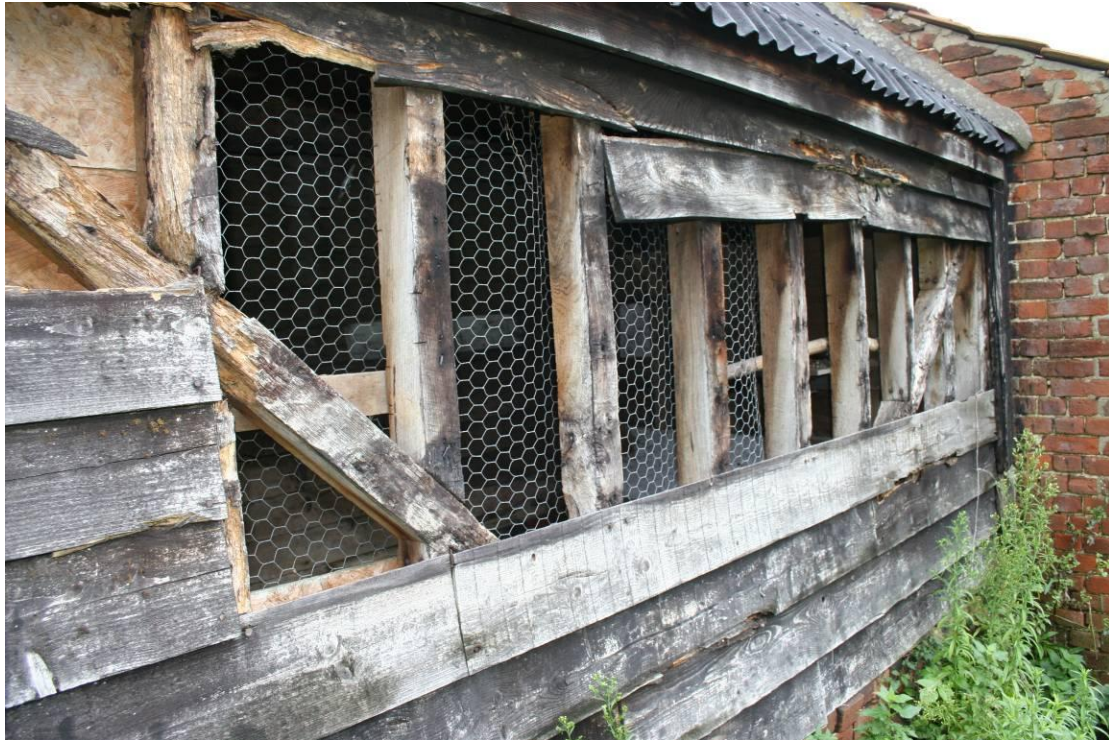
The framing of the easternmost outshut.

The cladding is bandsawn LC20th weather-boards and 3-4 runs have been deliberately removed to create light and ventilation. The frame has then been chicken wired on the inside to create bird cages for game birds such as pheasant. Unfortunately this has allowed the weather into the frame causing it to rot prematurely. The studs all appear to be oak.

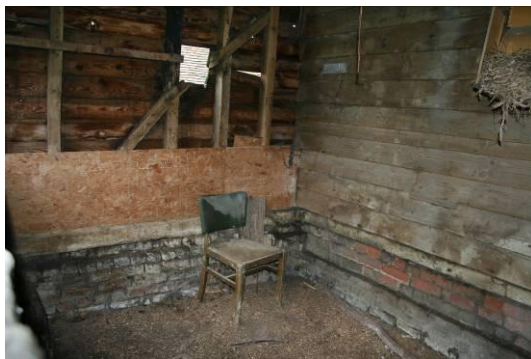
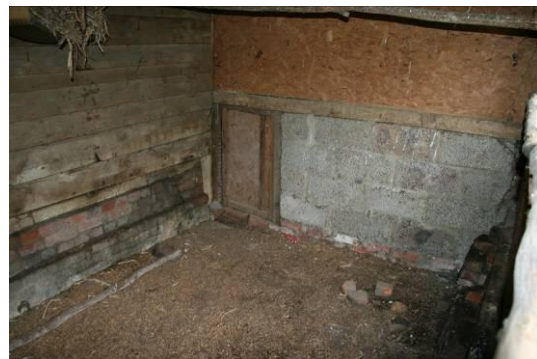
The interiors of the west (LHS) and eastern outshut bird cages.

The interiors of the bird cages are unremarkable except that the main frame retains its original weather-boards fastened with wrought iron nails. The dividing corridor is also boarded with these but the door to the exterior is a LC20th piece of plywood sheet. The western opening into the western outshut is badly positioned as the diagonal brace has been pointlessly severed to achieve it.

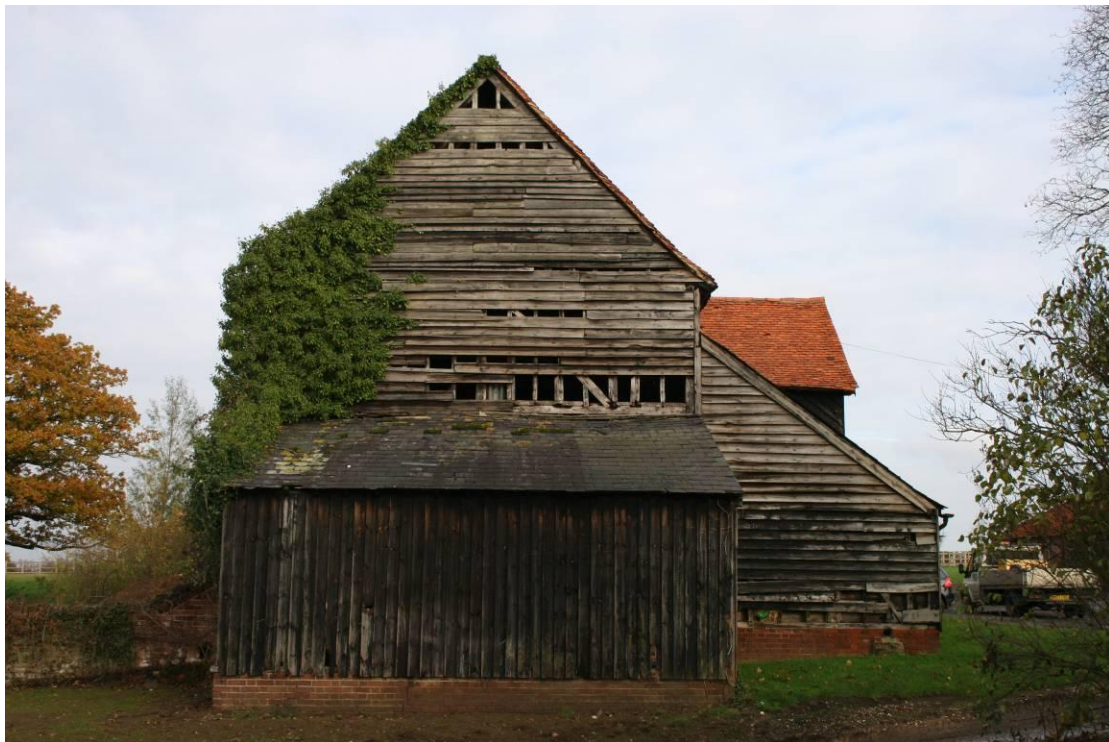
The western elevation with a lean-to garage.

The western elevation presents the gabled end of the Double Barn in poor condition with boards missing and the nailed, interrupted studwork revealed. Most of the boards are C20th but there are a few older ones picked out by their darker colour. The apex has been left open and this is probably deliberate to aid ventilation.

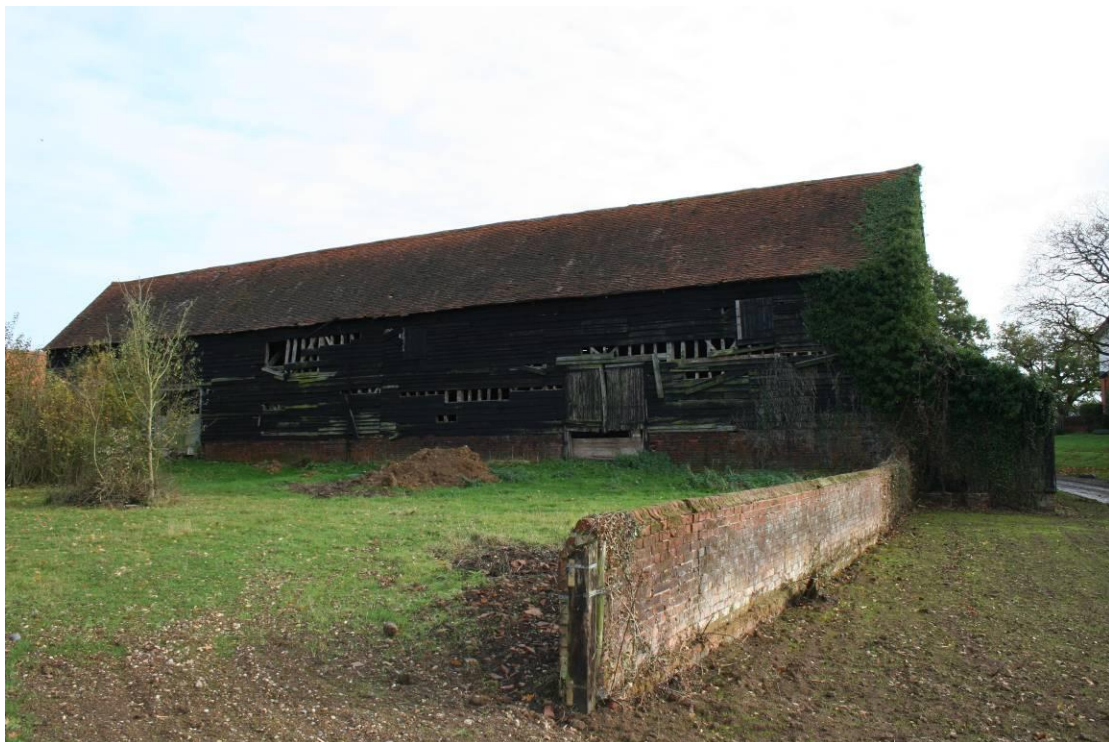
The rear of the Double Barn. The wall is of C19th bricks.

The northern side is effectively the rear of the Double Barn. The yard is closed off with a C19th brick wall with bell-shaped copings. The Double Barn has two half-height rear midstre doors in poor condition. The weather-boarding is hot-tarred and nearly all of the older type. There are patch repairs mostly highlighted by the green mould growing on them. A large number of boards have fallen off due to the failing of their wrought iron fixings. The two easternmost have recent cladding.

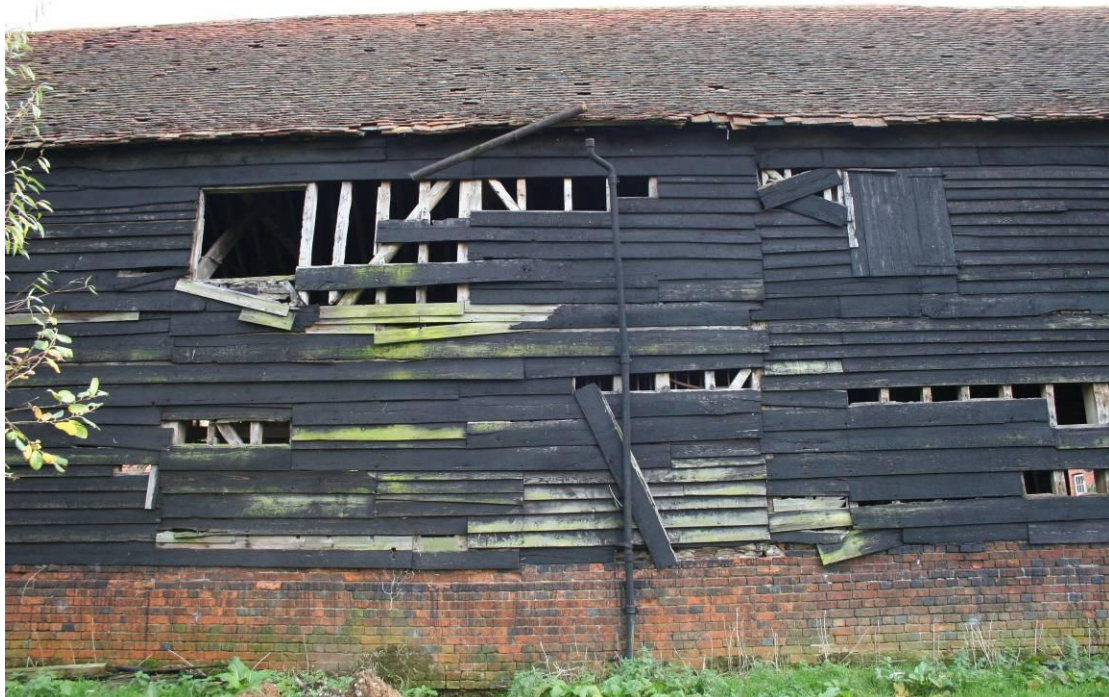
Vertical break in the weather-boarding. Framed hatches with C19th door remaining.

Between Bays 5 and 6 there is a vertical break in the weather-boards but not the plinth.

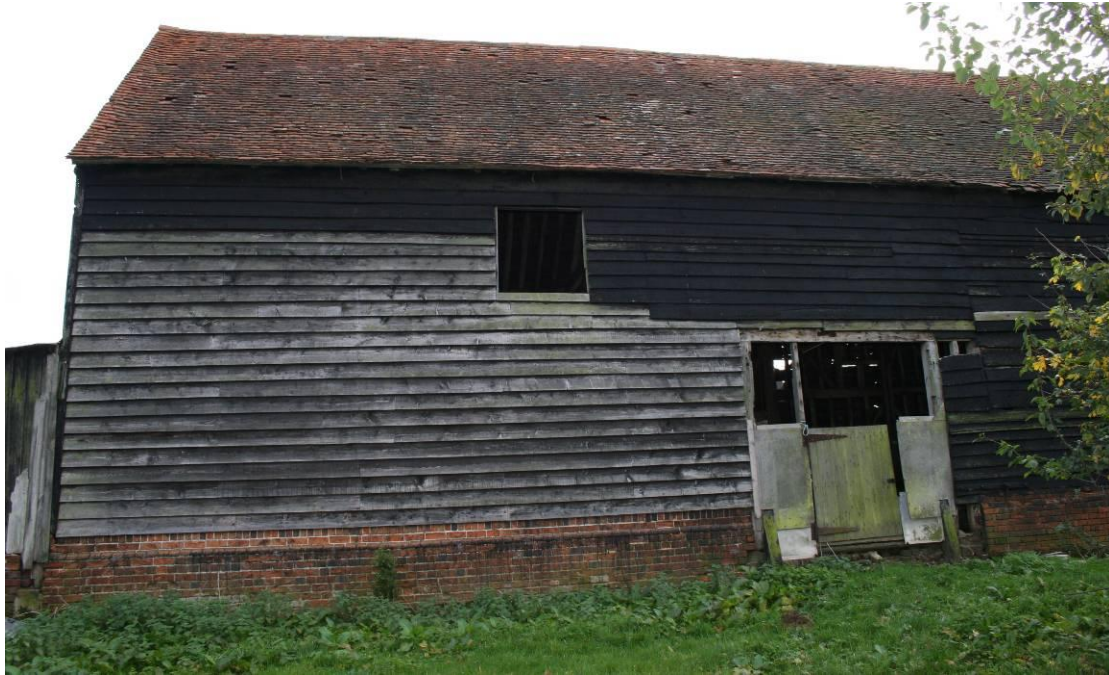
The eastern end of the Double Barn has been reclad in the C20th.

The last two bays to the east have been clad in LC20th softwood and the doorway infilled with a marine ply construction to reduce it to a pedestrian door with side lights. This has mostly failed.

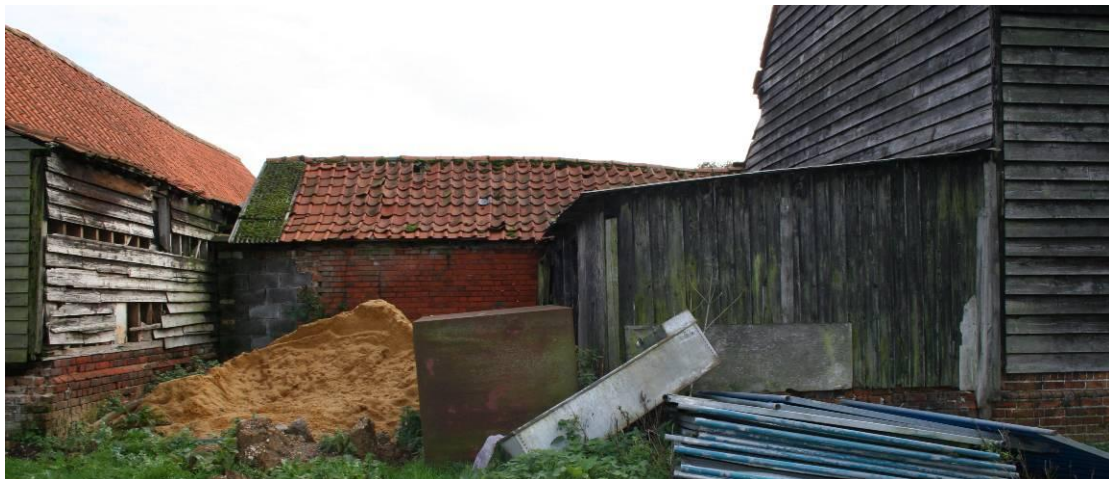
The western flank is in very poor condition. Extreme left.

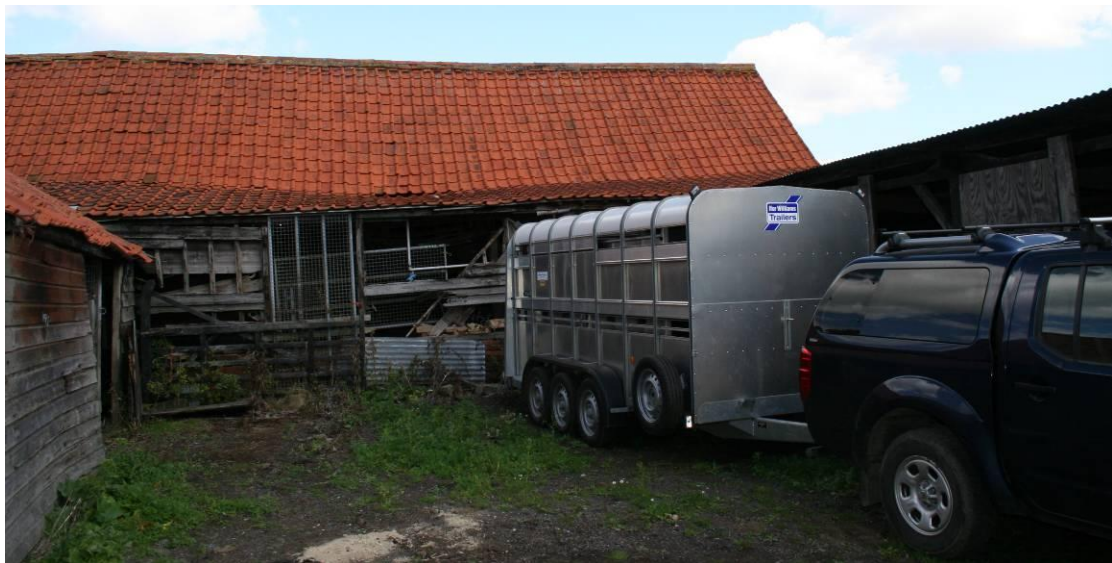
The section visible in the stable yard is in poor condition and shored up.

The wider tarred boards can be seen in the horse stalls inside the Barn Stable and the Modern Stable which form the Livery courtyard. The timber is in poor condition having suffered from water ingress and being chewed by bored horses. The section exposed has failed very badly and is blocked off with a variety of old gates and corrugated metal sheets. The roof of the extension is badly bowed allowing in rainwater and rotting the frame. The pitch of the roof is near flat which is very unsuitable for roman style tiles.

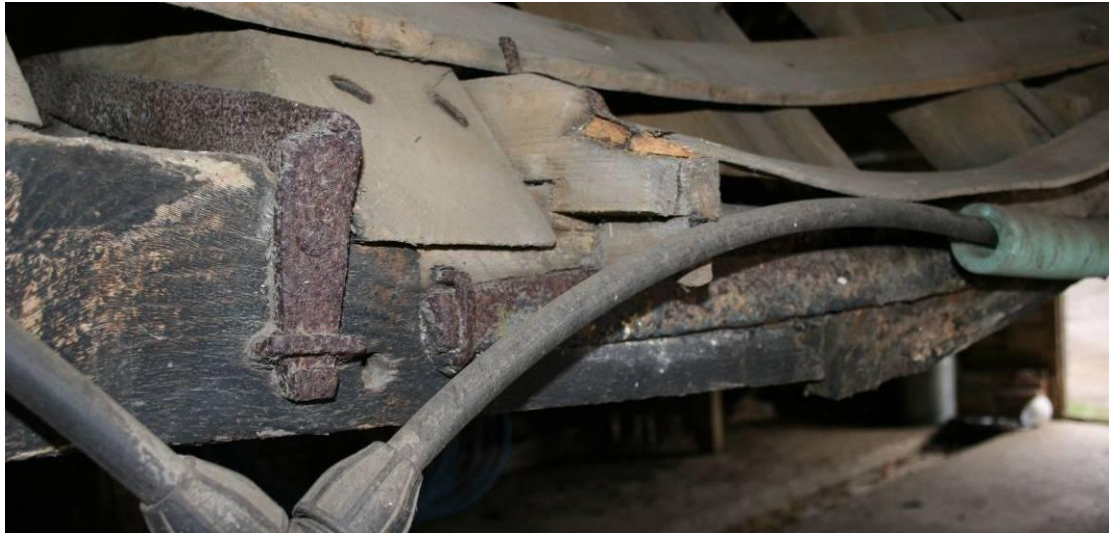
Victorian ironwork reinforcing the western plate.

The vertical posts supporting the western plate have LC20th fish plates at their bases set into the concrete but the rest of the ironwork is Victorian in design. This ironwork is typified by its flat section and simply bent and twisted form. Earlier blacksmiths would have upset (thickened) these bends to prevent fatigue failure. By the MC19th the properties of the iron were better understood and the sections thinned out. The same can be said of the timber-studwork and that in the western wall of the extension is made of nailed interrupted scantling which may have been robbed out from the earlier wall.

The use of fish-plates (two straps either side of a failing joint) and the round headed machine made clout nails also point to a M-L19th intervention.

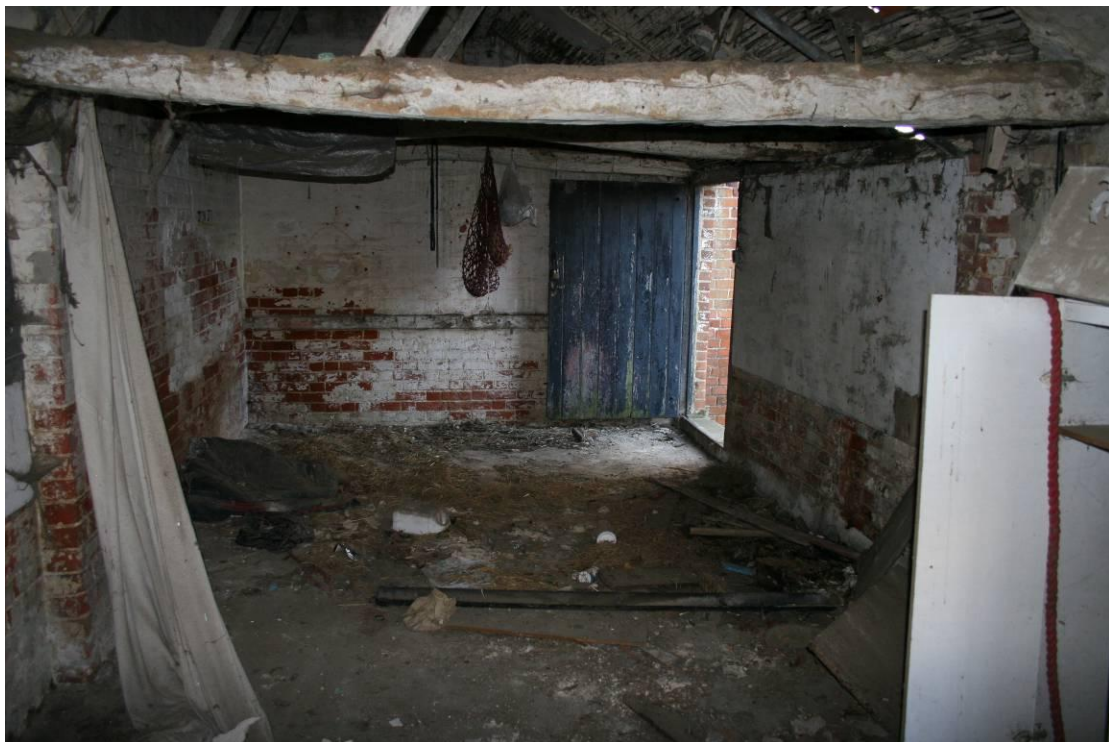
Inside the Tack Room looking W.

The interior of the Tack Room is rather derelict. The ceiling was finished with riven lath and plaster of which much has failed and the roof has badly bowed. The two elm tie-beams have raking struts to support the central purlin. There are fittings to show a horse called Jonjo was recently kept here. The LC20th cupboard and bookcase indicate this was a tack room.
