Havering Grove Farm, Hutton nr Brentwood, Essex.  
Description and analysis of the farmyard buildings.  
Surveyed 19 07 2011.

This report deals with the farmyard buildings that were formerly part of Ellis's Farm and are now under conversion to residential use. Planning app. no: Brentwood Borough Council - BRW/0265/09 and BRW/0278/11. The buildings were recorded to report at RCHME Level 2.

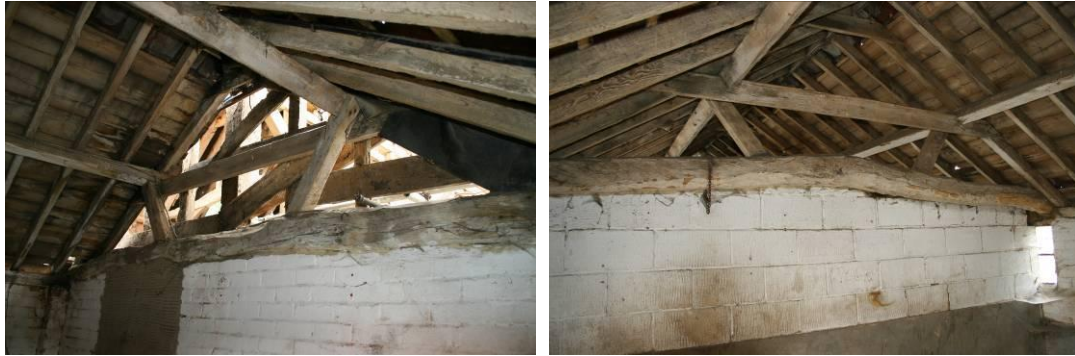
The low-pitch roof has short raking struts to the purlins. Stall 4 looking SE and NE.

The roof structure is again a simple clasped side purlin design with short struts off the reused elm tie-beams, halved and nailed with large clouts. The principal rafters pass alongside the tie-beams so there are no true trusses. The rafters are sawn 2x4in softwood nailed onto a ridgepiece and the eastern side is boarded horizontally.

The pitch of the roof is low, suitable for grey slate tiles and a few remain near the eaves. One of the rafters on Stall 2 has a merchant's mark '201' made with a race knife.

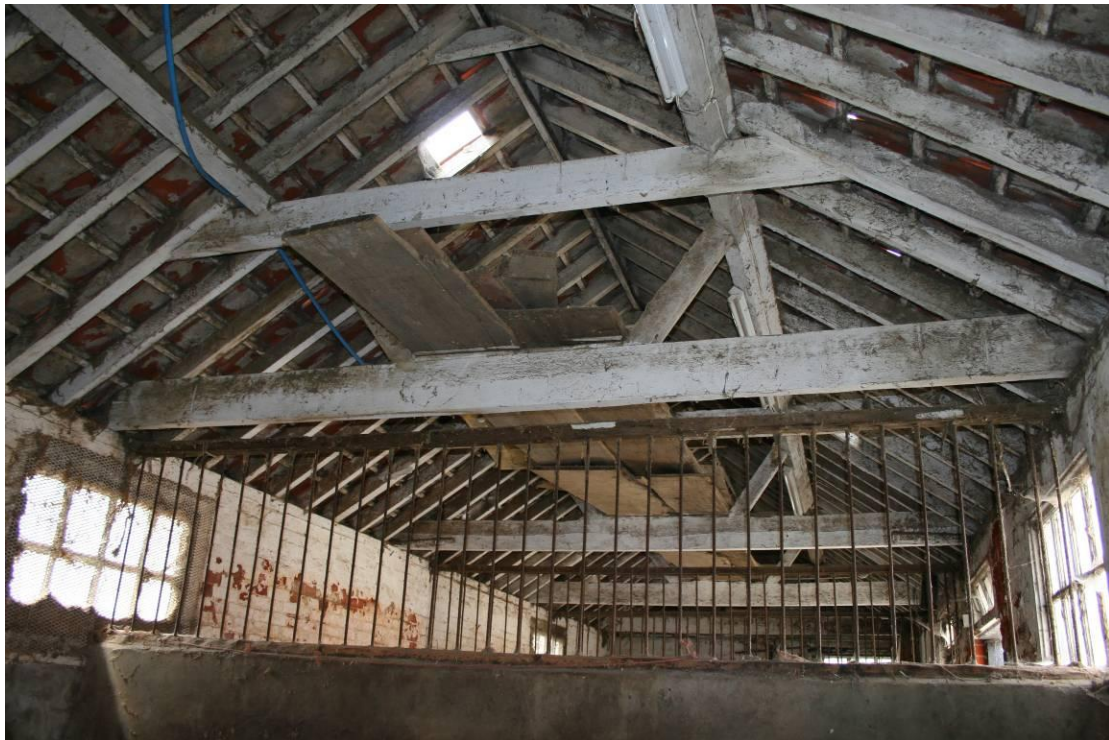
Roof structure looking west. Oak planks are stored on the tie-beams.

The roof structure is again a clasped side purlin design with short raking struts off the tie-beams. However all the timbers are machined. The 2x4in rafters are nailed to a ridgepiece, the side purlins are 4x6in, the tie-beams 3x9in and the principal rafters are 3x4in and secured with halved and nailed collars of the same section. The tie-beams are secured with iron ties which are rusty enough to be mild steel.

The roof is heavy battened with no underlay but all tiles look relaid. The walls, timbers and tiles have been coated in limewash which has been rubbed off the tiles. Some very wide and long oak planks have been stored on the tie-beams along with various other planks.

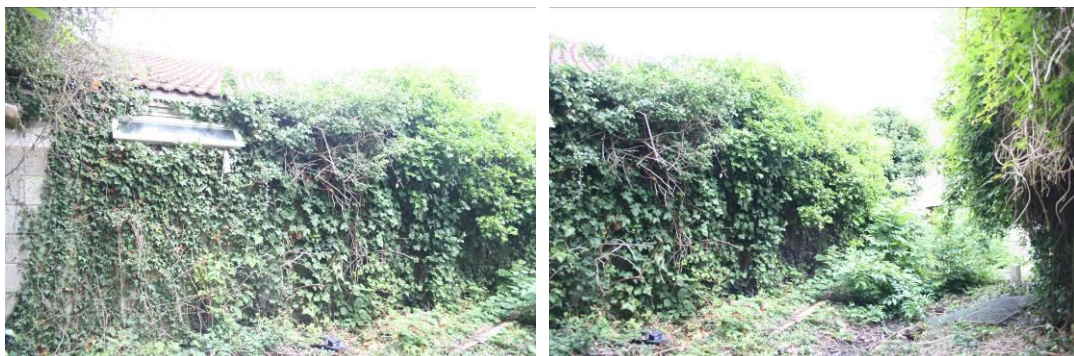
The south elevation is consumed by foliage. Window to store. Looking NE.

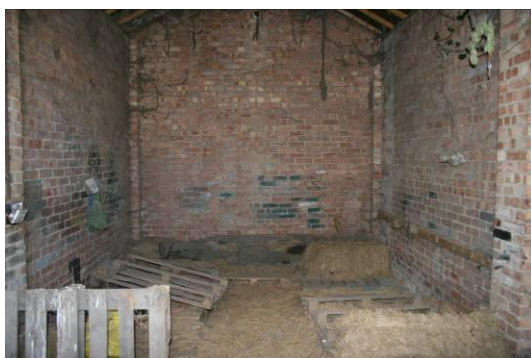
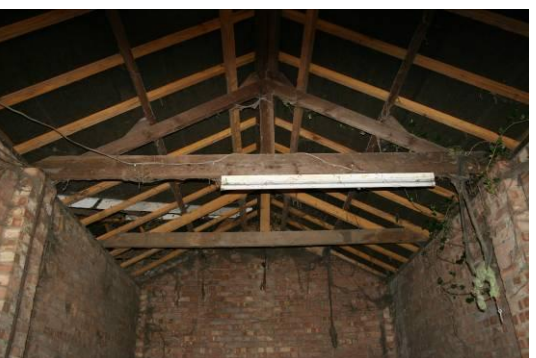
Blank interior and repaired roof using a C19th machined timber truss.

The interior is devoid of features and is currently in use to store hay for the stables. The floor is concrete. There are no windows. The roof is supported on a reused LC19th king strut truss cleated to support pairs of reused side and ridge purlins. A second pseudo truss has been created using a plank. The rafters are all LC20th and are bright in comparison to the old brown timbers.

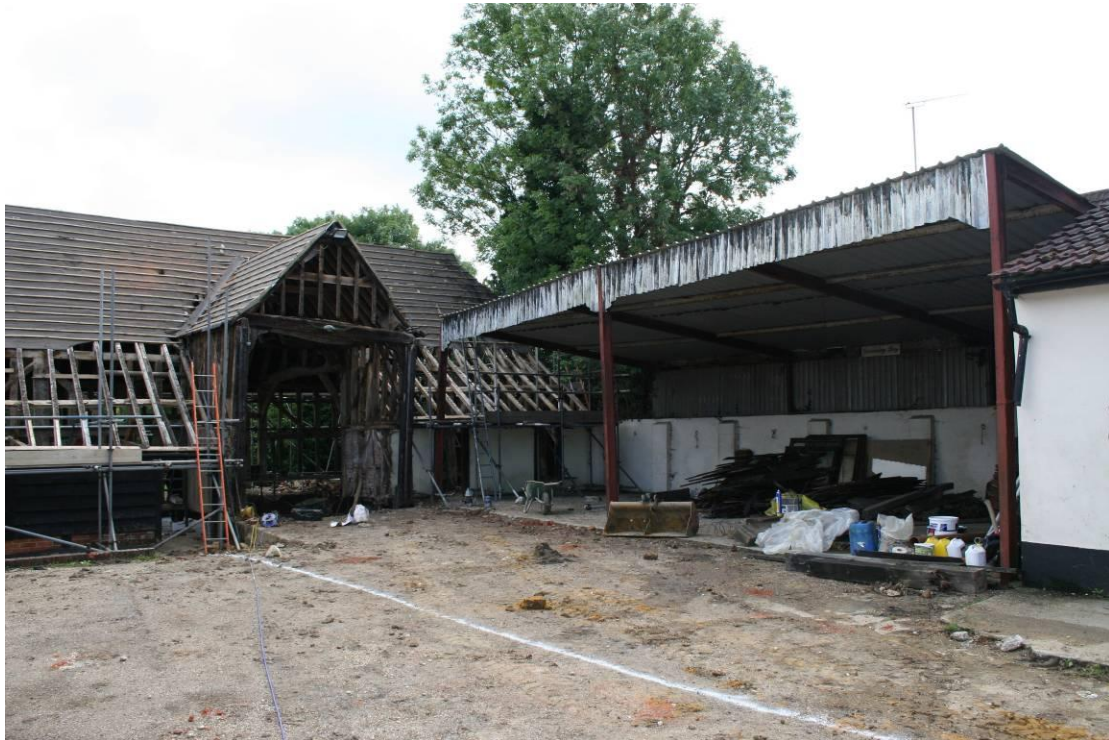
Asbestos roofed shelter. Looking SE.

Lodged between the Barn and the South Stables is a LC20th steel framed implement shelter with a corrugated asbestos roof, front valance and rear panels. The lower rear wall is built of brick to the same pattern as the stables. On the walls are modern galvanised tethering rings and a sign saying 'Grooming Bay'.

Asbestos was regulated in 1969 (the Asbestos Regulations 1969) but not banned until 1985 (Asbestos (Prohibitions) Regulations) but its use was phased out in the 1970's as it became realised what a dangerous material it was. However prefabricated buildings continue to be reused where the danger of exposure is negligible. Aerial photography shows the building was not in place c.1980.

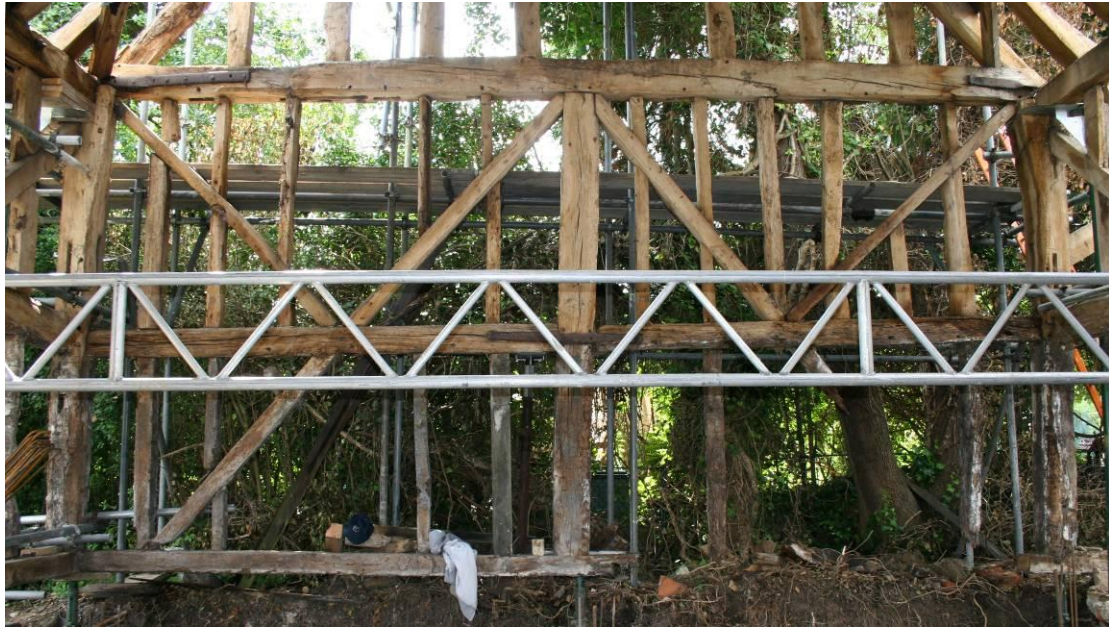
South elevation of the Barn. Note rotted away sole plate.

The south wall exemplifies the style of construction throughout the Barn. The tie-beam is reused with the original mortices left and the studs repositioned and in most cases turned through 90 degrees and nailed in place. Many have darts for wattle and daub panelling either turned or upside down. The primary braces are set in a V formation either side of the central post. The mid-rails are secured with Georgian style wrought iron straps and ties clout nailed and stapled. Much of the lower part of the south wall and the west walls have rotted away due to the raised levels on the outside from tree growth and the laying of concrete.

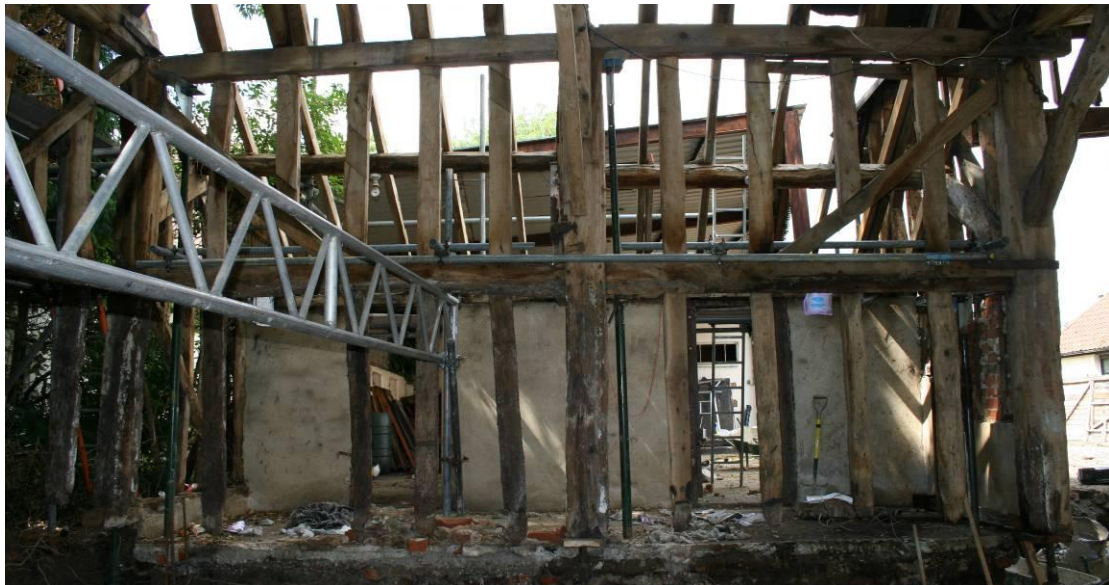
The SW corner of the Barn. Bays 4 and 5. Note trenched studs out of place.

Each bay has a single primary brace above the mid rail and the 6in thick oak studs are all clearly reused with darts and trenches for earlier braces all out of place. Where possible the original mortices have been used but many studs have been turned.

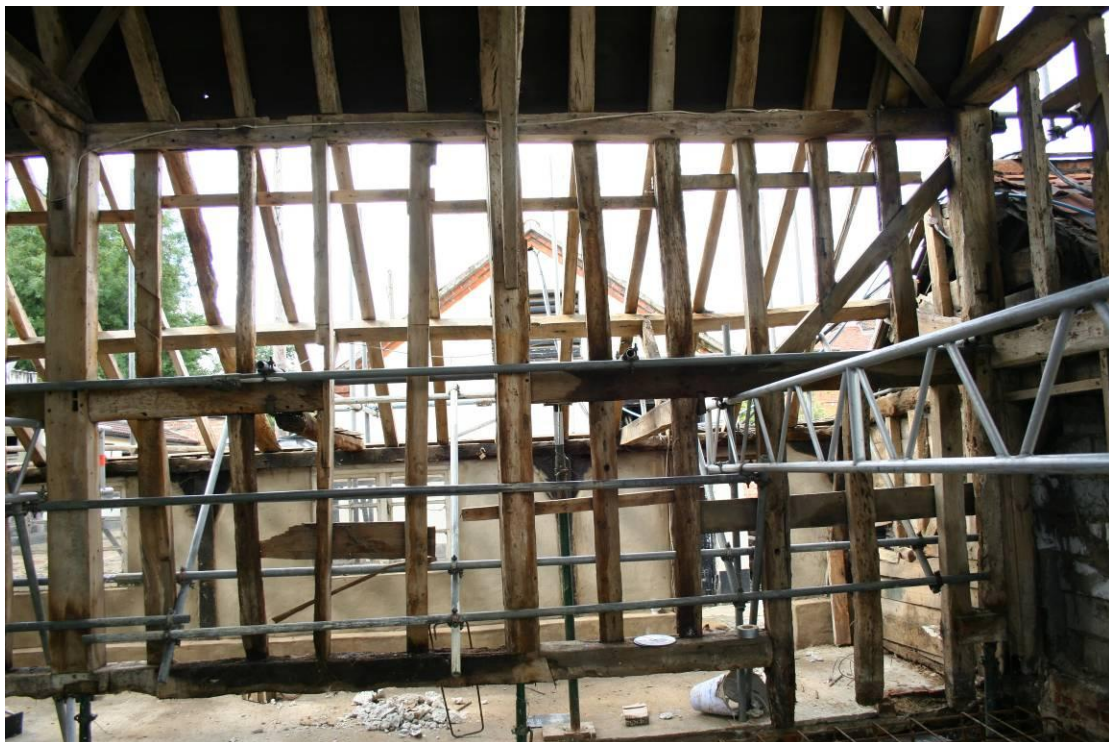
Bays 1 and 2 looking west. Note severed mid-rail and sole plate for former openings.

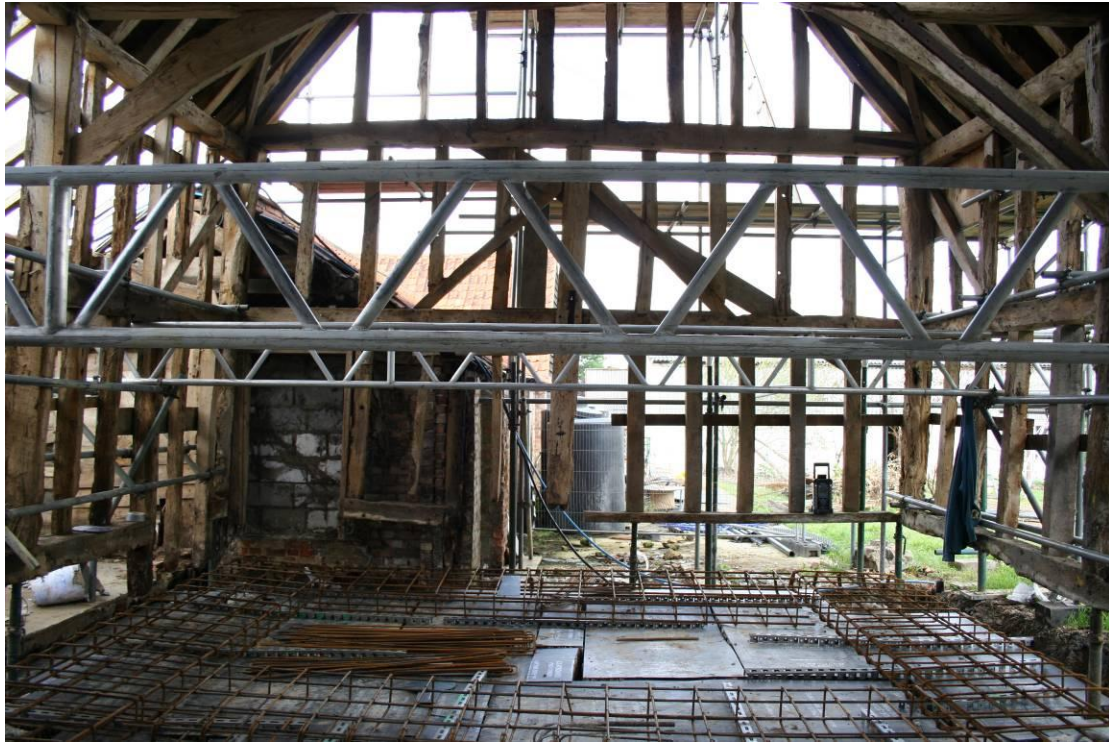
The northern elevation. Note opening for door into East Stables.

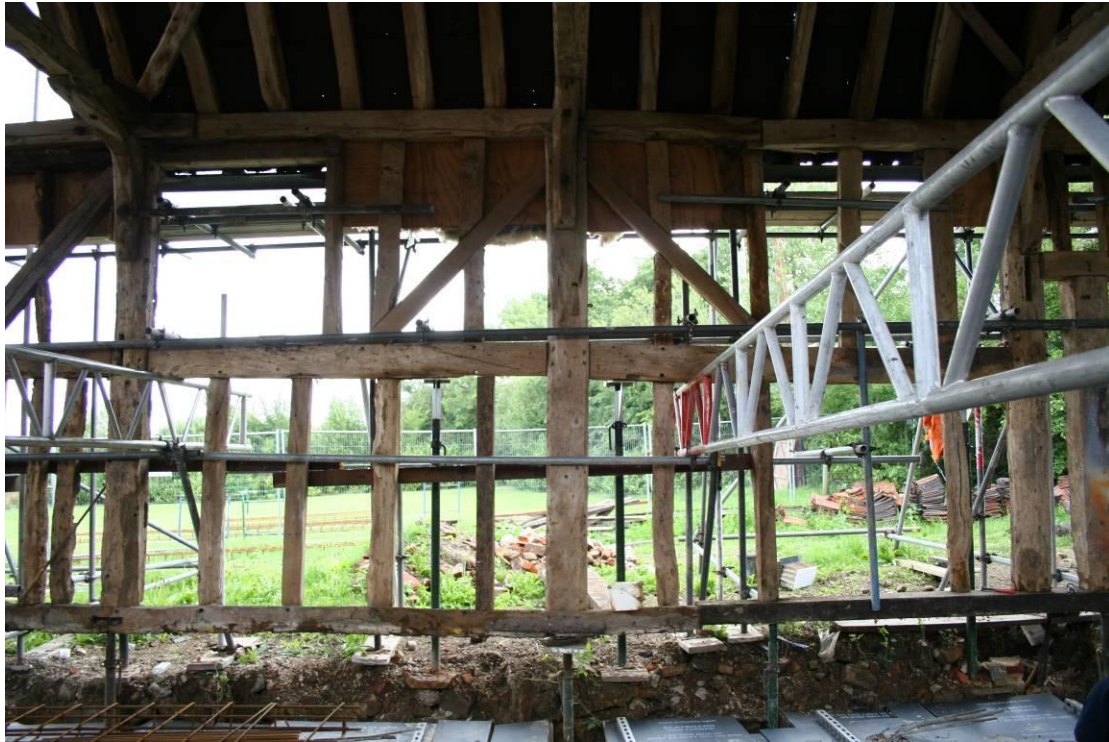
Bays 3 and 4 looking east. Note openings for high level hatch and doorway.

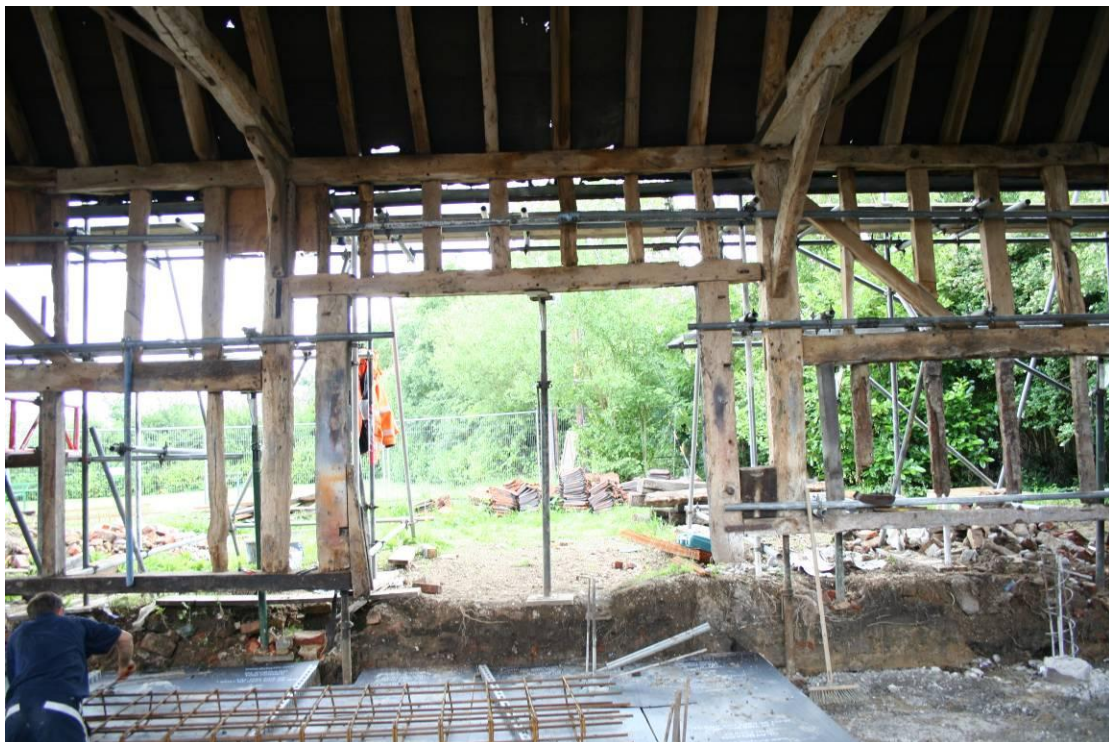
Bay 5. Framed doorway for full height doors. Note hanging knee and straight braces to tie-beams. Also mid-rail removed to insert door lintel.
