Ken Browns Garage, 42-44 Potter Street, Harlow, Essex.
Description and analysis of the timber-frame contained within the
Maintenance Workshop. Surveyed 06 10 2011.

| Type of Work: Historic Building Recording | Site Director/Team: Barry Hillman-Crouch |

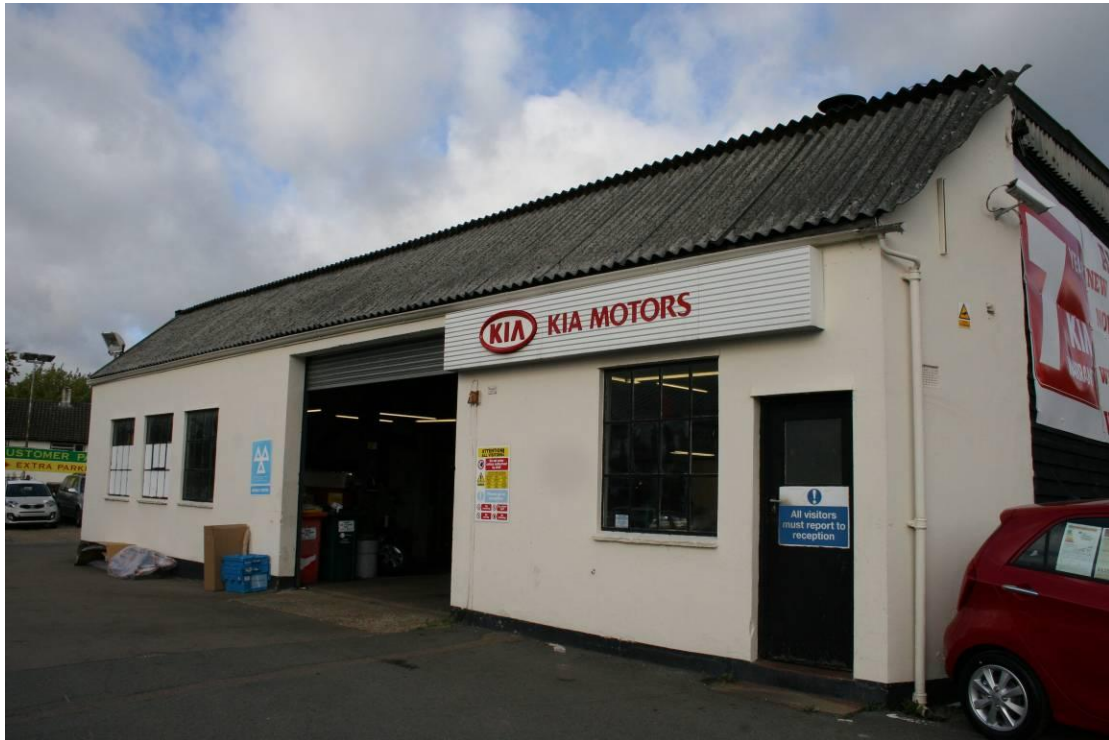
Southern Elevation

Southern elevation is built of reinforced concrete beams and blockwork.

The southern elevation is the main facade and houses the front entrance door sealed by a modern roller shutter. The doorway is off-centre and represents the midstrey of the original timber-framed barn. Either side there are large 12 pane rolled steel casements of which the second from the west has an opening light. In the SE corner is a LC20th half glazed door to an inserted WC cubicle.

The facade is built of reinforced concrete beams, visible inside and blockwork rendered with cement or concrete and painted over. This style of fabrication became popular in the 1920's with some of the earliest examples in the country in Braintree and more notably Silver End but really took off in the 1930's with the expansion of aviation inspired buildings.

The roof has three pitches and is a 2x4in softwood construction clad in corrugated asbestos and drained with painted metal rainwater goods. There is a C21st illuminated KIA MOTORS sign, an MOT sign and various health and safety notices.

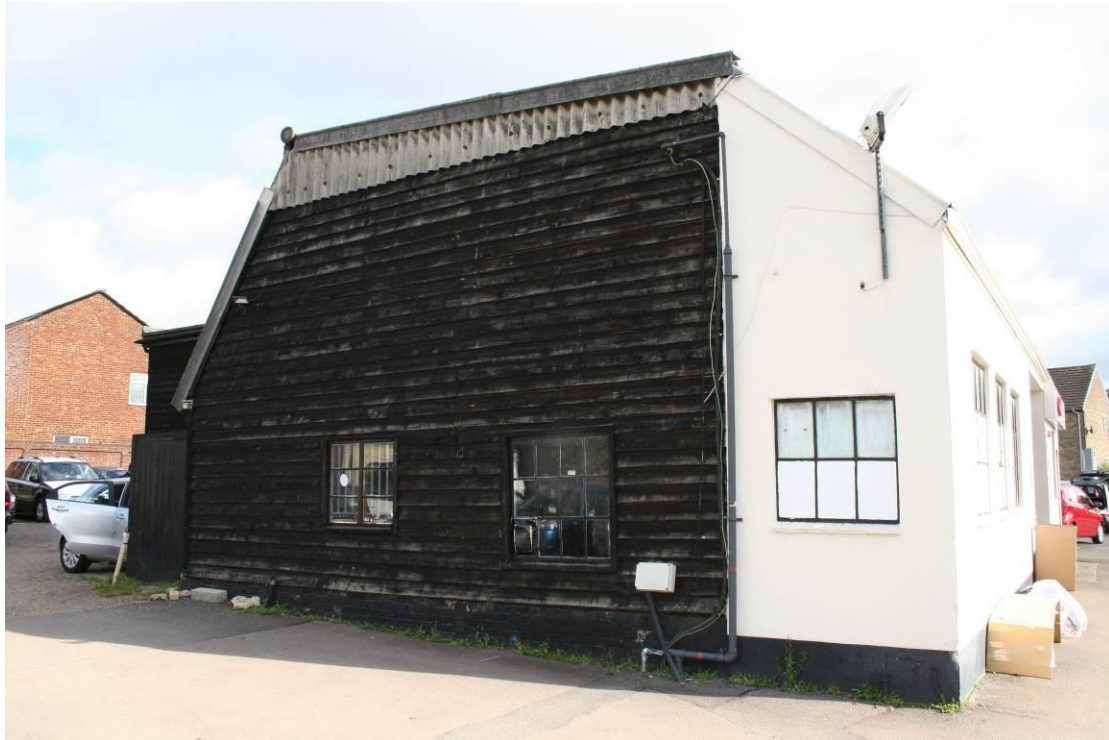
Western Elevation

The western elevation retains the original pitch of the barn roof to the rear.

The western elevation is to the back of the plot and shows that the concrete facade has been returned to give it stability. The return section represents the width of the original aisle of the barn within. The remaining structure is clad with LC20th bandsawn weather boards fixed with galvanised nails. The roof is sealed with asbestos barge boards and a corrugated asbestos skirt.

There are 3 rolled steel framed windows. The 6 pane window to the south is of the same pattern as those on the front facade, while the central window is a fixed casement with smaller panes. There is also a domestically styled opening casement which is barred inside. These are all typical in style of the Crittall window company who were producing in vast quantities from the mid 1920's onwards from their Silver End factory.

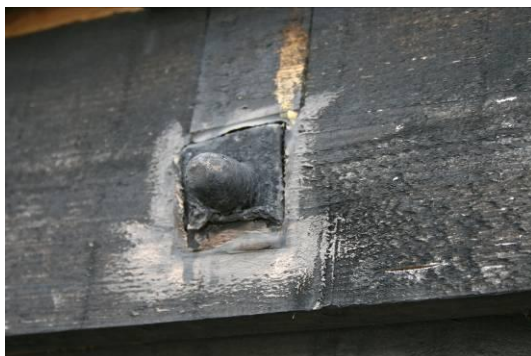
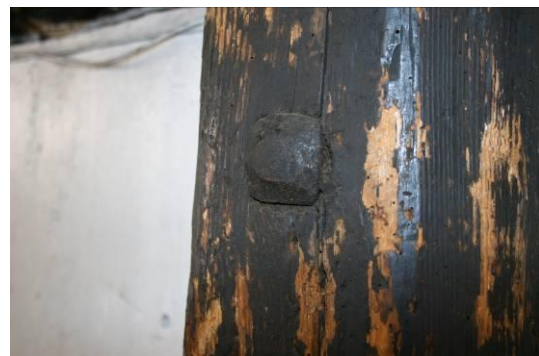
Square headed threaded bolt of the EC19th. Inside they secure a full height post.

Of note is a pair of square headed bolts which represent a Georgian period repair.

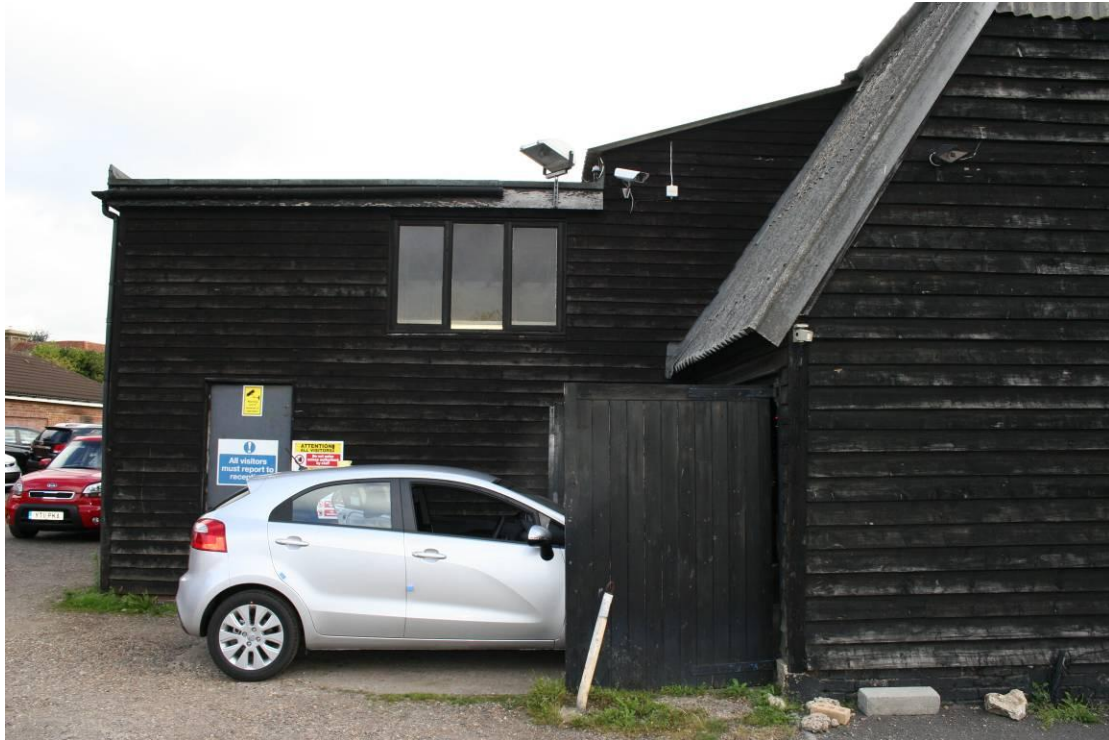
The rear of the building looking E. The rear bays were added in the LC20th.

To the rear of the building can be seen the flank of an extended bay also clad in the same weather boards with a high level plain glass 3 light casement. There is also a metal clad solid timber C20th security door into the bay. The roof is of two pitches dropping down from the main roof to a large asphalt covered flat roof. The rainwater goods are grey plastic.

The rear of the main barn retains the steep pitch of the former roof although there are no original rafters inside.

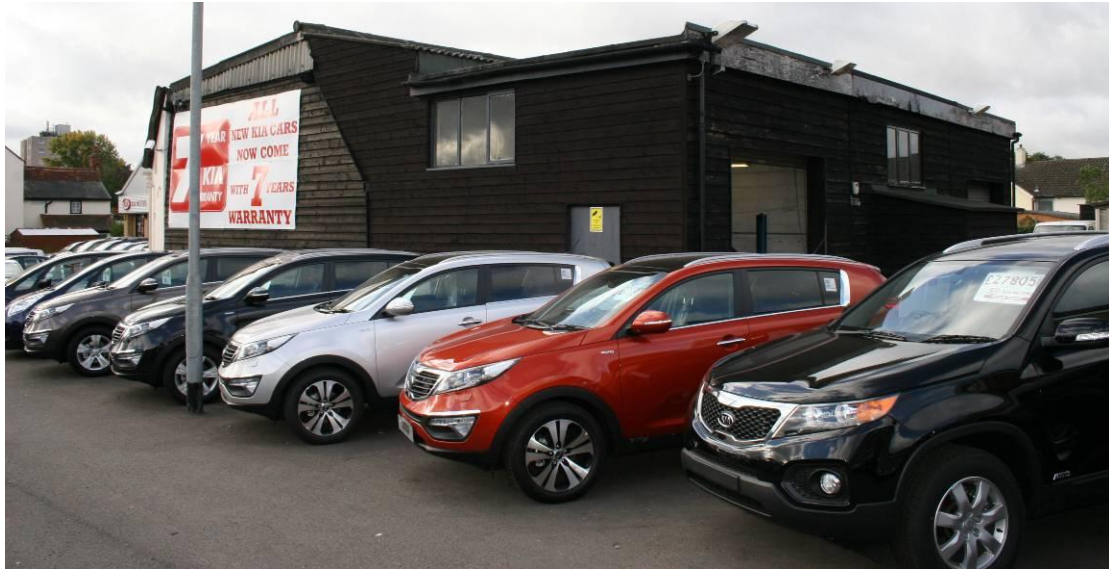
Eastern Elevation

The eastern flank is a reflection of the western minus the large windows.

The eastern elevation faces the road and its bland appearance has been exploited for temporary signage. Like the western end the flank is weather-boarded with a concrete return from the main facade. There are no low level windows but the high level lights and door into the rear bay reflect the other side of the building.

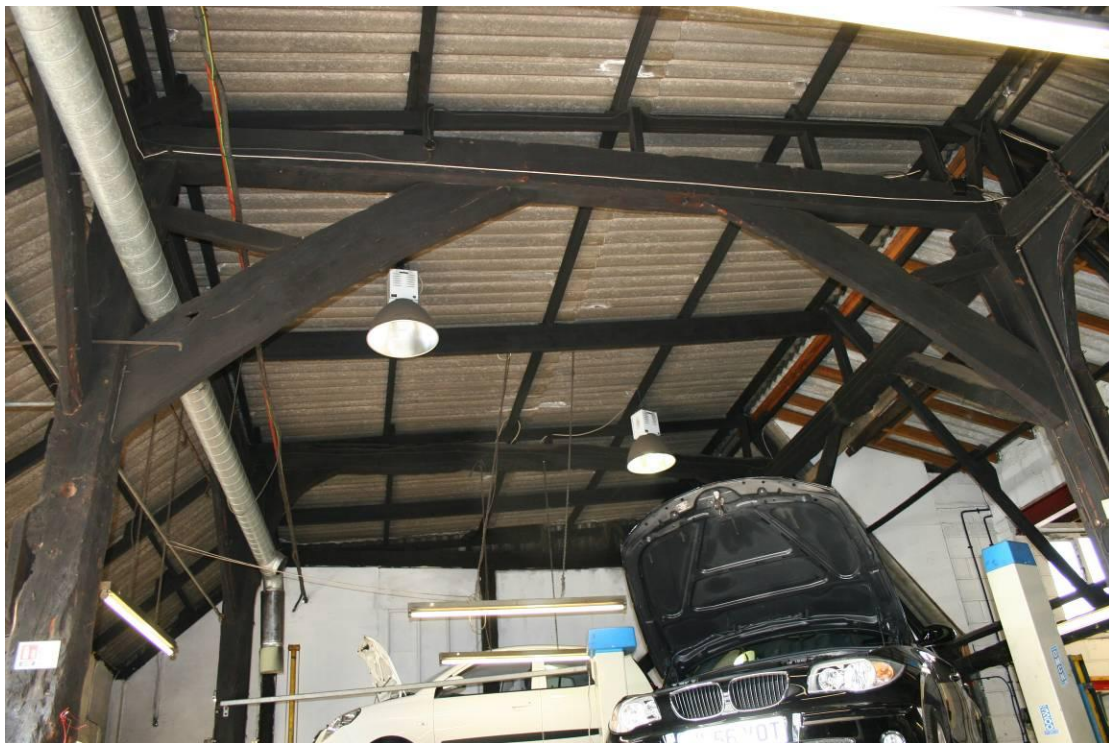
The arcade posts of an aisled barn. Truss 2 from the west.

The trusses are largely complete but only two aisle ties remain. All the timbers have been painted black except where they were evidently boarded over at the time.

The main building is of four bays between the arcade posts of a timber-framed aisled barn. The walls have been removed except at the ends where they have been remodelled for the current roof structure and the studwork clad in hardboard. There are three open aisled trusses with heavy, curving spandrels from the arcade posts to the tie-beams. There are also straight braces up to the arcade plates. The roof structure has been removed including all the rafters but the form is indicated by two pairs of pegs in each tie-beam showing where queen posts would have been.

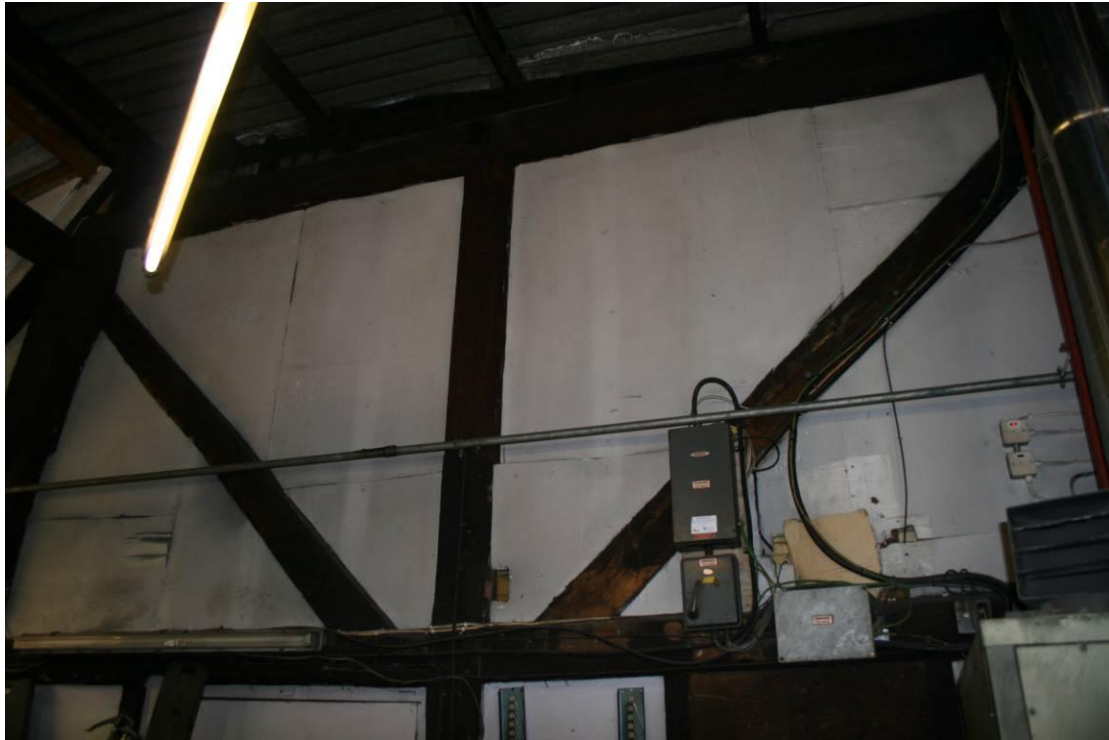
The eastern wall.

The eastern wall is of interest because it contrasts with the features of the western wall. The corner posts both have heavy wide jowls sharply cut in at their bases. Large, very slightly curved primary braces fall to the mid-rails and have double pegs. The braces have no peg holes so it is likely they are trenched across the original studs being nailed with pairs of wrought iron nails.

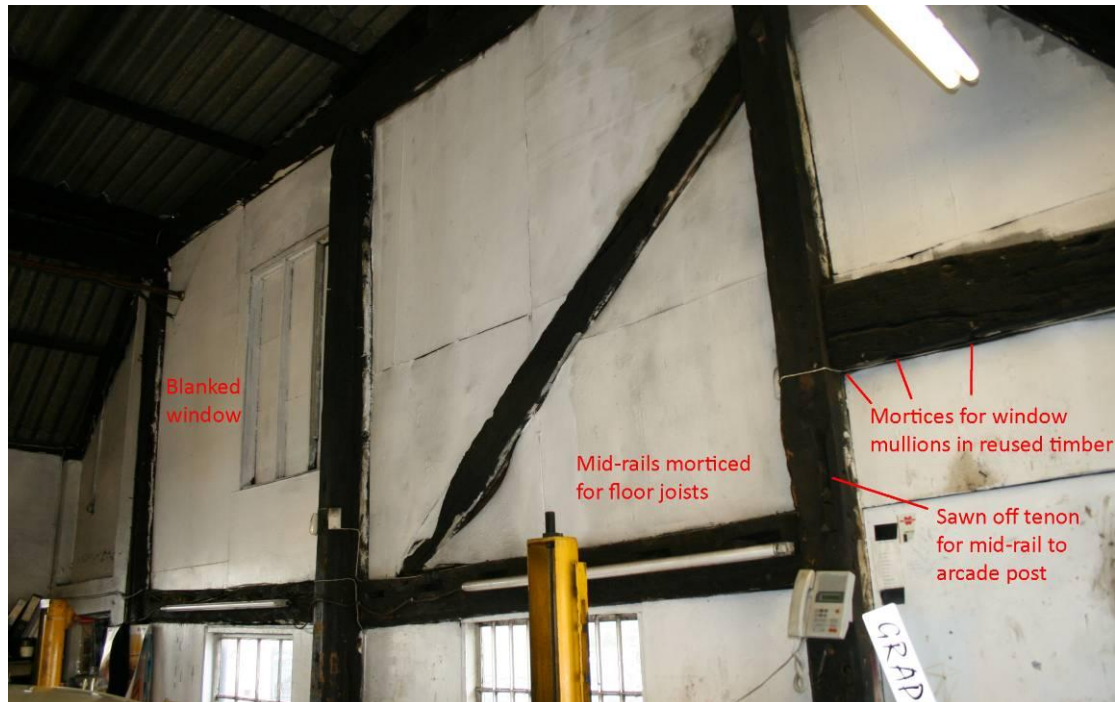
The western wall is made from reused timber some probably from the original wall.

The western wall mimics the eastern wall (which is fully framed) but the corner posts have no jowls and one of the primary braces has been removed to insert a (now blocked) window containing a rolled steel casement.

The mid-rails are morticed for a hayloft floor and the arcade plates are morticed for stud walls to create a room within the added bay. Sawn off tenons in the arcade posts show where the plates to create the side wall were once installed. The northern arcade tie is cut from a much larger beam with has the diamond mortices for a mullioned window in the underside.

The addition of the western bay has meant the partial disassembly of the frame was necessary in order that new, longer arcade plates could be inserted. Unusually these are scarfed over the arcade post heads in Truss 2 with halved and bladed scarfs which makes for a weakened and complicated joint. The frame was renumbered to aid re-assembly.

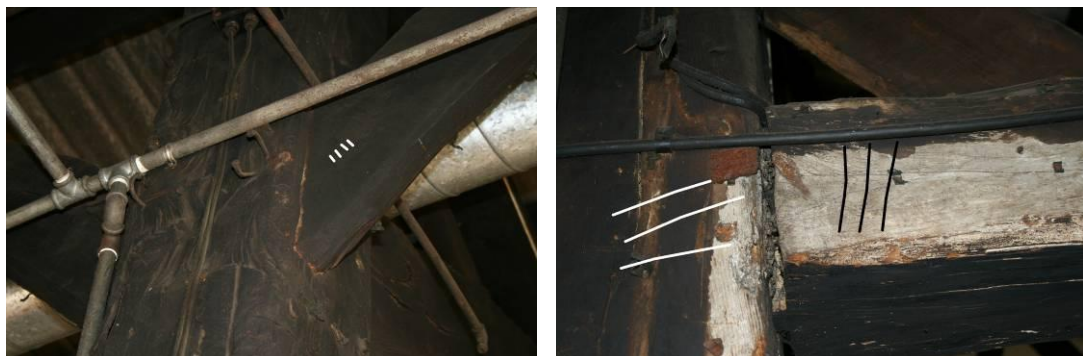
The different styles of carpenter's marks indicate reassembly. Enhanced.

The south faces of the arcade braces on the south post have been numbered IIII and VI with a chisel point and form a continuous sequence from east to west. This is a renumbering indicating again an episode of disassembling. The original timbers are marked with a race knife although the only number actually visible is on the northern aisle tie.

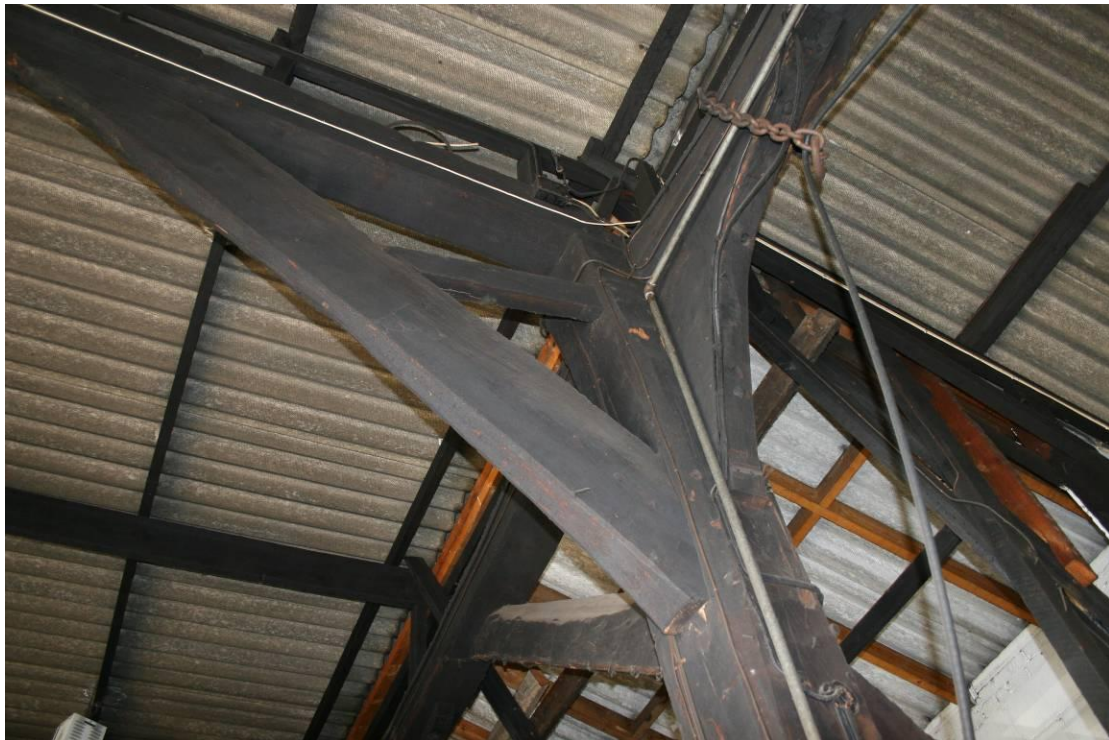
Truss 2, north post head. Looking upwards to the NW.

Truss 2 is the most complete and it is from this that the rest of the trusses can be reconstructed. The arcade post is 11in square at the base which is now encased in a concrete cylinder. It tapers from quite high up, above the spandrel, to a wide solid jowl tenoned into the tie-beam. The posts are chamfered with run-out stops.

There are straight braces to the tie-beam and arcade plates but that to the east has been replaced with a hanging knee that is clout nailed in place. The knees (in general) do not have iron bolts visible but there are large, deeply drilled holes where they should be.

The knees have been inserted to open up the midstrey to allow tall hay wagons to pass through and represent the Georgianisation of the building when the midstrey porch would have been added. Although it is no longer in place there is a single full height post to indicate its dimensions.

The heavy curving spandrels have short single struts from the jowls which appear fully pegged and original. These are normally associated with quite early buildings and are not common. It would also be expected for them to be lapped and not tenoned.

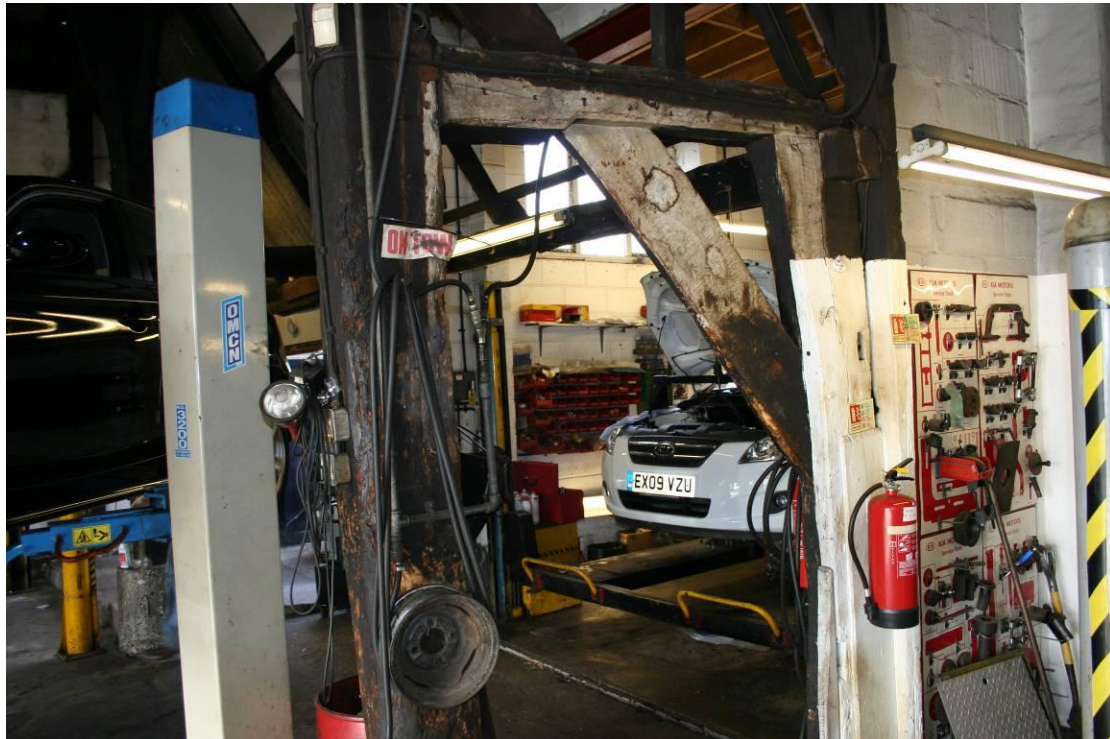
The north side of Truss 2 retains the arcade posts and braces.

Truss 2 retains the arcade structure on its northern side. The aisle tie is jowled where it meets the arcade post and connected to the wall post with a teasel tenon and dovetailed onto the wall plate.

A deep bladed, slightly curving brace connects the two and there is another short brace from the tie-beam up to the arcade post. Its form is awkward as it does not follow the curve or have the depth of the lower brace. Where the wall plate passes through the post head it has been sawn off on the midstreyside.

The wall post (which has a long tapering jowl) and the arcade tie are only 6in deep in comparison to the 11in of the arcade post. The tie has a deep chamfer and a run-out stop. The other remaining aisle tie is in Truss 1 where it has been reinforced with modern timbers to keep it in place and the jowled wall post has been replaced with a badly eroded square post.

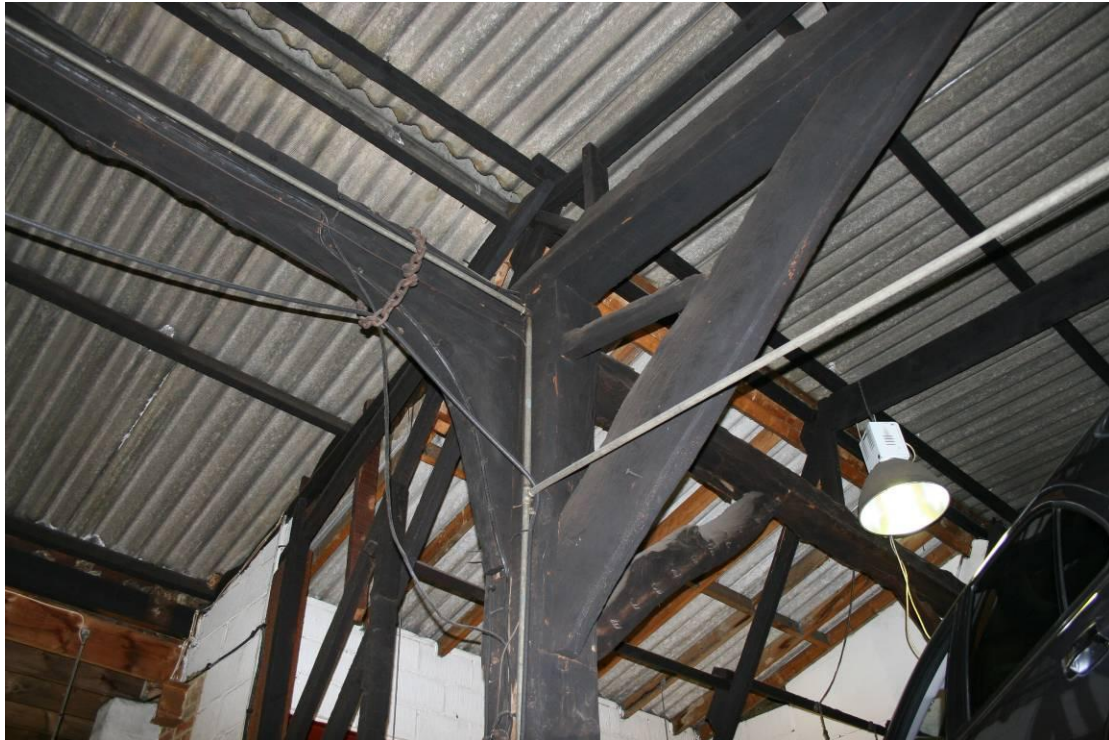
Truss 3. Looking up to the NE. Note waney, ill-fitting brace.

Truss 3 is nearly identical to Truss 2 but it has lost the aisle constructions on both sides and is difficult to photograph due the proximity of an hydraulic lift beneath it. The arcade braces in the fourth bay are very waney and do not fit the mortices correctly and must be later replacements.

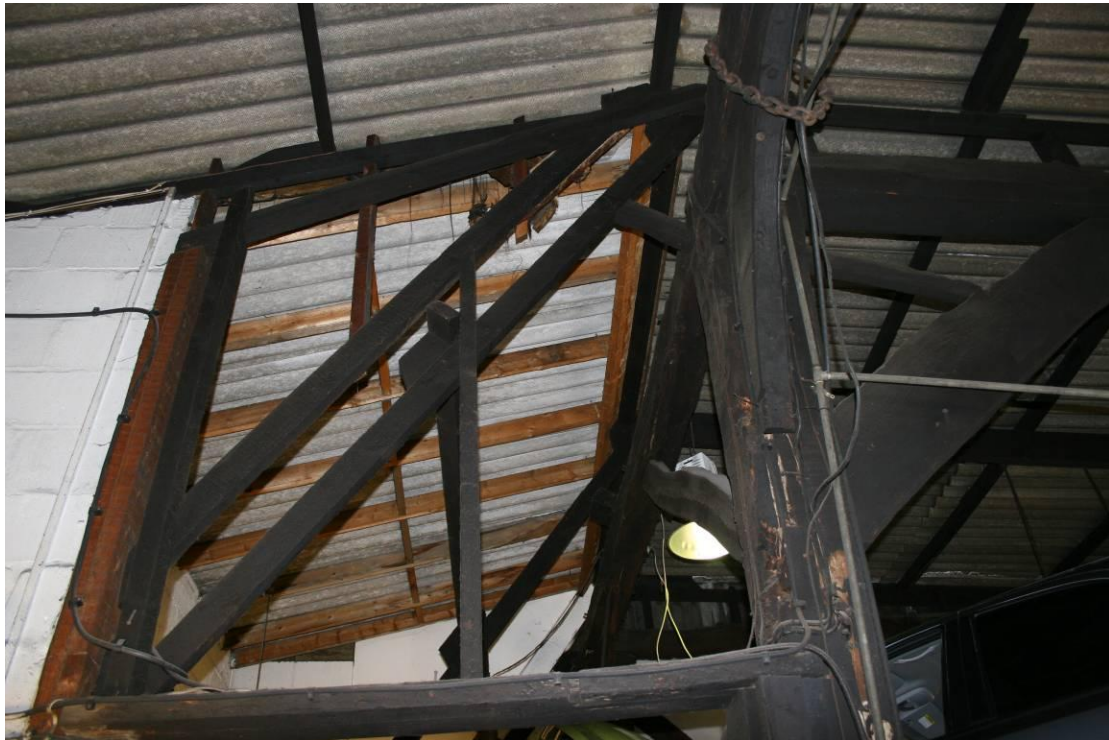
Roof structure above Truss 3 on the northern side. Looking E.

The roof is composed of 2x4in rafters and battens skinned with corrugated asbestos sheets. The rear rafters are doubled up and indicate the steep pitch of the original roof as well as the remodelled asbestos roof before the rear extensions were patched in. There are various short struts and cleats to support the EC20th structure all French nailed in place.

The roof associated with the frame, which photographs show was thatched has been completely removed. There are pairs of double pegs in the tie-beams to indicate queen struts but it was not possible to examine the mortices to ascertain if they were raking or vertical.

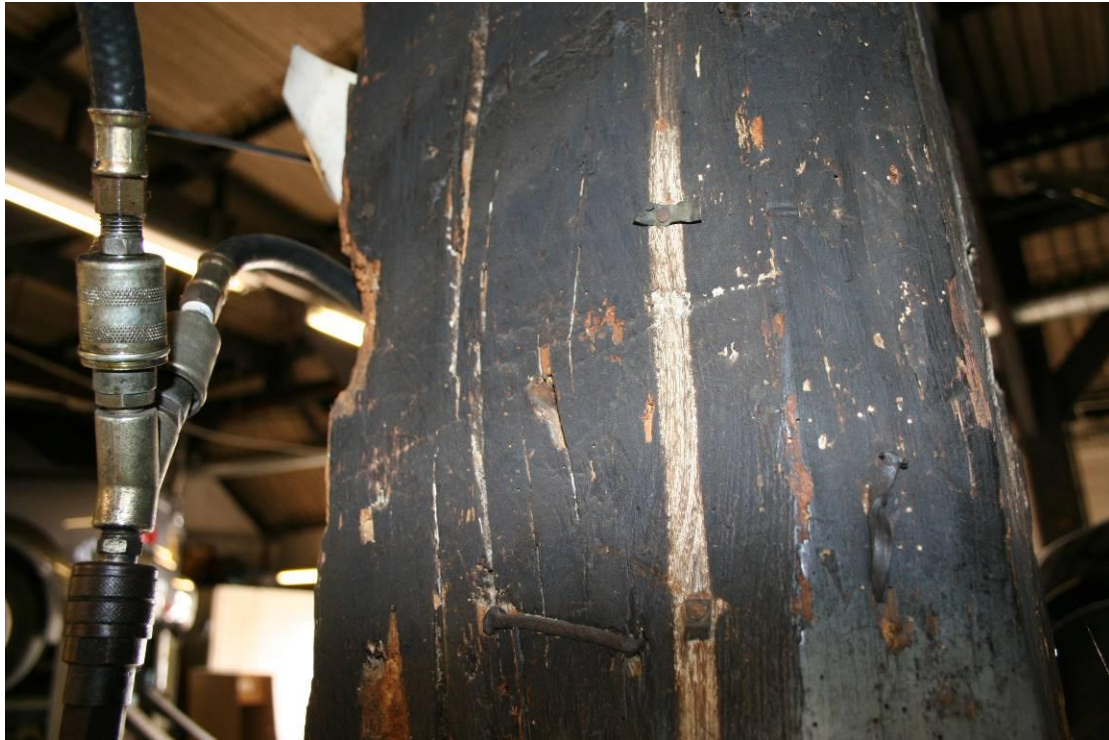
The levelling marks, which take the form of an arrowhead made with three lines all run through at the same height, at eye level. These are commonly found on later buildings where some reassembly is present. Photo follows.

Levelling mark on the back of Truss 1.

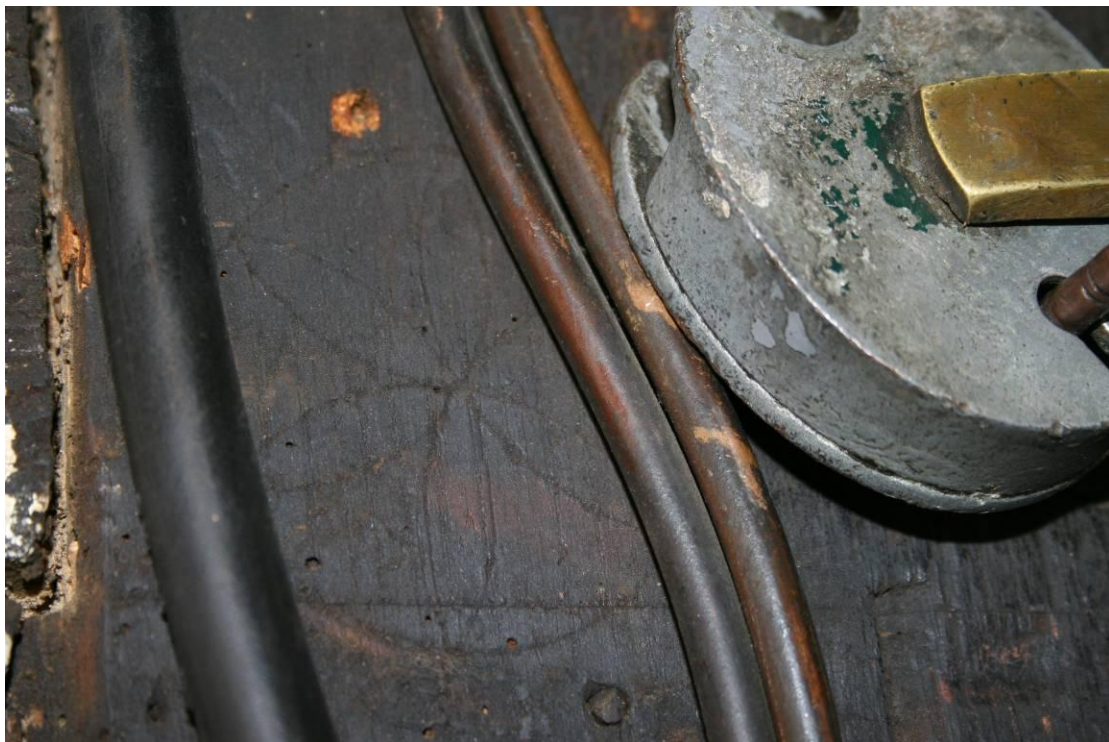
On the west face of the arcade of Truss 1, also at eye level (1.7m) is a perfectly scribed daisy wheel about 2in across. It is effectively just under the wall plate for the inserted floor in Bay 1 on the outside of the older frame. This is an apotropaic mark to ward off witches. Photo follows.

Apotropaic daisy wheel on Truss 1. Sawn off tenon to the left is for the inserted hay floor.

There is the problem of the apotropaic mark on the arcade post of Truss 1. Its position implies it was put in after the barn was extended. These types of marks are always inside protecting the occupants or produce. The daisy wheel emblem is common in the C16th and C17th but it was also revived in the MC19th. This one is perfectly scribed with a small compass so it is more like c.AD1850 than earlier.
