Cordwainers, (Cordwinders), 89 High Street, Lavenham, Suffolk.
EH Level 1 description and analysis of the house. Surveyed 03 09 2012. Revised.
Also - Impact analysis of the proposed scheme of alterations.

Scope of this Report.

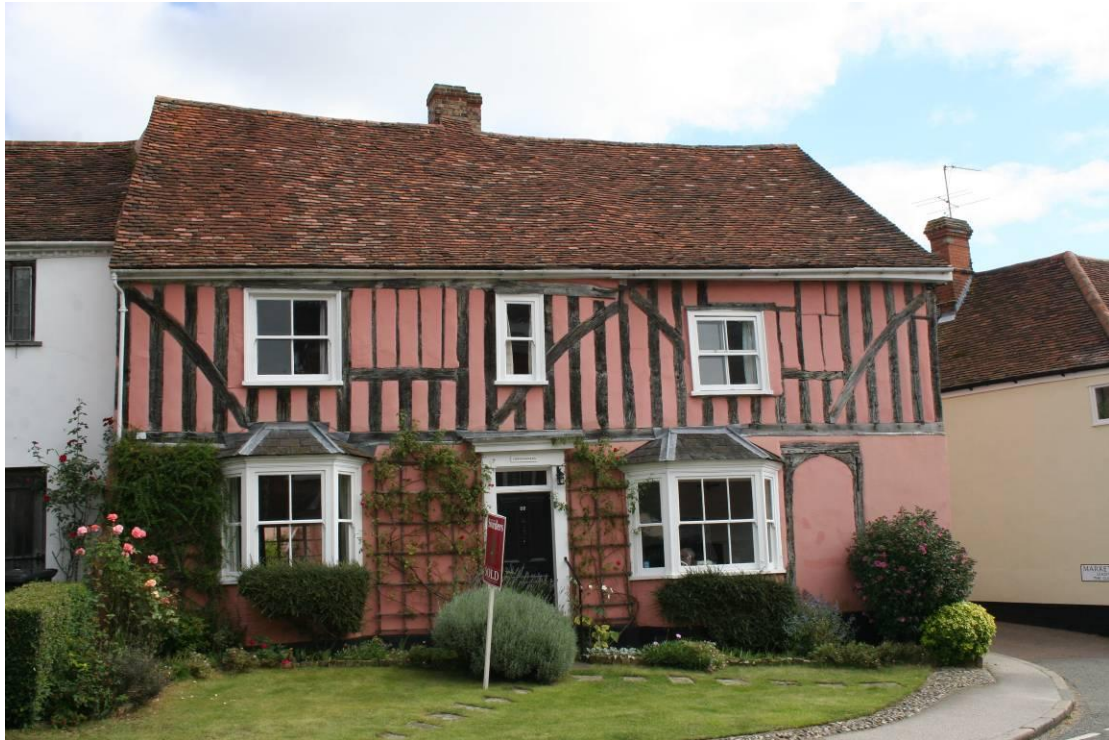
Western Elevation.

The western elevation of Cordwainers facing the High Street.

The western elevation has an exposed timber-frame. The upper section, above the bressummer reveals the structure of the early house with 6in close studding decorated with curving display bracing. The current C20th windows are all inserted into earlier openings clumsily cut into the frame in the C18th or EC19th when the frame would have been rendered over in lime plaster and the frame hidden.

There is framing for two large 4ft wide windows, that to the north retaining all its mullions. The other has been much cut about and there is evidence for a contemporary ceiling light and later windows.

The front of the building was originally jettied along its length and there is evidence in the front room to clearly show this. A Tudor arch headed timber doorframe has been exposed in the otherwise plastered lower wall which must represent a Georgian intervention, probably using an original frame.

There are two canted bay windows which are Victorian in style but C20th in execution. The central doorcase has plain jambs (not really pilasters as stated in the Listing) and a modest hooded cornice with lead finishing. Again these are C20th. The four panelled door appears to be an original late Georgian one.

The plain clay tiled roof has a majestic sweep implying there is no ridge piece. There is a slightly off-centre chimney rebuilt from reused bricks. The rainwater goods are of white painted metal with cast iron downpipes.

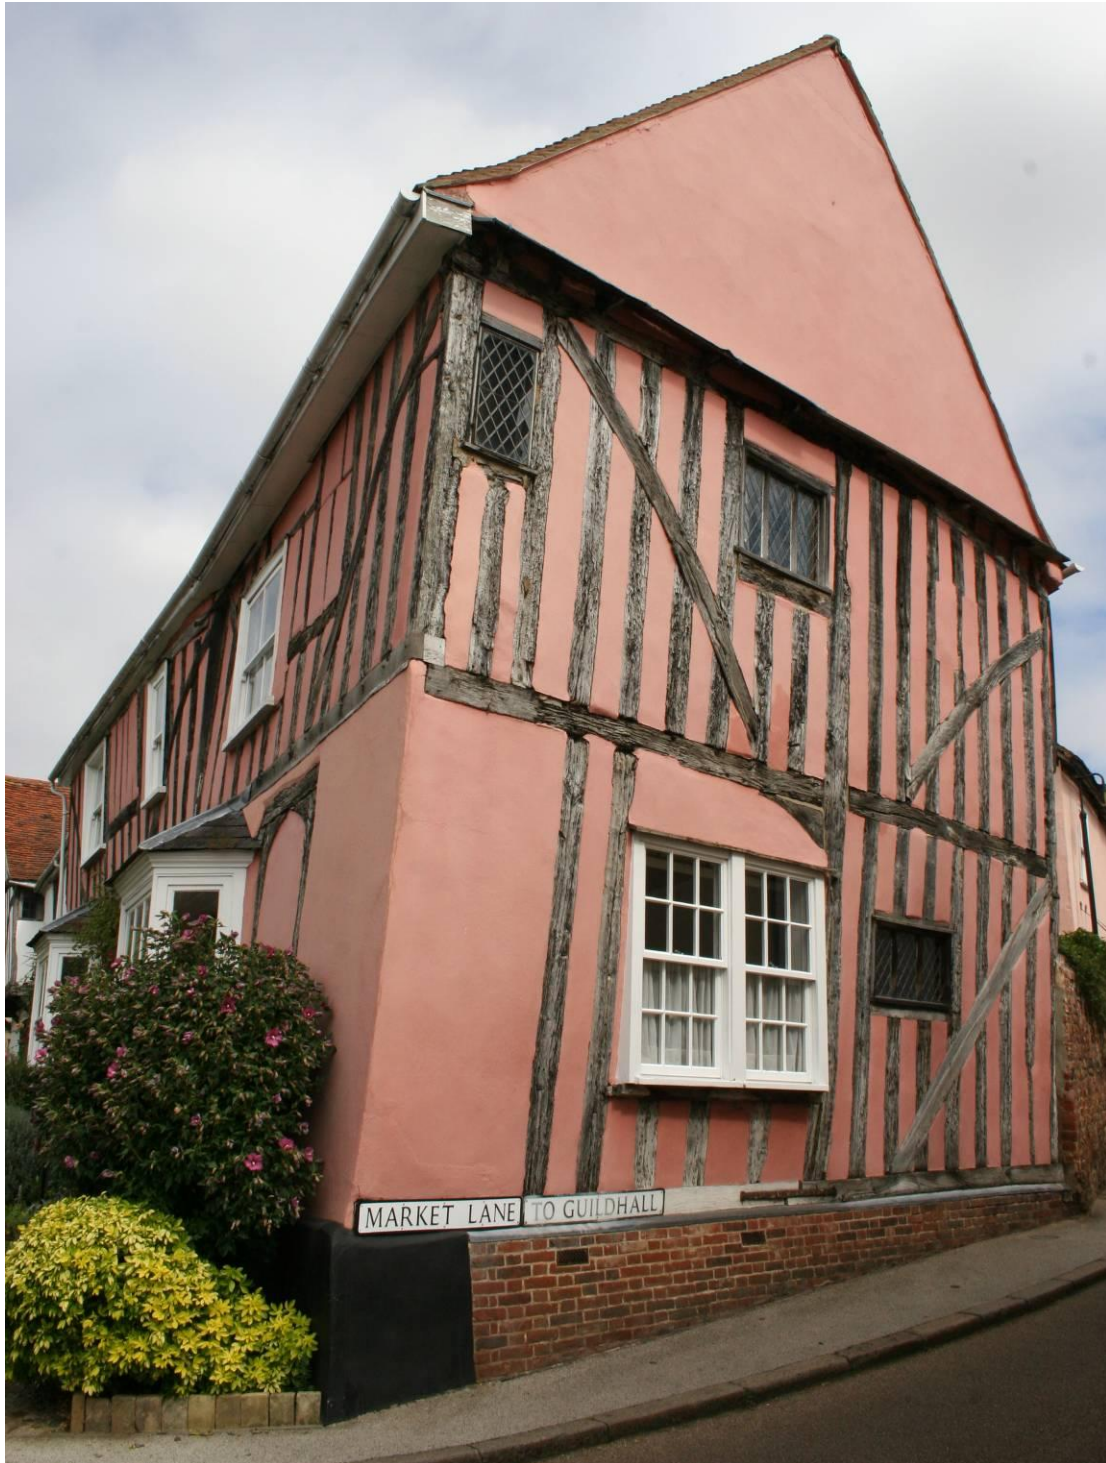
Southern Elevation

The southern elevation. The building leans at a characterful angle. Looking NE.

The original frame has been exposed and the 6in close studding is decorated with display bracing trenched across the timbers. The central, full height storey post is bracketed to the frame perhaps to provide rigidity around a large window opening. The western part of the lower wall is plastered and shows where the jetty has been underbuilt. The frame is on a plinth of red bricks set in beige sandy mortar. The building looks more racked than it really is because of its trapezoidal plan.

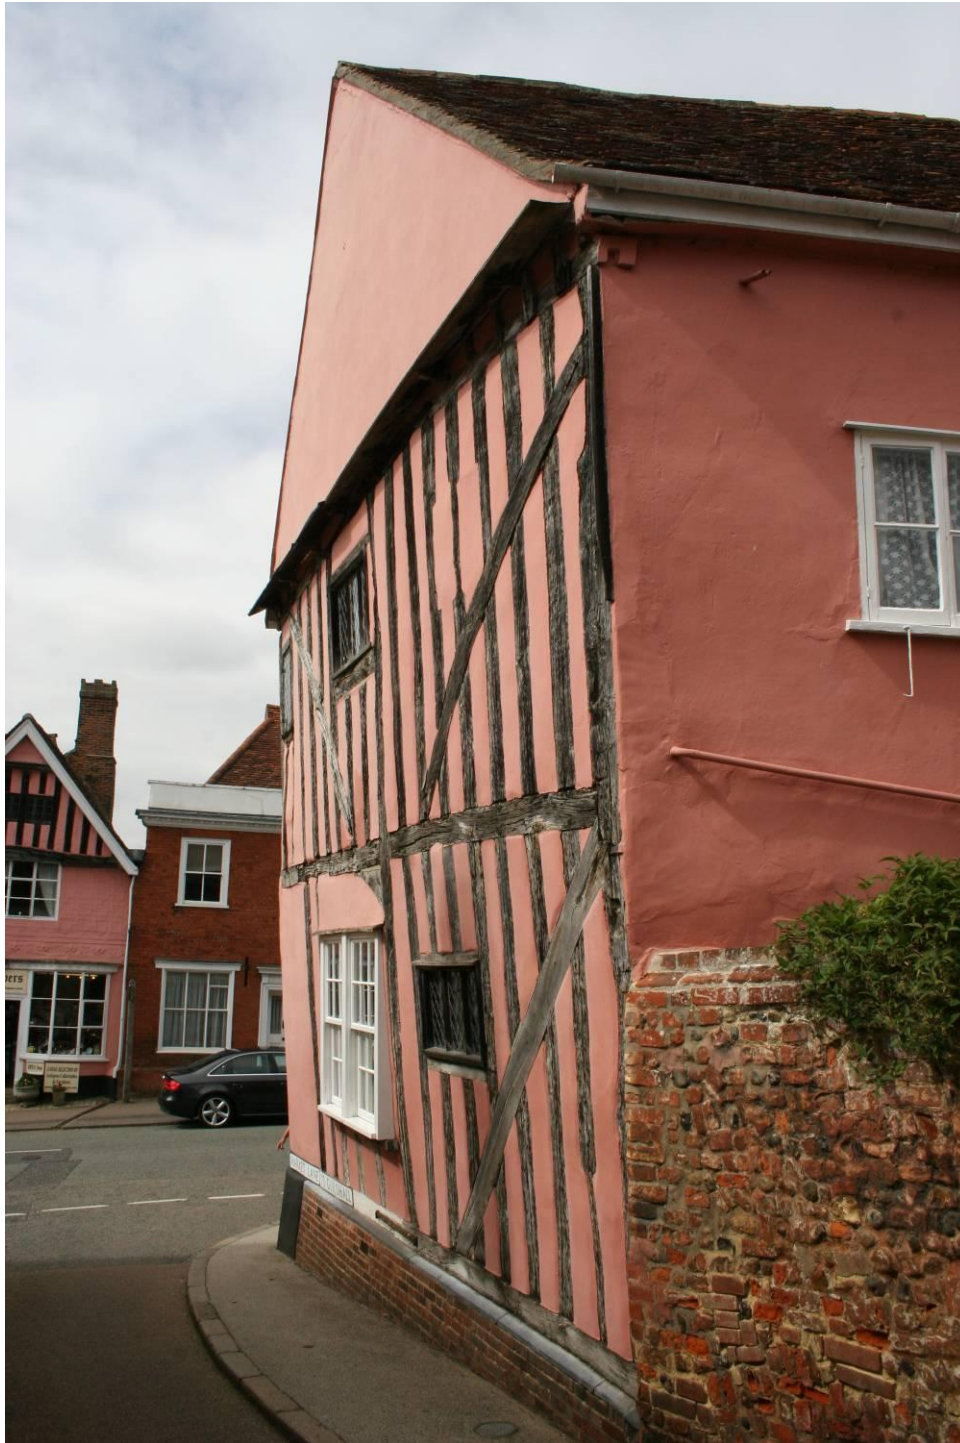
The southern wall looking W.

There are three correctly framed opening for windows with facsimile leaded light mullioned windows. There is also an indication of another upper floor window cut into the frame and then later blocked off. The very large pair of 6/6 double hung sashes are display windows. The fact that they are set vertical in an otherwise off-plumb wall would indicate they too are renovated.

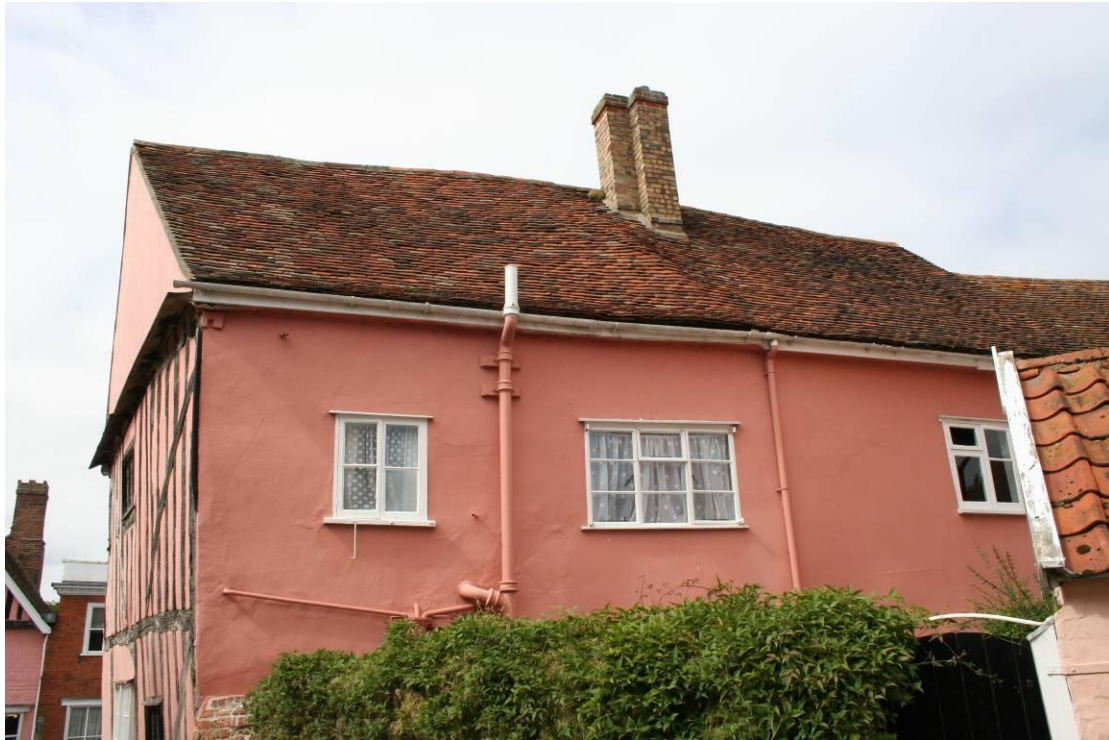
Eastern Elevation

The eastern elevation.

The eastern elevation is completely rendered in lime mortar. The windows are EC20th and all different in style. The upper central 9 light window is a Crittall style rolled steel casement and there is another to match it lighting the main lounge. From here it can be seen the chimney has two shafts both of EC20th Flettons with red brick banding.

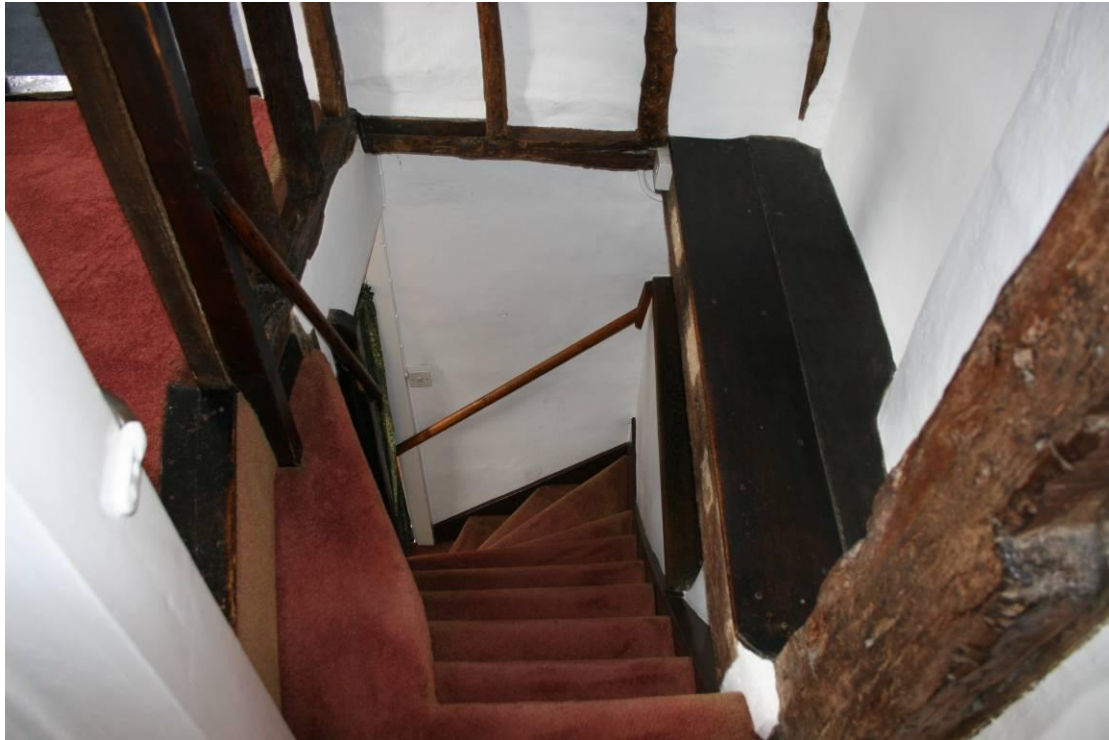
Looking down the winder stair. Note the redundant mortices filled with lime mortar.

Several joists have been sawn through and the empty mortices in the axial joist filled with rough lime mortar.

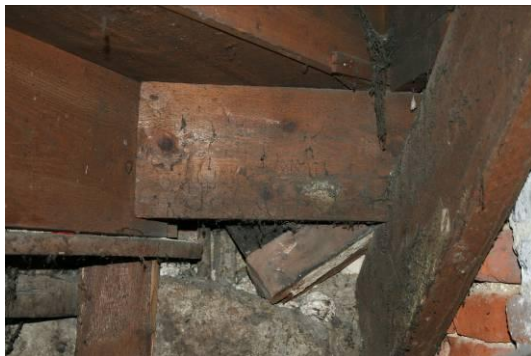
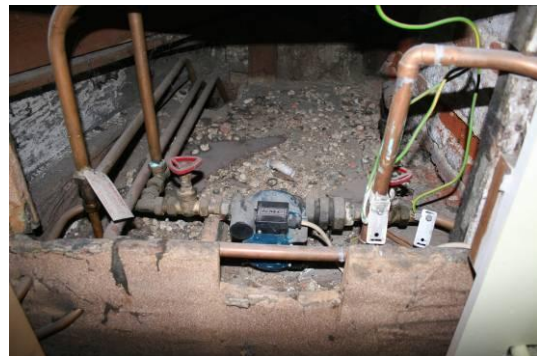
The machined structure of the C20th staircase. Some older panels remain.

The staircase is EC20th made from machined softwood, nailed with flooring brads and marked up in pencil. There is a small section of earlier boarding with many layers of wallpaper to show there was a previous structure that has been removed.

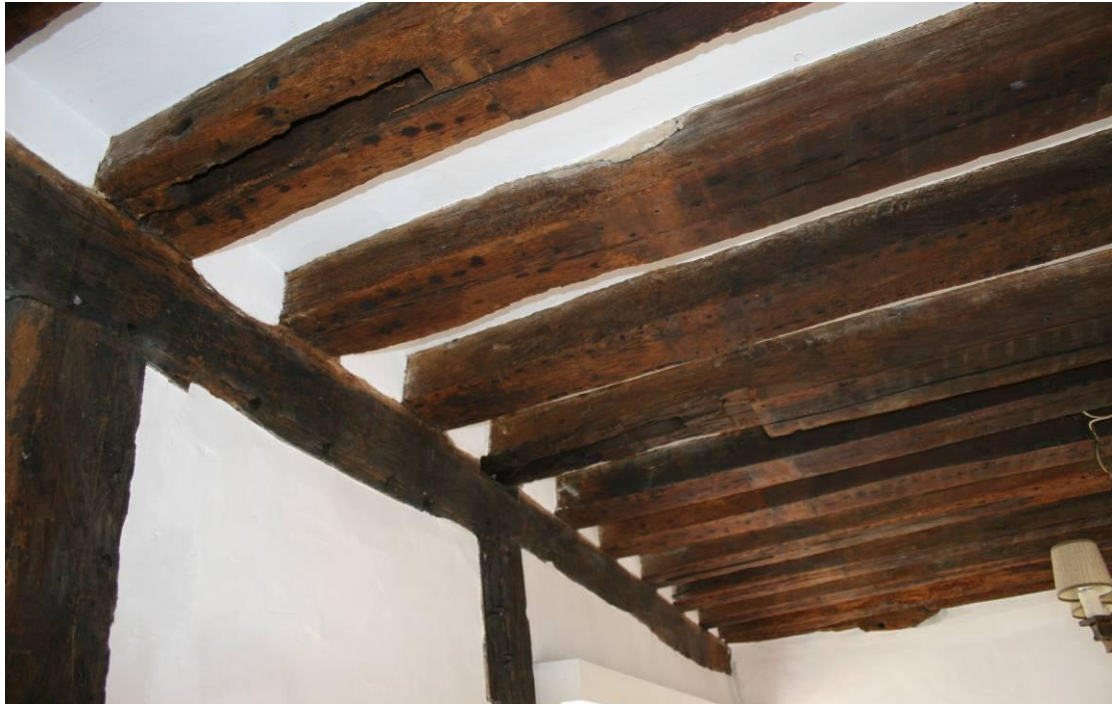
The Front Room displays the frame in the ceiling with 8x4in joist at 16in centres. The shadow of the removed lower top-plate can be clearly seen along with large mortices for timber brackets to support the bressummer. In the SE corner there is just such a bracket.

Ceiling showing the line of the removed top-plate and mortices for brackets. Looking NW.

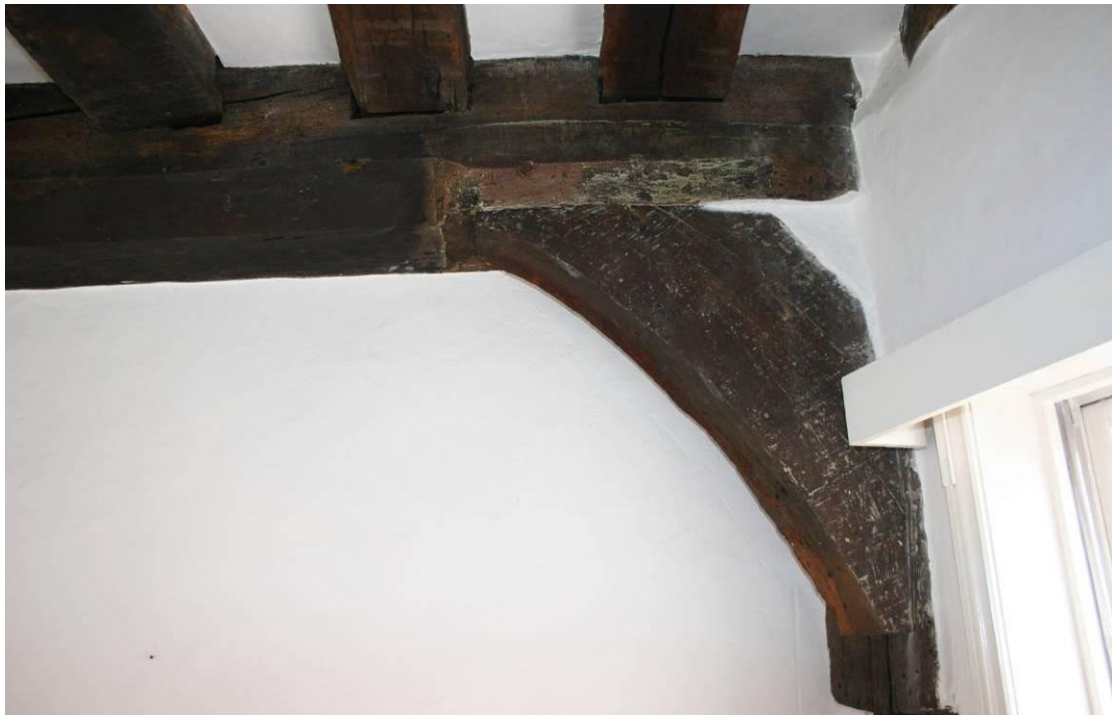
Bracket used in the SE corner. The beam has a new chamfer to fit it.

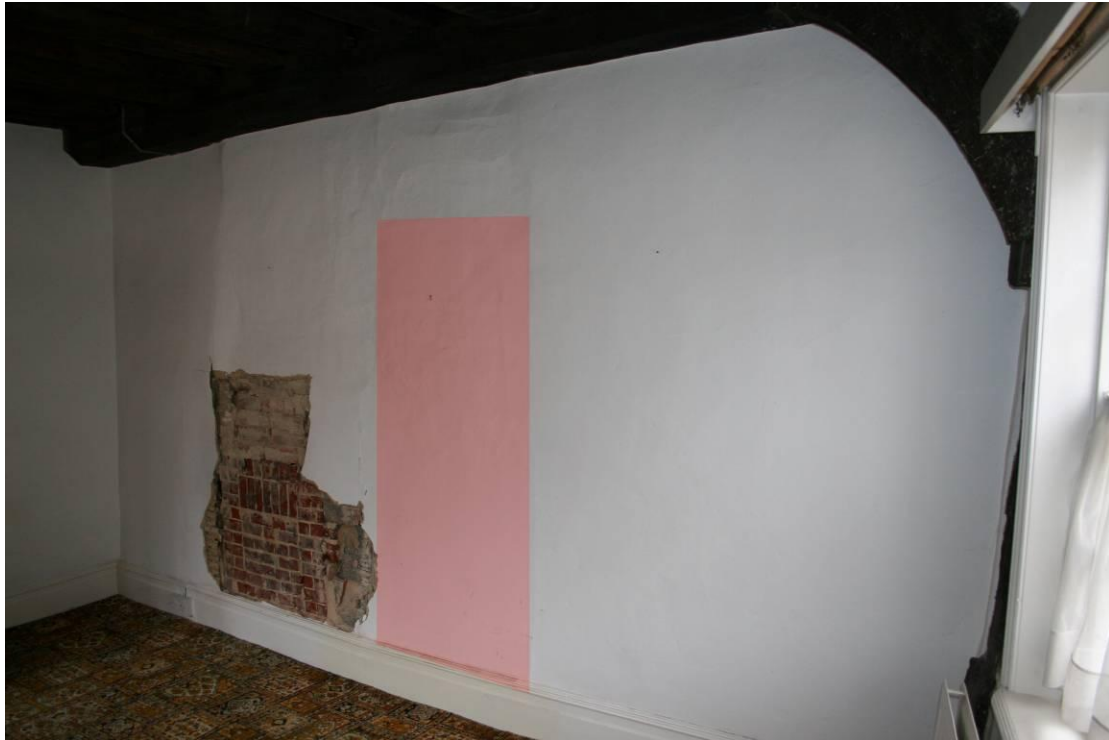
The fireplace was revealed in December 2012. Note also the blocked doorway.

There is a 1920's or 30's style 'catalogue' brick fireplace made from narrow 6x2in bricks set in white cementitious mortar that was uncovered in December 2012. The fireplace is 28in wide with an aperture of 16x24in high. The chimney breast has been continued in C20th Flettons. The aperture has been bricked in with the same bricks as the original fireplace and it seems they have been robbed out of where the Flettons now are. (Also see Page 32).

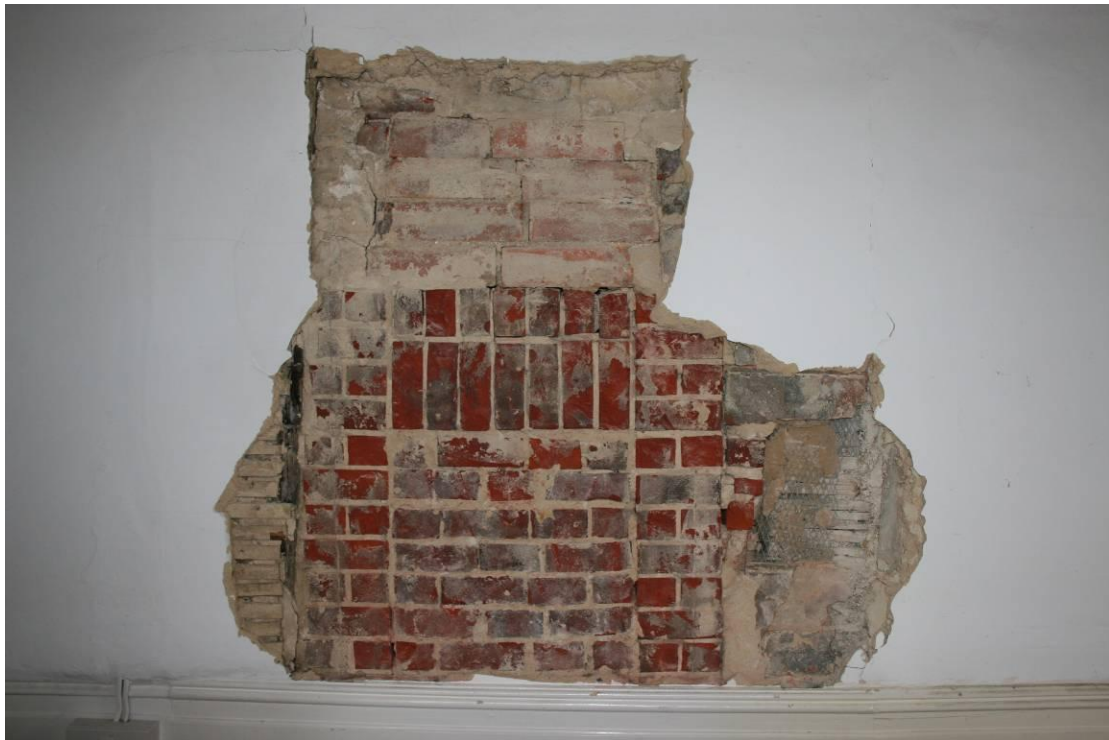
The fire place has been blocked with bricks taken from its partial dismantling.

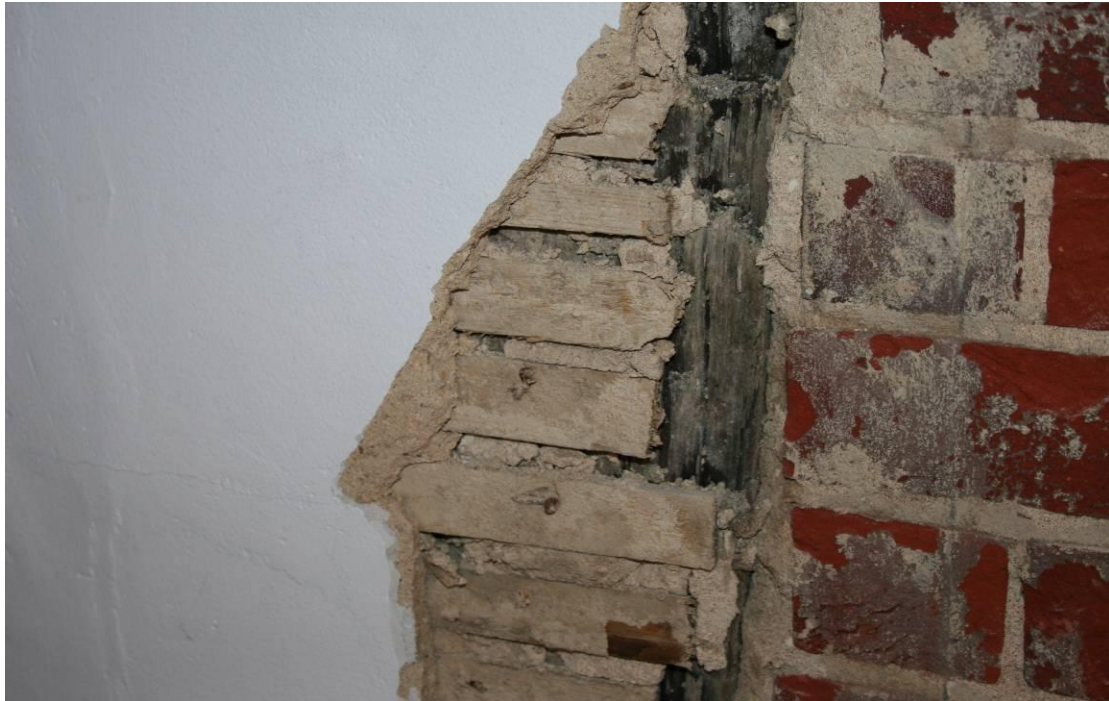
C20th lath and plaster on older poor quality studwork to the left of the fireplace.

The section of wall to the left of the fireplace is clad with swan softwood laths fastened with wire French nails and rendered with cementitious mortar and is clearly a C20th repair. In the Kitchen, a small inspection hole revealed wattle and daub (see Kitchen). To the right of the fireplace there is a blocked up doorway and a sequence of C20th finishes. The earliest is of riven laths again fastened with wire nails and then over clad with EML and roof tiles. All the plaster is cementitious.

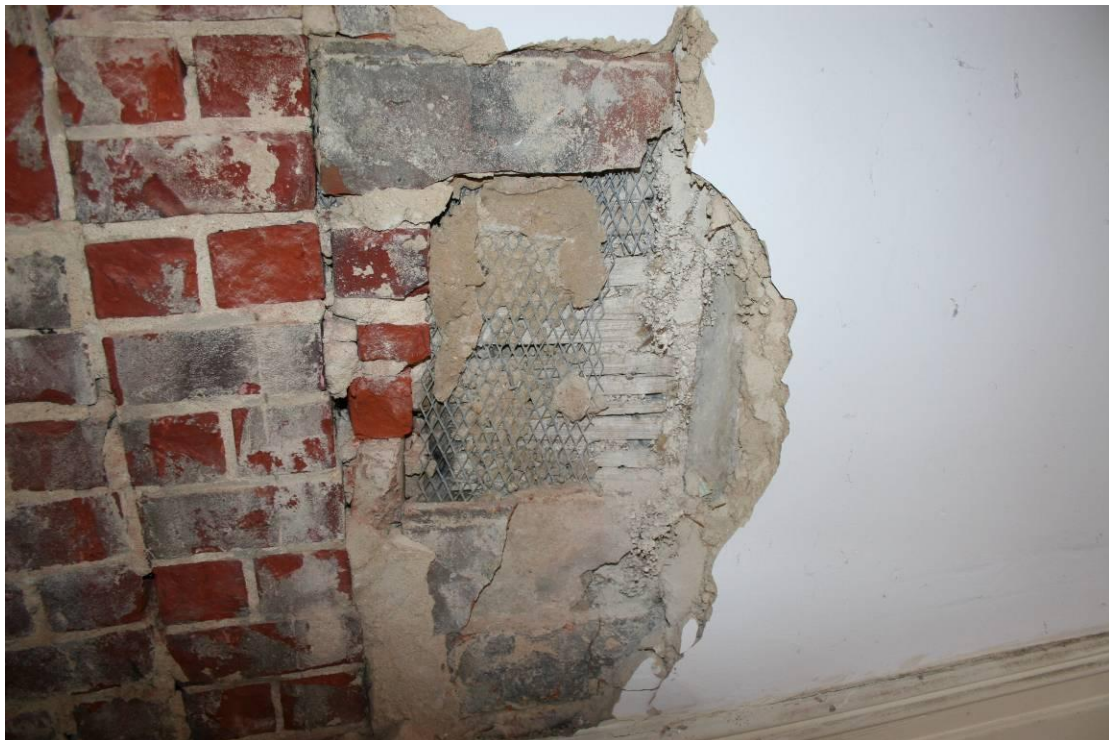
Modern repairs to the right of the fireplace. Note the galvanised EML.

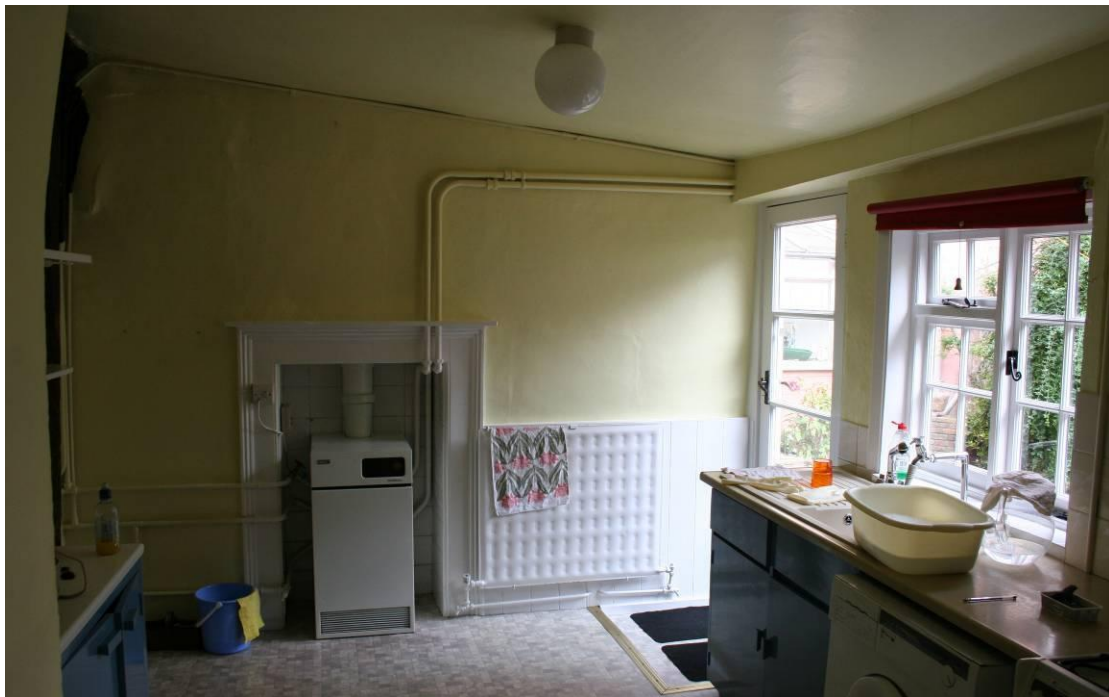
The Kitchen looking N. Note the huge slant in the ceiling.

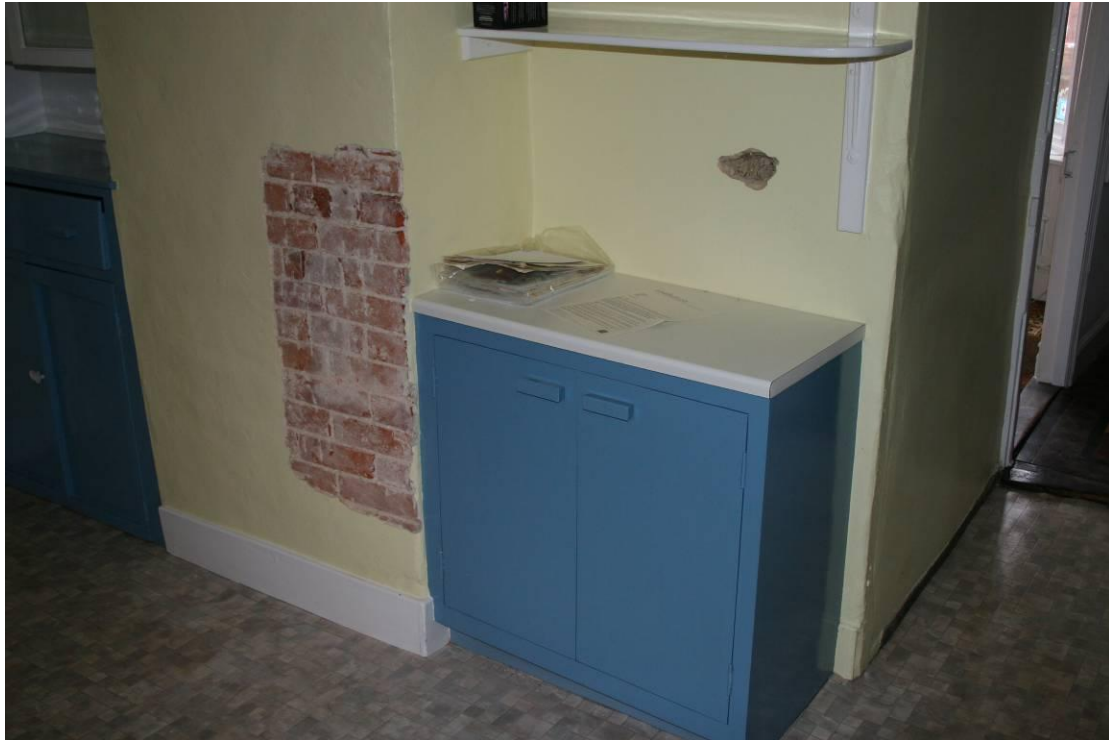
Opening up in December revealed the chimney stack and wattle and daub in the wall.

Opening up in December revealed the bricks in the chimney stack to be an older larger type than the Flettons elsewhere. However, the mortar used is identical and therefore they are reused. A small inspection hole in the Kitchen wall revealed a hazel rod wattle and daub panel beneath. However, this is not an old panel. The straw is very fresh and there is too much of it, there is very little binding soil and too much mortar. It is probably EC20th.

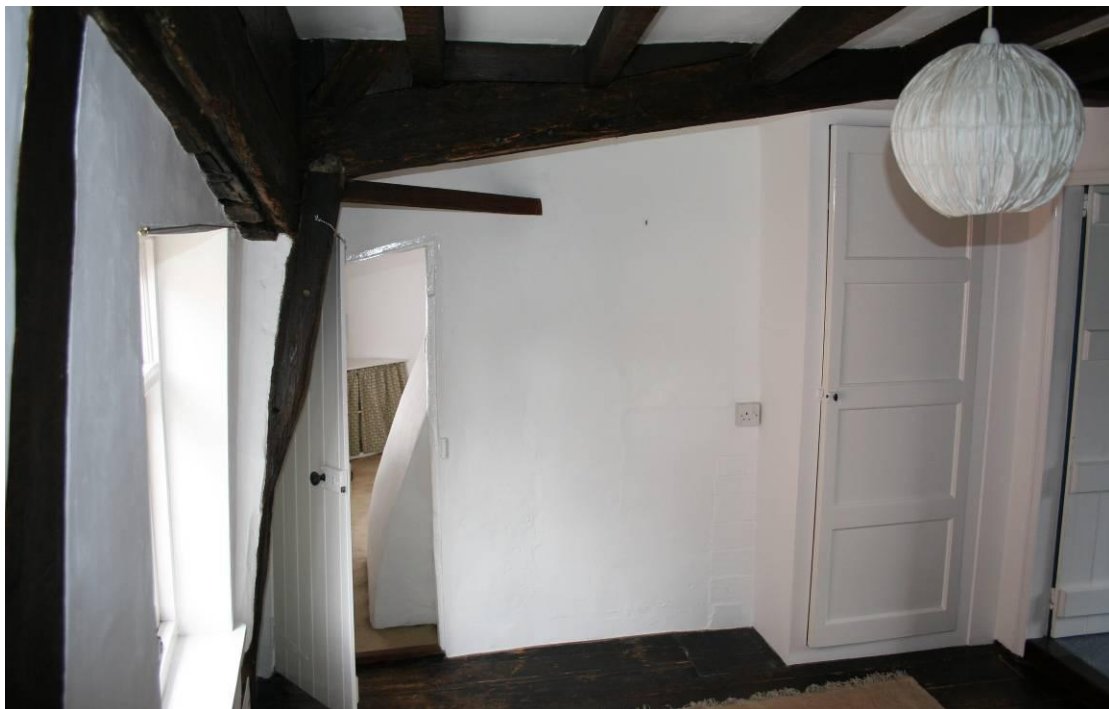
The frame is very contorted. The C20th closet is vertical. Looking S at the tie-beam.

The frame in Bedrooms 1 and 3 has been heavily contorted because the braces have been cut off and the effect redressed in the Georgian era. Rather than try to straighten the frame the builder has inserted a plate that he has bolted onto the underside of the original tie-beam. The plate has then been morticed through and the ceiling joists levelled by cutting the tenons in different positions to suit the level. The ceiling is thus Georgian and the scantling joists are only 3in wide set on edge.

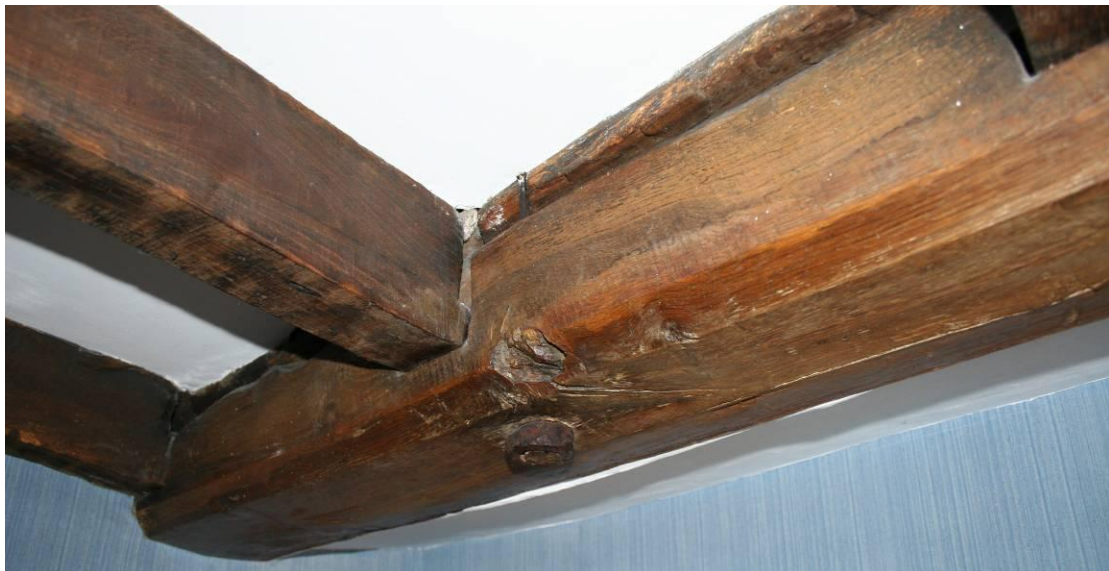
Georgian era bolt securing the repair plate to the underside of the tie-beam.

The bolt has an unusual head and is likely to be a forelock bolt rather than a threaded one and so early in the period rather than closer to 1800.

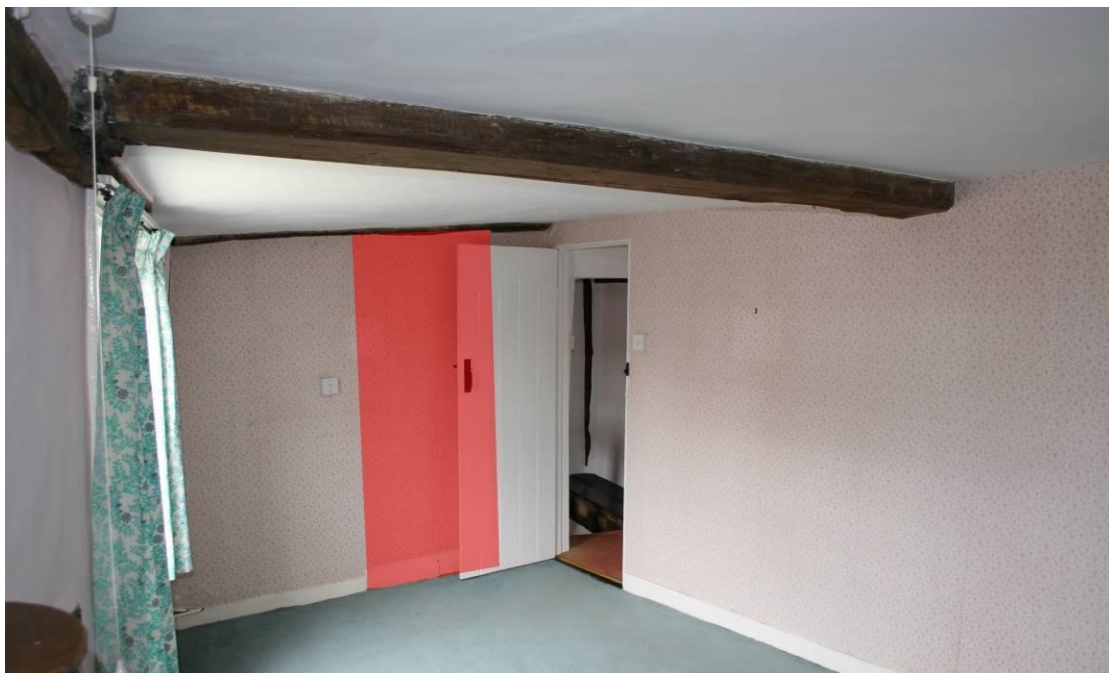
Looking NE in Bedroom 4. Blocked doorway is indicated by lack of pegholes and new skirting.

The frame in the south and west wall concurs with that seen on the outside and it can be seen that there has been a succession of original and inserted windows. The north wall is of interest because it is pegged for a central doorway which has been blocked up in the C20th and is marked by a poorly matched skirting board and a shadow in the wall.

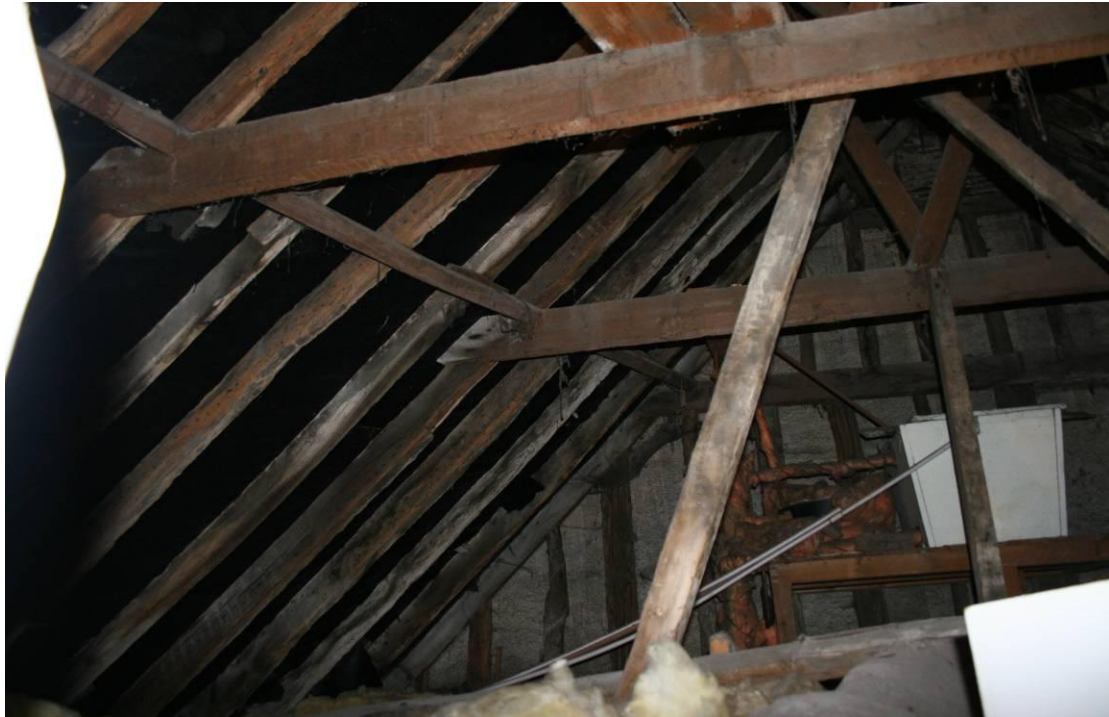
Looking SE into the roof space. The roof was re-tiled in 1973.

The roof was re-tiled in 1973 and there is a black asphalt membrane under the battens. The scantling rafters are set on edge and are now paired onto a ridgepiece. The roof is a clasped side purlin roof with side lapped and nailed collars. The purlins and collars are of the 1973 rebuild.

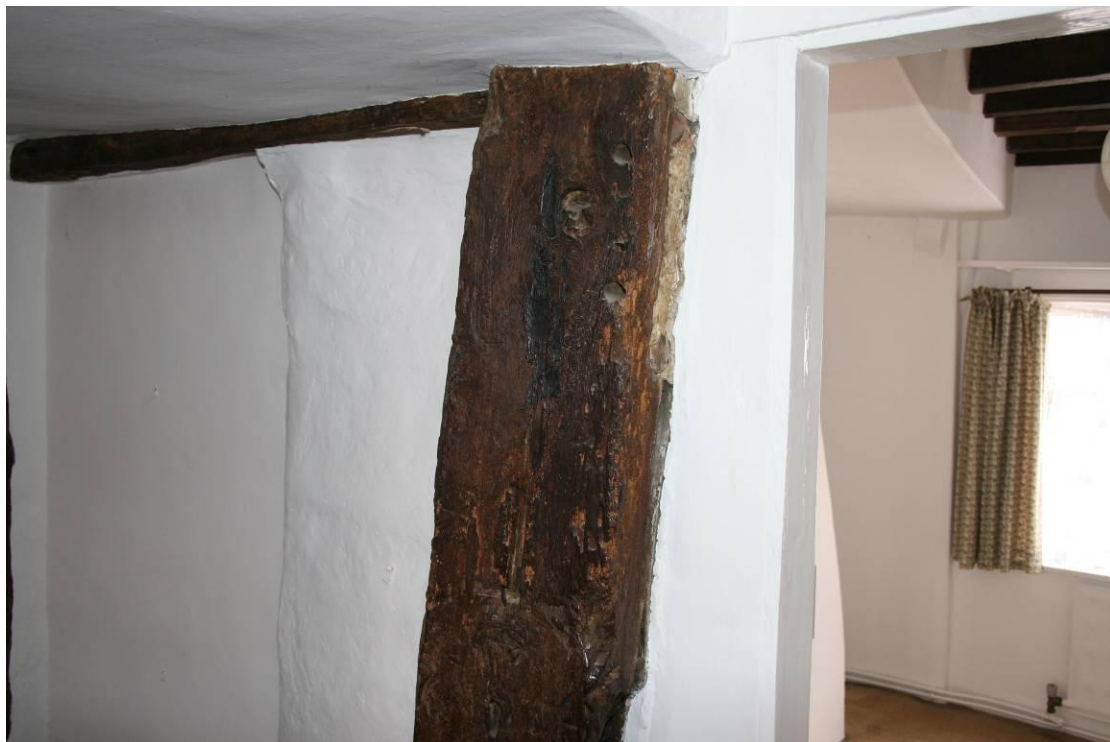
Many taper burn marks are visible at the top of the stairs.

There are a large number of taper burn marks throughout the building. The most impressive are those at the top of the stairs burnt into the storey post. These are caused by placing naked flames next to the timber and allowing the flame to burn a candle shaped scar into the wood. Often they show where the previous occupants sat and read and wrote at night time in the bedrooms.

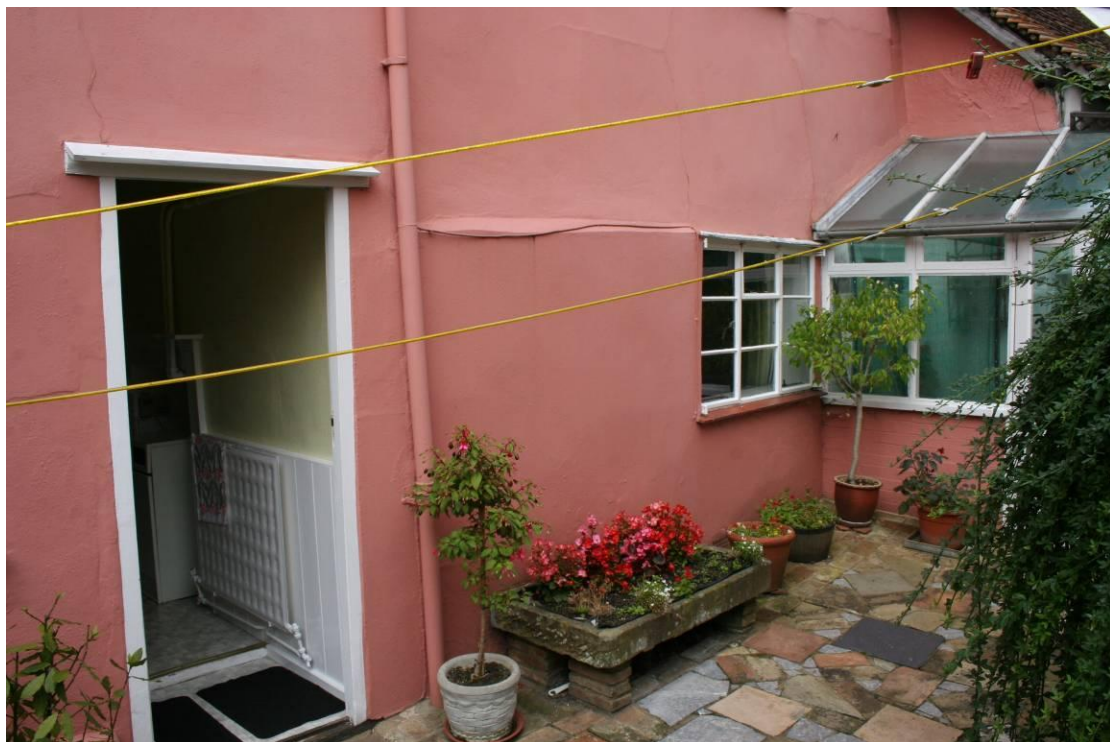
Crittall windows on the rear elevation. Looking NW.

The Crittall windows are a C20th insertion popular in the mid 1920-60's. These particular casements have landscape panes of glass – a form adopted by the International Moderne style. The casements were made in Silver End, Essex where there are countless examples of this type of window. Close examination shows these are a later, more refined model, probably from the 1950's or 60's.

However these windows are not compatible with timber-framed buildings for the following reasons:

1a. They are very rigid being made from strip rolled steel and do not flex with the building leading to cracking of the render and stress of the frames.

1. It is proposed to replace the Crittall windows with timber windows.

It would be to the long term benefit of the building to replace the steel casements with timber ones. The visual impact on the building would be negligible as only the upper window is visible from the street. As there is no cohesiveness in the window types on the rear elevation, changing two of them will not create an unbalance in the facade.

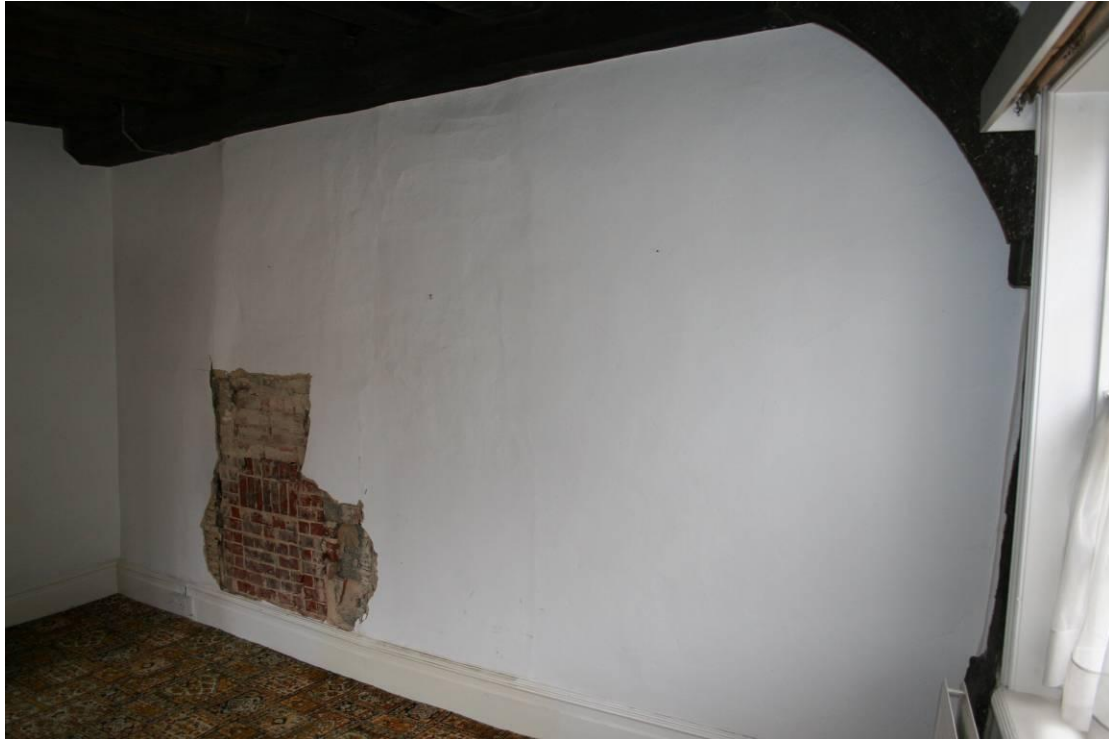
The dividing wall as revealed in December 2012.

2a. Examination of the timber-frame shows that originally there was no partition wall in this position. The present wall houses a circa 1930 'catalogue' fireplace and a chimney made from Flettons which has been subsequently blocked. To the LHS (north) is a section of scantling studwork which has EC20th lath and plaster and wattle and daub. The properties of the wattle and daub are not authentic but an uniformed recipe with too much mortar and too much fresh straw. It is proposed to remove the plaster which is failing to reveal the structure of this section. If it proves to be older than the C20th then it will be retained.

2. It is proposed to remove the dividing wall between the Living Room and the Kitchen.
