Thorley Houses Farm, Thorley Lane West, Thorley, Hertfordshire CM23 4BN.
Recording and analysis of the thatched barn. Surveyed 05 07 2017.

SUMMARY SHEET

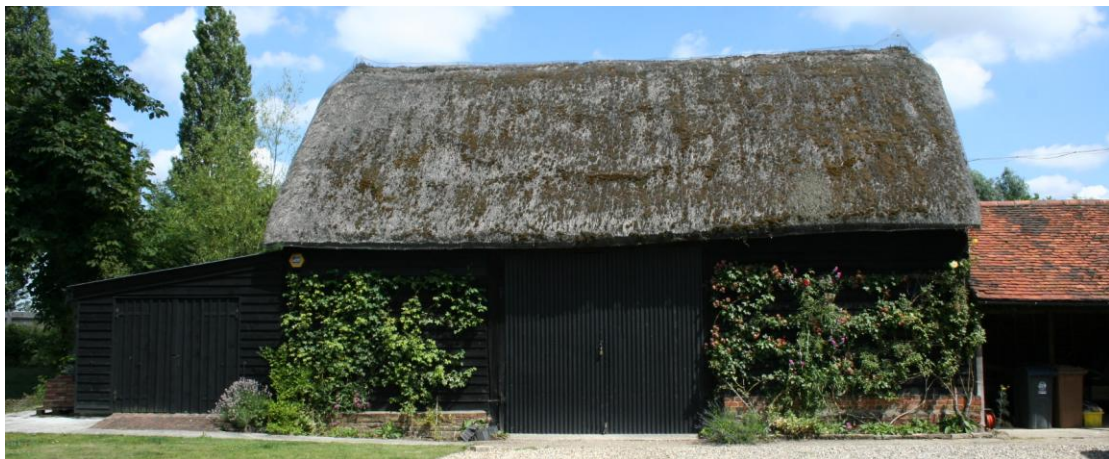
The southern elevation.

The timber-framed Barn is of three bays with a thatched roof that was last replaced in 1990. The present owner met the thatcher who explained that he sat on the roof as John Major was made Prime Minister. It is also evident from inside that most of the machined softwood frame and all the weatherboarding on this side is of the same repair job.

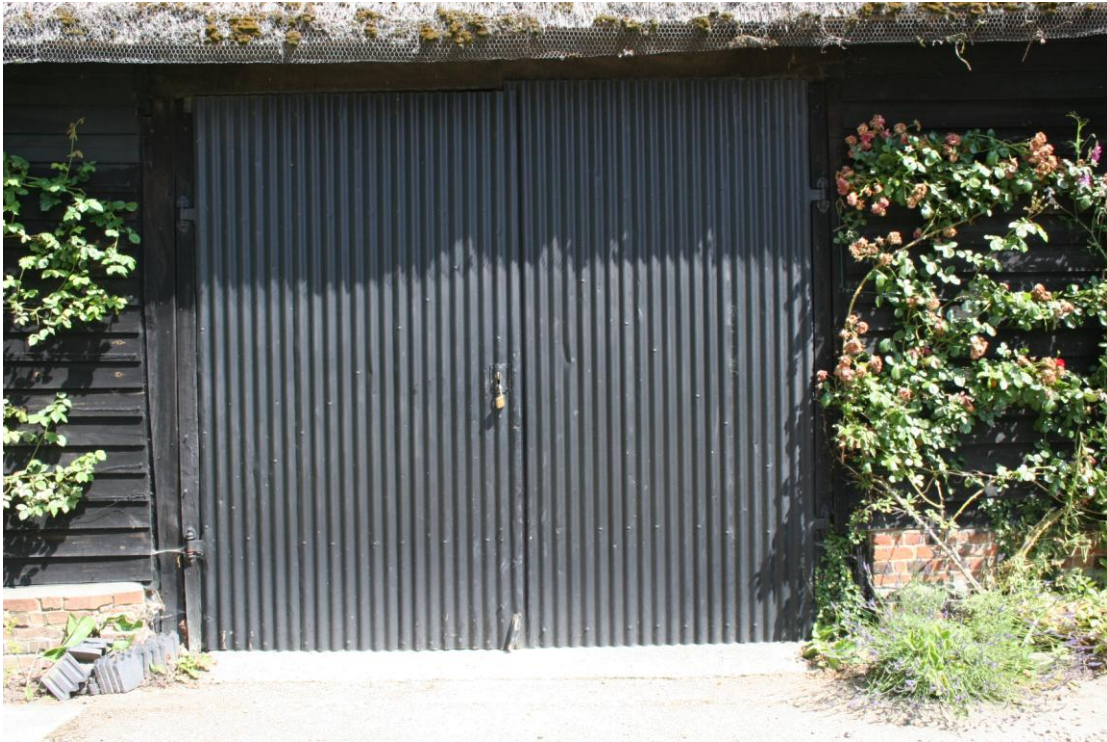
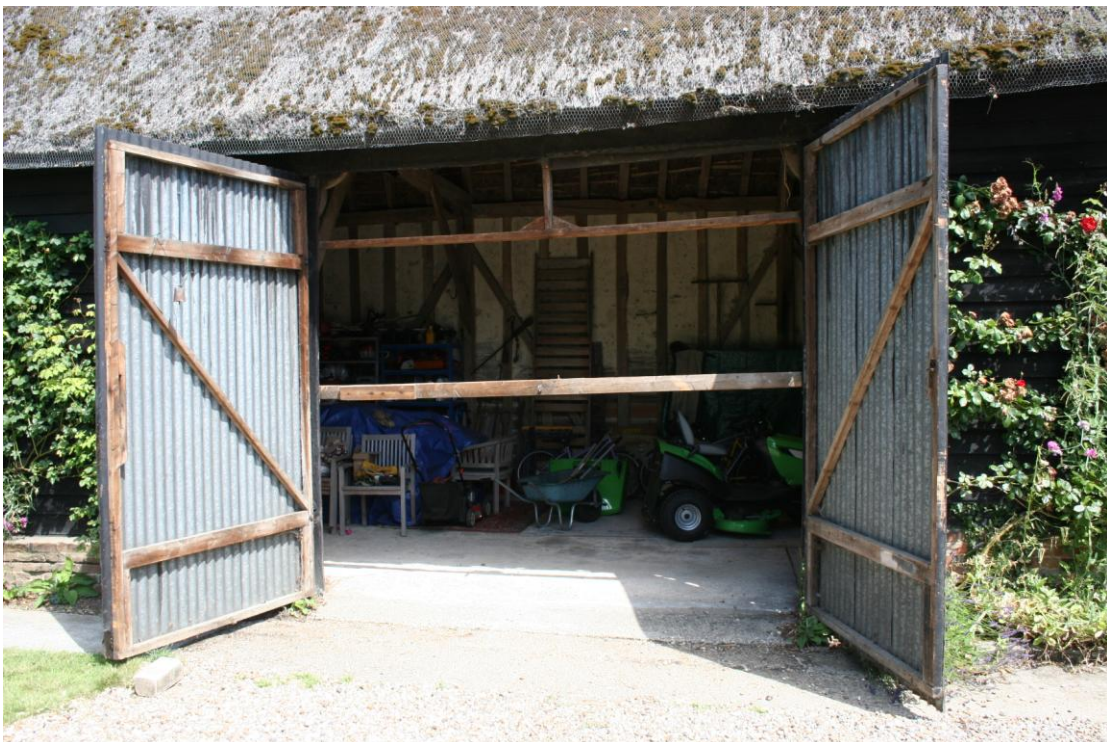
The main doors are LC20th.

The LC29th main doors are simply constructed.

The main doors are simple frames skinned with corrugated iron sheets. The frame has been strengthened with bandsawn brackets because the original door jambs have been removed to widen the opening. Again 1990 is a likely time for this alteration.

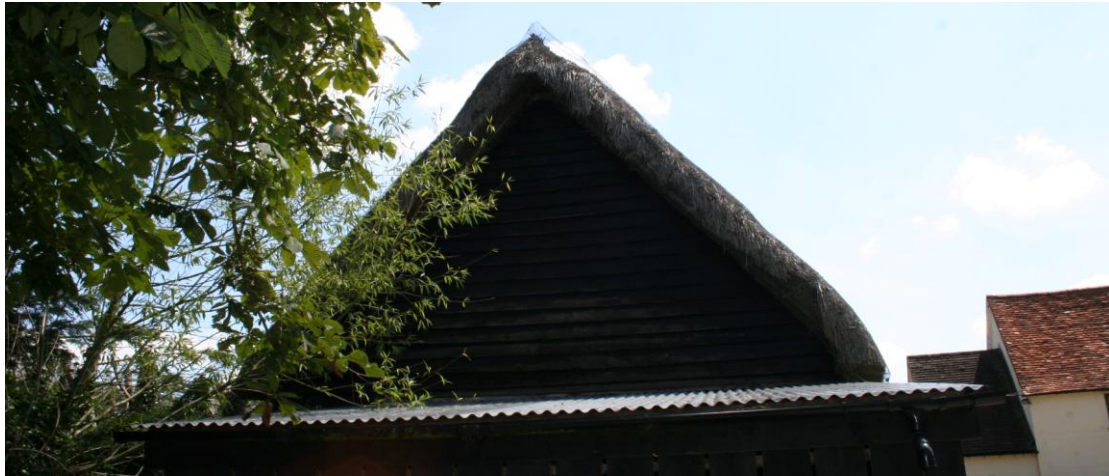
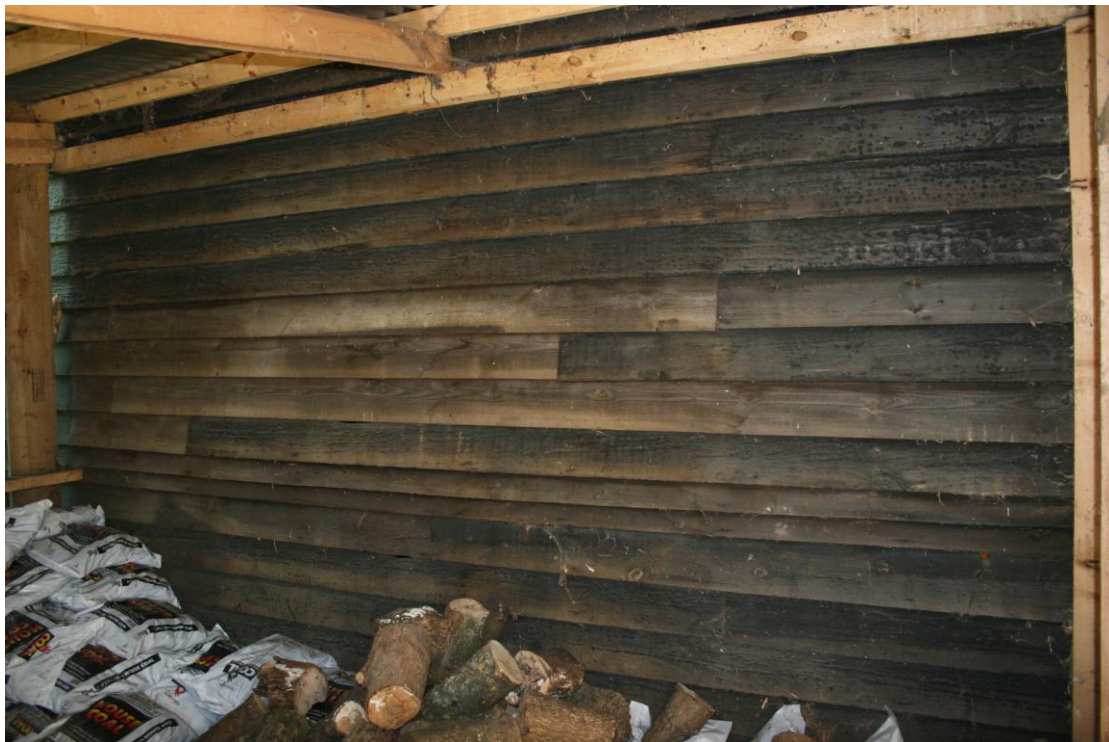
The western elevation.

The western elevation inside the Shed.

The western elevation is clad with LC20th weather-boards fastened with French nails. A number of repairs are evident and there is shadow formed by hot tar to show a smaller building was once adjacent. Hot tarring of timber buildings only ceased in the 1960's due to health and safety legislation.

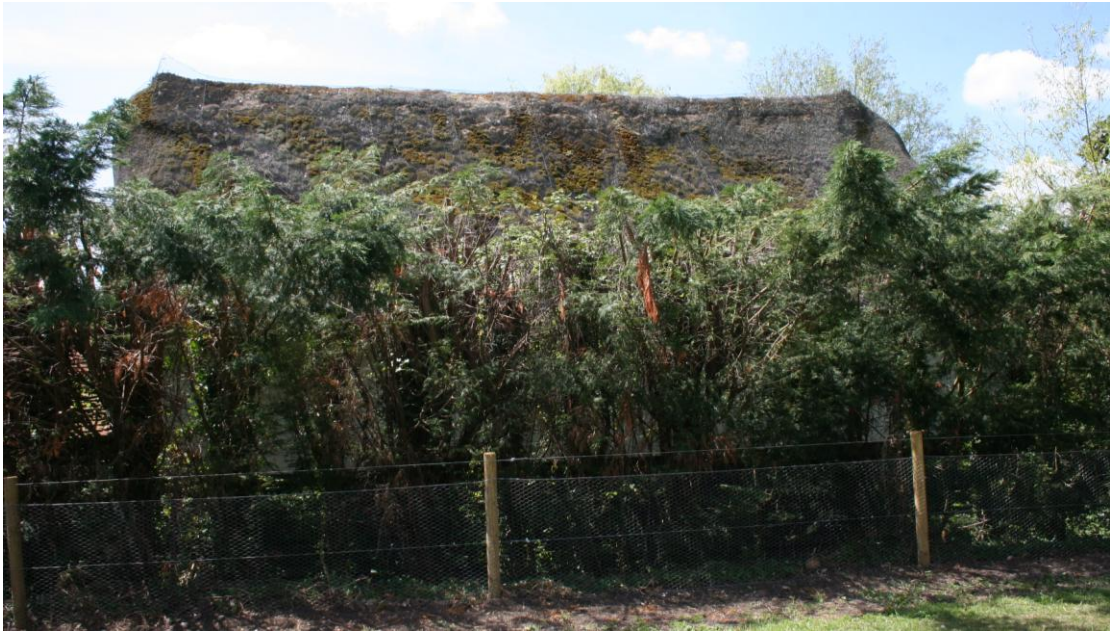
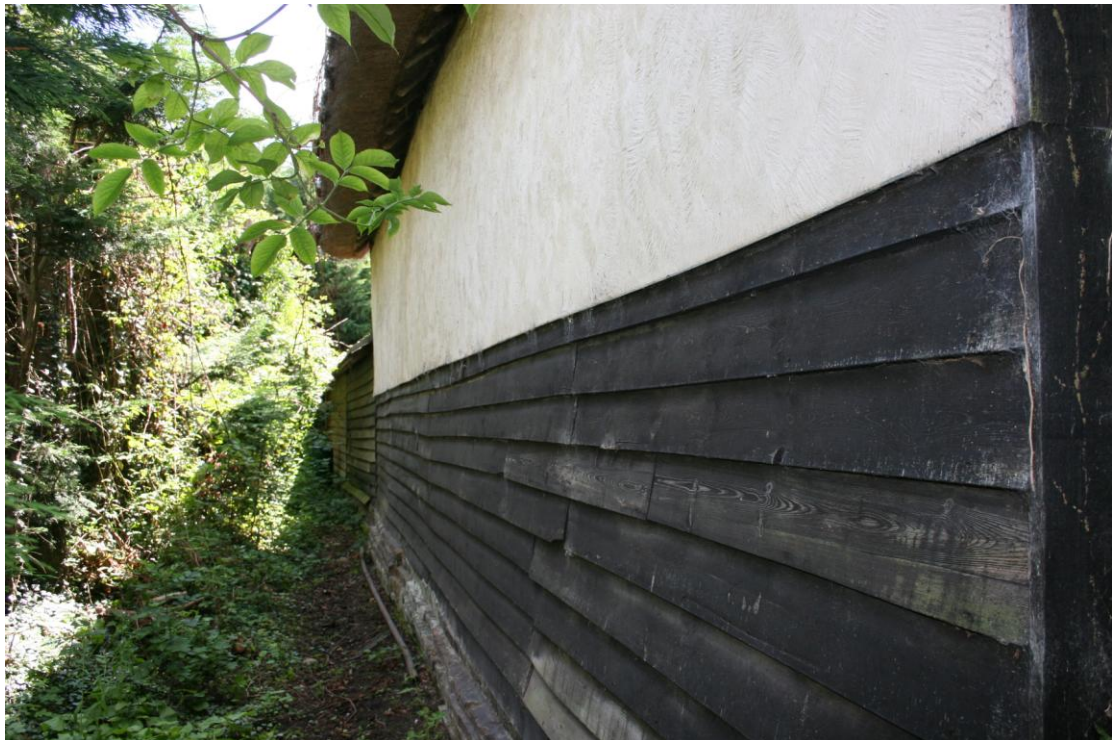
The northern elevation is obscured by trees.

The northern elevation looking E.

The northern elevation is clad with bandsawn C20th weather-boards to about 6 feet high. Above is a section of hard cement render on EML. However, looking inside large sections of lath and daub and haired plaster render still remains in-situ in very poor condition.

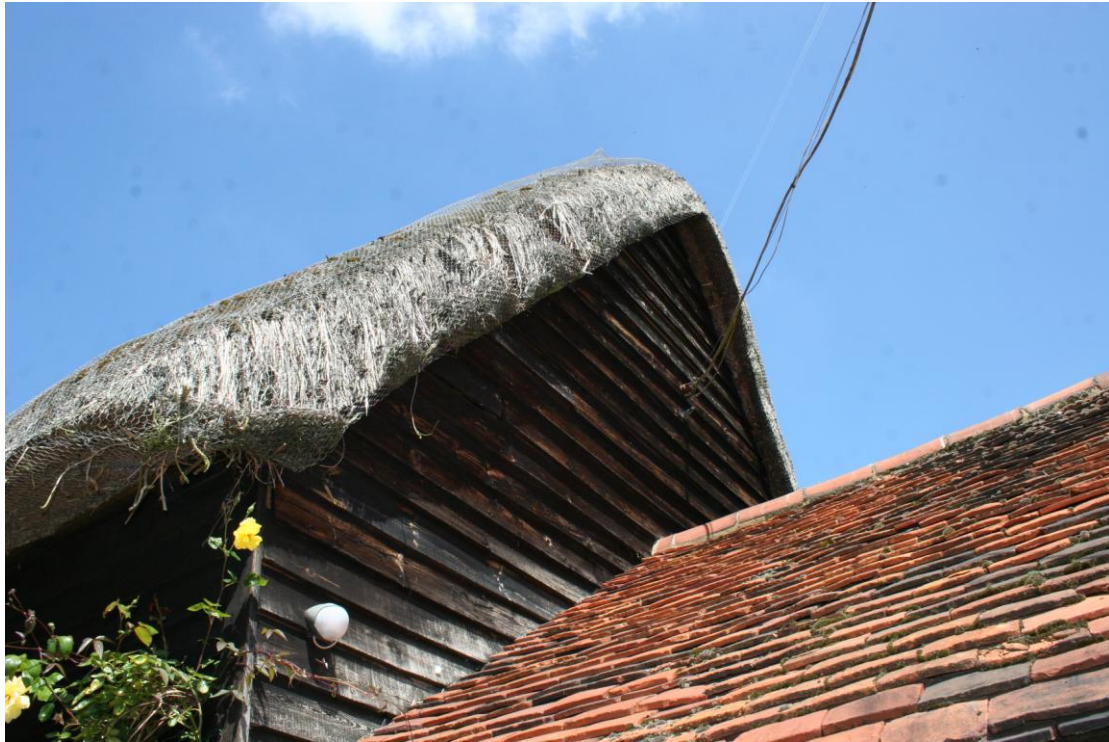
The eastern elevation. The exposed section has LC20th boards clearly bandsawn.

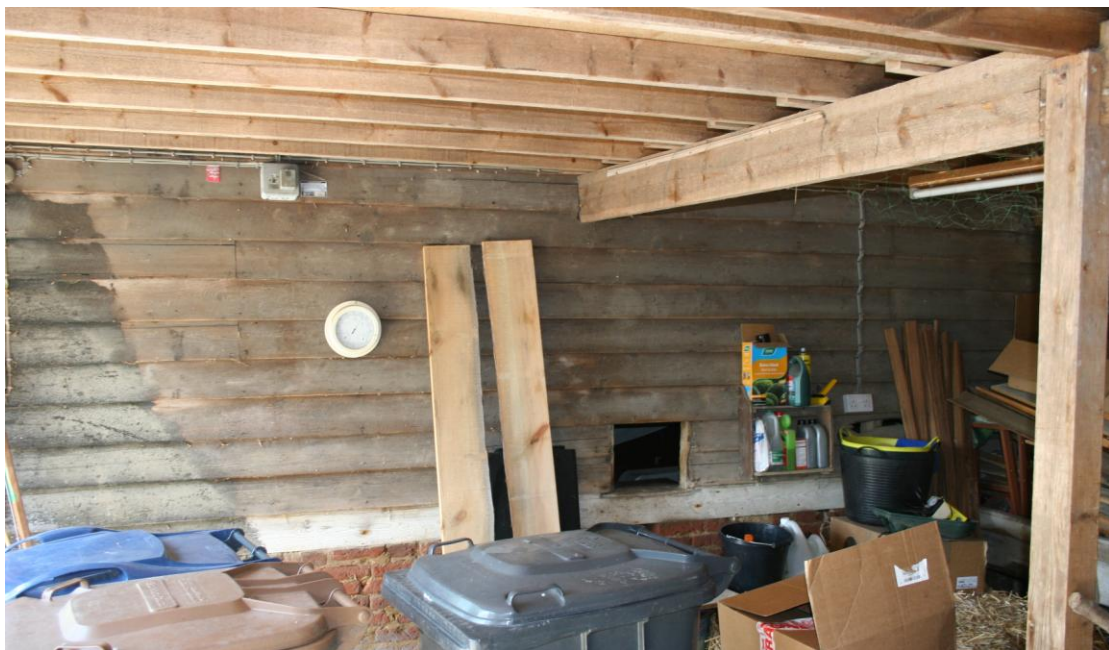
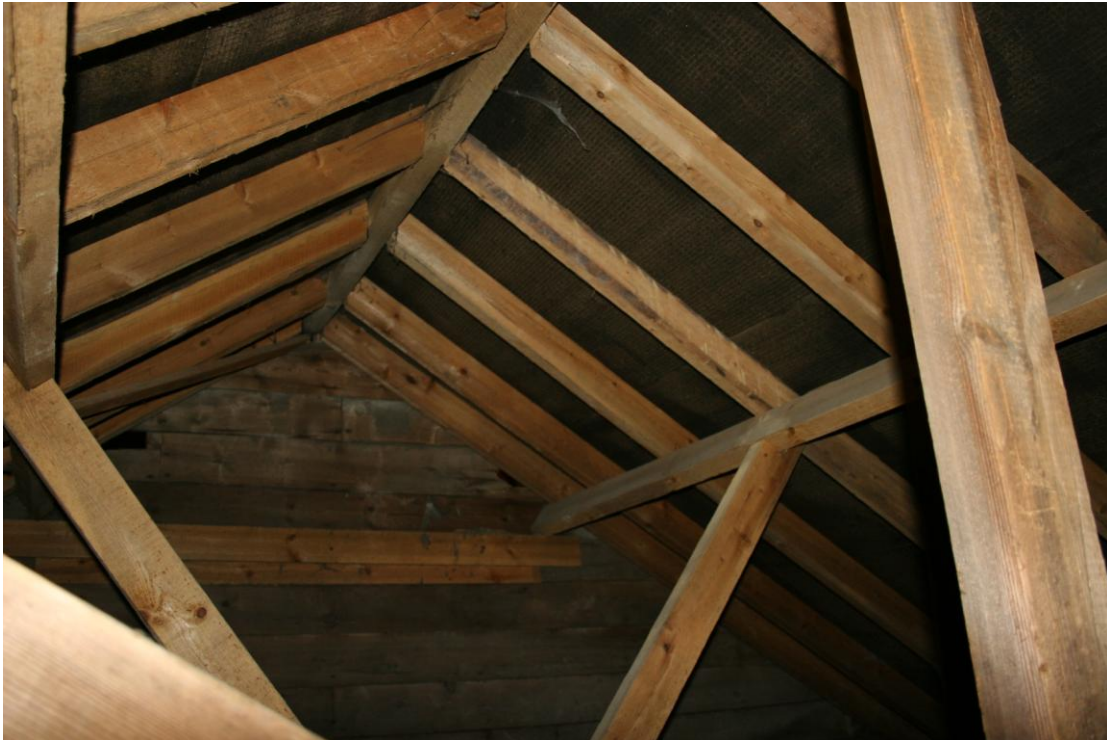
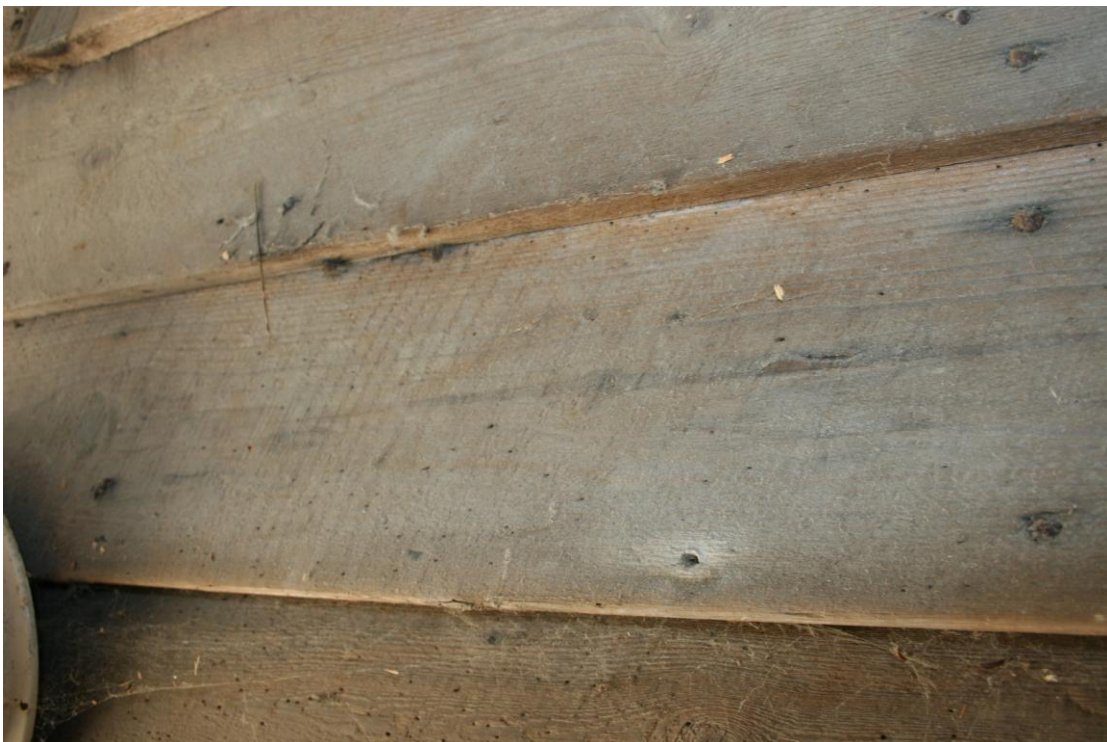
The eastern elevation inside the Shelter.

The eastern elevation retains some MC19th circular sawn weather-boards fixed with wrought iron nails. The adjacent structure is LC20th but it can be seen the boards were always undercover except where they have been tarred.

Detail of the weather-boards showing the circular saw marks and wrought iron nails.

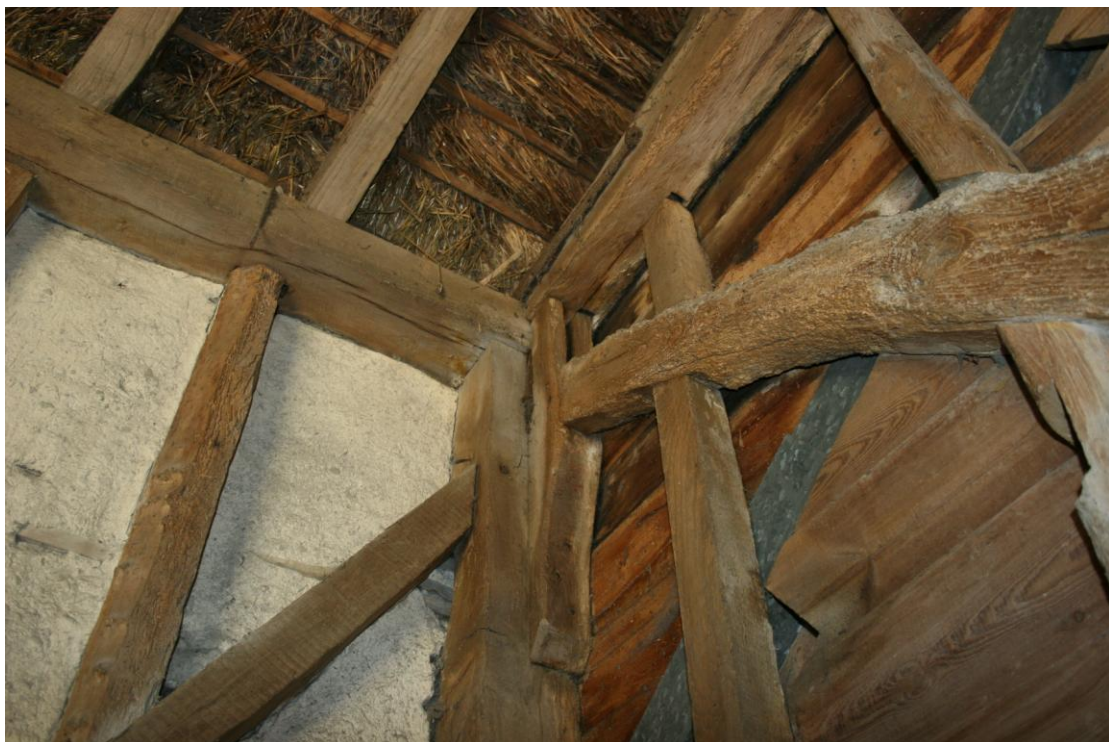
Detail of the NE corner post. Note the applied jowl piece.

The primary braces are cut very straight except for one in the eastern wall which is supported by an added jowl piece at the post head. Most of principal posts have no jowls and the joints are held with LC18th style wrought iron ties. The SW corner post is a reused post with swept jowl.

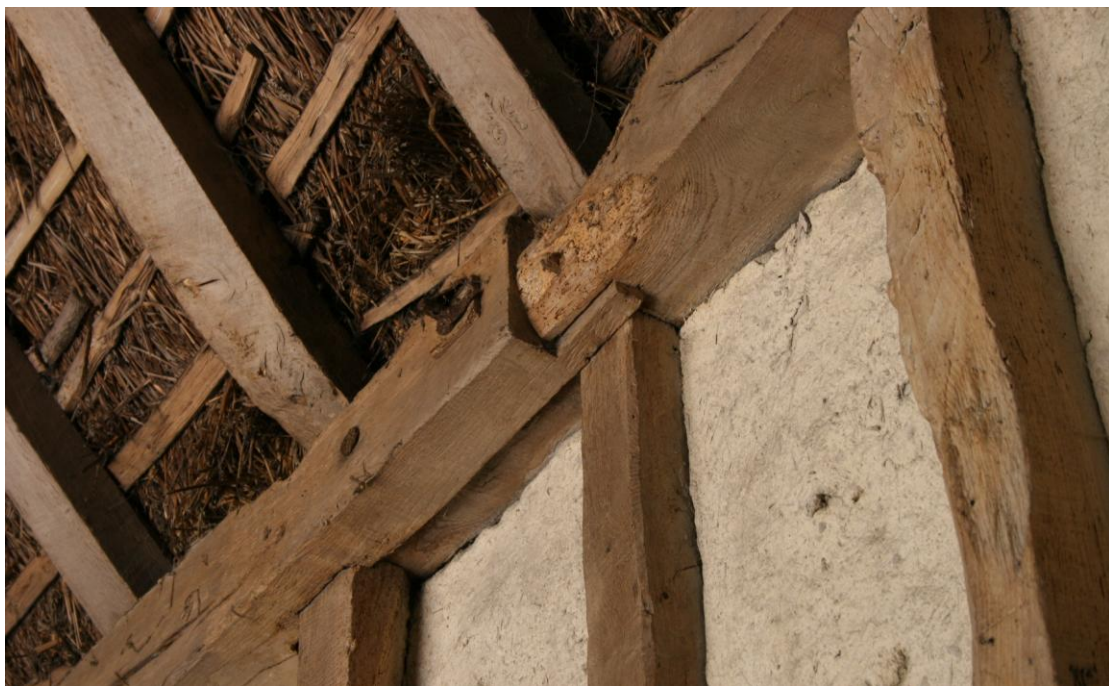
Detail of the forelocked scarf joint.

The principal posts are of variable sections, 8x7in, 5.5x6.5in, 6x6.6in and 6x6in. The studs vary more so but are cut on a 3in module. The face halved and bladed scarves are secured with forelock bolts which are original (not repairs) dating the joints to the LC18th.

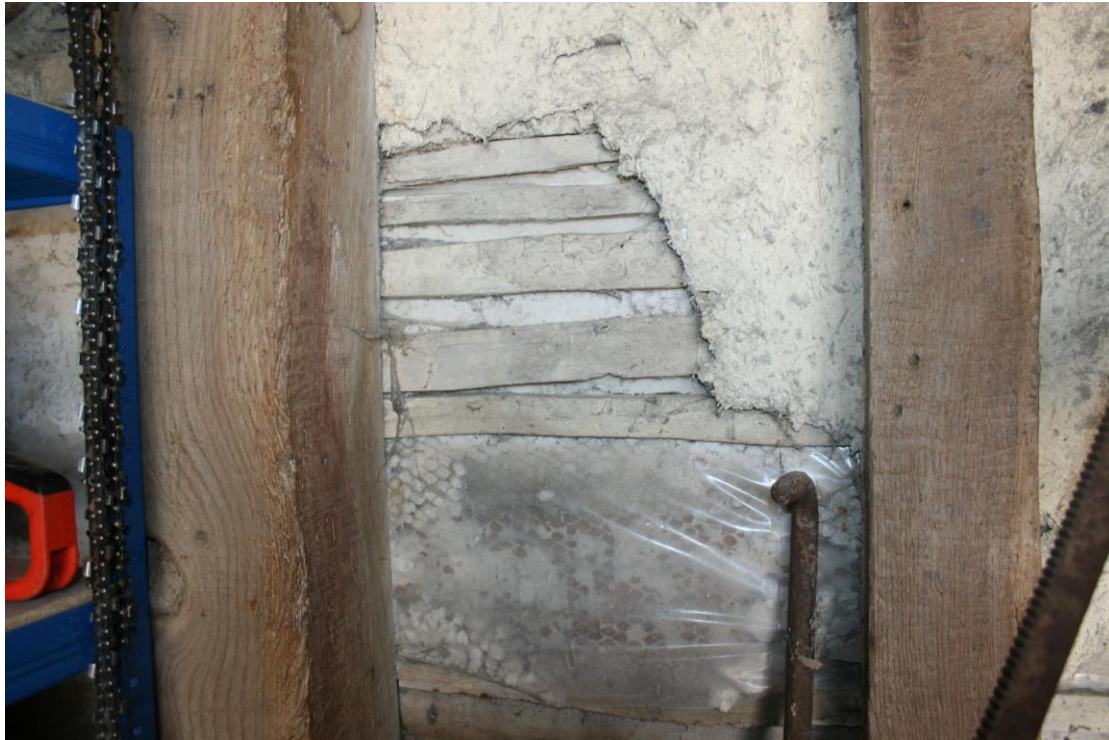
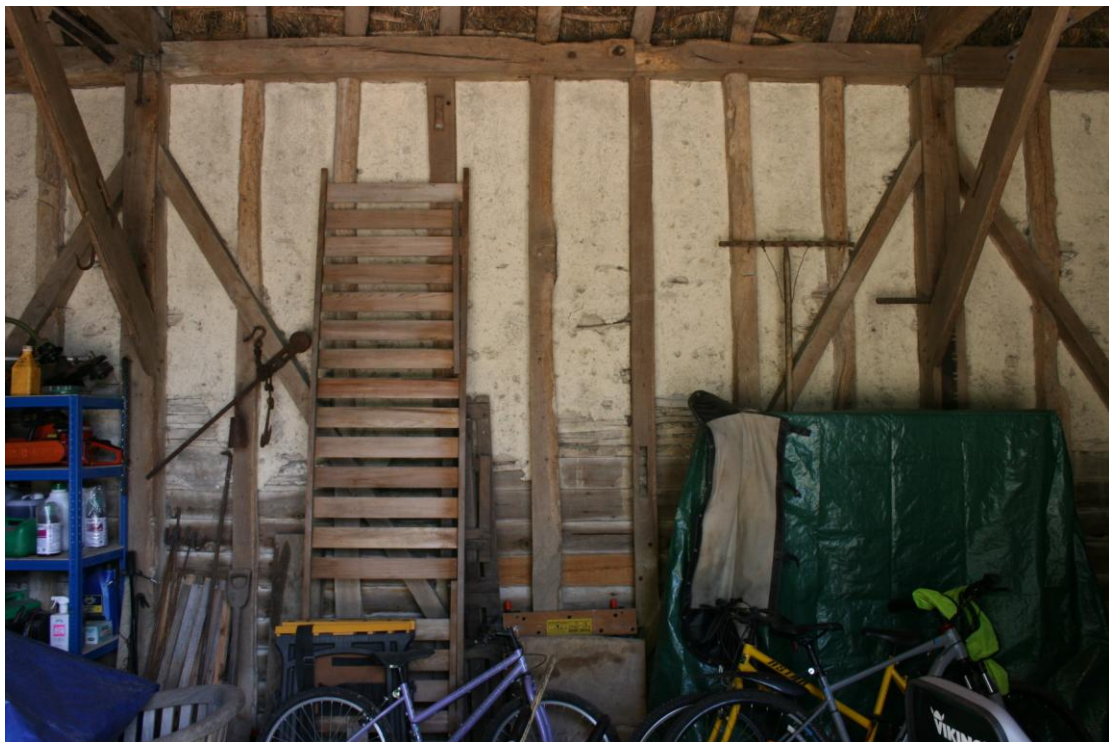
Detail of the north wall showing the layers of EML and lath and daub.

Large areas of lath and daub remain but are very friable. Central bay looking N.

The northern wall was originally rendered with horizontal lath and daub and later repaired with haired plaster. This format is very common in C.1800 farm buildings into the C19th.

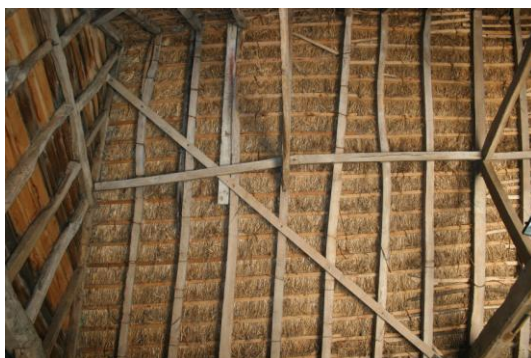
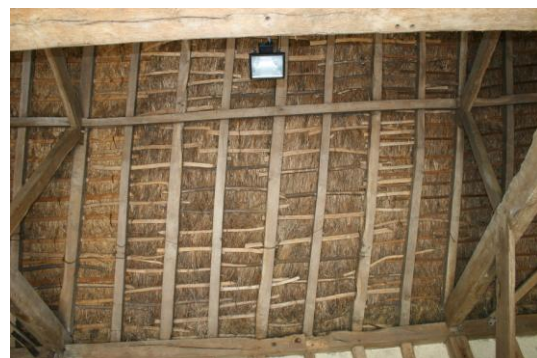
Bay 1 from the west compared to Bay 2 (central). The riven laths are still fresh.

The thatching is LC20th and was largely done in 1990. However the laths are of different qualities, some being machined softwood and some being riven laths and rods, pointing to an incremental approach to repairs. In particular the central bay has a different character to the end bays where the thatch is darker and so presumably older but not by many years. The split rods and riven laths are still fresh.

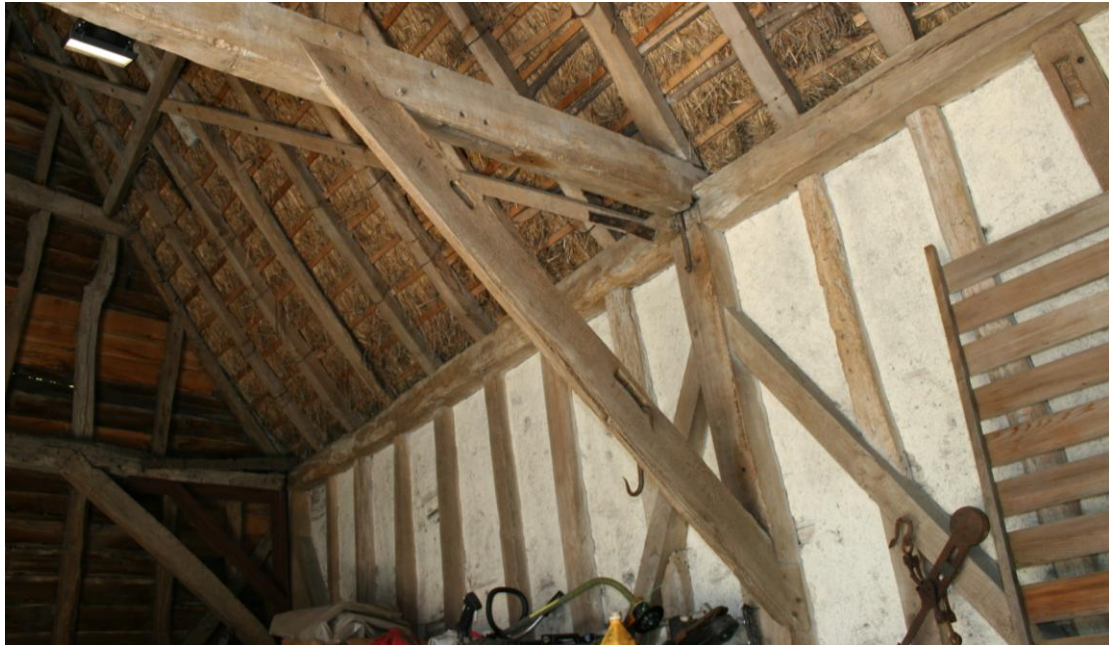
The spandrel has been slotted for a hay rack.

The Barn retains no historic fixtures or fittings. Of note however are several round ended mortices which would align to support a hayrack. Although termed a barn the building is more likely a stable.

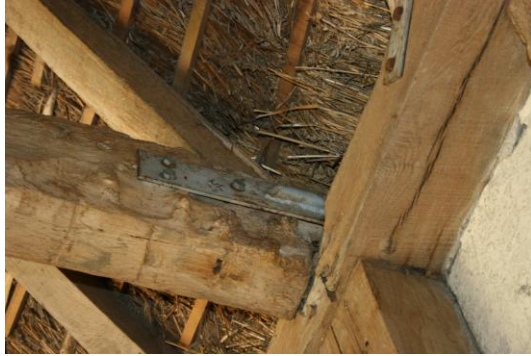
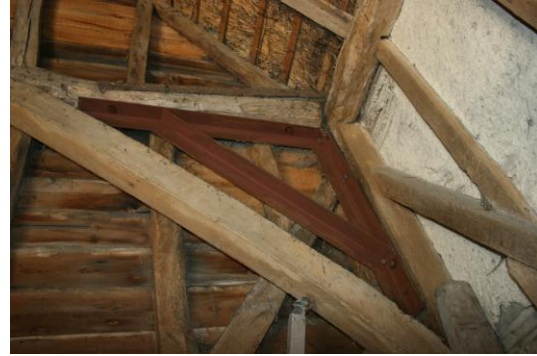
LC20th metal work repairs.

The modern repairs are easily identified as angle iron, threaded rods and milled mild steel strip which has rusted where not painted. Most of the work can be attributed to the 1990 re-thatching.

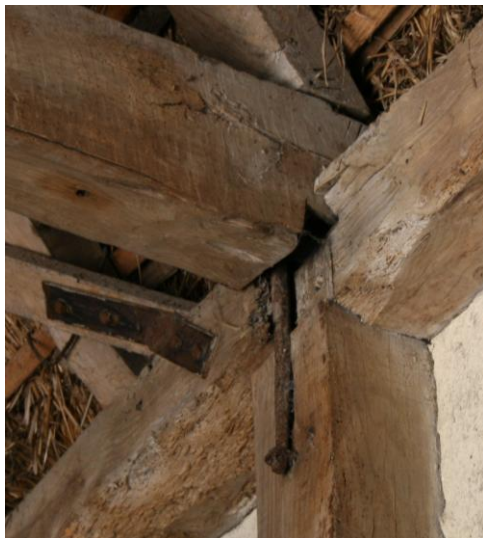
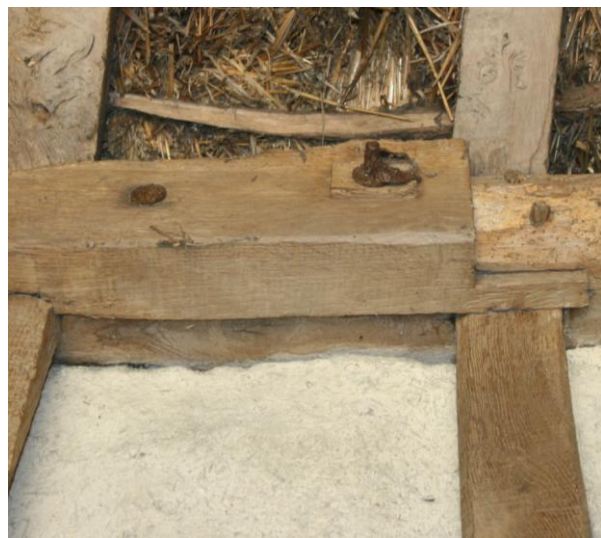
Original wrought iron tie.

Pair of forelock bolts securing the scarf joint.

The frame was built with wrought iron reinforced joints in the form of L-ties and forelock bolts. The L-ties are placed over the principal posts and alongside the tie-beams to prevent them from pulling out. This was done because the posts have no jowls to form a tenoned joint.

The forelock bolts are in pairs in the scarf joint, with one inserted from inside and the other from outside.
