Street Farmhouse, Main Street, Shudy Camps, Cambridgeshire CB1 6RA.
Recording and analysis of the house. Surveyed 19 09 2016/04 06 2017

Scope of this Report

This report describes and analyses the farmhouse from records made during visits before (19 09 2016) and during its refurbishment (04 06 2017).

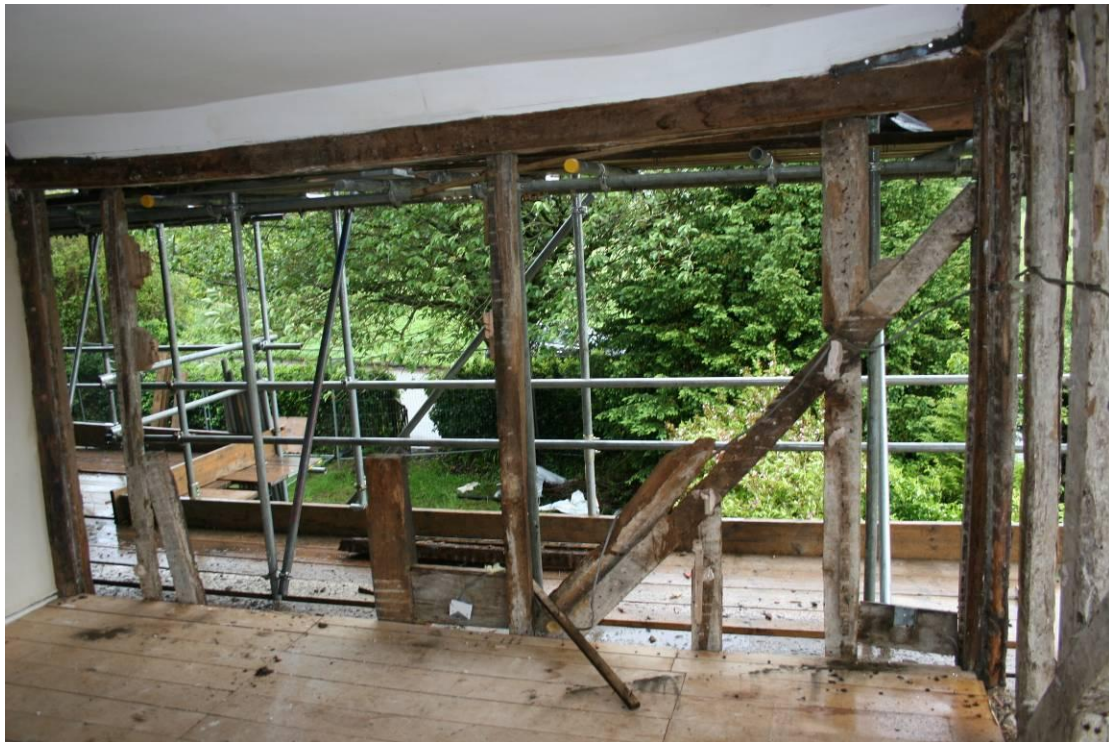
Looking S out of the front of the house.

The strip out revealed a highly altered frame with C16th origins but remodelled in the C18th to its present form. The south wall had been particularly dismembered and redesigned and it can be presumed it was fitted with sash windows which were replaced in the MC20th with Crittall style windows.

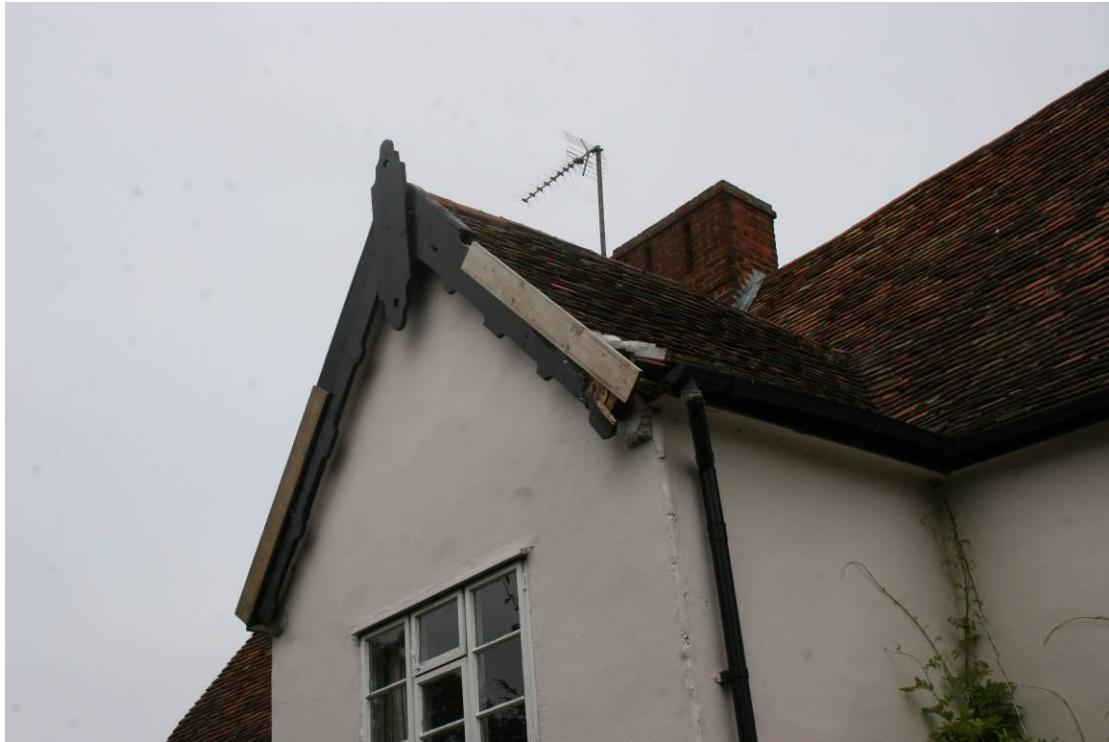
Detail of the porch. The crude boards are likely C20th.

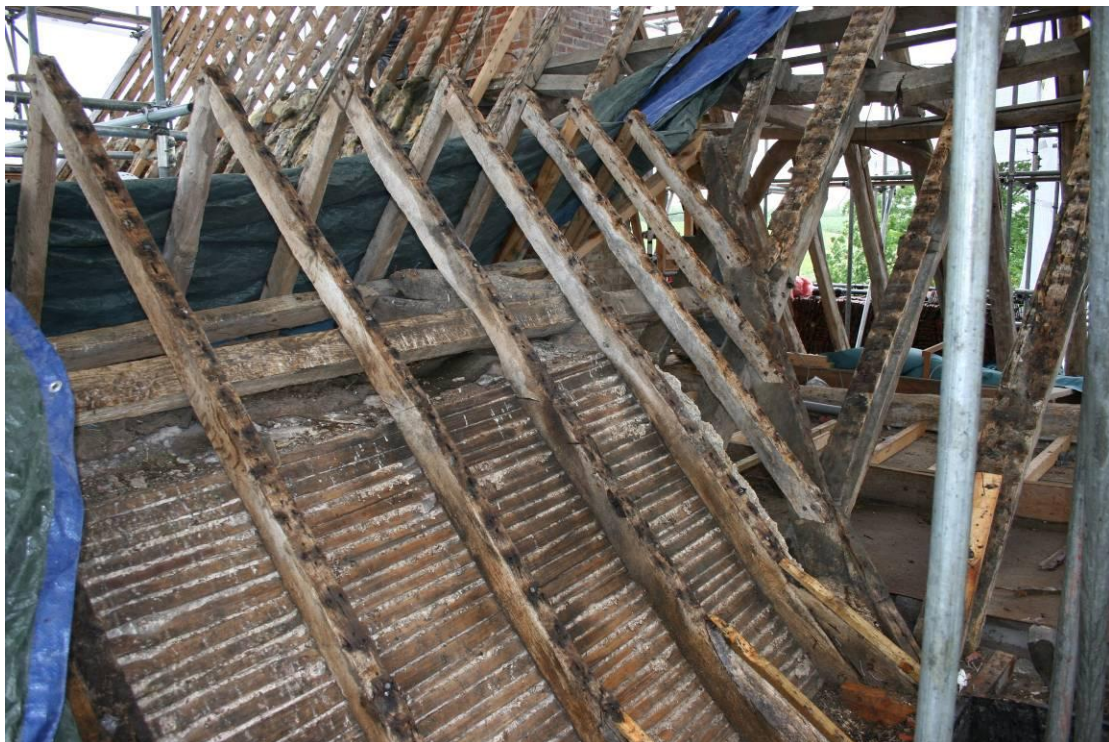
Roof structure of the porch.

The stripped frame revealed the porch has a paired rafter roof with clasped side purlins. The porch roof rafters are nailed to deep section jack rafters which pass over the rafters of the main roof to form the junction. The interior is clad with riven laths and haired plaster. The form and design of the frame would suggest it was added in the C17th.

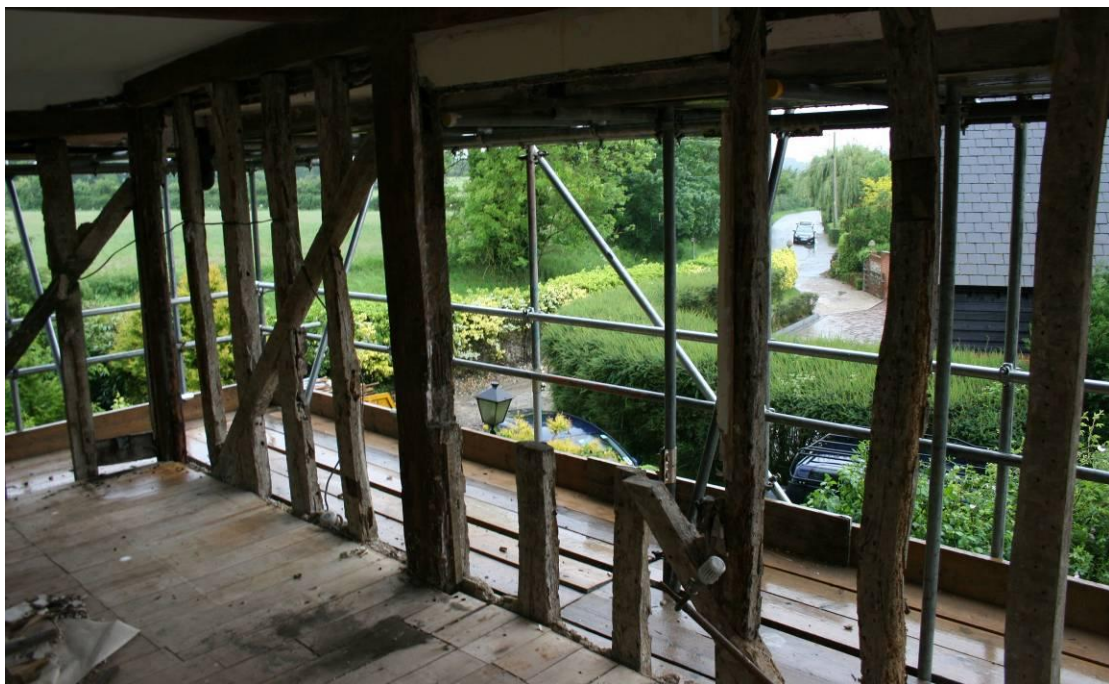
The western wall on the first floor looking SW.

The western elevation has a jettied gable with an attic room over a two storey timber-frame. There are two centrally placed Crittall style windows serving the ground and first floor and a LC20th simple casement for the attic room. The strip out revealed a nailed interrupted studwork primary braced frame made from reused timber almost certainly from the earlier frame.

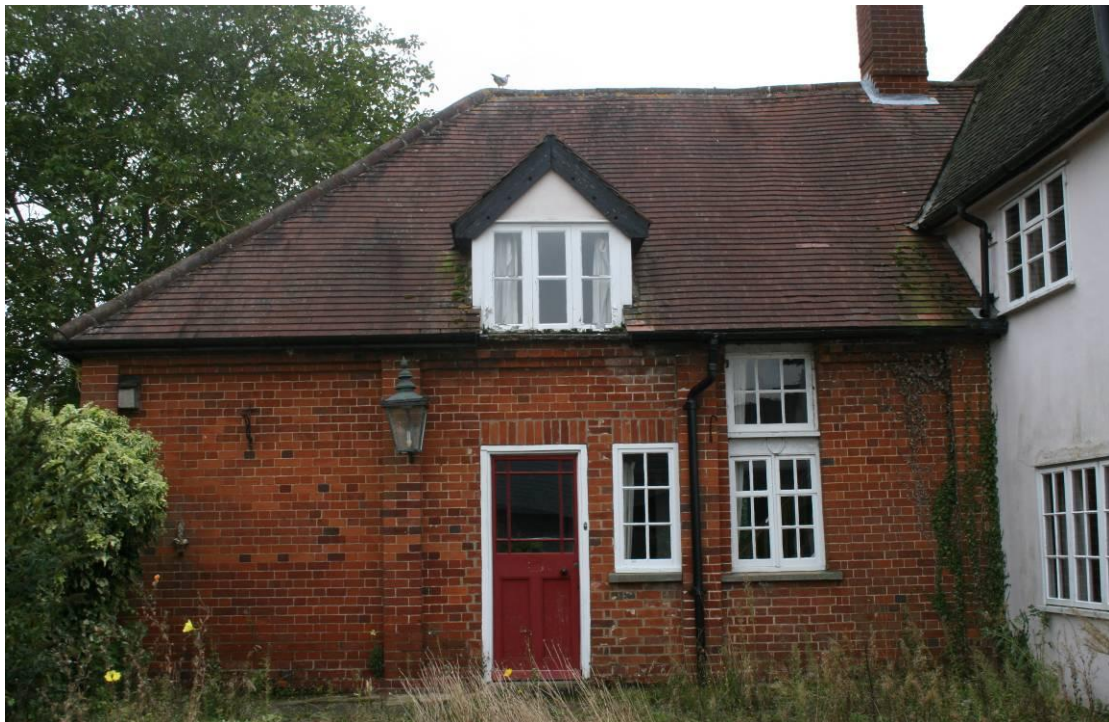
Western elevation of the Rear Range.

The house has been extended in red brickwork under a fully hipped roof clad with C20th plain tiles. The one and a half storey chalet style extension houses the Kitchen with bedrooms and bathroom above and is LC19th in character. The brickwork has pilasters giving three equal panels and there is a corbelled architrave beneath the eaves. The windows are mismatched and indicate an alteration in the LC20th, most likely to insert the staircase which has required an upper window. The brickwork indicates that the door was originally where the staircase windows are as the queen closer bricks are full height on one side. The doors and side window are inserted under soldier course lintels and have no closer bricks. The door itself is a peculiar mix of a Victorian style four panel door with over sized margin glazing. The brickwork is marked KK 1885.

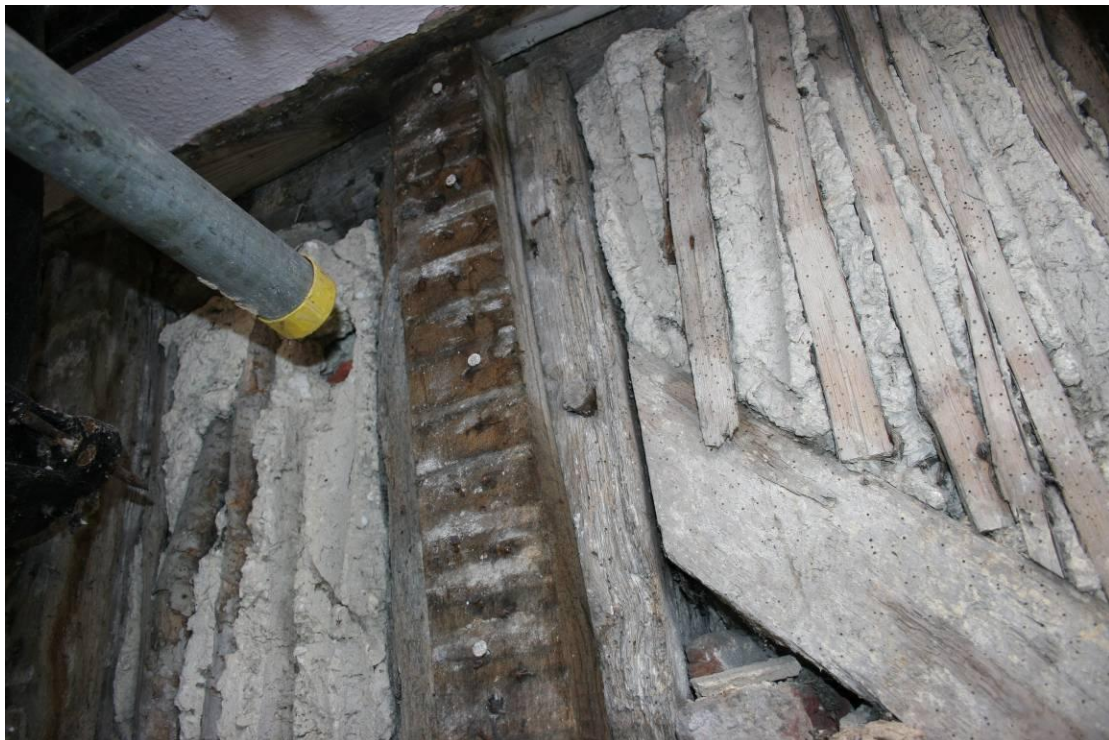
Detail of wattle and daub and lath and plaster panels on the first floor.

The northern elevation has seeming a randomly placed selection of windows from the 1930's to the LC20th and these respect the positions of the primary braces which are pegged and side nailed in position.

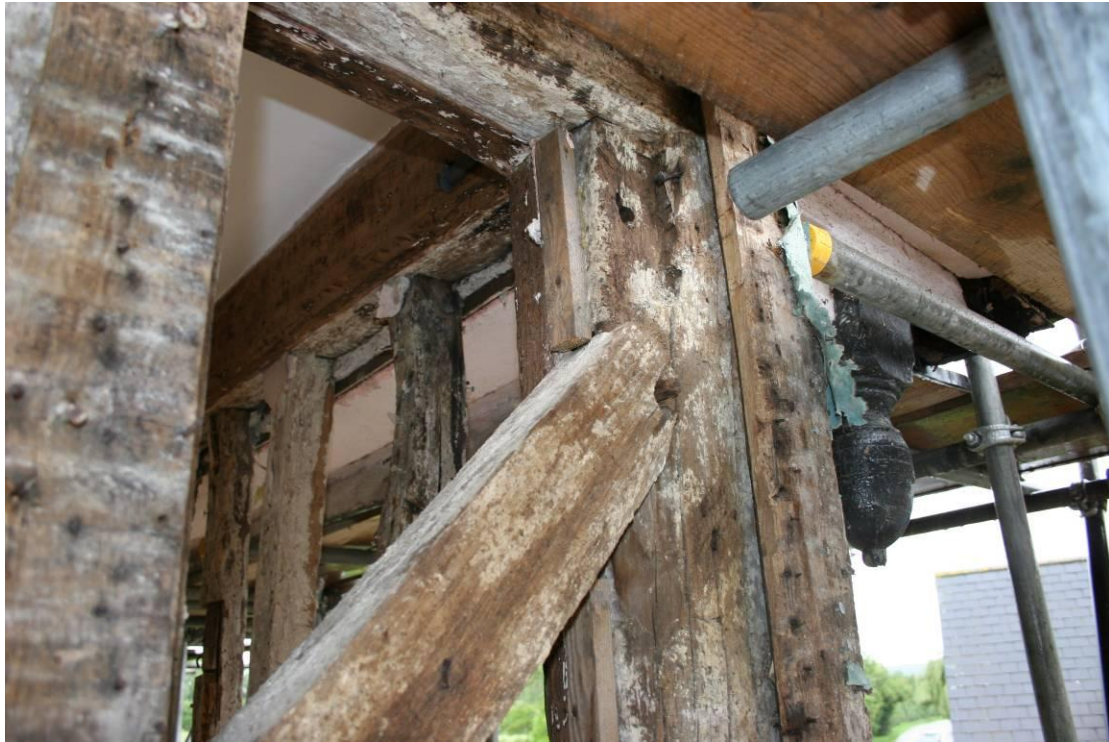
Reused primary brace nailed in position.

The original heavy frame has been reconfigured to incorporate straight primary braces and the studs sawn down and nailed in place. The studs below the braces are of narrower sections.

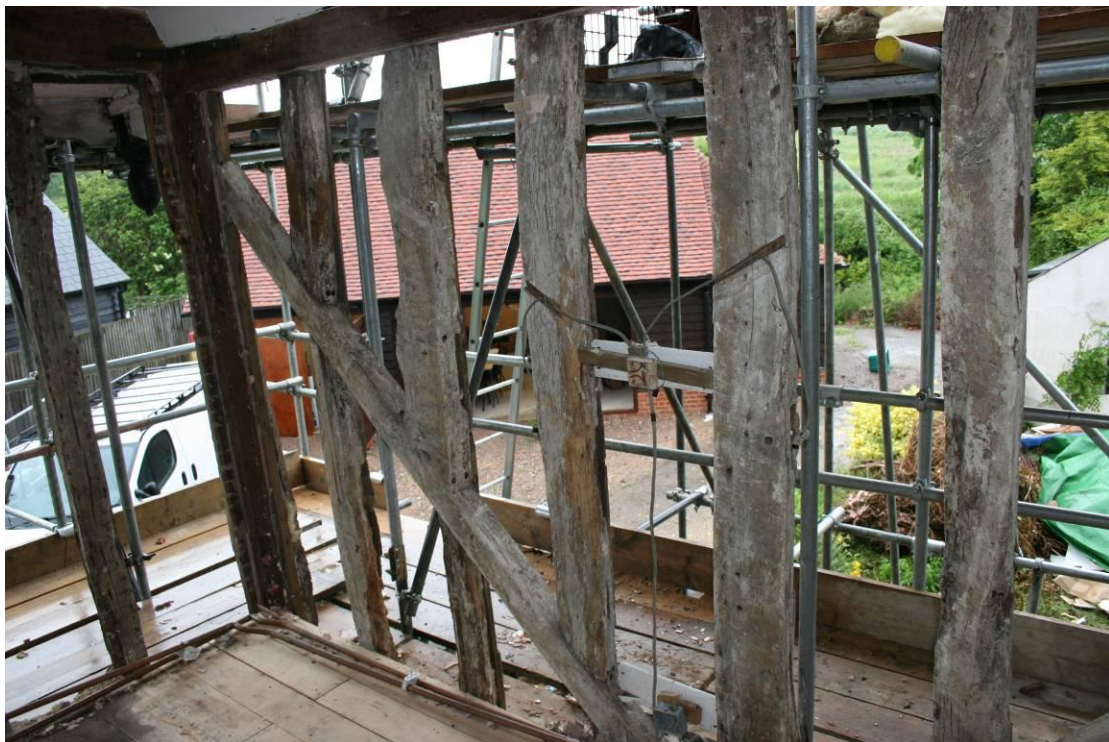
The same brace from inside the building looking NW.

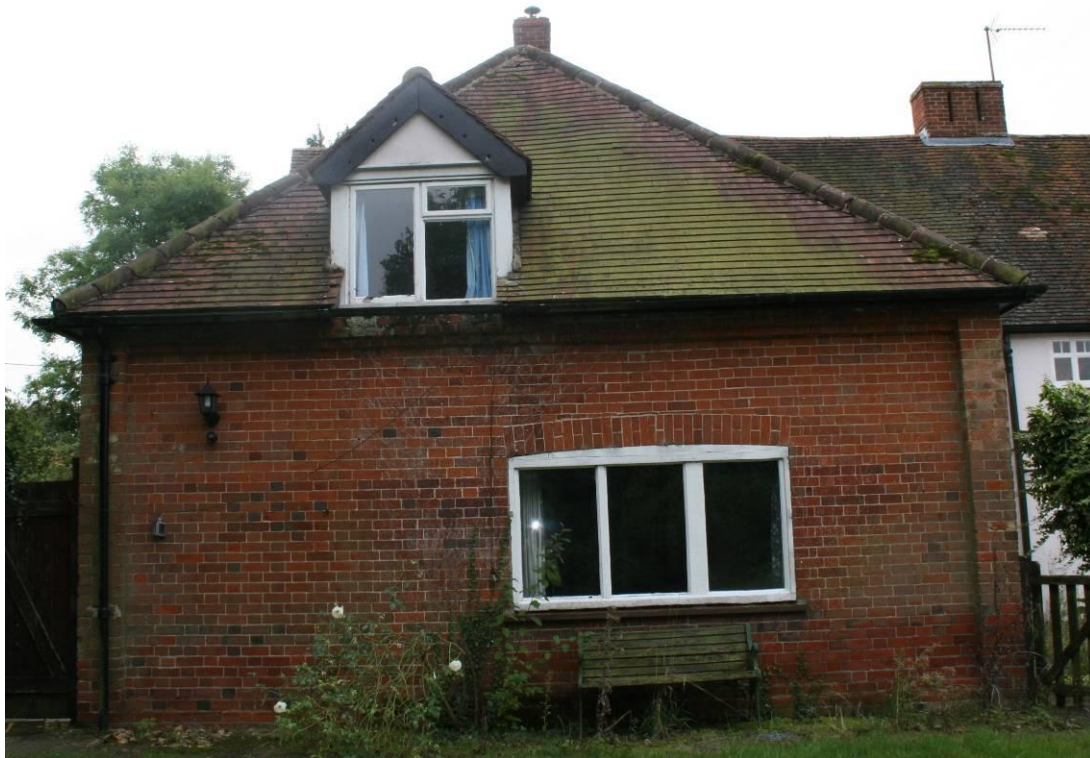
Detail of the brick Rear Range.

The Rear Range has a LC20th 3 pane casement placed in an original opening that is correctly finished with closer bricks and a segmental curved lintel. Above and off centre is a dormer with LC20th casement window and deep barge boards with circular holes that matches the other on the western side as part of a LC20th conversion.

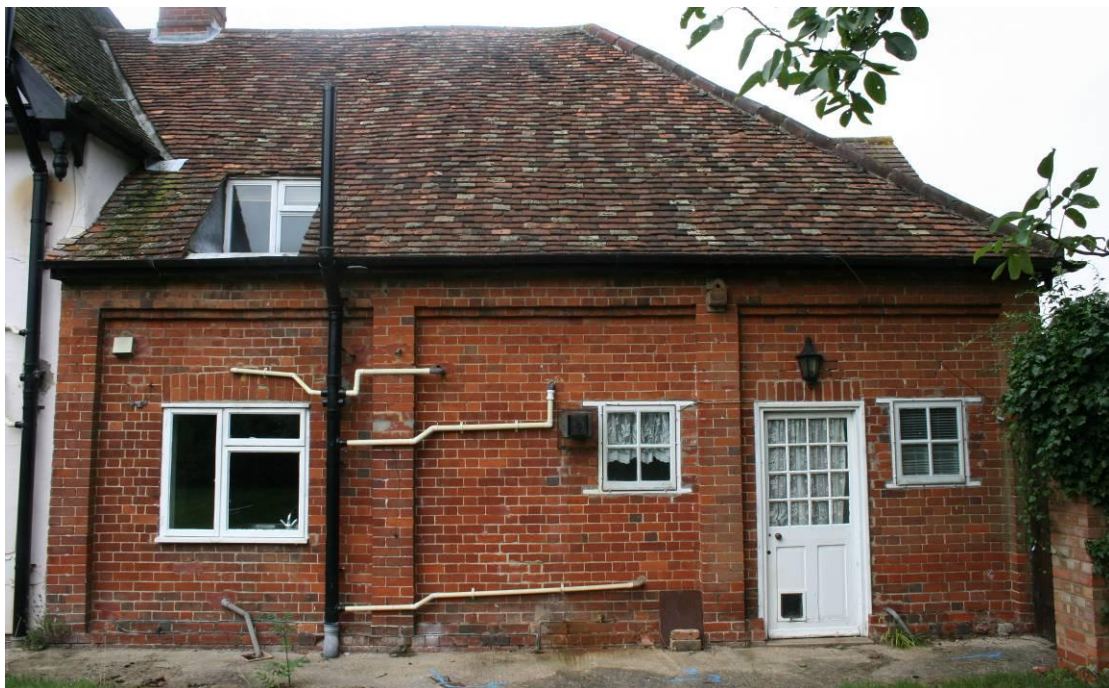
Detail of the Rear Range.

The eastern elevation of the Brick Range has three recessed panels defined by pilasters and a corbelled plat band. A LC20th casement has been let into the roof for the bathroom which is betrayed by an ungainly set of white plastic waste pipes. One large LC20th casement is set in an original window opening under a segmental arch. The MC20th half glazed door is inserted and under a soldier course lintel. The two top hung four pane casements are crudely inserted and pointed with grey cement.

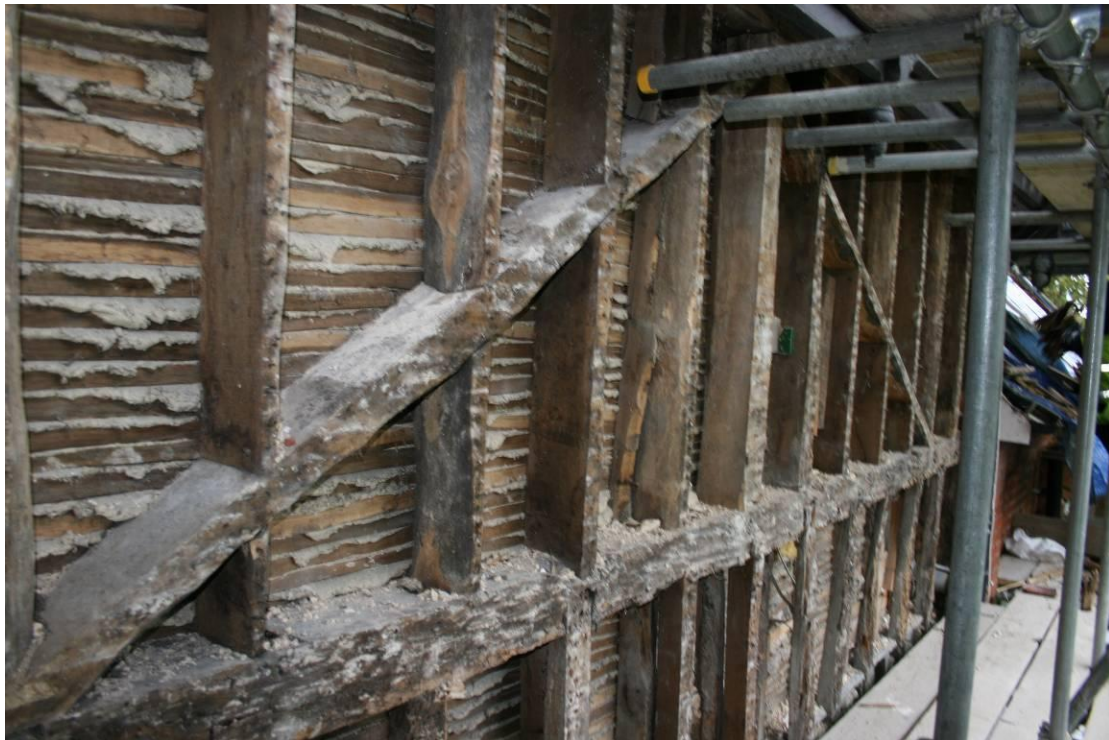
The frame of the eastern wall just below the jettied gable.

When the frame was stripped it became more apparent that the entire western half of the House was a new building from c.1800 (+or- 20 years). The wall frames are composed of deep section nailed interrupted studwork with primary braces. Many of the studs are skew nailed at the midrail. There are no full height storey posts instead the frame are spilt above and below the midrail.

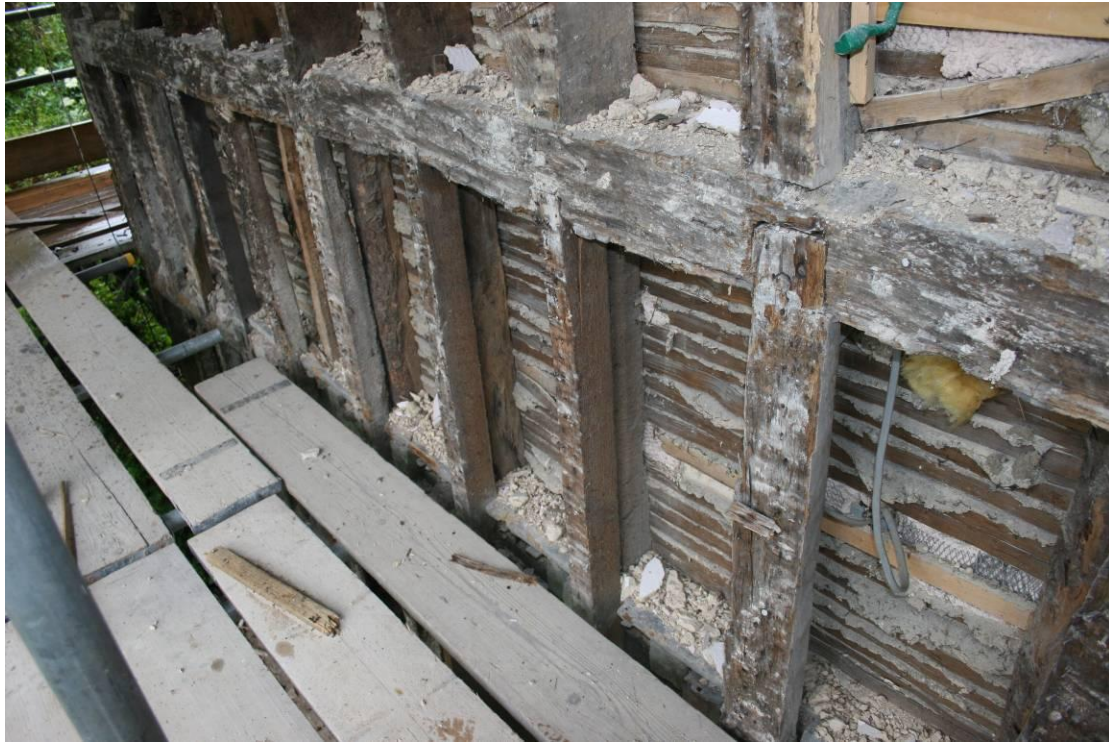
Skew nailed studs.

An interesting feature is the creation of a deep cavity wall by the use of deep section, plank like studs. Where the large timber stock ran out there are pairs of studs to make up the depth and these are all skew nailed in place. There are very few carpentry marks and those found seem to mark alterations such as for the window openings.

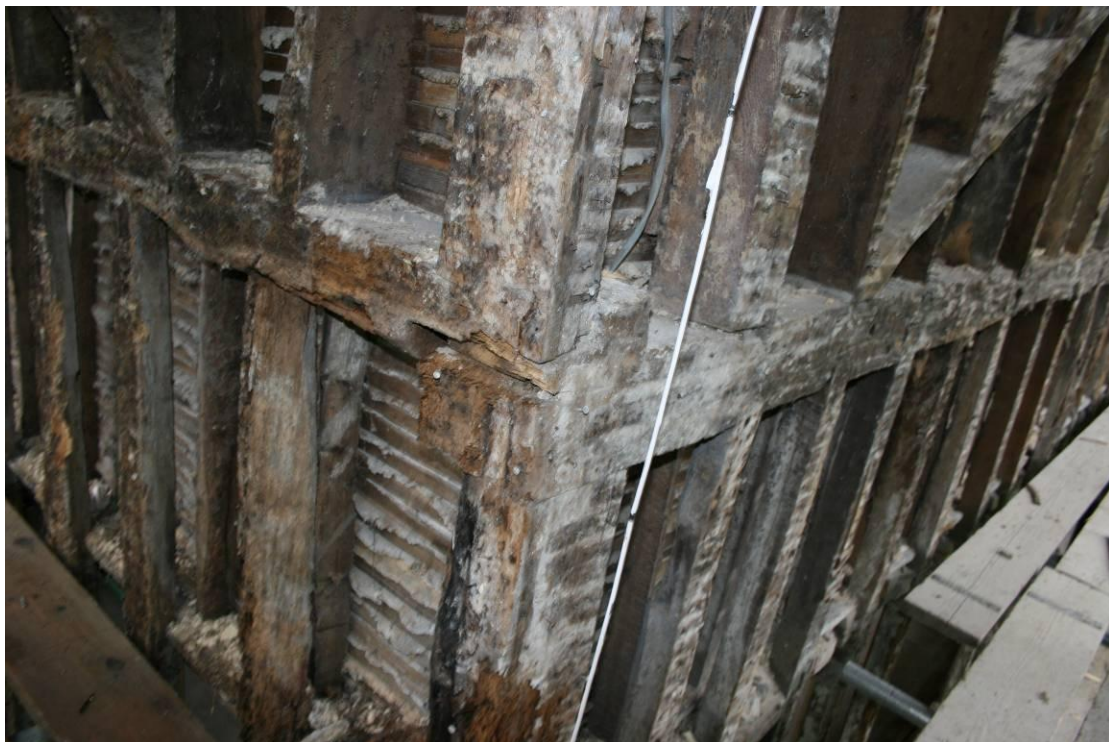
Detail of the corner post. One midrail sits on the other.

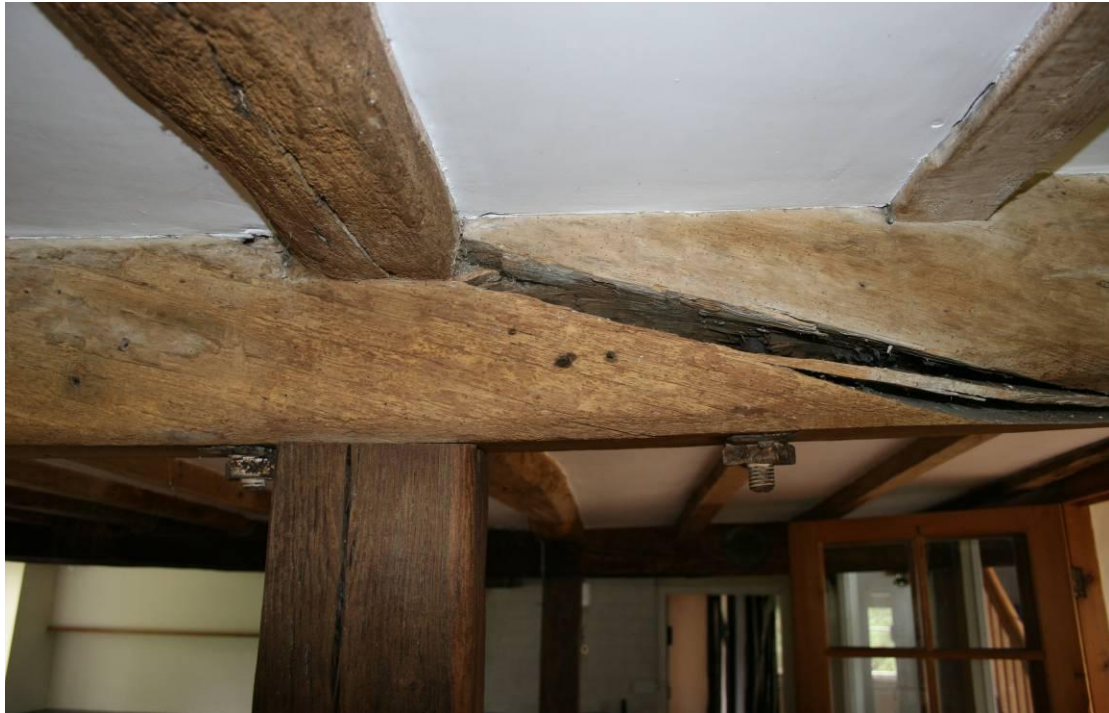
Historic failure addressed with C.1800 style wrought iron bolts.

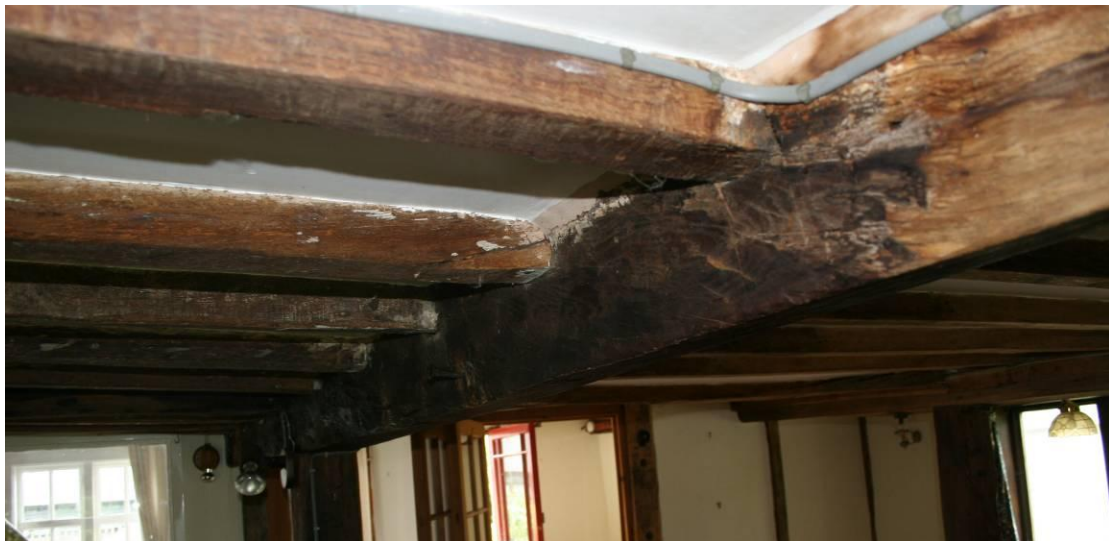
Detail of the frame over the Kitcehn.

The exposed frame has been cleaned in various episodes and a large number of LC20th repairs and insertions carried out. The area over the Kitchen is most convincing as it still retains the sooting expected from being over a fireplace. The northernmost transverse main joist has a massive split that has been arrested with C.1800 style wrought iron bolts and is also likely to be original. The common plain joists are of varying sections and some are much less convincing than others. The originals have soffit tenons.

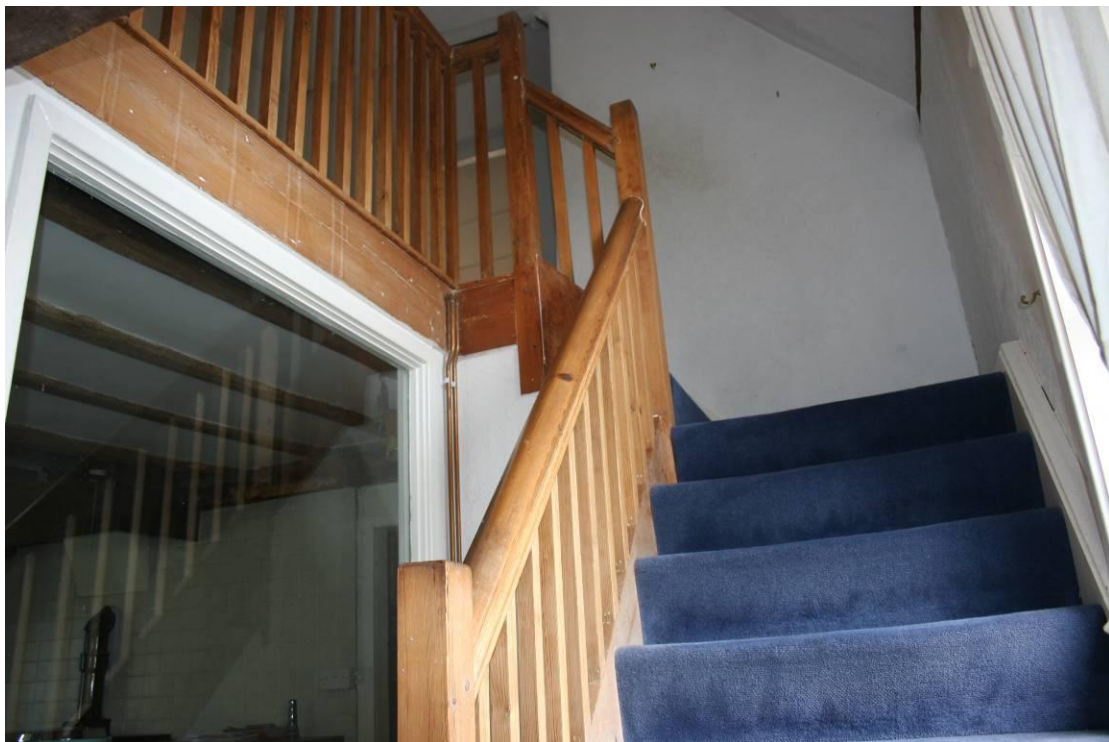
Distressed pine staircase.

There is a LC20th inserted staircase which has been enclosed in a glass booth presumably to conserve heat and prevent cooking smells going upstairs.

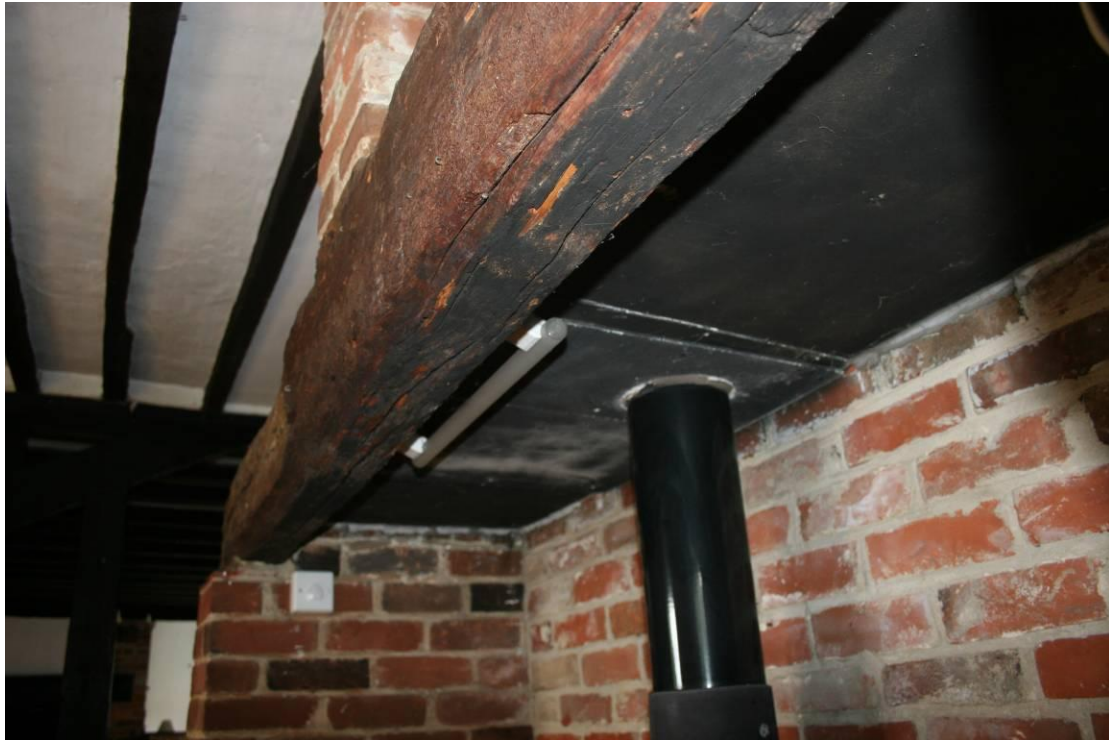
The Sitting Room has a large red brick firestack that has been almost completely rebuilt below the bressummer in the LC20th and the upper section which has 2in Tudor style bricks pointed in grey cement. The bressummer itself is a reused timber from elsewhere as the soffit chamfer continues right through into the brickwork repairs instead of being correctly stopped. There is some EC19th style brickwork in the outer flanks with very white lime mortar and timber stakes to apply panelling to.

Detail of the bressummer and modern brickwork.

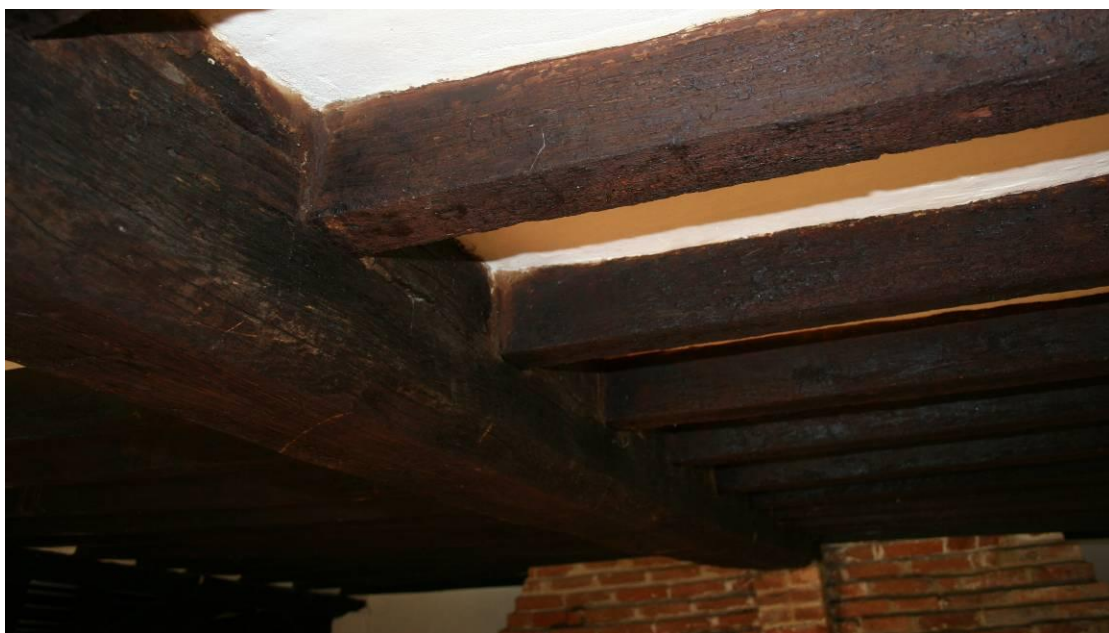
Detail of the main and common joists.

The heavy main joist has a deep chamfer. The common joists are plain and set on edge. They have soffit tenons with refined entry mortices. A central pillar has been built in to support the failing end of the main floor joist. Originally the fireplace would have been plastered over and ruled to look like stone. Its present appearance is a LC20th interpretation common to that era.

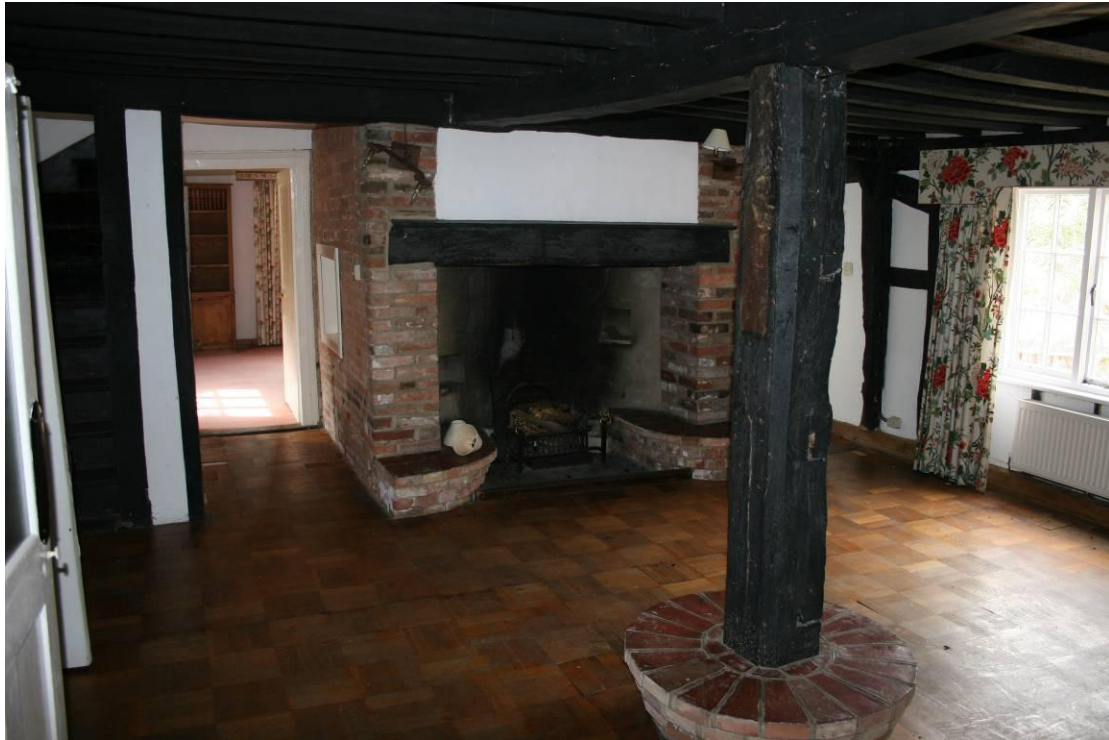
Looking W in the Living Room. The post takes the weight of the failing main joist.

The framed floor above has a heavy axial main joist with chamfers and stepped cyma (lamb's tongue) stops. The common joists are plain, nearly square and set on edge indicating a C17th design. The main joist has sagged and is supported on a post cut from another main joist of which the other half has been used as the bressummer for the inglenook fireplace which has been entirely rebuilt in the 1970's.

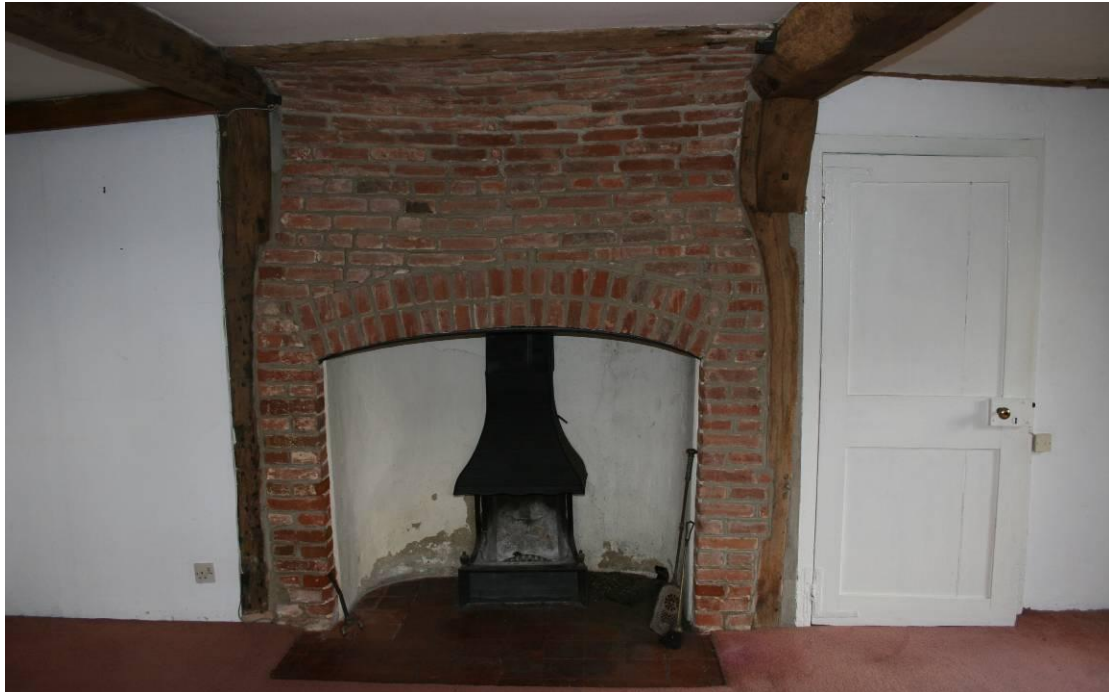
Detail of the fireplace and Georgian style door.

The fireplace has been rebuilt using Tudor style bricks. The bressumer is a segmental brick arch (very similar to the window lintels in the Rear Range) supported on a wrought iron strap. The back is curved to accept a range or hob grate. The upper section has been corbelled out to support a hearth for the fireplace above. The current hearth is of LC20th quarry tiles.

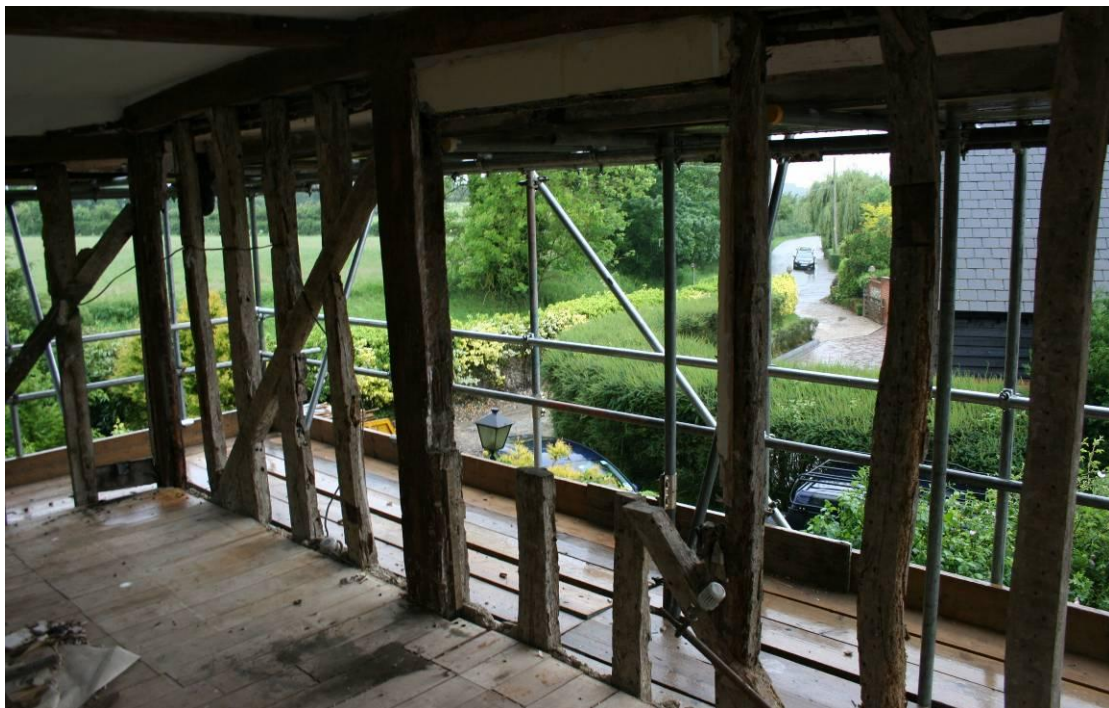
The stripped frame in Bedroom 1 looking SW.

An airing cupboard of the 1950's remained in Bedroom 1 and could be dated by newspaper stuffed into the cracks in the walls from the Radio Times of December 6 1957. The stripped frame revealed an earlier oak frame with full height studs that had been cut up to insert primary braces and nailed interrupted studwork. One primary brace was later cut through to insert a larger window in the western wall.

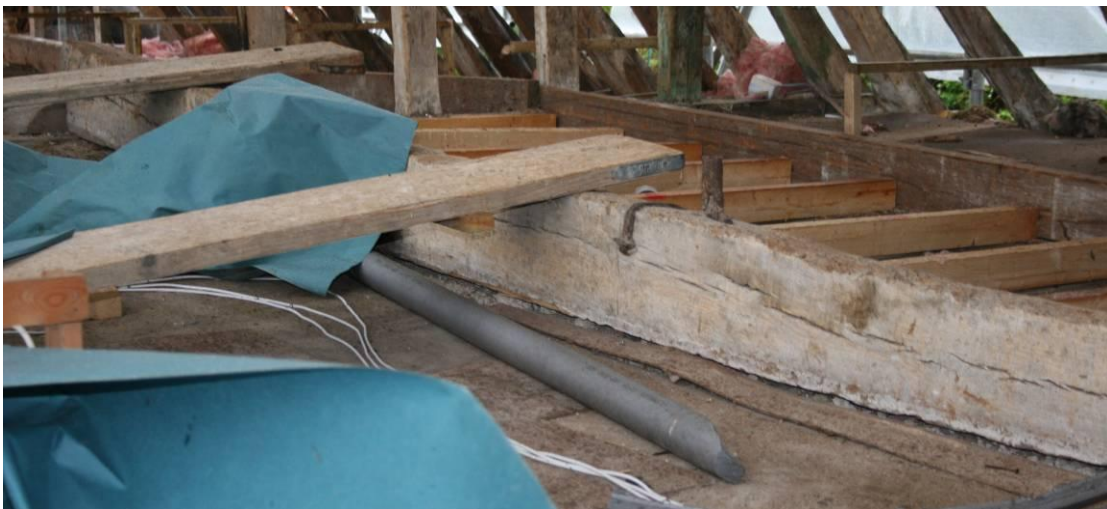
Detail of the forelock bolt and strapping. Looking SE.

The stripped frame revealed that a second axial joist has been placed above the first and secured with wrought iron straps and a large centrally placed forelock bolt. Forelock bolts are the pre-cursors of threaded bolts (which do not become common until c.1800) and indicate a repair in the C17th or C18th. The timber itself is a pitsawn elm tree trunk cut in half.

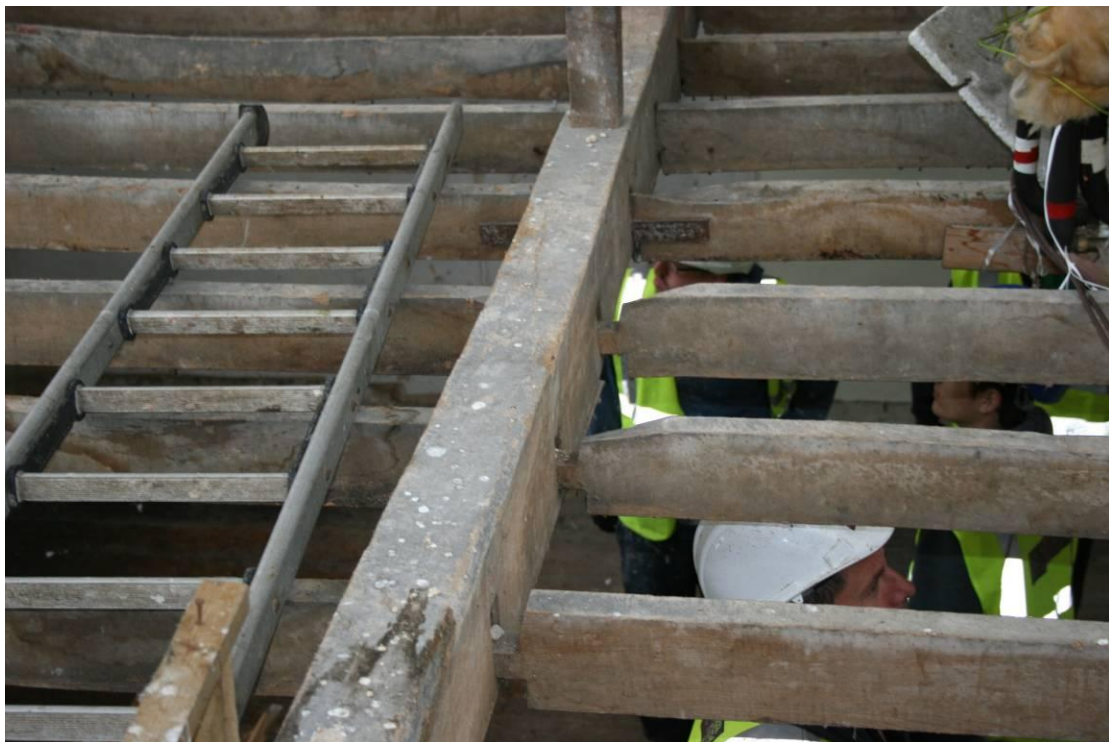
Detail of the ceiling structure above Bedroom 2.

The frame above Bedroom 2 is of c.1800 design and fabric with elm joists set on edge with centre tenons with refined entries. Ironwork straps are inserted to prevent spreading. The mass of the joists indicates an attic room was put in above.

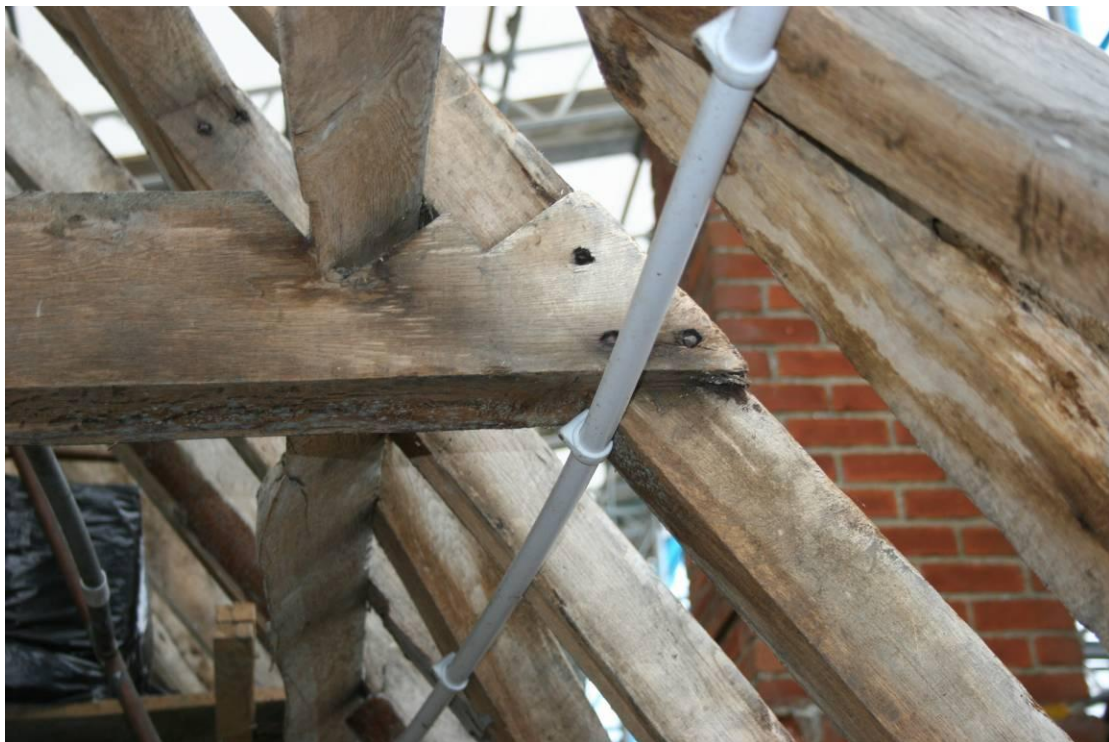
Detail of lapped and side nailed collar.

The rafters are paired, lapped and nailed together. All the construction is nailed suggesting a Georgian design but late in the period circa 1800.

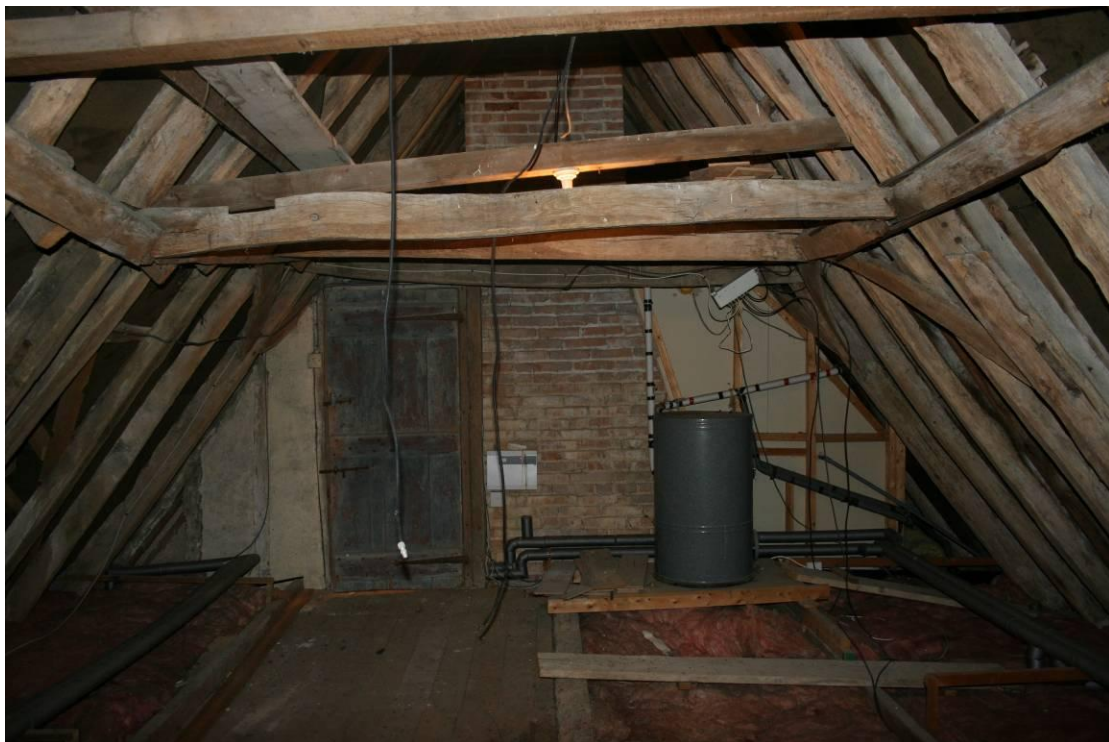
The junction of the original roof with the added eastern roof. Looking W.

The roof changes form part way along the purlin where a primary brace has been inserted to stiffen the frame between the two structures. The windbraces by the door are numbered V with a race knife. The original lapped and pegged collar has been removed and replaced by a birdsmouthed strut.

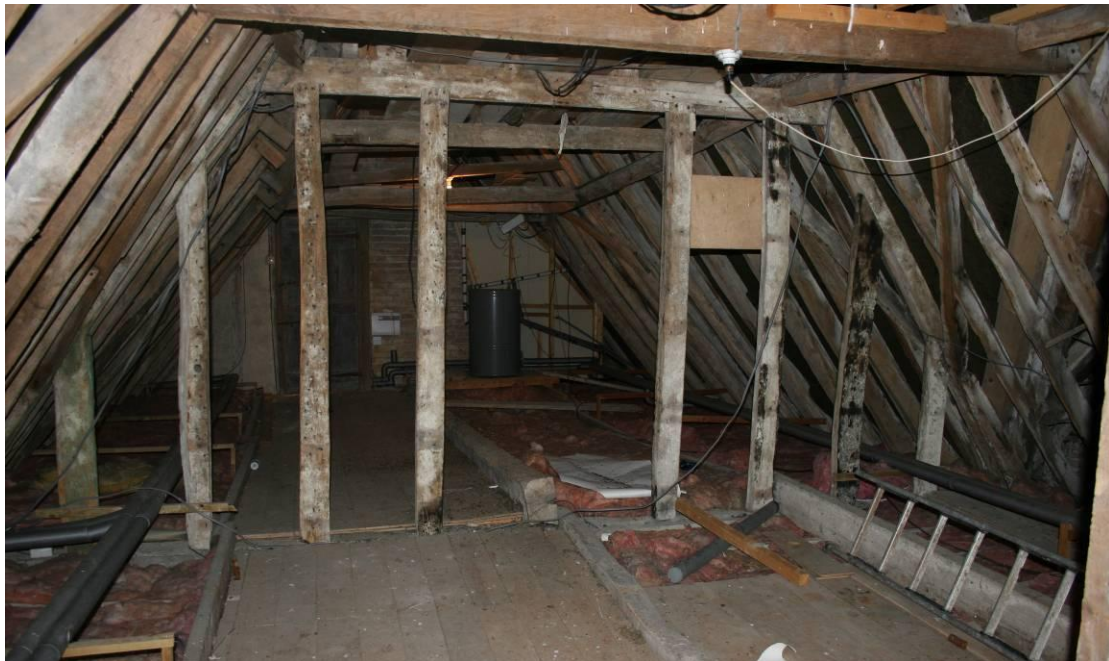
The Eastern Attic was boarded out as two store rooms. Looking W.

The Eastern Attic was converted in the EC19th and divided into two areas with side nailed studwork some of which appeared burnt before reuse. The striping across them indicated they were boarded rather than lath and plastered. A stout edge moulded plank and ledger door hung on wrought iron pintles was used to protect the rooms which may have been habitable as the Suffolk latch and bolt are on the inside. (The other option being the door has been turned upside down).
