Shemmings Farm Buildings, Hardys Green, Birch, Essex. CO2 0NY.
Recording and analysis of the farm buildings. Surveyed 08 05 2017.

Scope of this Report

This report describes and analyses the buildings with a view to mitigating for and informing future development.

The report adheres to Historic England Level 2 as outlined in Historic England. Understanding Historic Buildings – A guide to good recording practice. 2016. Page 22.

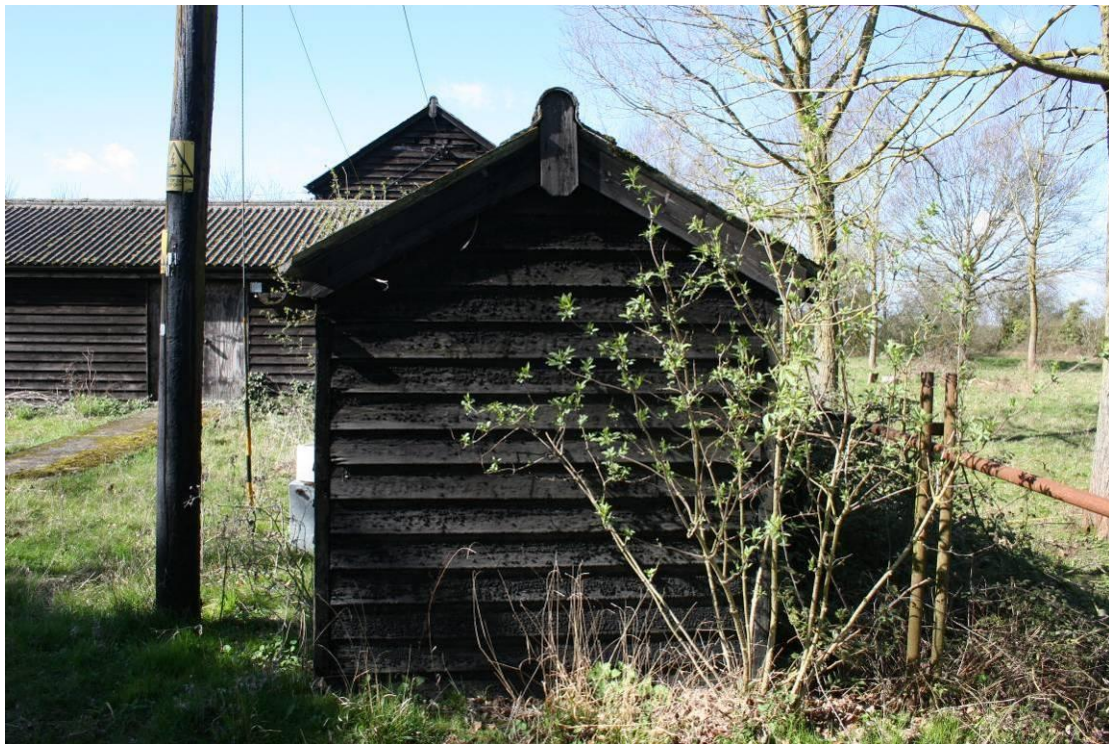
Eastern elevation of the narrow building.

The Sheds are three conjoined timber-framed buildings that have been highly altered in the LC20th. The primary braced interrupted studwork frames are clad with MC20th weatherboards, some hot tarred and some cold brushed, fixed with wrought iron and French nails. The southern, farmyard side, is equipped with narrow, stable like door openings that have often been blocked and others inserted.

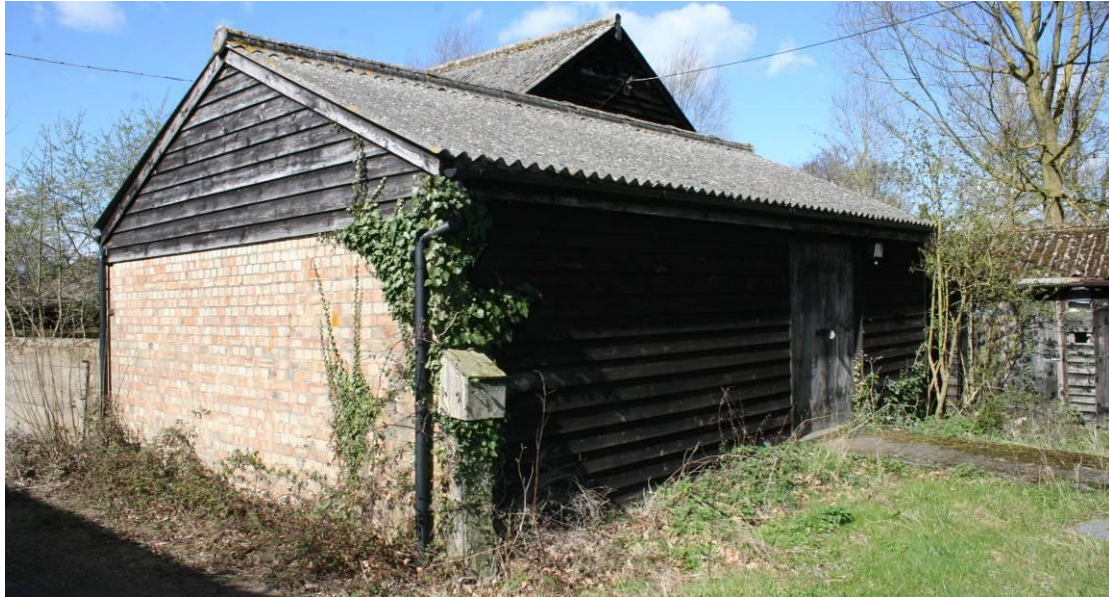
Southern and eastern elevations of the Garage.

The Garage has a timber-frame clad with M-LC20th weather-boards and a southern wall built of LBC Flettons. The roof is clad with corrugated asbestos. There is a pair of garage doors and to the rear a large pane window armoured with bars on the inside. The concrete ramp up to the doors suggests vehicle access for a small tractor or car.

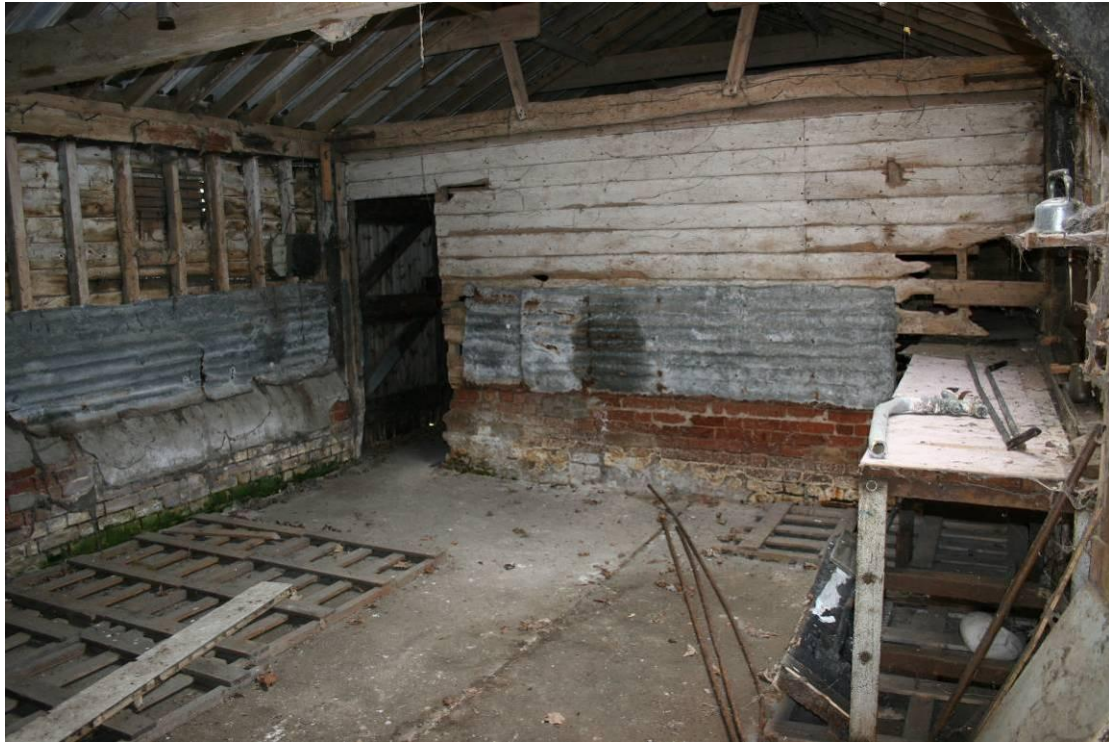
Looking SE in the northern room of the Stables.

The interior of the Stables has been outfitted with elm kick boards of which only those on the partition wall remain. The walls have also been lined with corrugated iron which indicates they were used as pig sties in the M-LC20th.

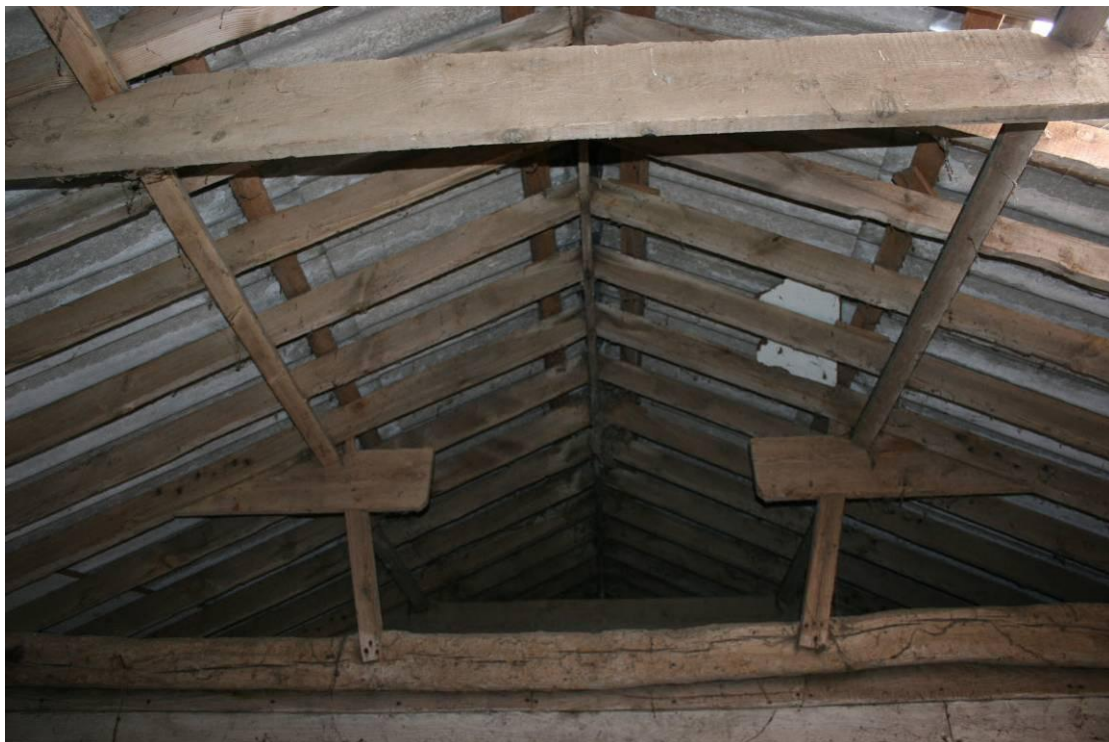
The collar has been cut through and supported on raking struts from the partition wall.

The roof is made of machined pine rafters and plank collars, one of which has been sawn through to install a piece of machinery or water tank.

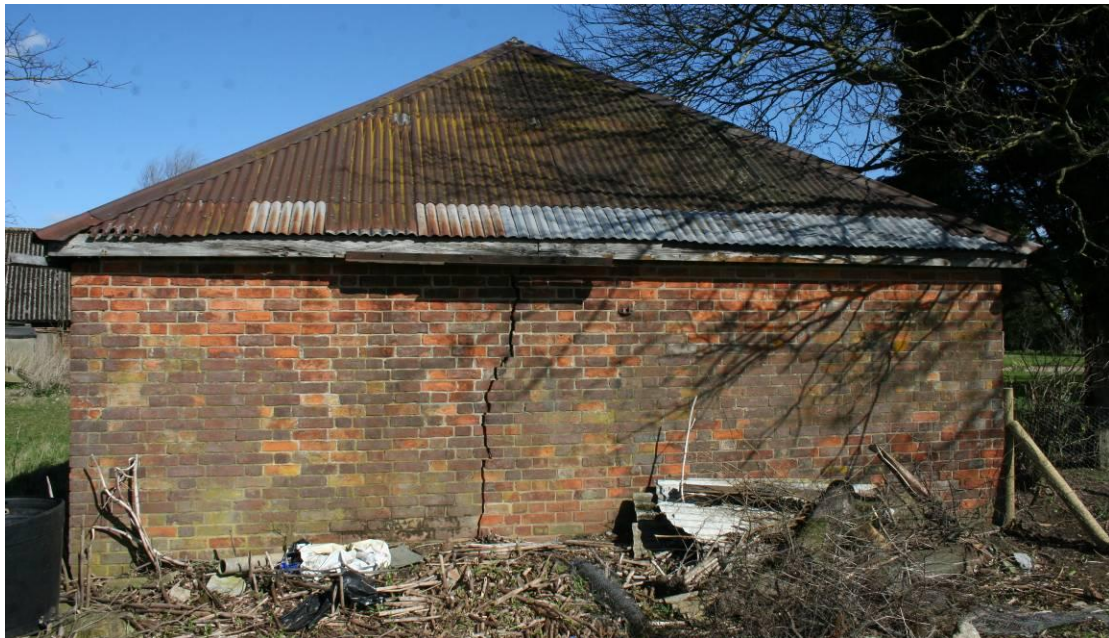
The southern wall of the Tractor Shed.

A building corresponding to the Tractor Shed is shown on the 1896 Ordnance Survey map as a closed building but the present structure was built in the MC20th. The walls are built of reclaimed bricks set in very buttered cement pointing with added buttresses to support the machined pine plank roof. The roof is clad with corrugated iron sheeting in very poor condition

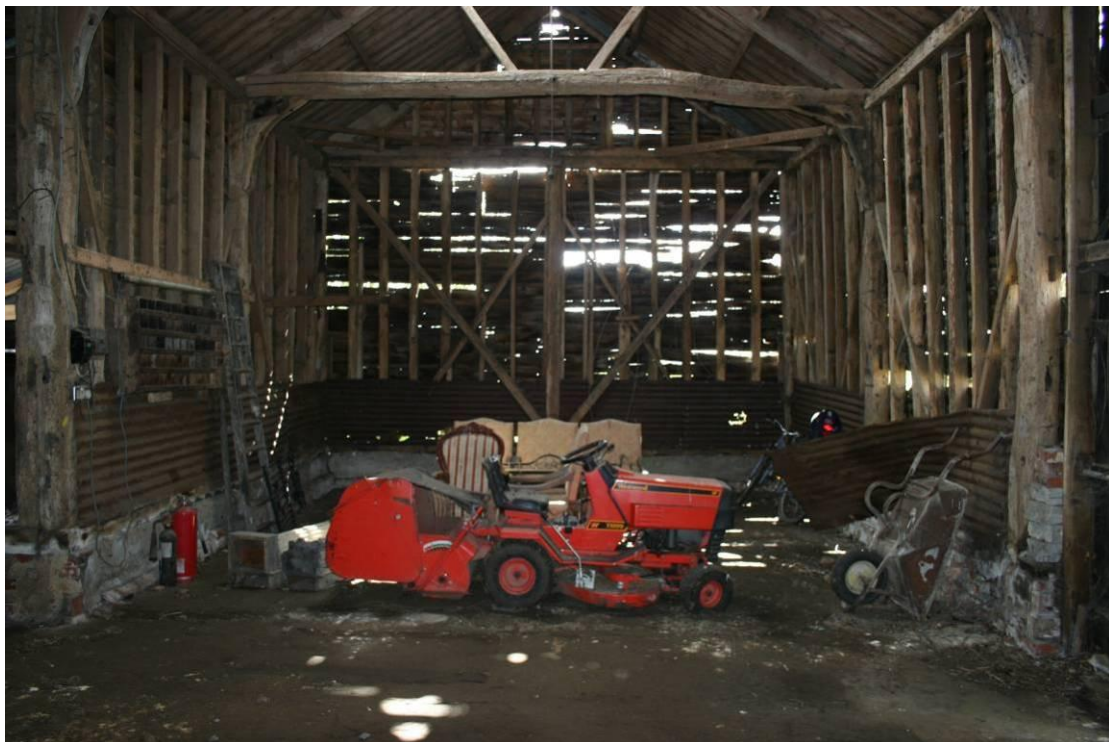
Looking N inside the Barn.

The barn has some C20th repairs adding in contra braces on the northern wall. The walls are lined with corrugated metal and this usually indicates the space was used for keeping pigs in the MC20th.

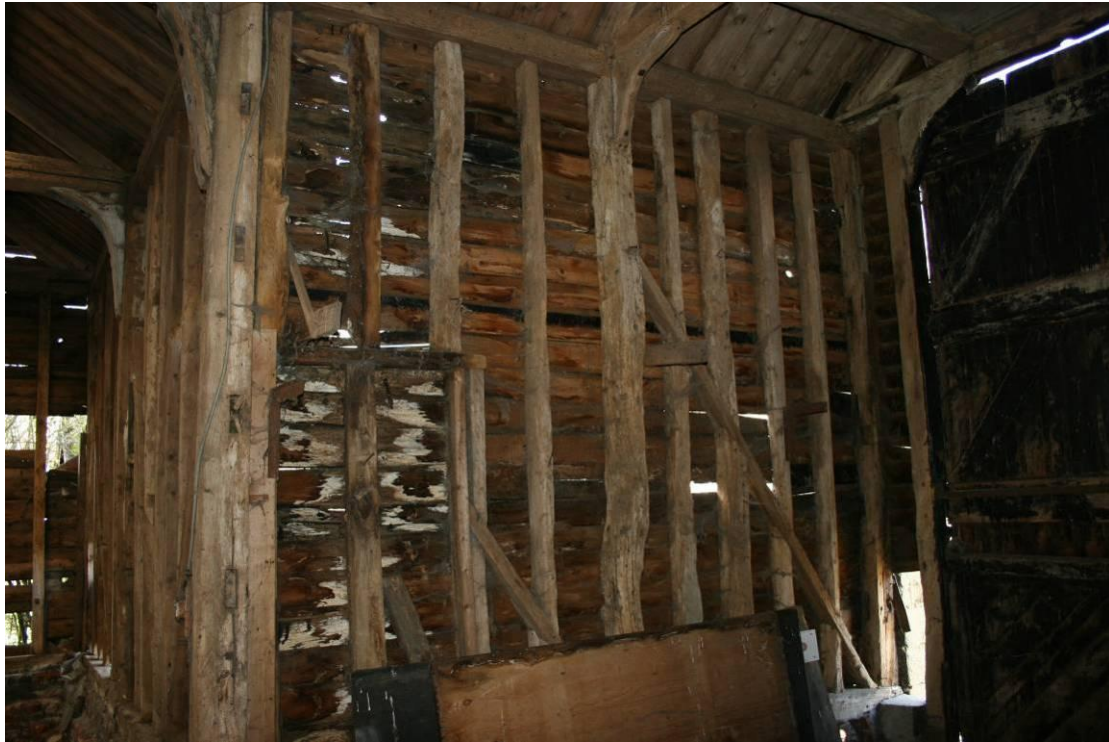
Originally the porch had doors on both sides.

The porch originally has pedestrian doors on both sides but the northern one has been boarded over in the C20th.

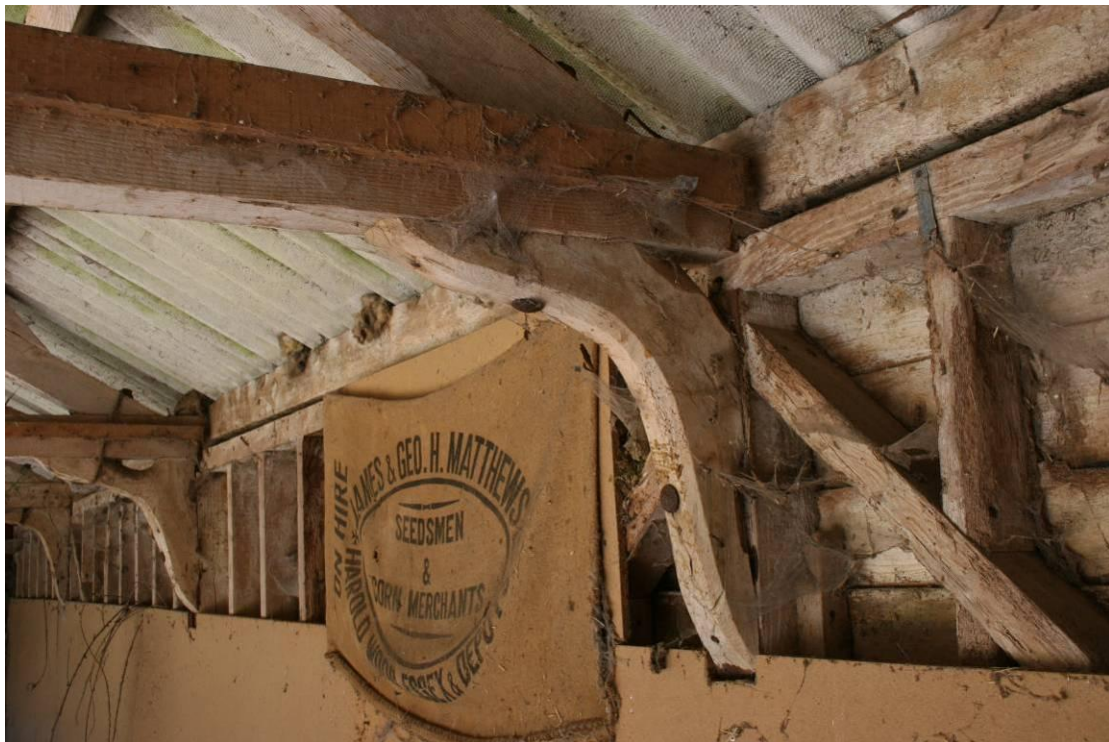
Detail of the hanging knees.

The hanging knees, fashioned from tree trunks, are fastened with carriage bolts and this would suggest the building was put up in the MC19th rather than the first 20 or so years of the century. EC19th bolts have square heads and nuts. Like the Barn some of the timbers have 'bracking' marks to denote where they came from.

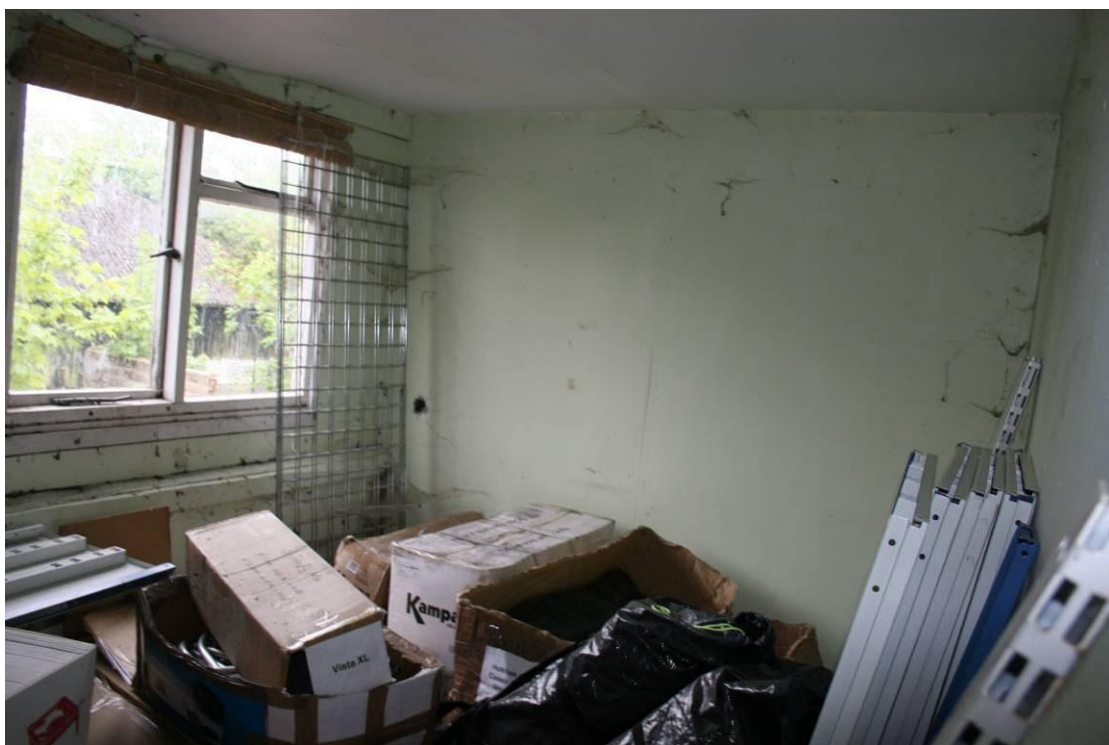
Small office at the front of the Granary.

A small office and workspace has been built in the eastern end of the upper floor and the details are all LC20th, most likely the 1980's. The work is of poor quality, cobbled together reusing old doors and cheap windows with aluminium fittings.
