3 Market Hill, Halstead, Essex. CO9 2AR.

Recording and analysis of the rear Workshop. Surveyed 20 04 2017.

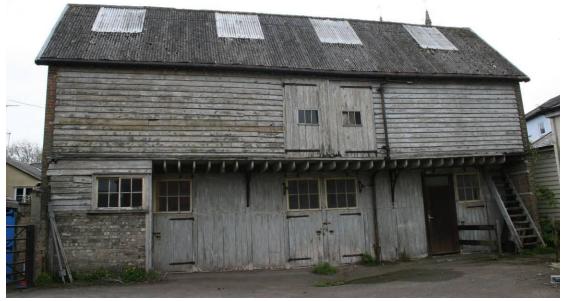
The western elevation of the Workshop.

The Workshop faces west and is built with a stable range beneath a deeply jettied upper storey. The end and back walls are built of 65x110x225mm bricks set in hard lime mortar. The upper storey is built of 2x4in machine sawn nailed interrupted studwork clad with LC19th weatherboards fixed with wrought iron nails. At the northern end is a small separated office with a horizontal sliding sash. These are often payment windows for the wages.

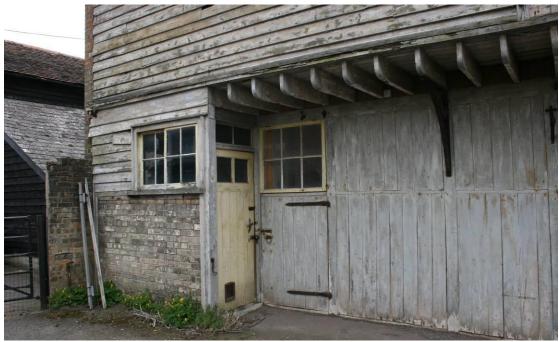
Detail of the jetty.

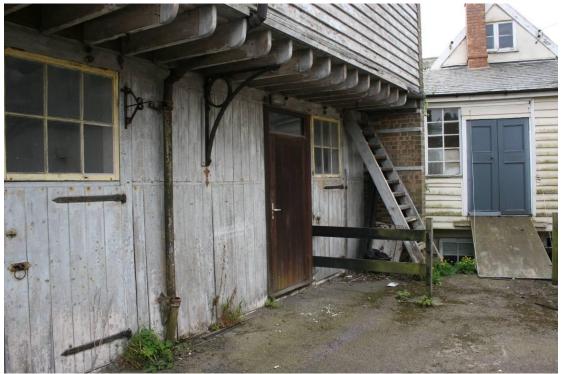
Looking SE along the jetty.

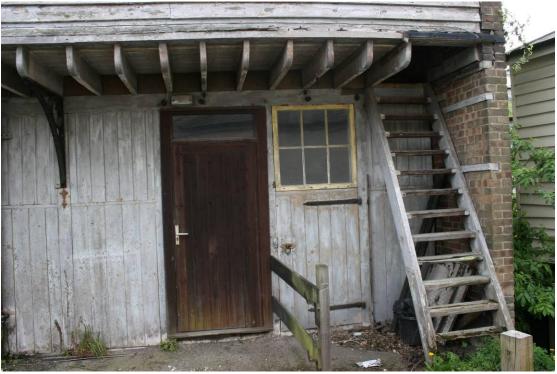
C20th additional door in the southern end.

The split stable doors have been screwed shut and LC19th style 6 pane window frames have replaced the upper leaves. This would have been done in the C20th when the use as a stable discontinued. A LC20th timber door with aluminium door handle has been inserted at the southern end. An original ladder, in parlous condition, leads to the upper floor.

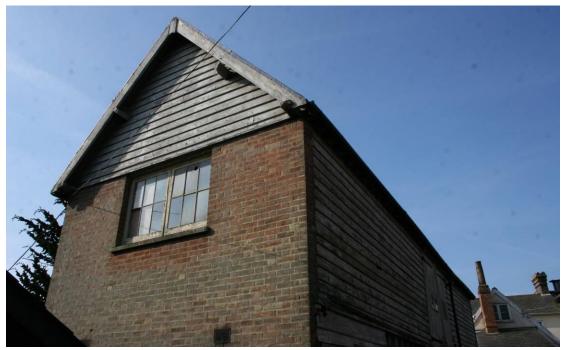
The northern elevation.

The northern elevation is built entirely of brick to eaves height where the roof is timberframed and clad with weather-board. The barge boards are held on extended purlins which are narrow, flat boards. There is a centrally placed original pair of 6 pane window frames with large deep portrait panes. There is a cast iron ventilation grille at first floor height for the office. The southern elevation is similar but lacks a window.

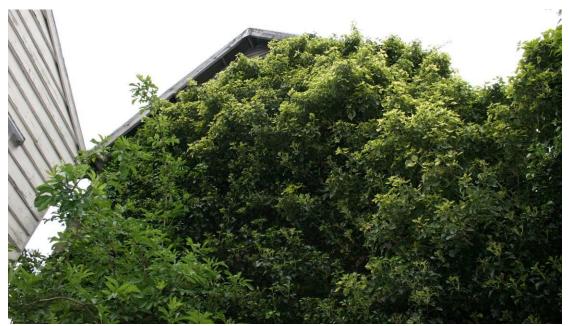
The southern elevation is obscured by foliage but appears similar to the northern.

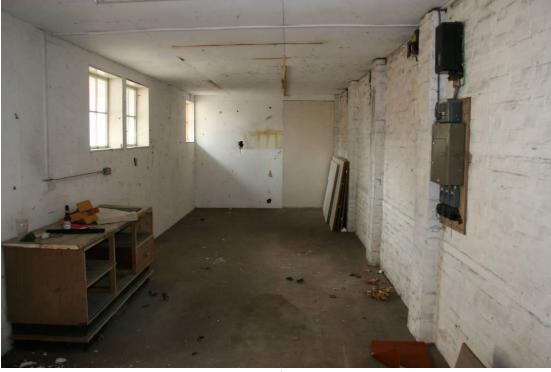
Looking N inside the Workshop on the ground floor.

The ground floor is 'quit through' and retains no historical fittings. The ceiling and western (front) are clad with boards and everything painted white. The eastern brick wall has full height buttresses that carry the weight of the floor above.

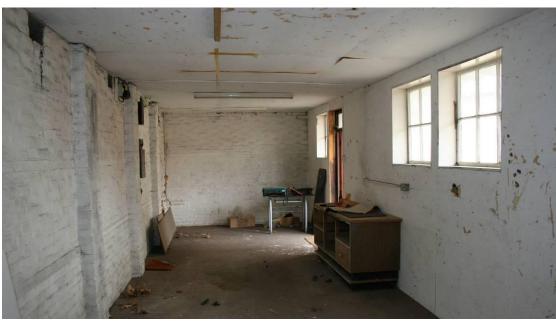
Looking S inside the Workshop on the ground floor.

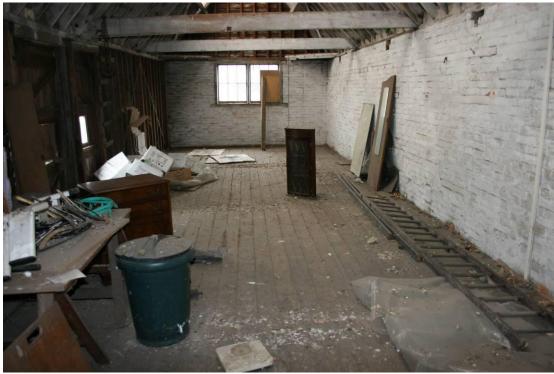
Looking N on the upper floor.

The first floor is boarded through with machined pine tongue and grooved 7in boards. The front wall (western) has exposed 2x4in machined softwood primary braced framing. Centrally placed are two large doors with a pulley wheel and chain for heavy lifting.

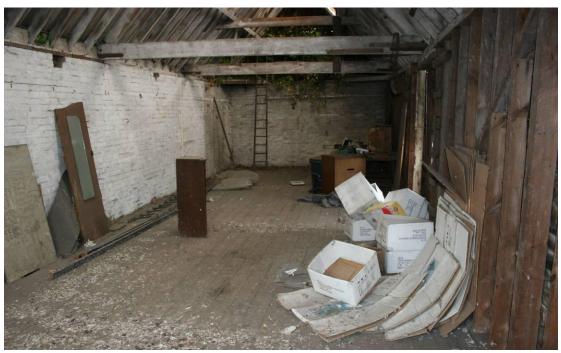
Looking S on the upper floor.

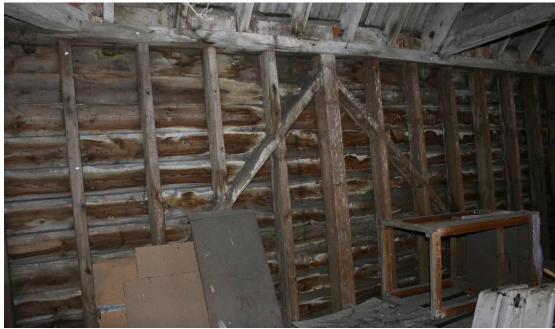
Primary braced 2x4in studwork.

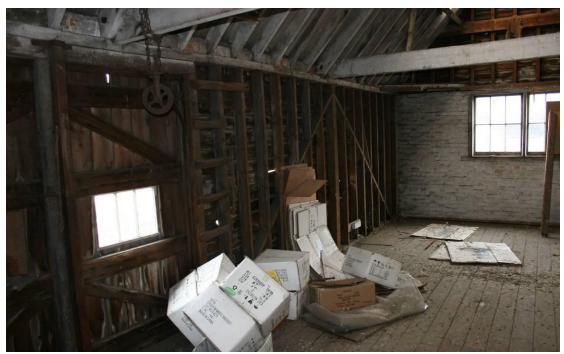
Access doors, pulley and ladder on the western wall.

The pairs of doors appear EC20th and are fixed with French nails. LC20th 3 pane lights have been inserted. Regular fixing points on the frame imply it was once boarded out. There is a ladder nailed to the wall that passes up onto the rafters implying there was a storage loft. In fact the entire roof and the brick walls have been whitewashed while the timber frame is left natural. A change in the colour indicates there was a partitioned room at the southern end. The roof is clad with corrugated asbestos sheets and has corrugated plastic roof lights. Aerial photography from 1929 appears to show a tiled roof with framed glass lights.

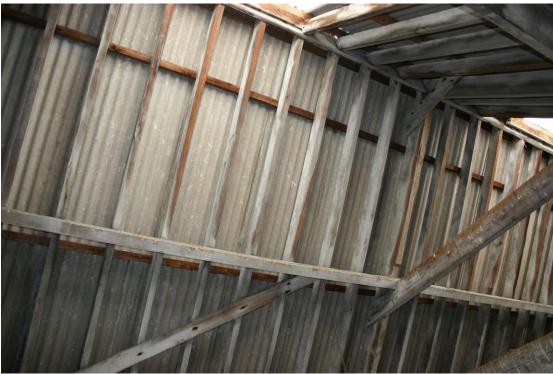
The roof structure looking NW.

The roof is a simple clasped side purlin construction with plank purlins, side nailed collars and tie-beams secured with ironwork. The 2x4in rafters are nailed to a ridgepiece and others are nailed across as windbraces. All the timbers are machine sawn softwood .

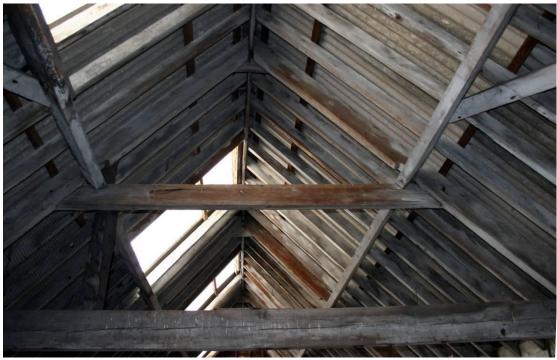
The roof structure looking N.

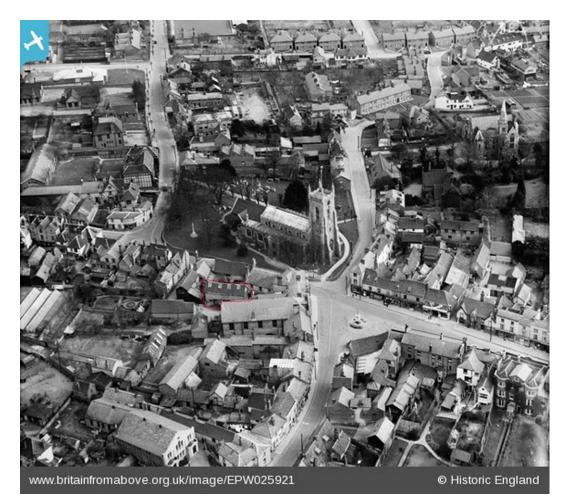
1929. The Workshop is shown. Used under Fair Use policy.

An aerial photograph from britainfromabove.org appears to show the building with a tiled roof and white framed glass roof lights. The transition to asbestos sheeting and corrugated plastic roof lights is a LC20th addition most likely done in the 1960's to 1980's. The style reflects the many farm buildings that were upgraded in that period. All the internal partitions forming horse stalls were removed and a partition on the first floor taken out.
