Hill House Care Home, 183 Lexden Road, Colchester. CO3 3TE.
Heritage Statement for the house. Surveyed 03 05 2016.

This report forms a heritage statement to support the replacement of a modern conservatory. The house is now a care home and has been highly altered and extended since the Listing entry.

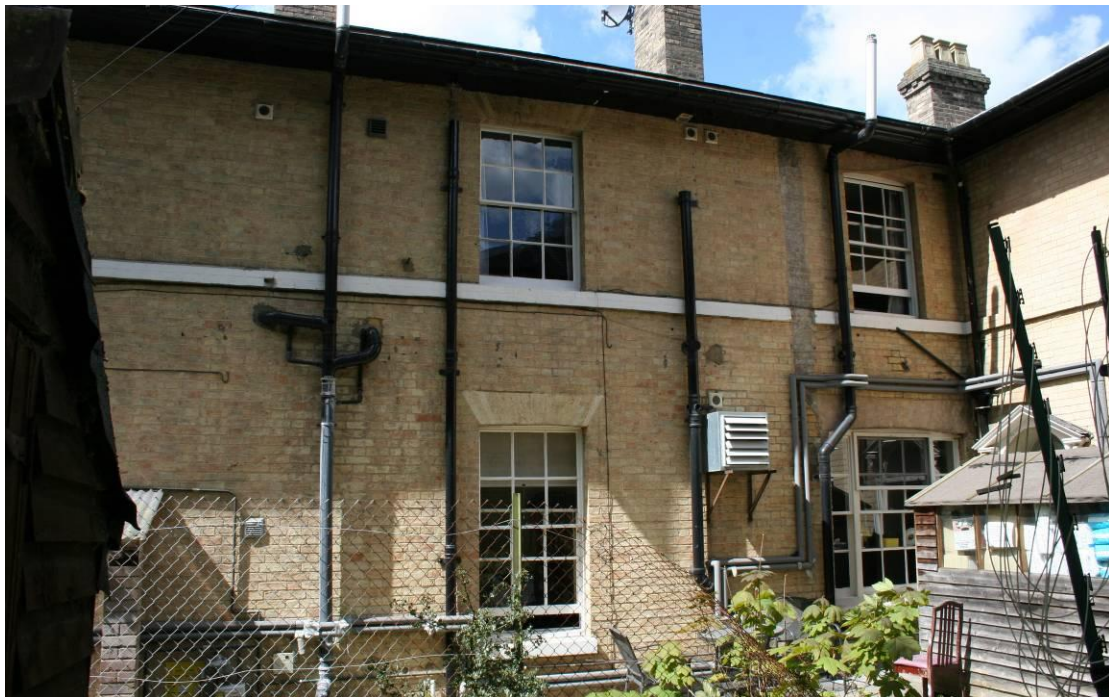
Eastern elevation of the original house

The service side of the original house is intentionally of lower status than the two facades. However, it still has 6/6 unhorned sashes under gauged brick lintels. There is a much larger sash with side sashes which appears inserted under a wider lintel of different coloured bricks. A former doorway has been bricked up and the doorway to the cellar is sunken down some steps from the yard.

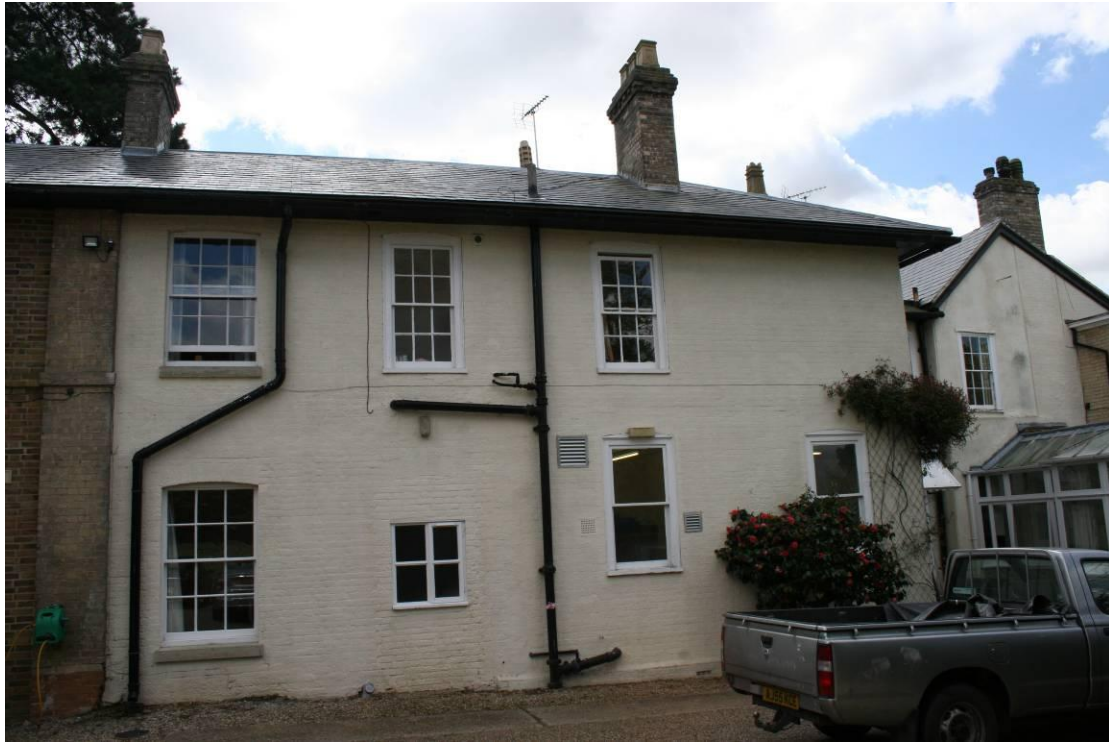
The northern elevation of the Victorian extension.

This part of the building has been altered with some unattractive large pane windows which are likely LC19th style C20th replacements for the sash frames. A doorway has been bricked up and a C20th smaller casement inserted. This may explain why the wall has been painted.

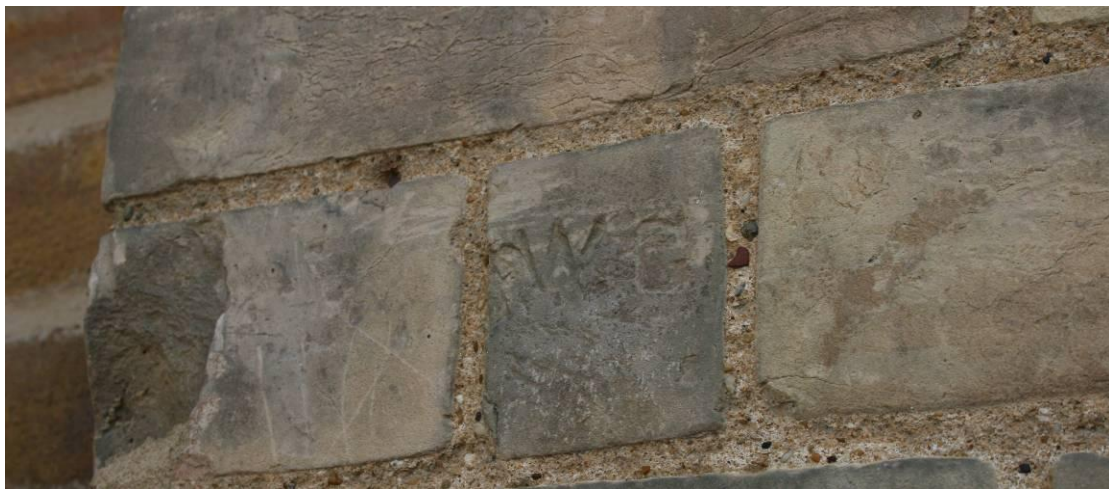
Detail of the Victorian brick work marked WG.

The northern elevation of the Victorian extension is of painted brickwork of which a single column of yellow and buff bricks marks the limit. This column has much graffiti included the well carved initials WG, EH, GT, GT and Law carefully scribed. These are likely to be the workmen who built the extension.

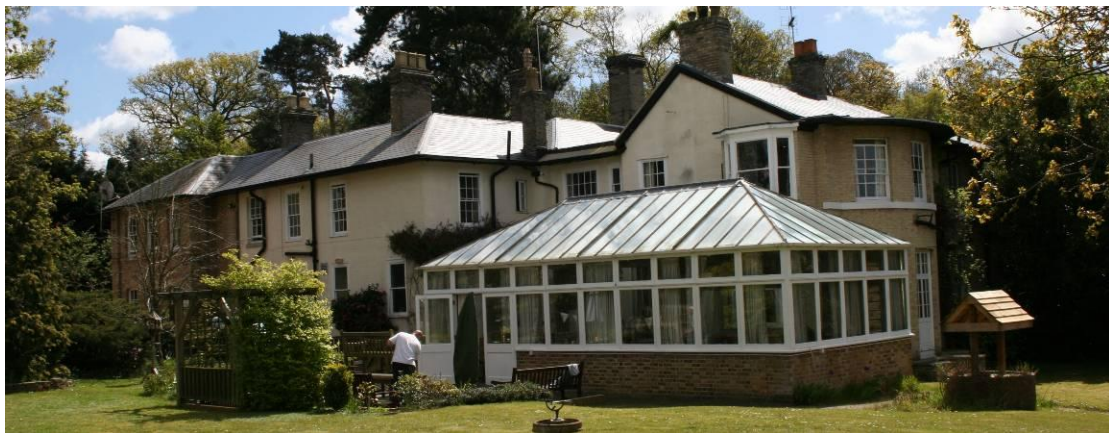
The conservatory from the NW.

The rear of the original house is now obscured by the conservatory which is used as a dining room. It was put up in 1988 and occupies the site of a Victorian greenhouse taken down between 1969 and 1973 according to the Ordnance Survey. Standing on a modern brick plinth it is of timber and glass construction.

The present conservatory is a building of its time. Erected in 1988 it is now used as a dining room and activity room. Like all greenhouses it is very hot in the summer and cold in the winter neither which are desirable climates for the elderly guests. The building is not double glazed and the glass roof has to be screened with shades and the windows with curtains. It also suffers from condensation needing the windows to be open.

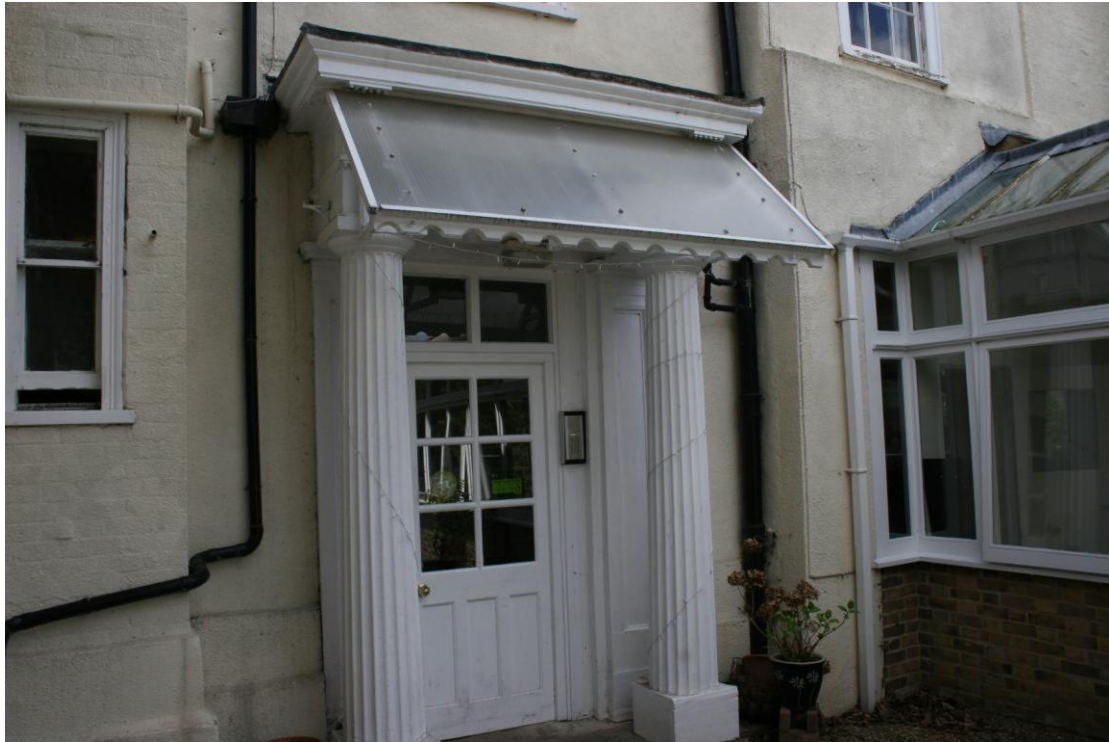
The porch to the rear door.

There is a porch to the rear door of a similar but less grand design than the front door. There are two fluted pillars with Tuscan capitals, flat pilasters against the panelled door frame, tryglyph and guttae decoration and lead covered roof. A recent timber frame and corrugated plastic shelter has been added.

The only effect on the historic fabric is the removal of the rear porch. This can be done in its entirety and replaced at the new entrance such that the historic fabric is retained with the building.

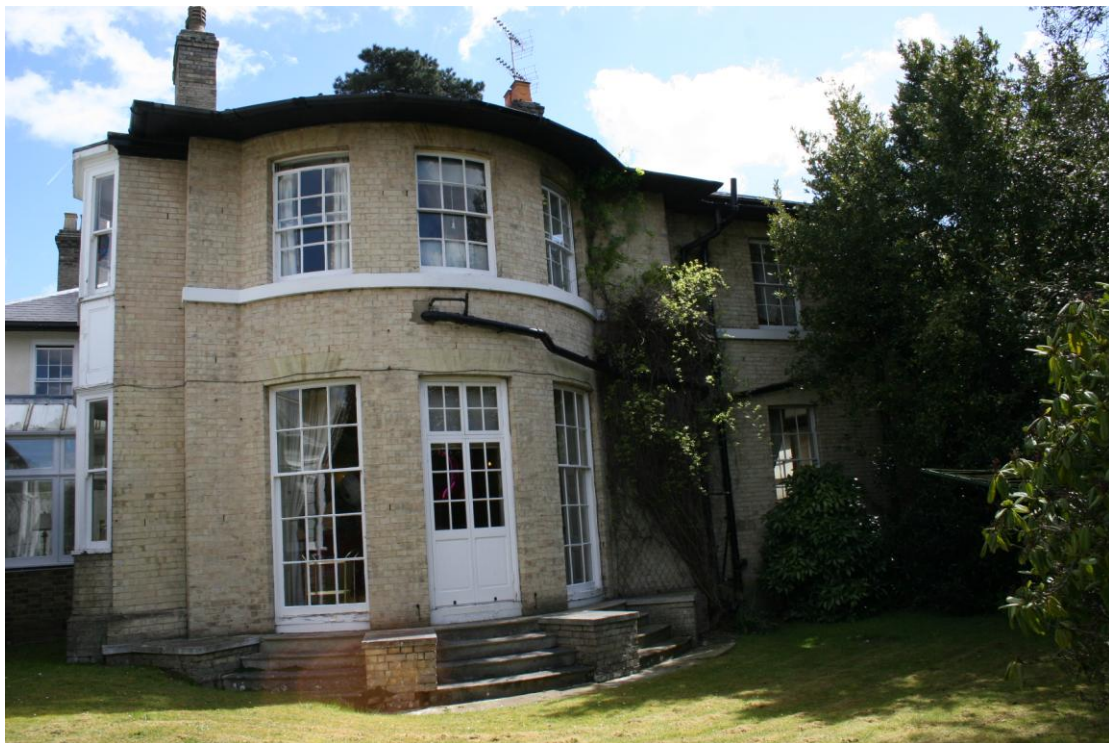
The western elevation of the original house.

The western elevation of the original has a single large bow fronted bay with full height large pane sash windows either side of timber half-glazed French doors. The upper windows are 6/6 sashes to match the rest of the house. The brickwork matches the front facade and is tuck pointed but repointed in grey cement in places.

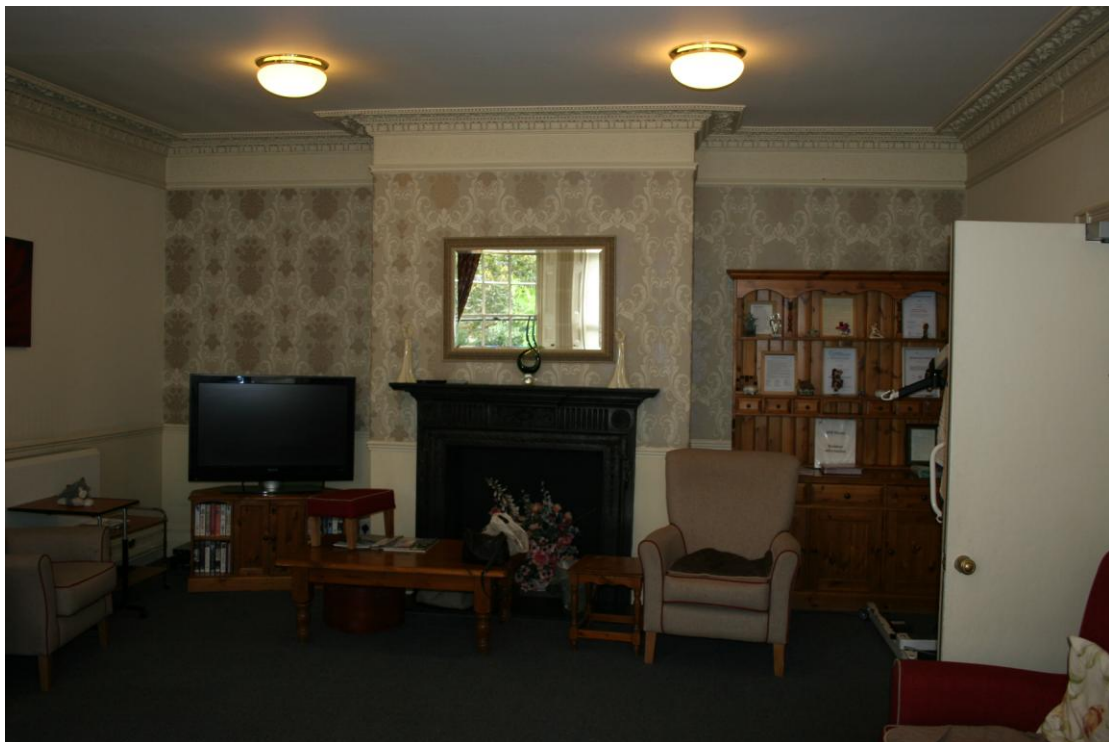
The Front Living Room looking N. The fireplace is a replacement.

The Front Living Room in the SW corner of the original house retains some fine plasterwork on the ceiling in good and original looking condition. The fireplace was put in about 15 years ago.

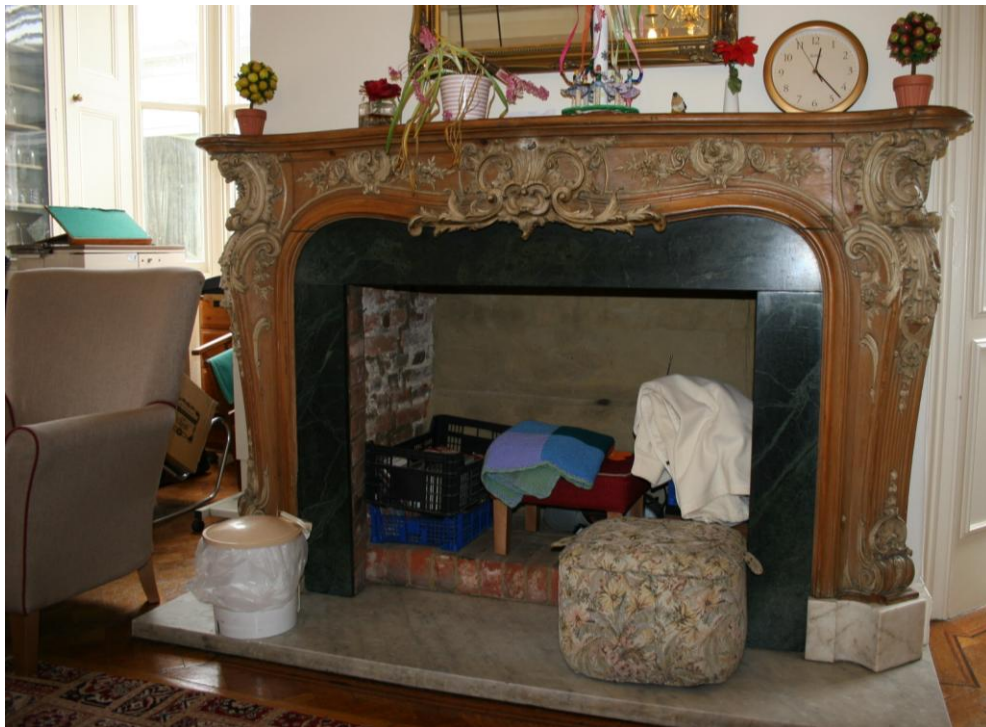
The Rear Living Room Fireplace.

The two fireplaces are interesting and attractive pieces within themselves but they are recent additions to the building. (Staff Manageress – pers comm). The Rococo style surround is French and out of period for the house. The other is cast iron and a curious mix of Victorian and Georgian designs including an eared border, ornamented bulls eyes, central plaque and mantel shelf. Neither are functioning.

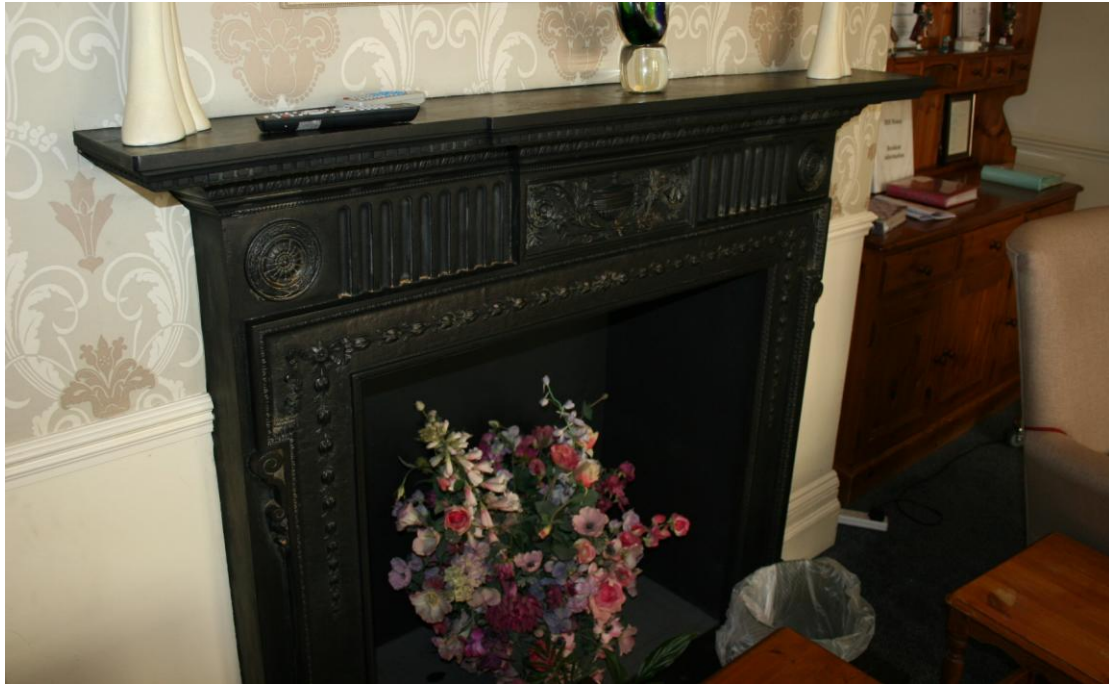
The Front Living Room fireplace.
