**Longstowe Hall, Longstowe, Cambridgeshire CB3 7UT.**  
Description and analysis of the Coach House, Squash Court and Kennels. Surveyed 24 03 2015.

This report describes and analyses the Coach House at Longstowe Hall to mitigate for conversion to a wedding venue. There are further descriptions for the Squash Court and Kennels with a view to future development.

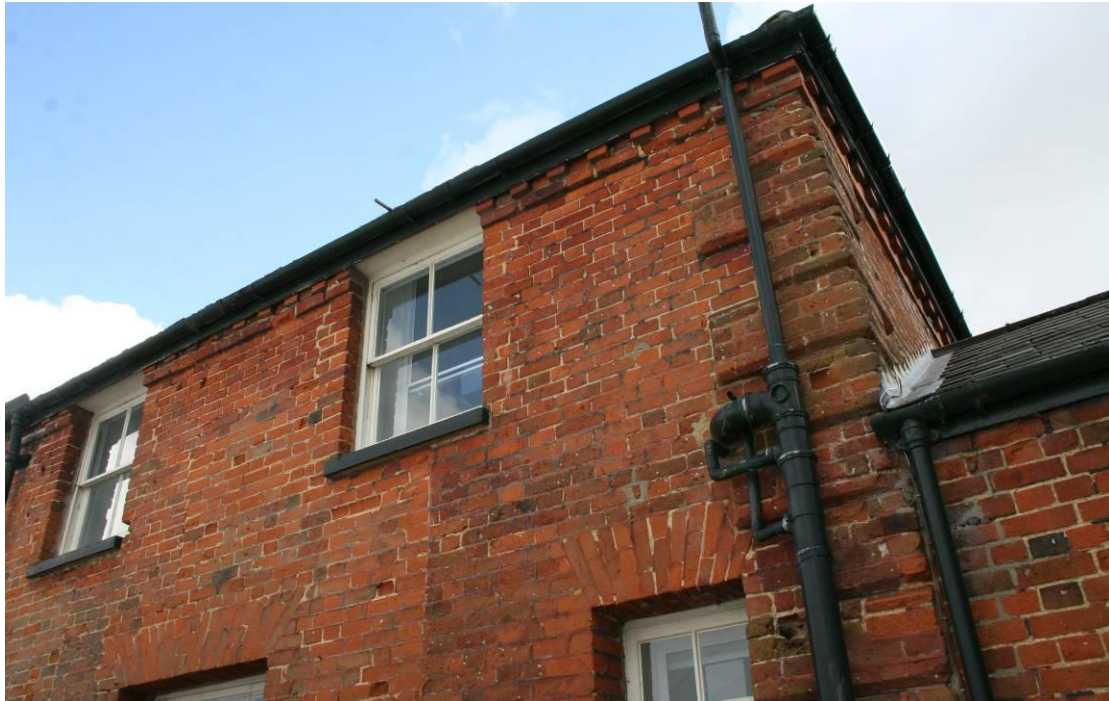
Detail of the NW elevation at the SW corner with the extension.

The NW elevation has suffered several rebuilds which may have been prompted by subsidence which is still evident in places. The SW corner has a straight joint in the brickwork that runs awkwardly under a window and must represent part of the C19th remodelling. The cottage windows have gauged flat arched and stone window cills but no closing bricks. The SW corner is rusticated with brick quoins.

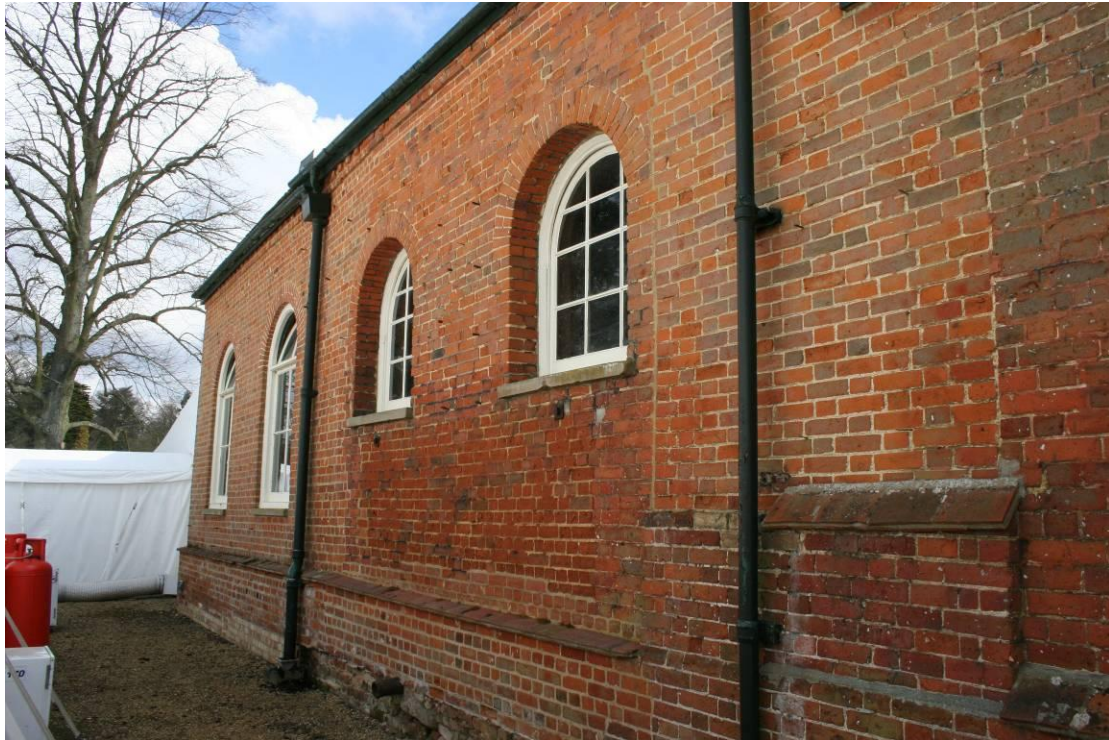
The north corner of the NW elevation.

It can be seen that the northernmost section of the wall corresponding to the first cell has been completely replaced with C20th brickwork. The other two cells have been remodelled with C19th brickwork and windows.

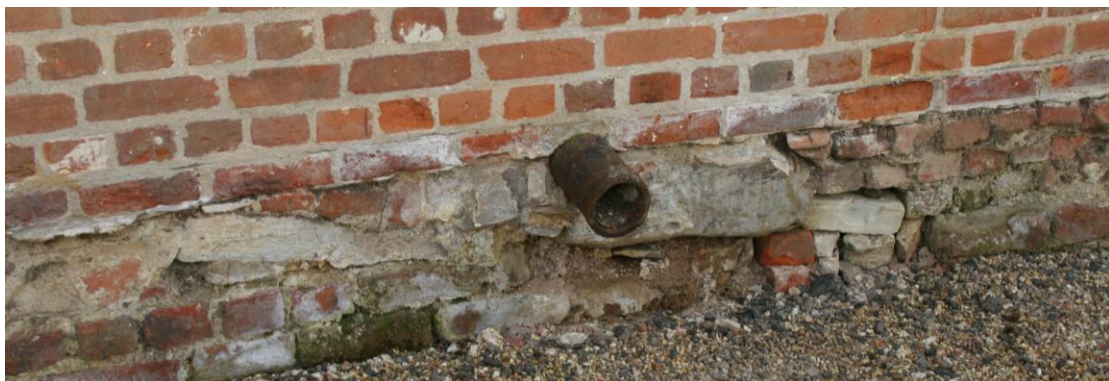
A large section of the wall has been underpinned with C20th Flettons and a number of random bricks and blocks of stone have been added around the floor drain. There is an asphalt DPC and a large area of repointing.

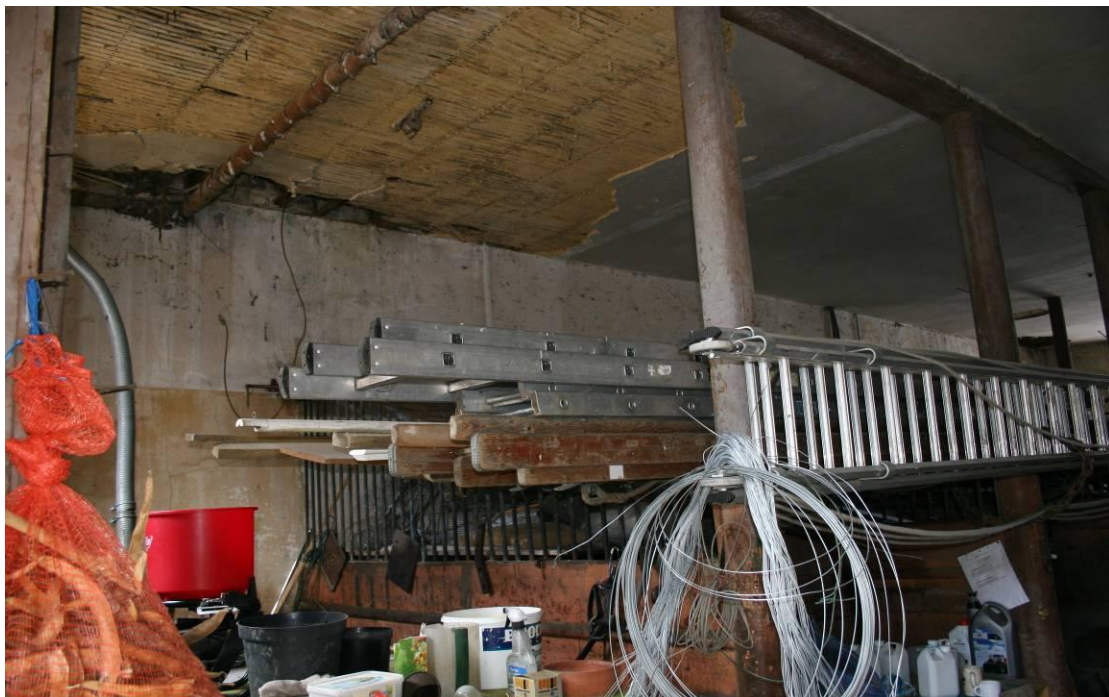
Looking SW up at the ceiling above the first stall.

As far as can be seen all the fittings are either cast iron or mild steel, placing them at the end of the C19th (mild steel was discovered in 1856). Looking up, the ceiling is of lath and plaster with fresh laths and a relatively thin skim of sandy plaster. There is a heavy duty pulley which may indicate why the ceiling has delaminated at this point.

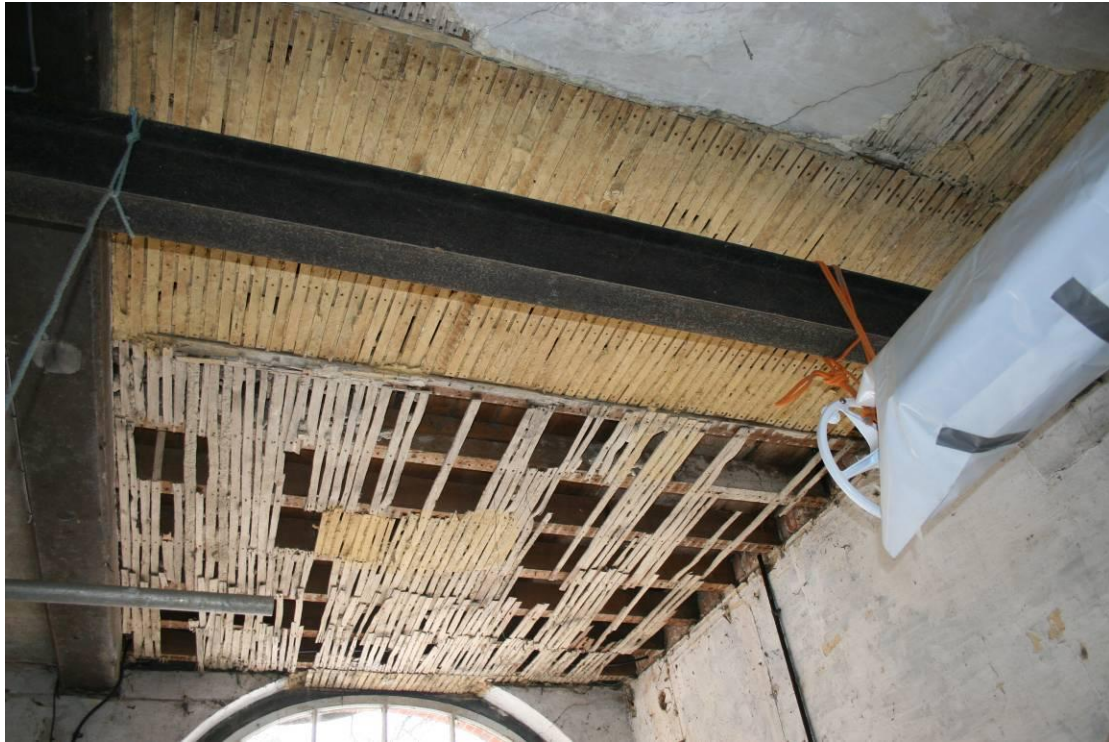
The Garage is a single open space where the roof has been reinforced with steel beams. It seems likely that the room was originally outfitted in the same way as the Stable and when the central columns were removed the beams were needed. Circles in the paintwork show where they would have been. The RSJ's (Rolled Steel Joists) may have contributed to the cracking of the brickwork. The lath and plaster ceiling has cracked and there are large patches of pink skim repair. The area near the main doors is completely denuded.

The ceiling above the Garage near the main doors. Looking E.

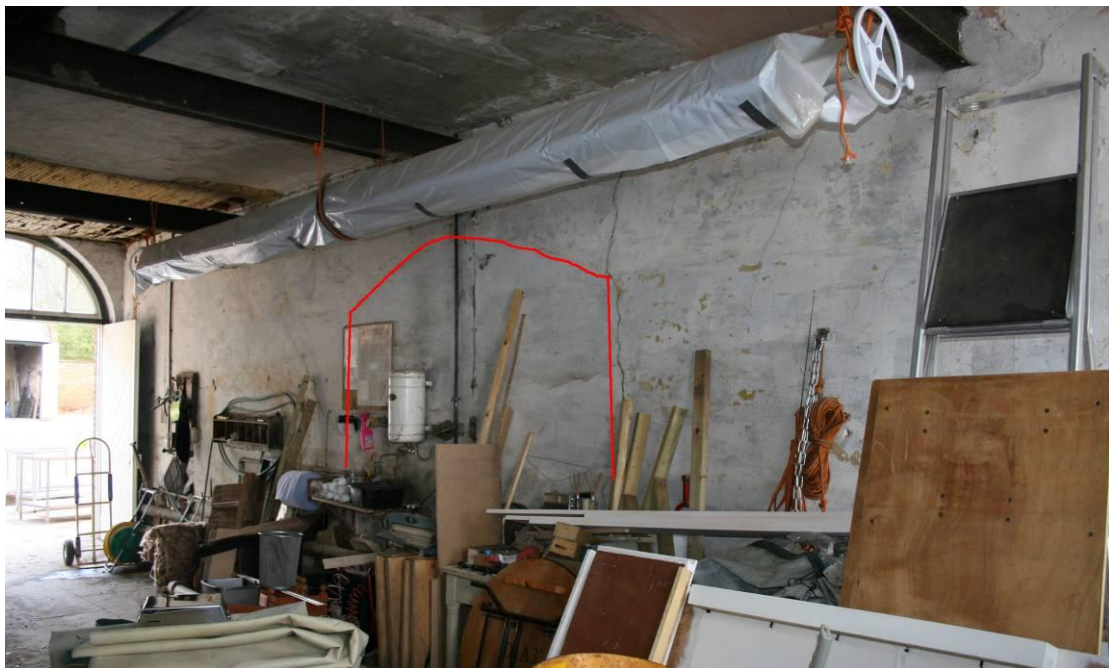
Looking SE at the south wall of the Garage. There is a blocked in archway.

In the south wall is the outline in the cracked plaster of a blocked in archway. It is visible on the other side where the panelling has been removed and the blocking brickwork exposed. The wall has several full height cracks that appear on both sides and would benefit from remodelling.

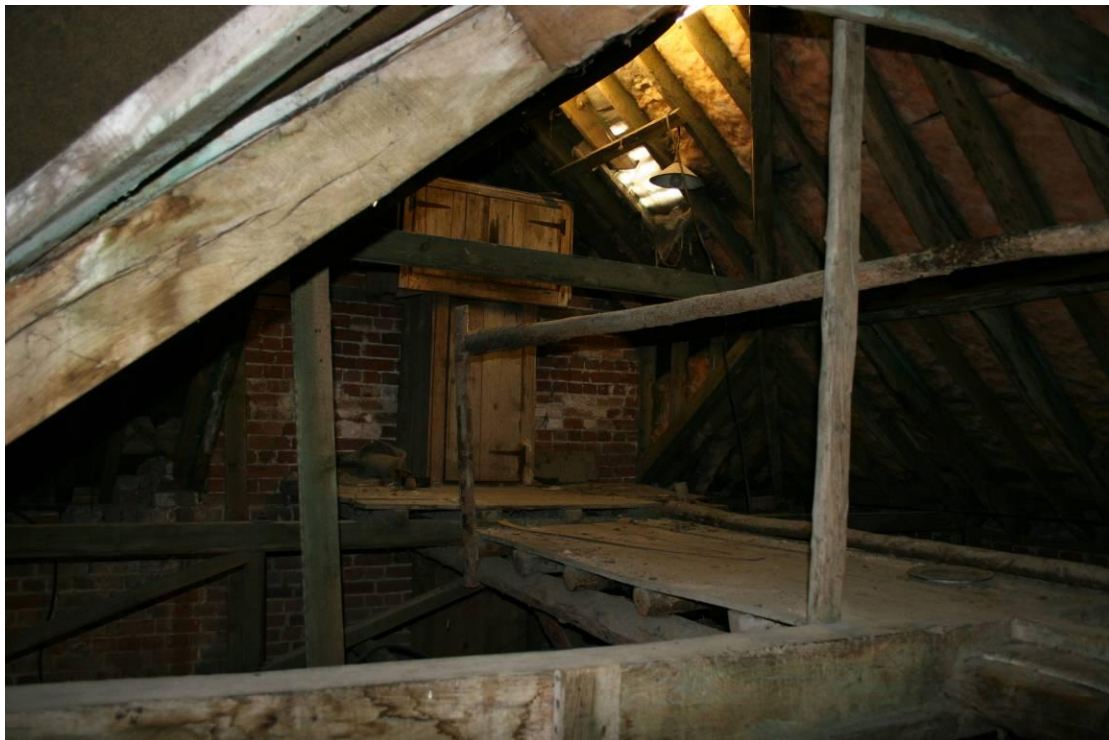
Looking SE at the clock cabinet. The rustic gantry is in poor condition.

The clock is contained within a poor quality timber cabinet with three opening doors held with mild steel strap hinges fixed with slot head screws. There are numerous pencilled instructions on how to clean and wind the clock. The clock is reached by a gantry made of rustic poles and old floorboards which needs some attention. The gantry appears much older than the clock case and platform.

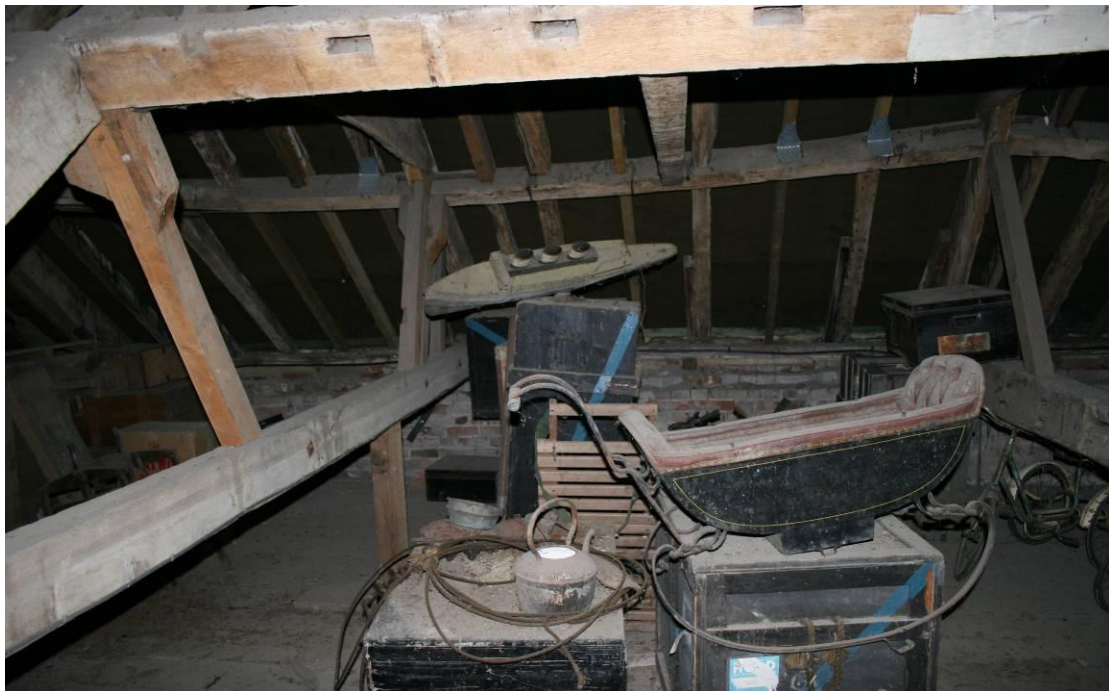
Looking N into the Garage loft space.

The Garage still has a working loft space but the floor looks fragile despite some old belongings, most bicycles and trunks being stored there. Some of the common rafters were removed to remodel the roof with a cross-ridge which interconnected the roof spaces. Additional props and tie-beams were introduced. The roof has been recently repaired with galvanised gussets and brackets and there is an asphalt membrane indicating a retille between the 1960's and 1980's. (The owner remembers it being done in the 1970's).

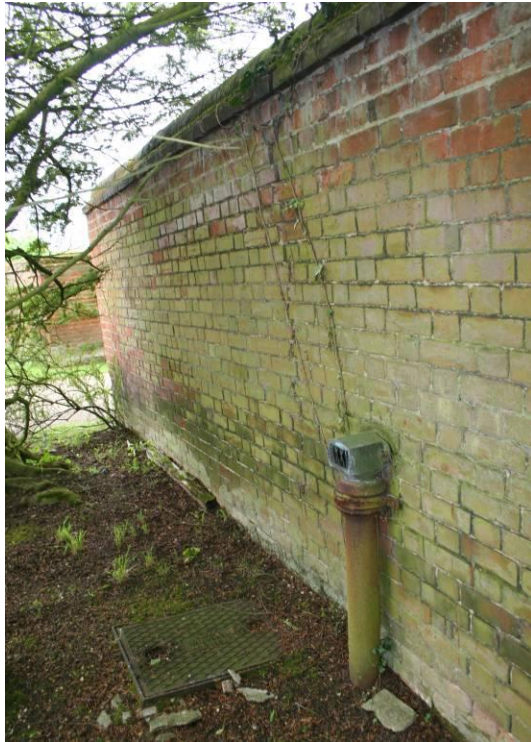
The exterior of the perimeter wall looking SW.

The perimeter wall has had some peculiar things done to it. On the exterior the brickwork runs through evenly until it bonds with the Squash Court. There is substantial crack all the way through it vertically above where the drain covers are. There is also a vent pipe.

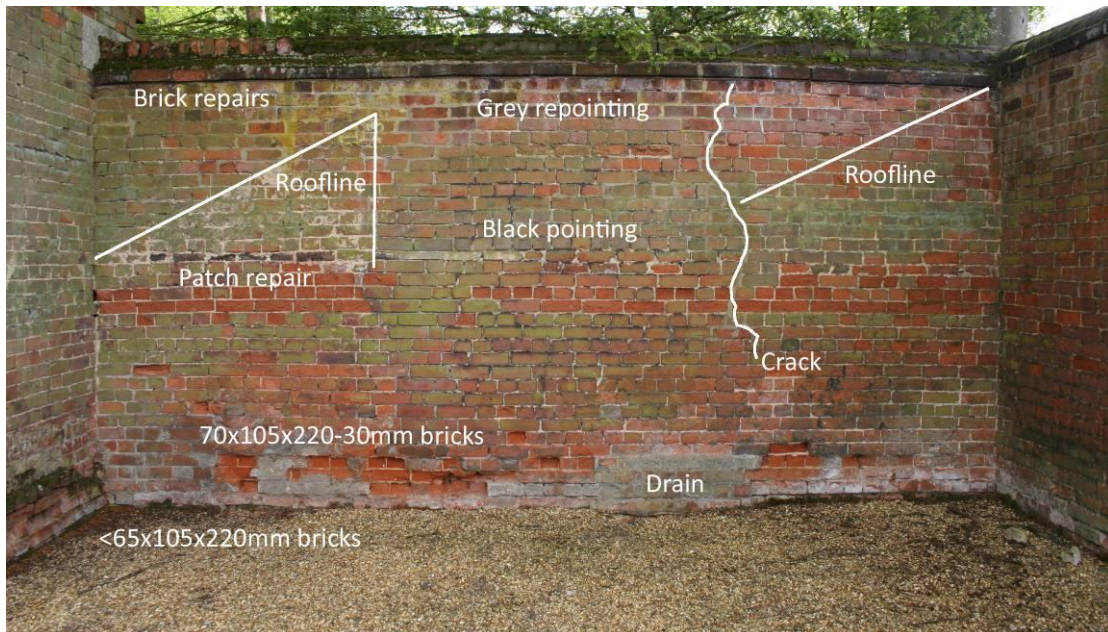
The wall inside the yard.

Inside the yard the wall appears to be built in English bond and there is a peculiar repair in the NE corner using random thinner bricks where a small structure was ranged against the wall that had a roof that sloped down towards the wall of the Squash Court.

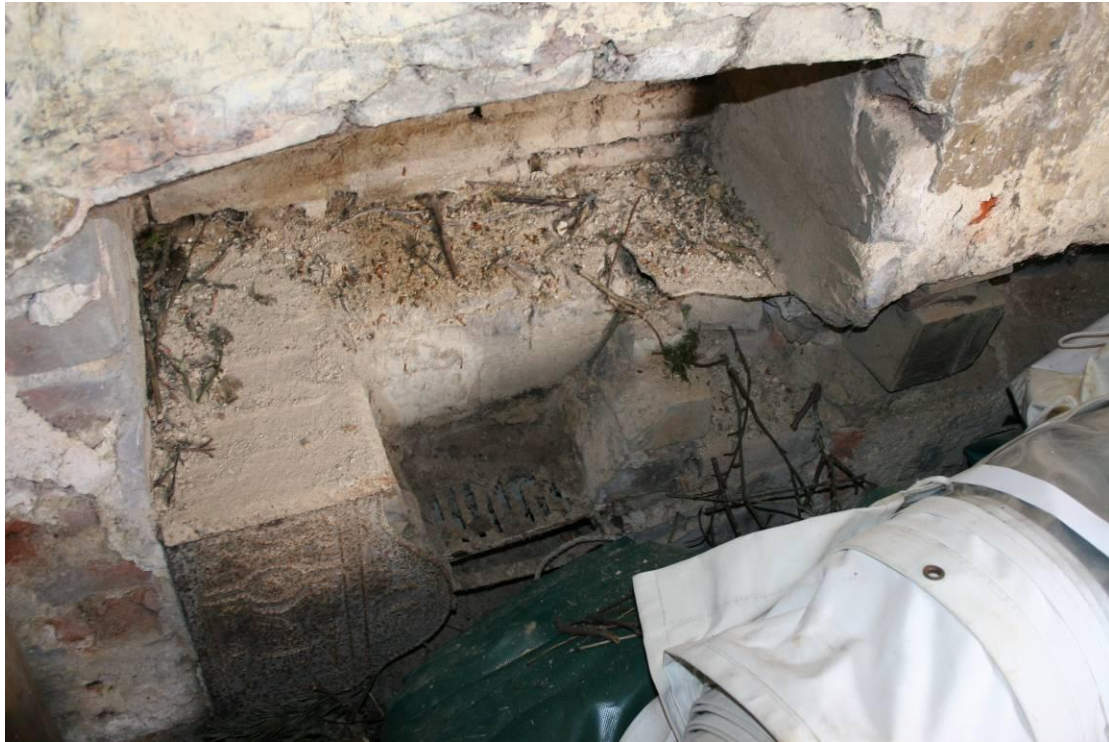
Detail of the hob-grate fireplace.

The fireplace has been partly smashed out and only one hob survives with the small coal grate. A large chunk of wall has been broken and wedged with a wooden block some considerable time ago as the block and wedges have shrunk and now do nothing. The fireplace has a wrought iron band as a bressummer and there are holes from where the fire surround was removed.
