Maypole Farm, Top Road, Wimbish, Essex CB10 2XJ.
Description and analysis of the Barn and Outshots. Surveyed 24 02 2015.

This report describes and analyses the conjoined buildings that form the Barn at Maypole Farm, Wimbish. The main building is formed from two large timber-framed barns containing old frames but extensively remodelled circa 1800. The outshots house the Workshop, Drier Motor, Sack Drier and the former Pre-Dresser Room. Most of the machinery has been removed but half of the C20th silos are still in-situ. A full length open-sided Shelter has been erected against the southern side.

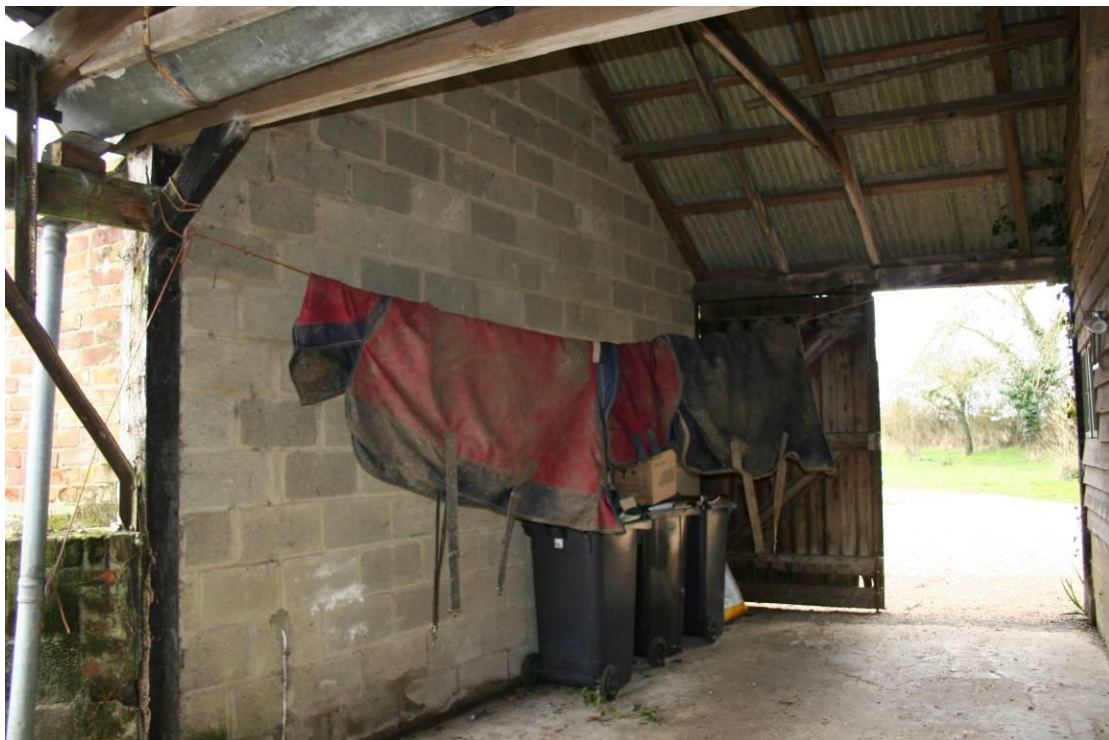
The House side of the carriage arch is made of blockwork.

The carriage arch was erected in the MC20th as the southern wall is constructed of medium density blockwork and the roof structure is of this period. The Workshop has been altered with blockwork and C20th weather-boarding.

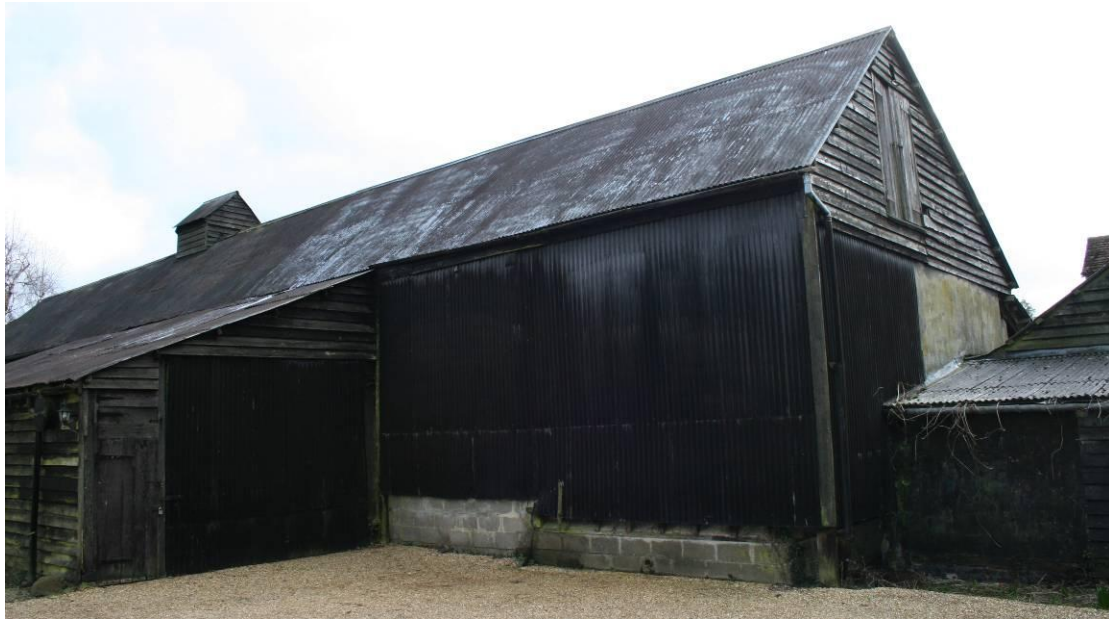
The northern elevation of the west half of the Barn. All fabric is M-LC20th.

The northern side of the Barn is entirely M-LC20th in design and fabric and consists of medium density blockwork plinths with a scant machined timber-frame skinned with corrugated iron.

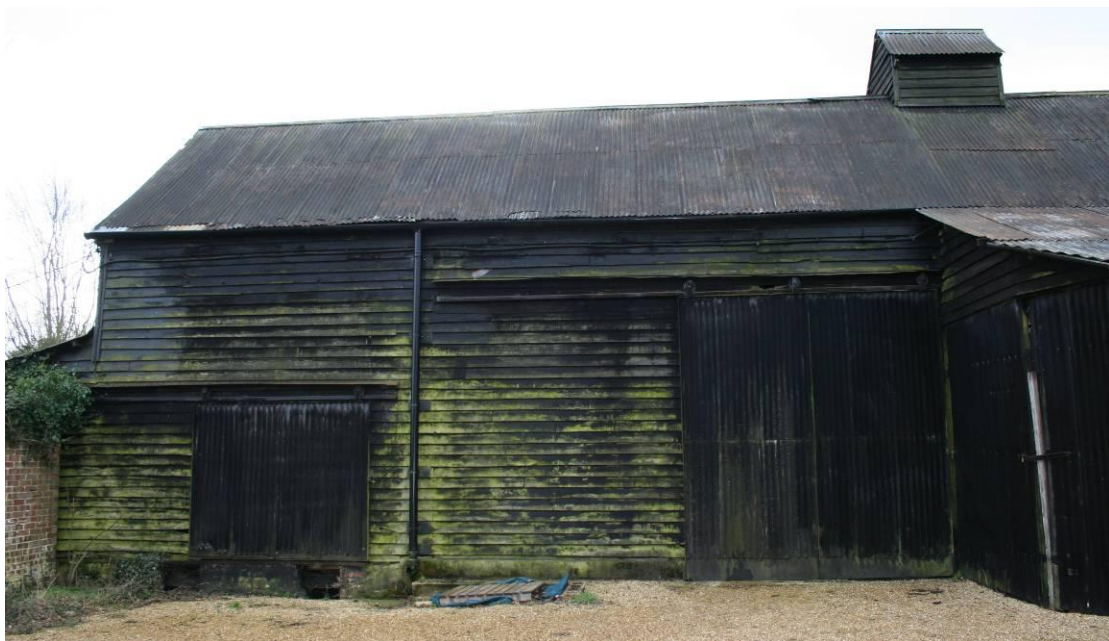
The eastern end of the Barn.

The Barn is clad with LC20th weather-boarding easily recognised by its green colour from the growth of algae. Some earlier riven boards remain just under the eaves which are slightly deeper at about 8in instead of 7in. Bay 3 of the East Frame has been fitted with a full height sliding door with a steel frame and corrugated iron skin. This replaces a pair of doors indicated by the frame inside.

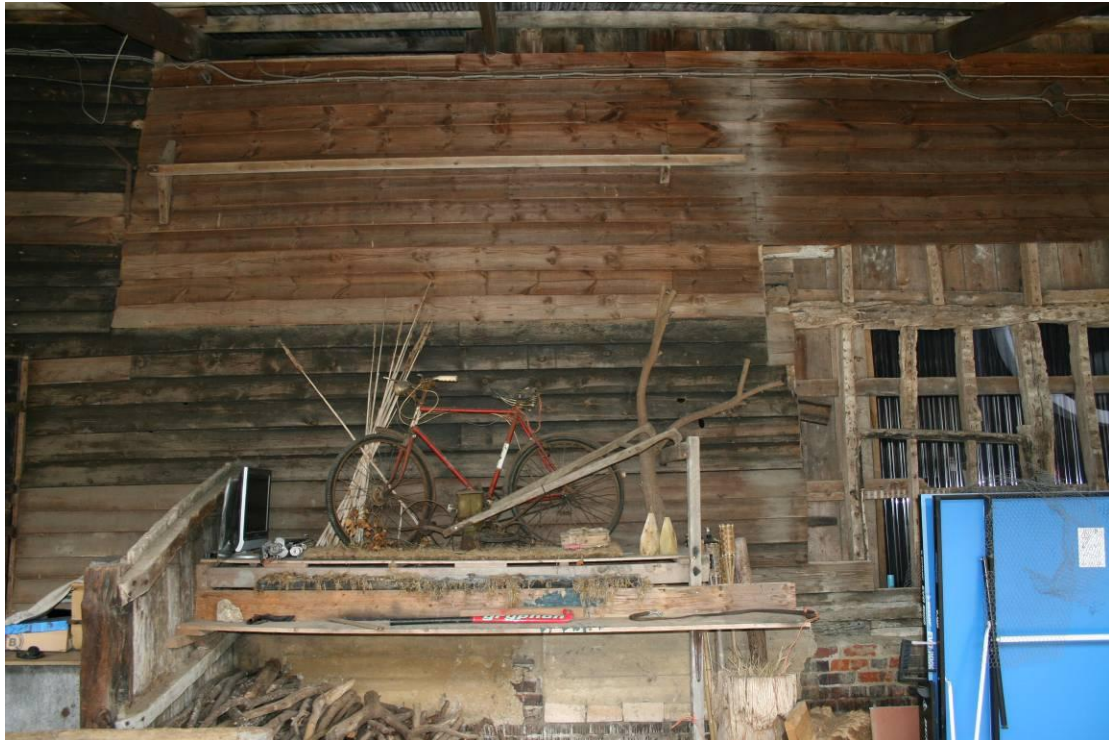
Bay E1 has been largely reclad with new boards.

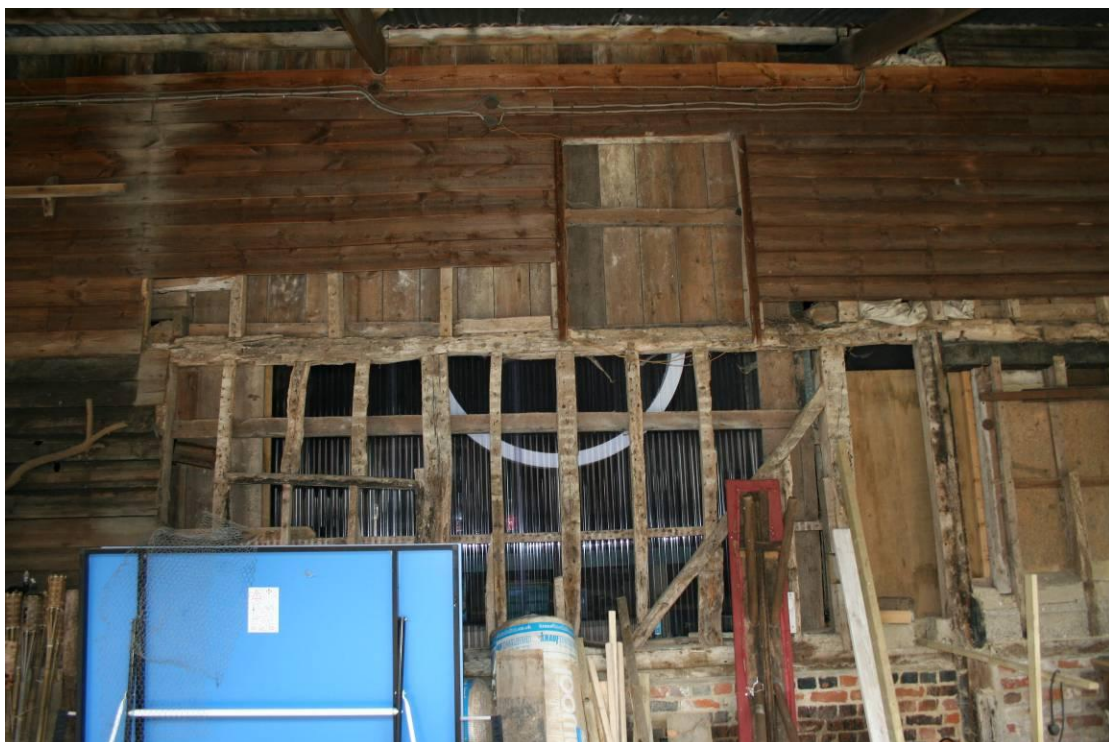
Bay E2 has the cladding removed exposing the circa 1800 frame.

Sections of the cladding are missing from Bays E2 to E4 revealing the interrupted nailed studwork with straight diagonal primary braces. The frame is raised on a rebuilt brick plinth containing EC19th bricks set in lime mortar.

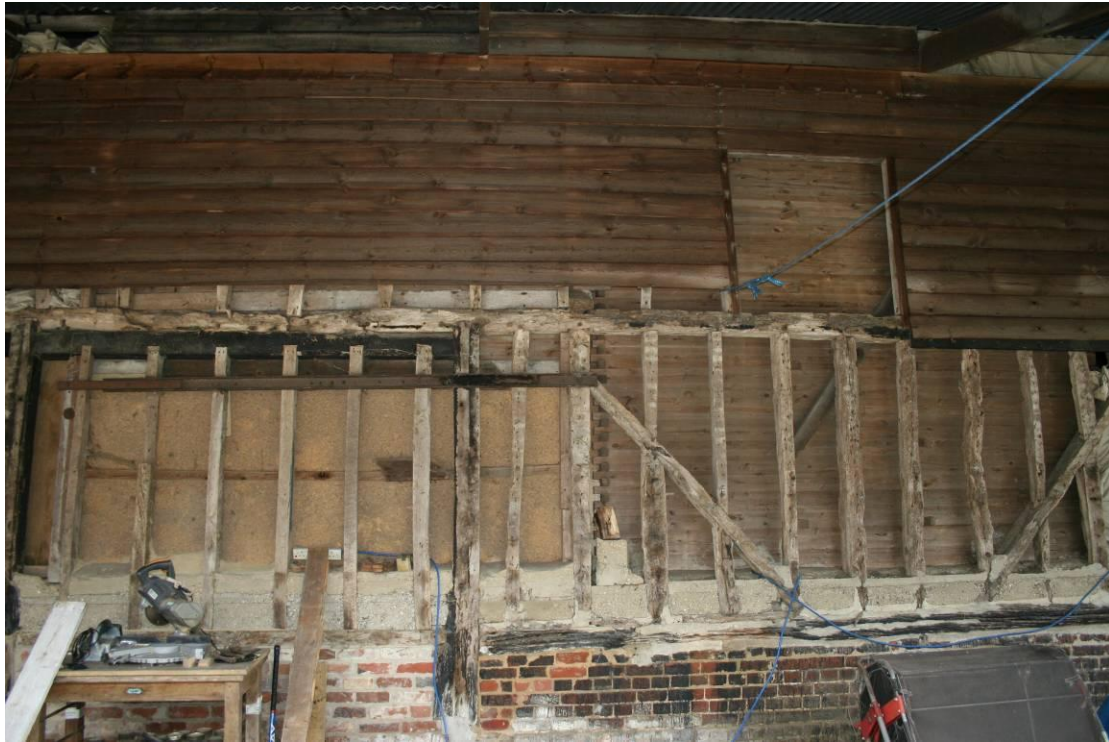
Bays E3 and E4. Bay E3 has been rebuilt with side nailed studwork.

The wall of Bay E3 has been rebuilt with an inserted lintel to support the failing mid-rail. The studs have been sawn down and side nailed to make up the wall panel in the C20th. The studs in Bay E4 are numbered in sequence on the outside with a chisel. Most marks are lost to rot near the sole plate.

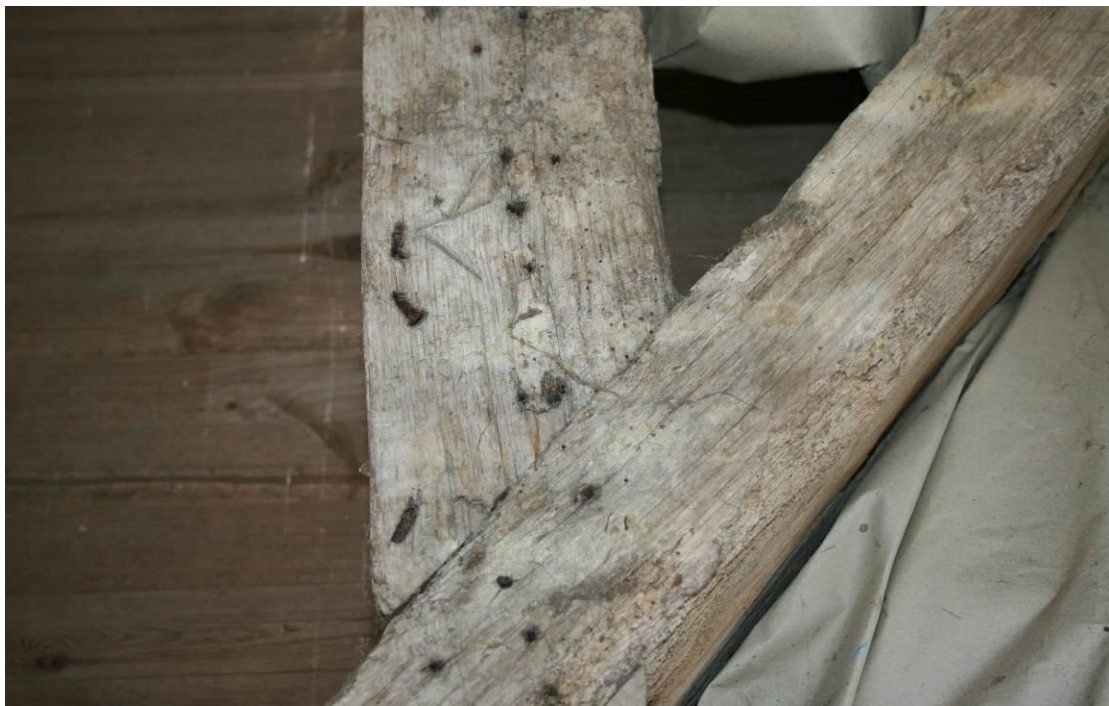
Interrupted stud nailed to the primary brace and numbered V.

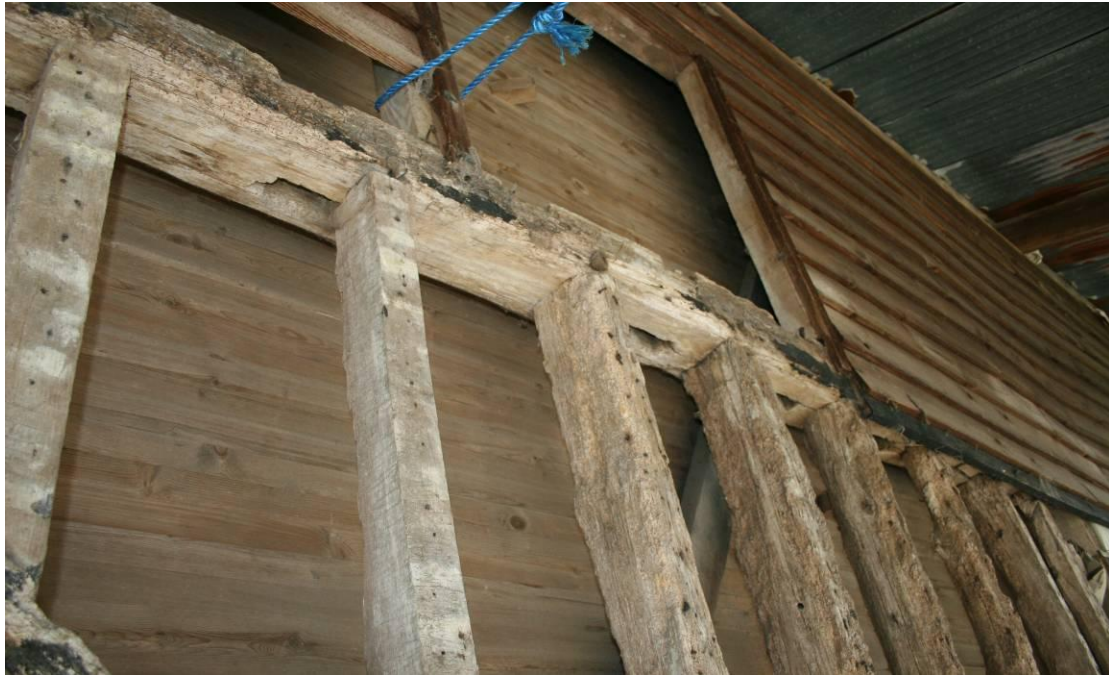
Looking up at the mid-rail in Bay E4. The shuttering is part of an old timber silo.

Nearly all the timbers in the southern wall are reused or do not coalesce with the mortices in the principal timbers. The aisle is clearly an addition to an earlier frame which has been dismantled and brought from elsewhere and redesigned into a circa 1800 building. A large number have nails and lime stripes from being lath and plastered – a common feature on Essex barns. The plasterwork has a tendency to fail and may account for the exposed frame.

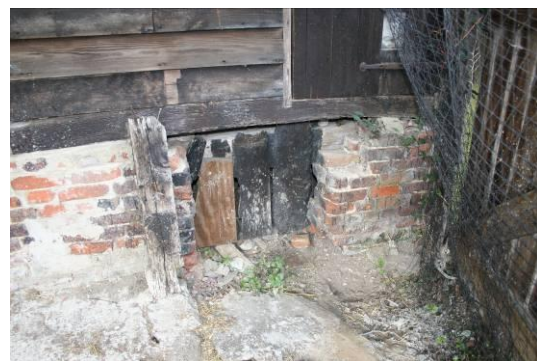
Ventilation duct for the boarded floor.

There is an EC19th boarded door hung on wrought iron pintle hinges with spooned terminals. It appears to be of the same type as that leading into the Sack Drier. Below it is a ventilation duct for the boarded floor that has been raggedly broken through the plinth. It has been blocked with split down logs to prevent the animals getting under there.

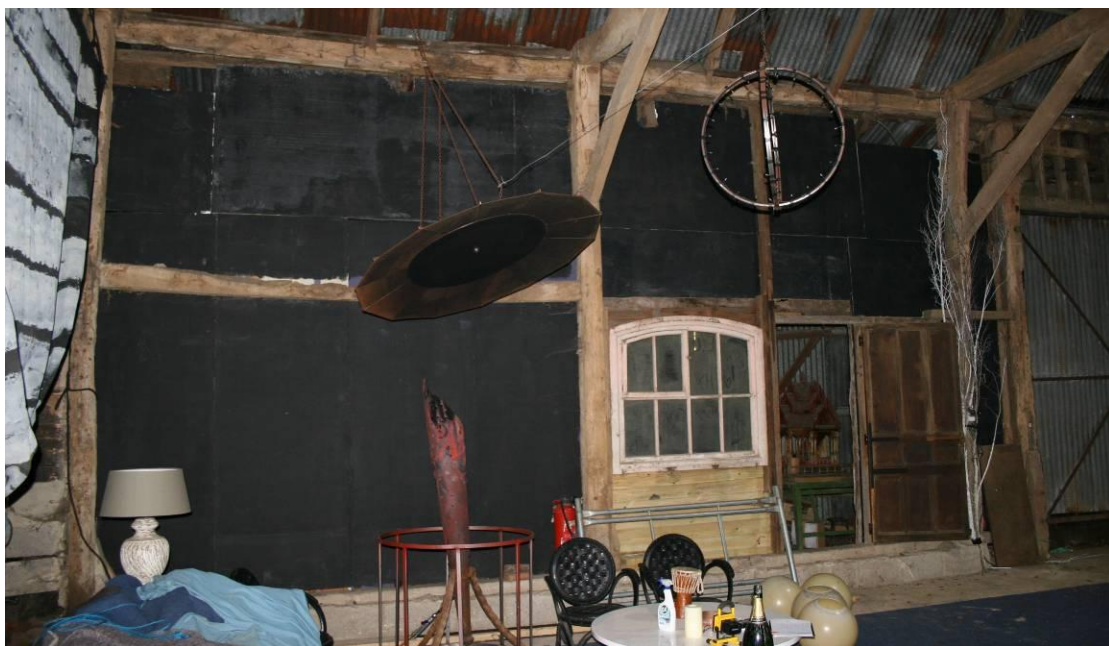
Bays 1 and 2 on the northern side. The studwork was removed for the Pre-dresser.

Large sections of the frame have been removed in the LC20th. The wall common to the Pre-dresser has had all its studs removed and the current panels are made up of theatrical flats and a prop door and window from a stage set.
