Wilderness, Drakes Lane, Little Waltham, Essex CM3 3NA. Description and analysis of an outbuilding. Surveyed 31 10 2016.

Type of Work: Historic Building Recording

Barry J Hillman-Crouch MStPA DipFA BSc HND.

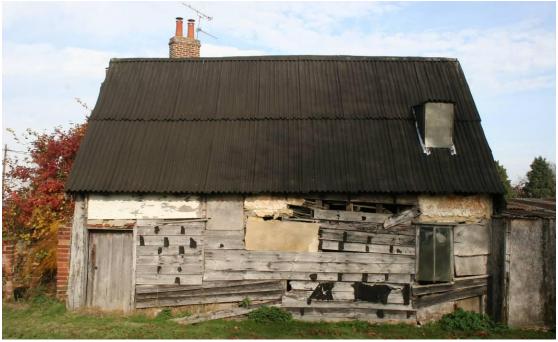
The southern elevation.

The southern elevation presents a single storey chalet building with a small dormer in the LC20th/C21st corrugated bitumen based roof product known as Onduline - Onduline is an extremely tough, lightweight, corrugated roofing and wall cladding material manufactured utilising a base board produced from recycled cellulose fibres which is saturated with bitumen under intense pressure and heat. The interrupted studwork frame is clad with LC20th weatherboards fixed with French nails, some EML and lath and daub panels.

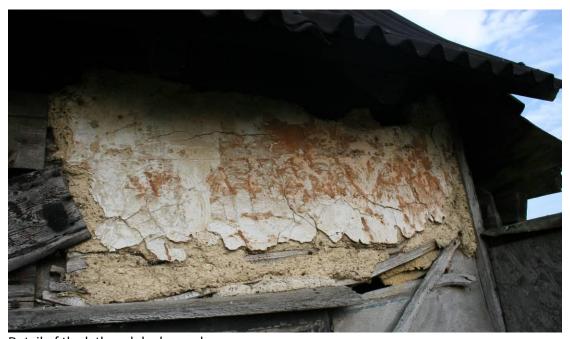
Detail of the lath and daub panel.

The laths are of two types, riven chestnut and spilt rods, probably hazel, nailed with wrought iron tacks. The daub varies in consistency but contains clay, straw, stones, chalk nodules and dark brown animal hair. The surface has been combed in swirls and painted red in places. The original finish appears to be rendered panels above weather-boards to door height. The small front door is vertically boarded with horizontal ledgers and hung on wrought iron pintle straps. An adjacent window has been boarded over. The building has been wrapped in roofing felt in the past which has fallen off leaving ragged patches here and there.

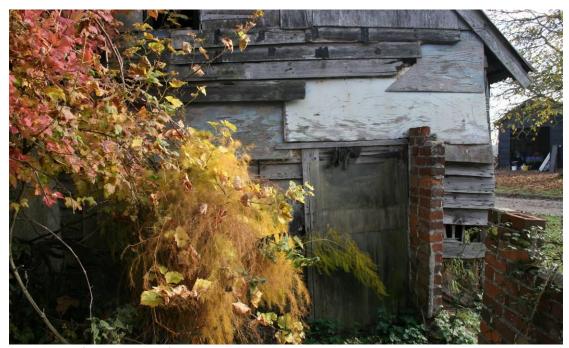
The ground floor section of the western elevation.

The gable of the western elevation has been clad with marine ply leaving a window opening. The ground floor has a C20th door with glass light and a four pane casement that has been boarded over. The rest is clad with C20th sheets and weatherboards. A pig sty has been built against the end of the building reusing old red frogged bricks set in hard grey cement.

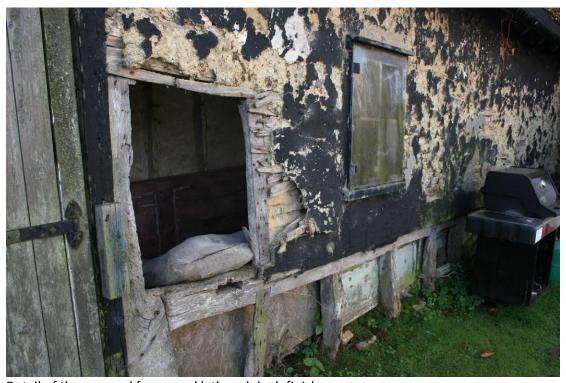
Detail of the exposed frame and lath and daub finish.

The northern elevation retains large sections of MC19th lath and daub finished with black bituminous paint. The exposed frame displays a reused rail to which the lower, short studs are lapped and nailed or skew nailed. A few are pegged. The lower section was weather-boarded but is now shut off with old panels and wardrobe doors on the inside.

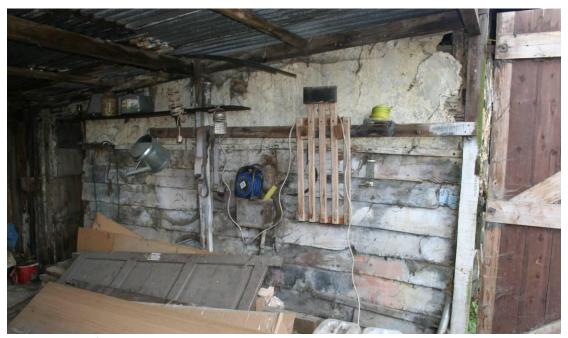
The end wall of the outbuilding in the garage.

The eastern elevation of the outbuilding is preserved within the makeshift garage which is constructed of machined timbers, marine ply and OSB (Oriented Strand Board) print dated to 2007. The present owners removed an adjacent similar shelter in 2010. The outbuilding retains a run of lath and daub above a section of 9in deep EC19th weather boards fixed with wrought iron nails. There is an opening into the outbuilding but this is not an original doorway. The upper section has been clad in marine ply as part of the reroofing of the building.

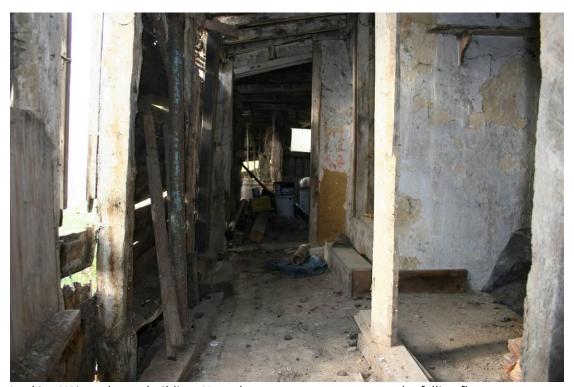
Looking W into the outbuilding. Note the many props to support the falling floor.

The building is now in a parlous state. The walls are falling outwards and the joists are failing from rot. Much of the weight is being taken on timber and steel props which have been in place many years. The upper floor is fragile and the boards rotted. The chimney has been reduced in height before the current was roof was added in the last 20 years or so. None of the doors or windows function, the frames have warped and the fabric is failing throughout. It is one of those buildings where only the woodworm holding hands is keeping it together.

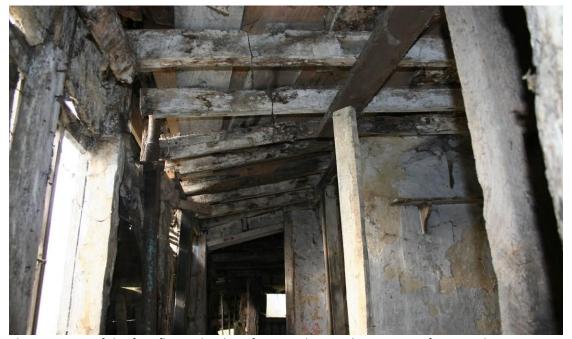
The structure of the first floor. The door frame indicates the amount of sag. Looking W.

The upper floor is supported on nailed on plates, leading to spread and failure in later years. The floorboards are of varying widths and materials.

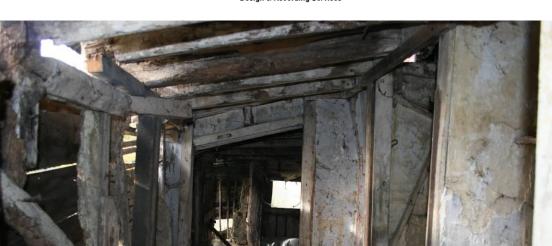
Lobby besides the firestack. Note the collapse of the frame.

There is a small lobby that gives access to the staircase and then the Living Room. The fall of the frame is very noticeable in this area. The frame has little remaining top plate. Instead ledgers or clamps are nailed in sections all the way round to support the joists. The scantling nailed interrupted stud frame has fallen out and the joists are hanging in the air supported only by the floorboard nails in places. The rest is supported on wooden props and very rusty Acroprops. The joists above the lobby are also supported by a nailed on C20th bed leg.

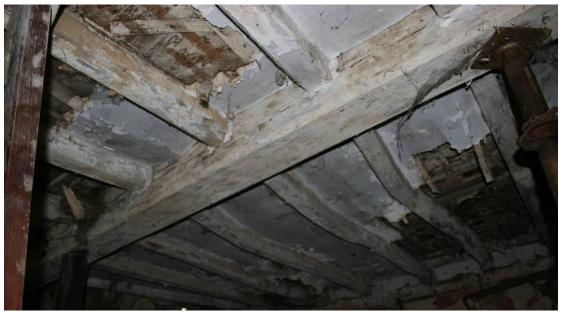
Detail of the ceiling looking NW.

The walls are framed using reused timbers of different sizes and apparently random primary braces. The north wall is lath and daubed on the outside in large panels. Again the ceiling joist rests on nailed on clamps and so is clearly inserted. The main axial joist is correctly morticed for the narrow 4in common joists which are waney in places. The 8x10in deep chamfered axial joist is not lodged in the brickwork of the fireplace but rested precariously on a ledge, while the other end has descended and is supported by props.

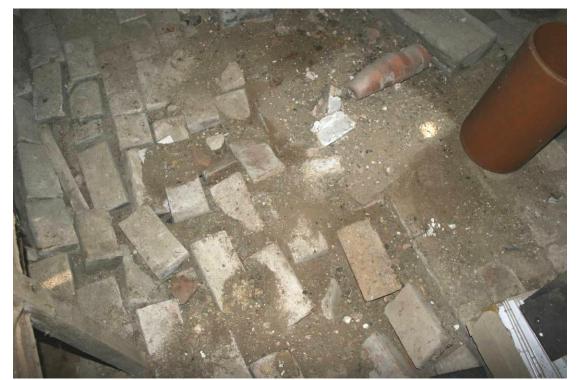
The disrupted floor of the Living Room.

The Living Room is laid throughout with white bricks varying in thicknesses of 40, 50 and 65mm (1.5, 2.0, 2.5in). They are all 110x225mm in plan, the standard size. The floor has been broken up by rabbit burrows but it can be seen that there is little wear on the bricks and therefore they are a late addition. In the Pantry the floors are broken and worn and pass under the daubed partition.

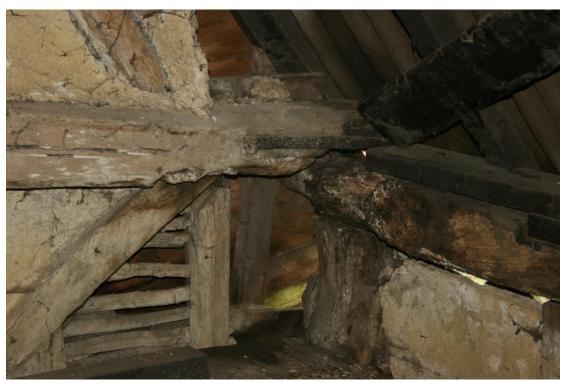
The tie-beam is fixed with an iron tie.

Marks on the brickwork of the chimney stack show there were two upper rooms before the roof was replaced. It is very likely there was a small landing and two partition walls. The eastern gable is still in place and shows the framing and lath and daub construction. The waney tie-beam is not jointed to the top-plate but is secured with a very rusty iron tie. The tie beam at the other end of the building is a large reused timber correctly dovetailed in.
